Experimental observations of an 8 m/s drop test of a metallic helicopter underfloor structure onto a hard surface: part 1

K Hughes*, R Vignjevic, and J Campbell

Crashworthiness, Impacts and Structural Mechanics Group, School of Engineering, Cranfield University, Bedfordshire, UK

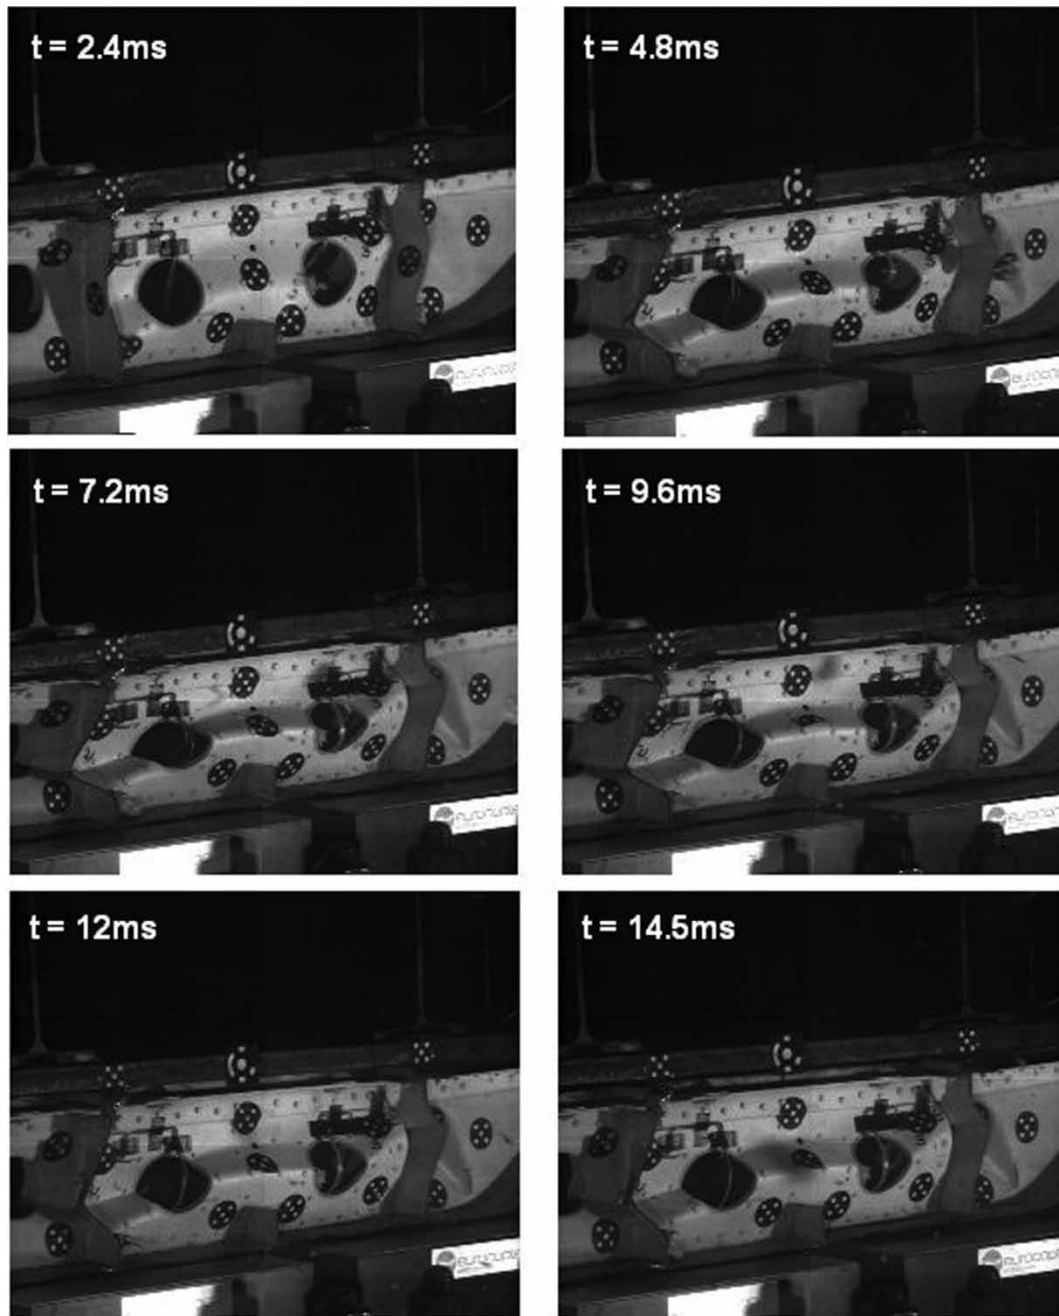
to the point where the first rebound occurs, 14.5 ms after initial contact. As can be seen, there appears to be no observable material failure, as damage is limited to frame folding, coupled with the bending/buckling of the front extension pieces.

Fig. 4 Deformation sequence of STN450F up to the point of the first rebound, which occurs at $t = 14.5$ ms

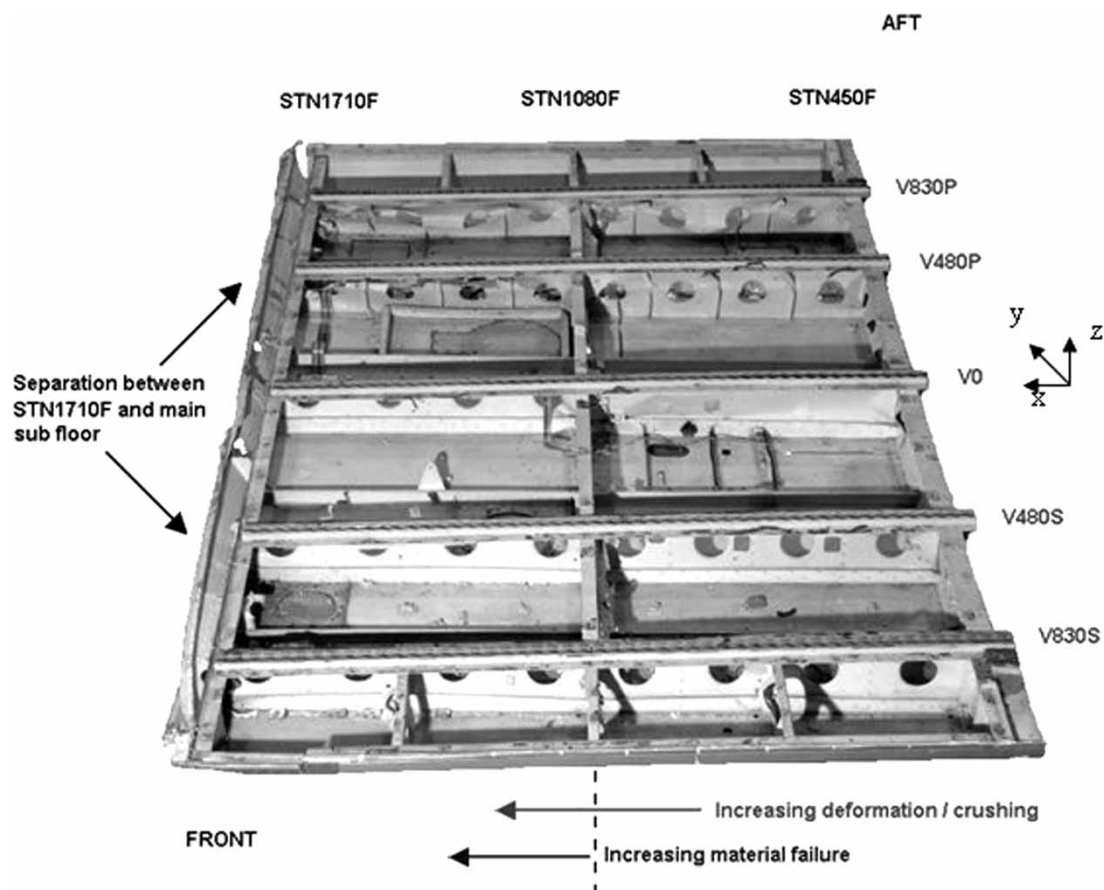
Despite the separation of STN1710F, the subfloor remains intact, with deformation observed in all longitudinal and transverse members, which is consistent with the nature of the distributed loading applied to the cross-section of the floor, due to the presence of the steel ballast plate. The degree of frame deformation is strongly influenced by its construction, as will be discussed in the next section.

One of the main features to note from the global view in Fig. 5 is the fact that the deformation is not uniform, as it is more severe towards the front half of the component between stations 1710F and 1080F. This asymmetry is caused by the separation between STN1710F and the rest of the subfloor. This loss in localized strength reduces the load-carrying ability in this region, permitting more deformation in the form of increased material failure and severity of the magnitude of the plastic hinges. Figures 6 and 7 provide a more detailed view of the damage to the forward and aft sections respectively, where only the port side is considered due to the similarities in the transverse direction either side of frame V0.

Fig. 5 Global view of post-test article where the instrumentation and passenger floor have been removed for clarity

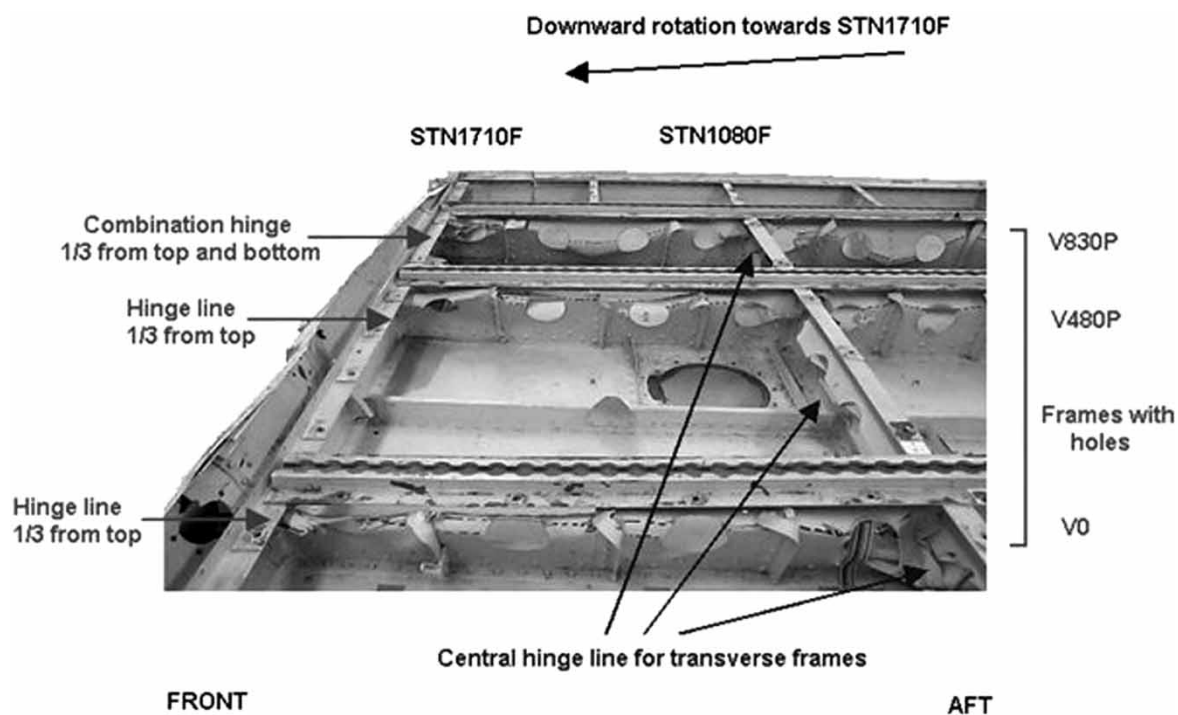
Fig. 6 Forward port side deformation observed between frames V0 and V830P

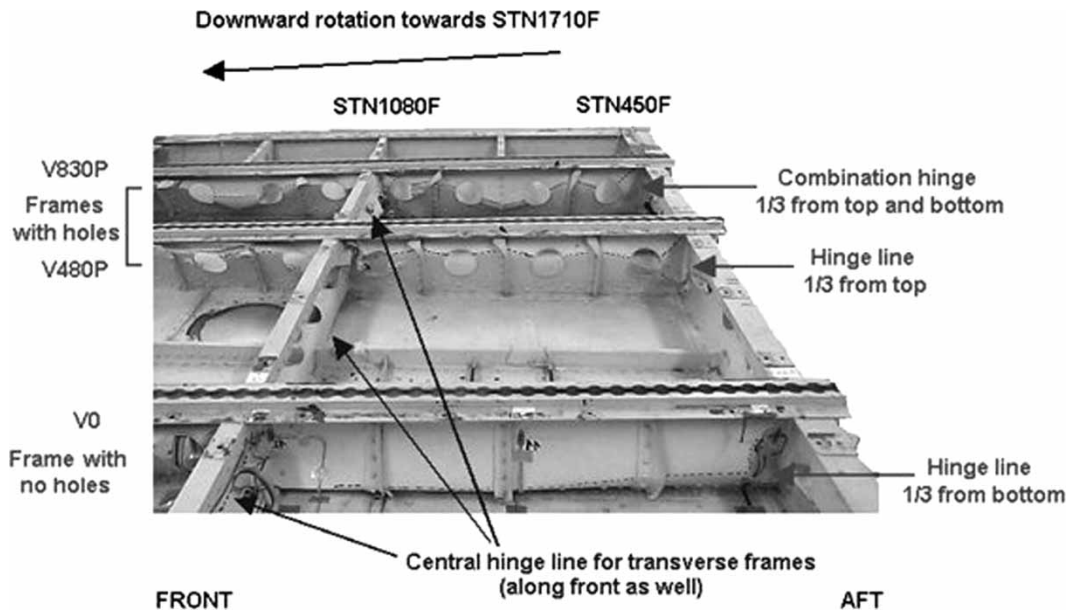
Fig. 7 Aft port side deformation observed between frames V0 and V830P

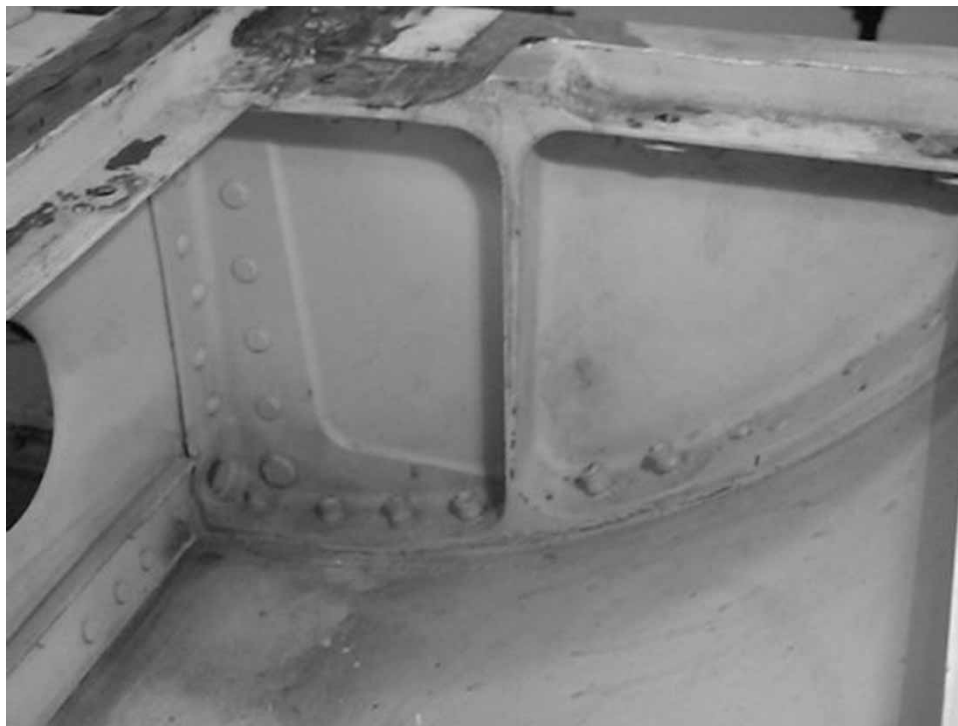
Very little deformation occurs at the doorframe attachment points located at the forward and aft sections of V830 port and starboard. This section is reinforced along both sides by reinforcing brackets, as well as with an I-beam section along its midpoint, as shown in Fig. 8. The lack of deformation is as expected, as the substantial nature of the construction will result in a higher collapse load when compared to the other frames in the floor. It is expected that this increase in failure strength at this location would result

in localized buckling in the main lift frames that are directly attached, due to the action of supporting the overhead masses.

Fig. 8 Interior view of the starboard doorframe attachment point, which shows the degree of reinforcement incorporated into the design

This increase in the measured force at F3 is expected, due to the substantial nature of the construction along V830, coupled with the reinforcements that are present in Fig. 8. This lack of deformation, when compared to frames V480 and V0 is accountable for the difference in the peak force observed. For all three locations, the force reduces to a sustained level between 6 and 12 ms, before reducing effectively to zero after 18 ms.

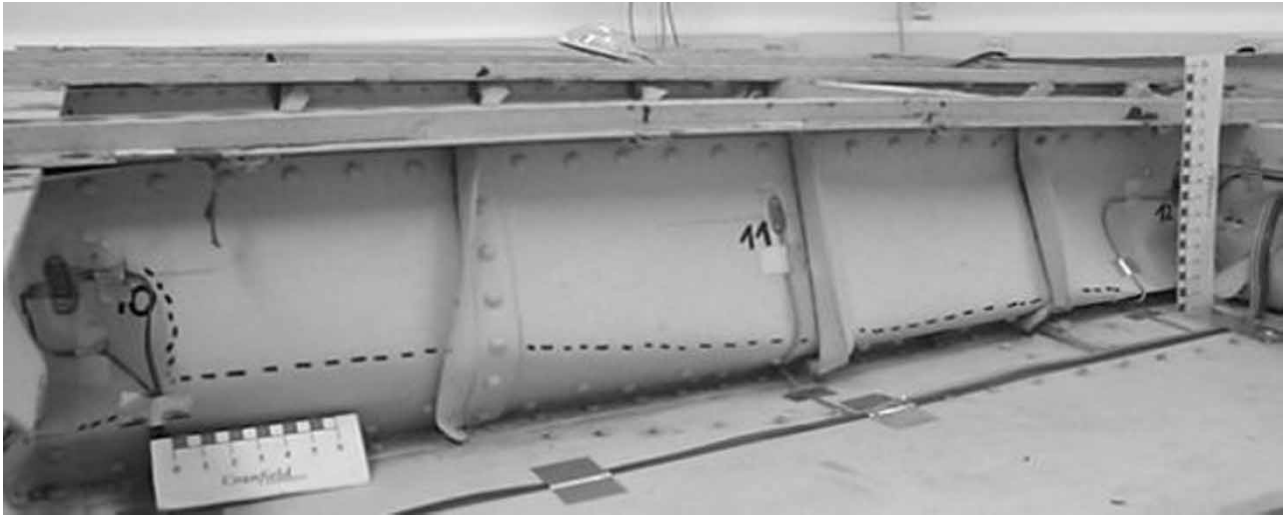
L-section stringers are directly attached. Riveted to the base, on the opposite side shown in Fig. 9, is a z-section stringer. The failure mode of this frame consists of a single hinge line that forms in the lower part of this frame, at a height corresponding to the top of the z-stringer. This positive outward buckle in the xz -plane results in the vertical stringers also adopting

this failure mode, causing small-localized material fractures at the location of peak z-stringer deflection.

Fig. 9 Global view of the failure mode for frame configuration no. 1, V0

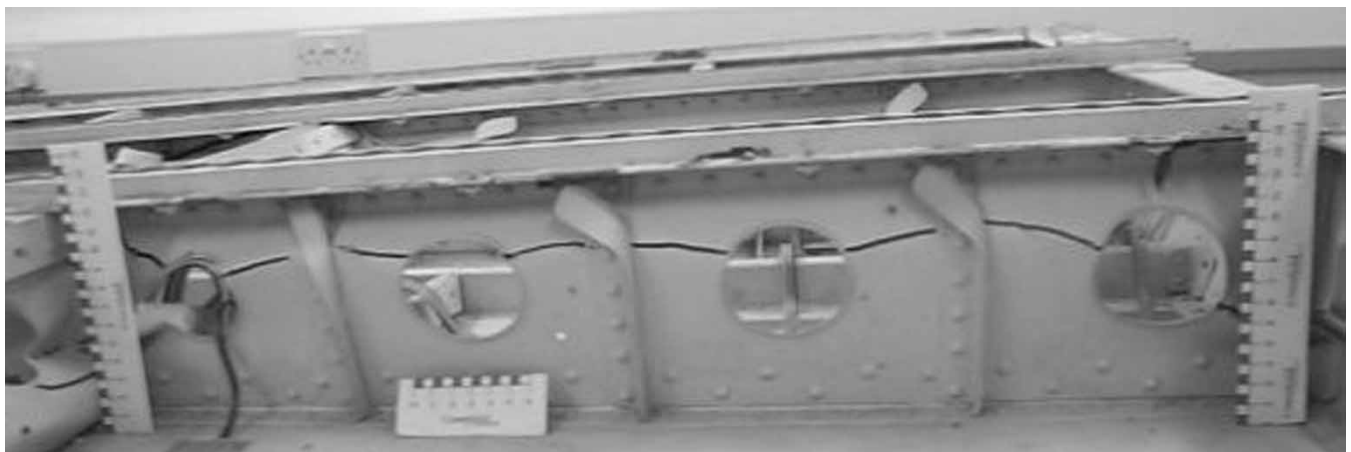
Fig. 10 Global view of the failure mode for frame configuration no. 2, V480P

The failure mode is opposite to configuration no. 1, as the dominant hinge line forms in the upper part of this frame, because of the high-stress concentrations around the cutouts. The vertical stringers reinforce this frame and deform in the positive x -direction, at a location corresponding to the peak deflection of the main plastic hinge line.

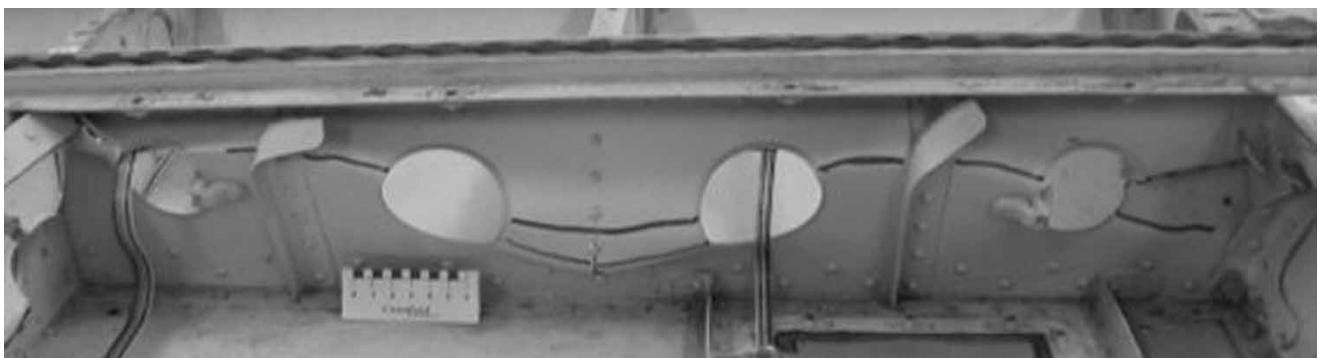
Fig. 11 Global view of the failure mode for frame configuration no. 3, V830P

The final frame configuration is similar in construction to configuration no. 2, except this frame does not have a vertical stringer located at the mid-point. Instead, this frame is directly riveted to a curved transverse end-frame, which provides the vertical support. Despite construction being similar, the failure mode is a combination of the other two configurations, as hinge lines form in both the top and lower parts of the frame. The difference in failure mode can be attributed to the end-section providing a buckling trigger that causes this large out-of-plane deflection and the lower hinge that is observed.

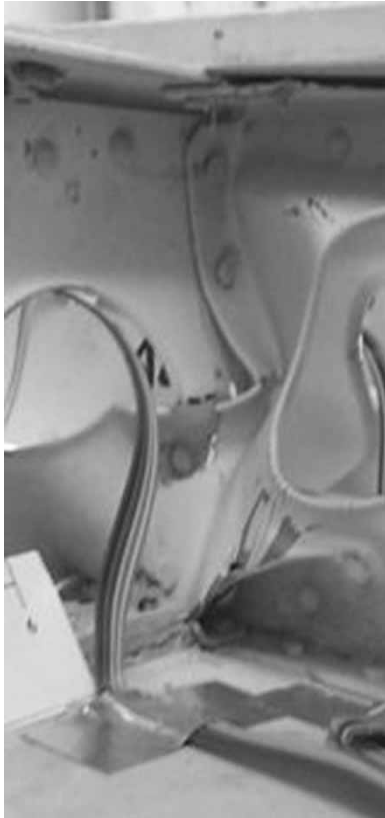
During a hard surface impact, the intersection joints together with the reinforcing L-stringers stabilize the collapse mechanism by providing support to the connecting frames that buckle under the loading. As can be seen in Fig. 13, the intersection joints also absorb part of the impact energy by buckling. The reduced height of the joints are small, with heights differing by up to (15 ± 1) mm, which indicates that very little energy is being absorbed with the current design.

Fig. 13 Behaviour of a typical intersection joint for a hard surface impact (V0 and transverse mid-frame)

This indicates that joint design is one area where significant development should occur, either through a change in geometry and/or the inclusion of a trigger in order to take advantage of the stroke that is potentially available. The progressive failure of these joints will be critical to allow increased and controlled frame collapse.

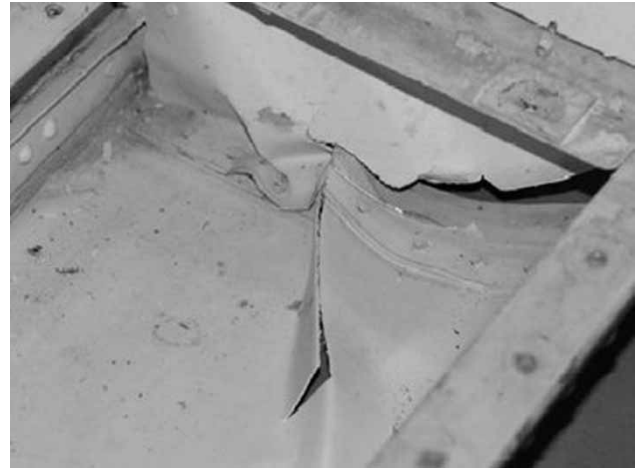
As expected, the skin plays no role in the energy absorbing process and remains primarily undeformed. The only observed damage occurs along the boundary between the curved end-sections and the ground, due to the compression of the hinge line that forms, as shown in Fig. 14.

Fig. 14 Localized skin-material failure that occurs along the curved end-section of the skin at the intersection with STN1710F

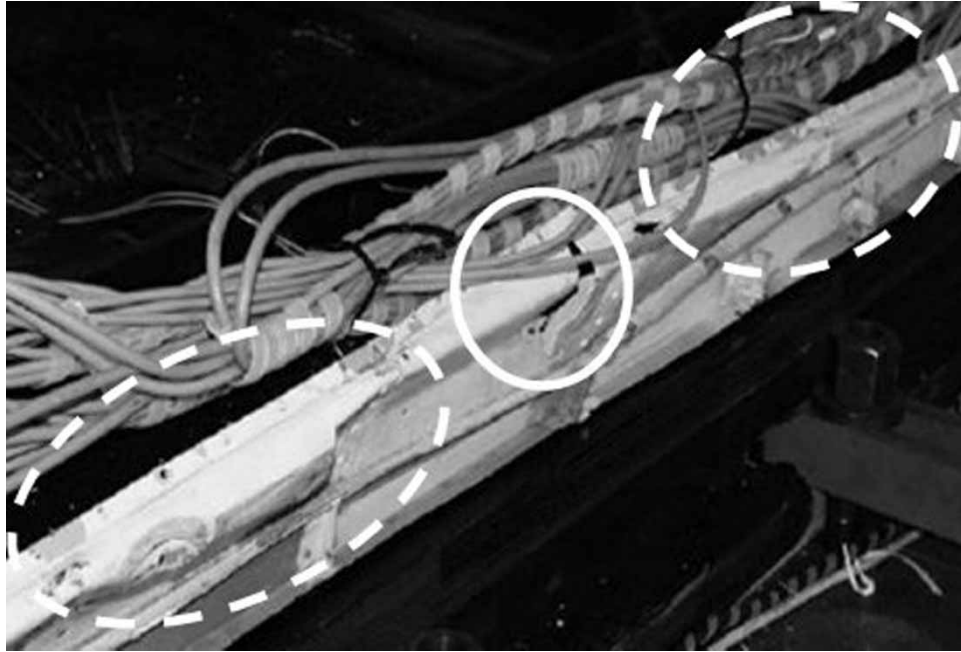
The failure of these rivets did not occur upon contact, as the frame deforms in response to the impact loading as Fig. 15 demonstrates. It is clear to see the dominant plastic hinge line that forms (dashed circles), which results in the buckling of the two halves of this frame at the intersection with V0 and the failure of the interconnecting rivets (solid circle).

Shear failure of the rivets attaching STN1710F to the aft part of the component floor was attributed to a change in load path caused by a rotation of the steel loading plate around the central connecting I-beams of the guided trolley assembly. The cause of this rotation was due to an unexpected flexibility of the joints connecting the four transverse I-beams in Fig. 3 and the central guided I-beam. It was assumed that these connections would be rigid, which was not the case upon post-processing the results. This rotation was unexpected, as the test rig was designed to constrain movement in the vertical direction only. This rotation was detected through laser-displacement sensors tracking the motion of the steel plate in Fig. 16, together with the asymmetry of the damage observed. The velocity time histories were obtained from the displacement results and can also be found in Fig. 16. Despite the differences recorded by the two lasers, the results provide well-defined markers for when the floor is brought to rest, as the rebound occurs between 12.5 and 20 ms, which corroborates what is observed by the high-speed cameras.

Fig. 15 Isometric view of STN1710F showing the location of the dominant plastic hinge line (blue) and the failure of the rivets (red)

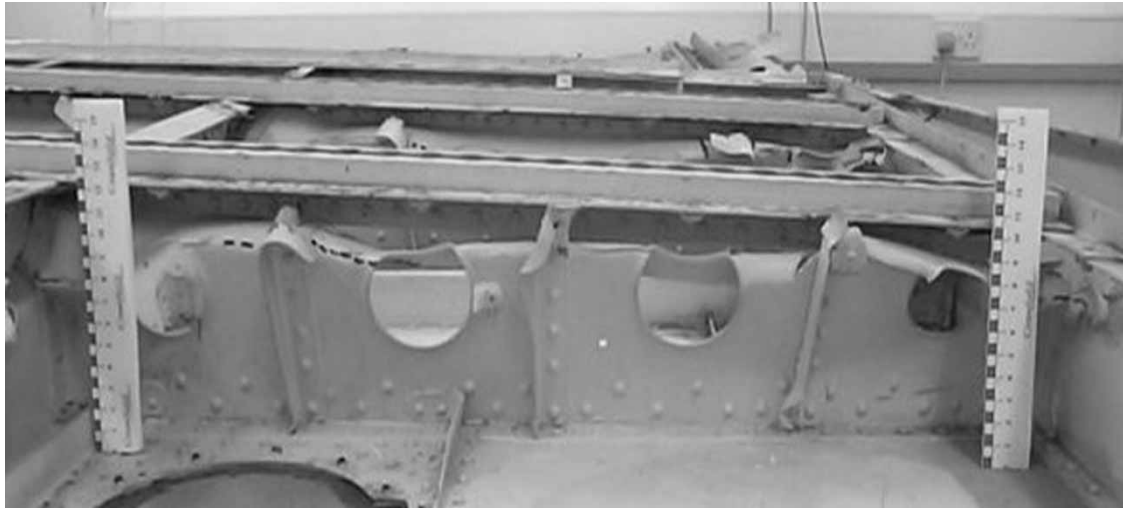
Fig. 17 Aft section of V480P showing the difference in height at the intersection with STN1080 (left) and STN1710 (right)

Fig. 17 that material fracture in the longitudinal frames has enabled the upper seat track to travel further, which has been estimated using the deformation of the surrounding components shown in Fig. 18. This photograph suggests that the seat rail has travelled a further 30 mm due to the tearing of the vertical supporting member, before elastically unloading to its final deformed height.

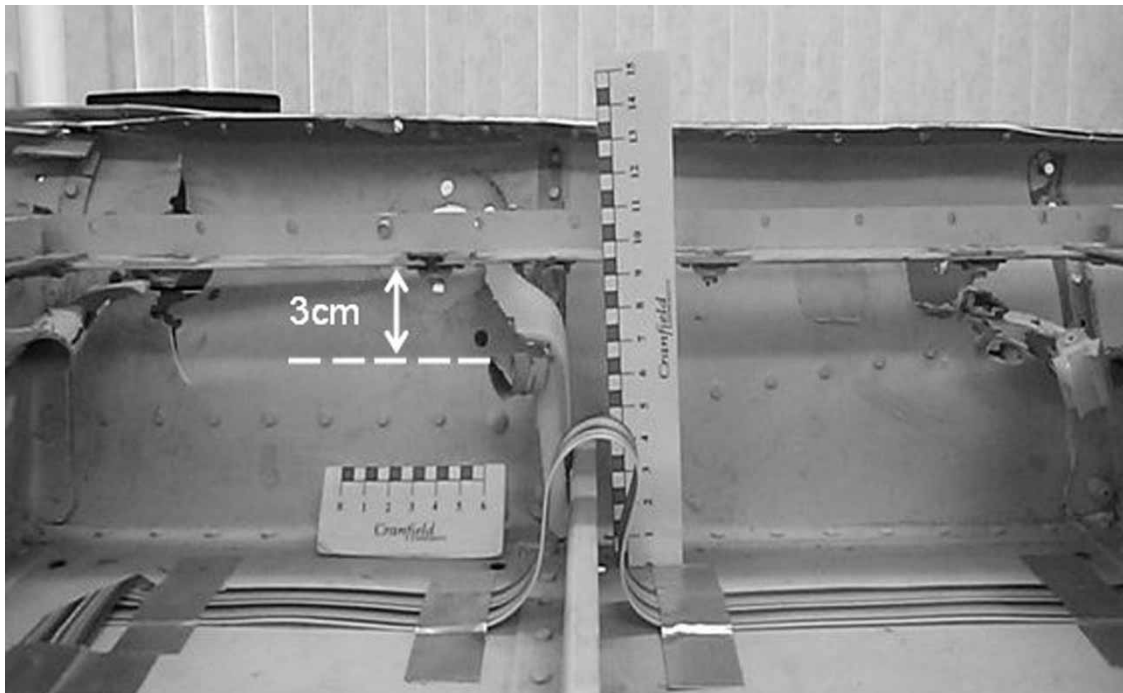
Fig. 18 STN1710F located between frames V0 (left) and V480S (right)
