Conversion of
DOUGLAS DAKOTA G-AMZE
for
WITH AUTOPILOT TYPE D DEVELOPMENT

Contract No. 6Aircraft/8911/CB24(a)

CONVERSION OF
DOUGLAS DAKOTA G-AMZE
FOR
SMITH AUTOPILOT TYPE D DEVELOPMENT
Contract No. 6Aircraft/8911/CB24(a)

Prepared by
A. FIRTH
of the
Department of Flight
College of Aeronautics

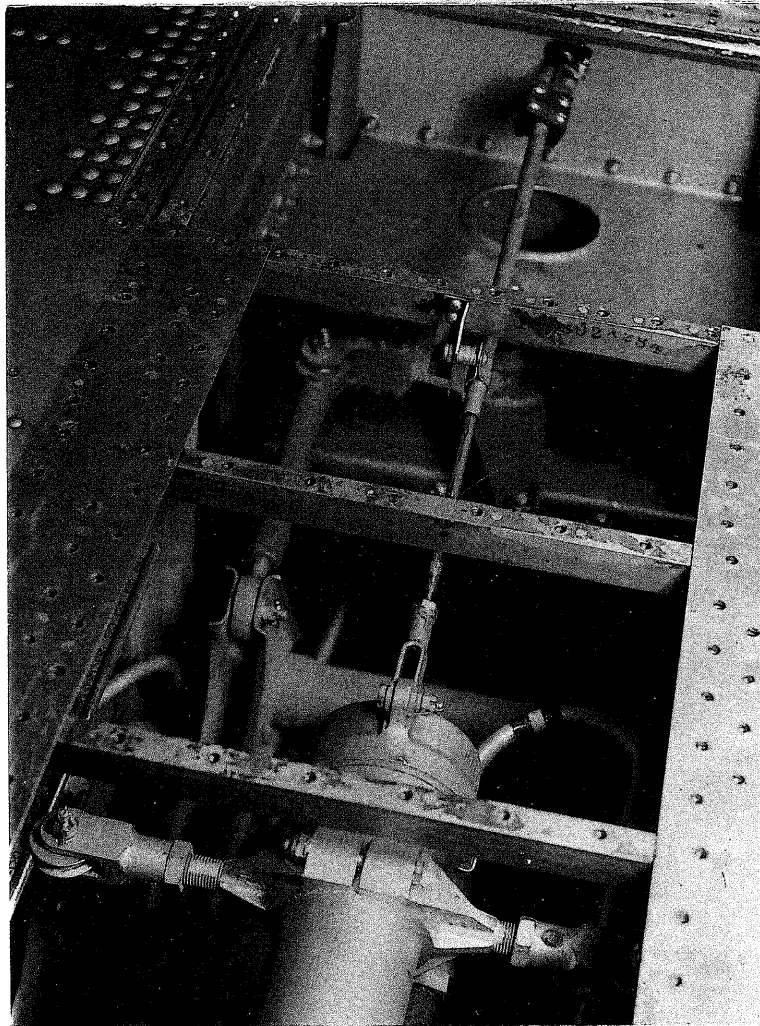
Fig.1. Aileron Servo Linkage looking forward.

The servo motor is mounted on two stiff Z section members which are rigidly bolted to the cabin floor. The drive is by a push rod passing through the cabin floor into the Flap Jack bay, and picking up on a bell crank lever which has been mounted in the bay to swing fore and aft in the vertical plane. This bell crank lever then transmits the drive forward, (by the smaller push rod) direct to the existing double bell crank lever mentioned above and thence to the ailerons through the present control cables.

A movement of $49\frac{1}{2}^{\circ}$, from neutral, produces full aileron deflection (i.e. total movement of drive lever is 99°). The servo motor and desynn transmitter are enclosed under a box type cover which is easily removable to provide full access to the units.

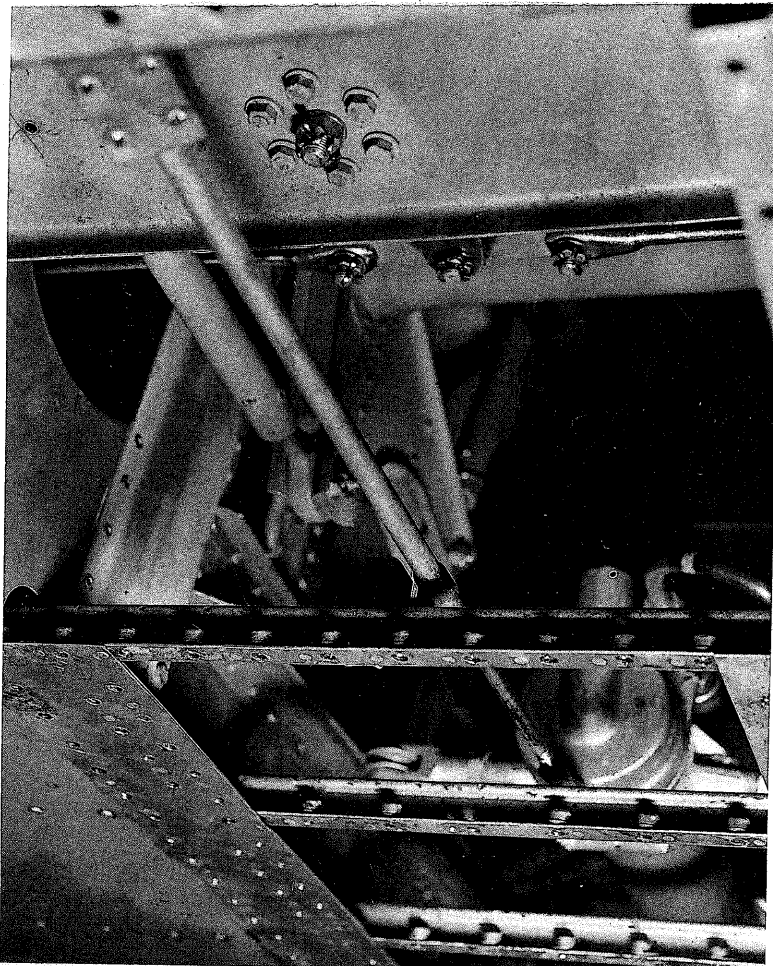
Fig.2. Aileron Servo Linkage looking aft.

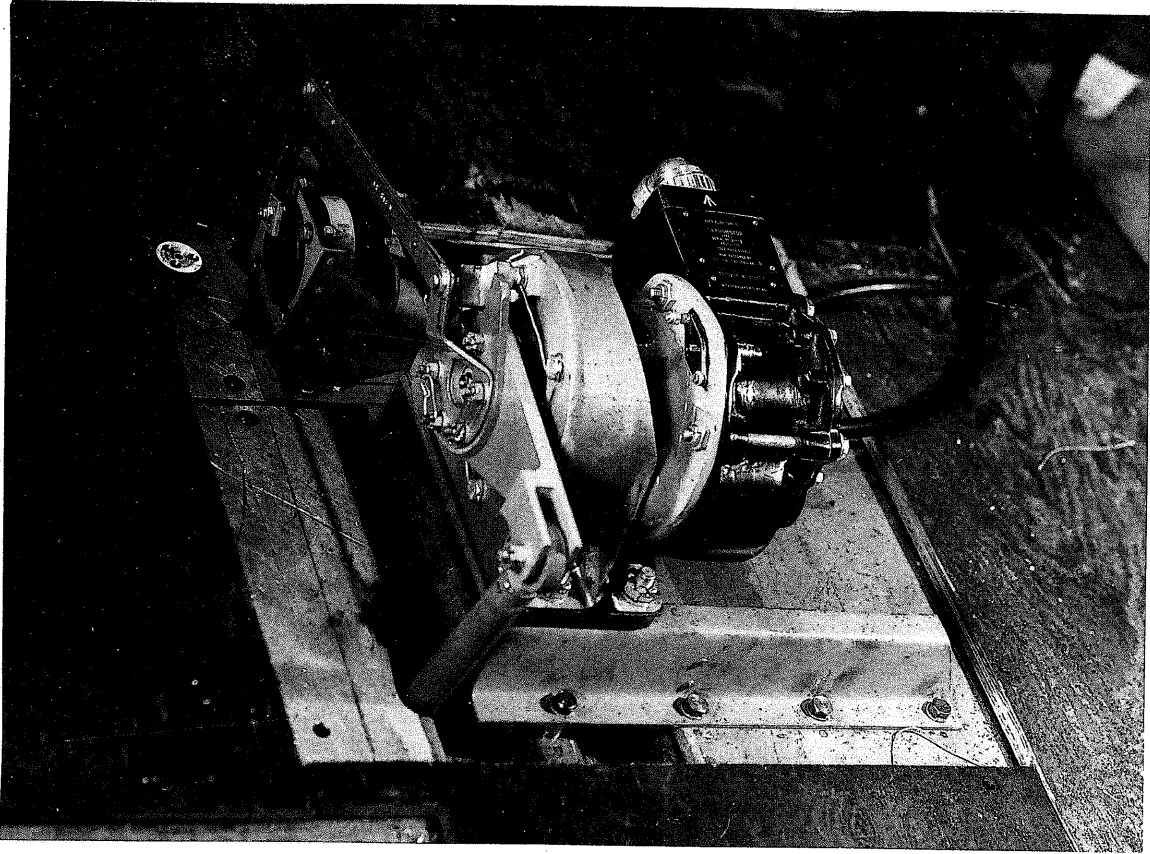
Fig. 3. Aileron Servo and Desynn installation

Fig. 4. Aileron Servo installation

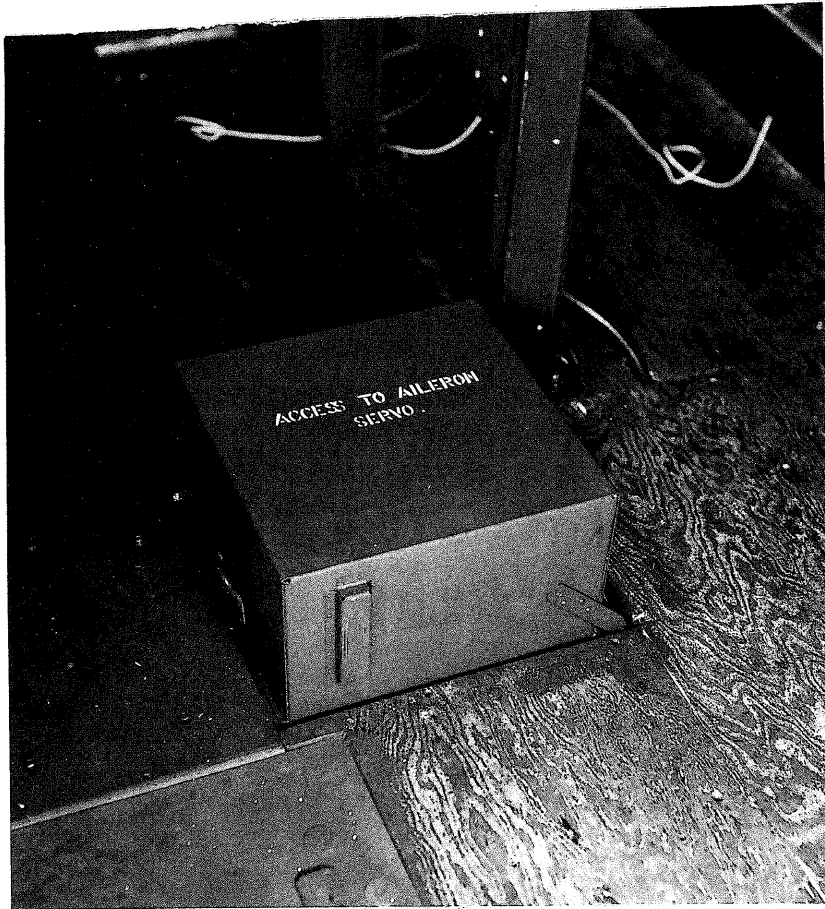
Fig. 5. Aileron Servo showing hinged protective cover in position

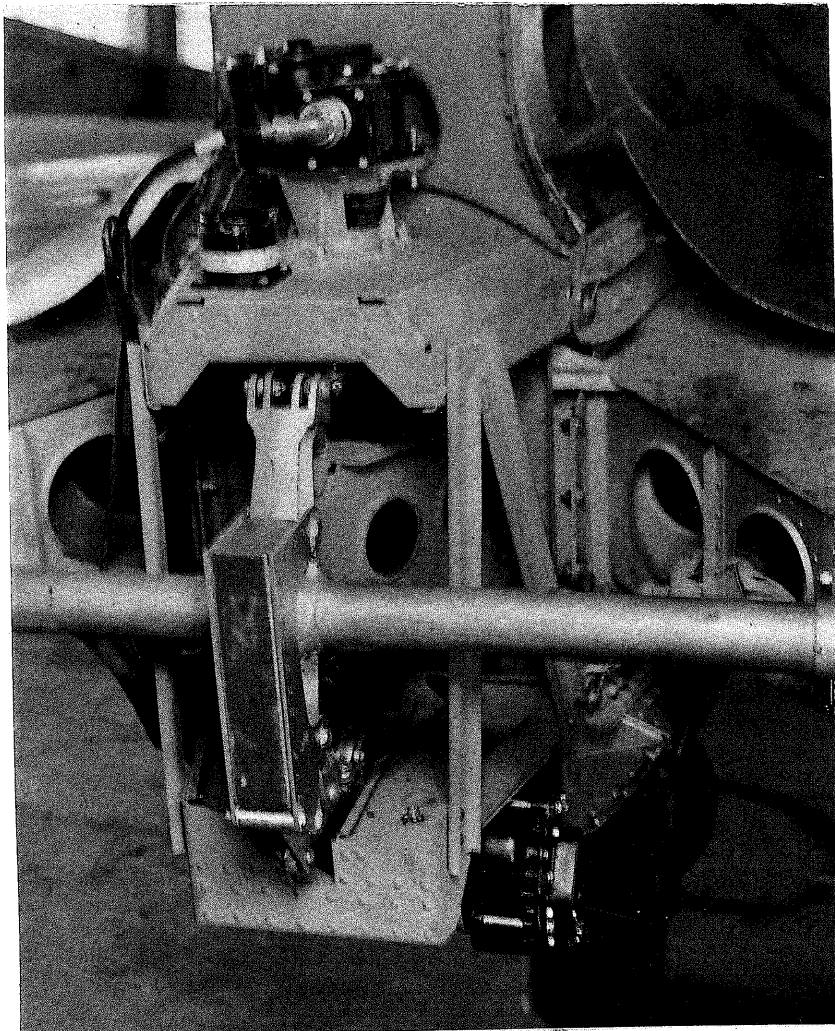
Fig. 6. General view of Rudder(Top) and Elevator(Lower)

At the extreme tail of the aircraft, enclosed by the fuselage tail cone, are four heavy lugs, formerly used for the attachment of a glider towing pylon. Two rigid platform, one above the other and approx. 14" apart, have been bolted to these lugs. On the lower of the two platforms the elevator servo motor has been mounted with its drive lever in the vertical plane and moving fore and aft. The drive is transmitted, by the short connecting rod, to a fabricated lever which is bolted to the existing forged lever, on the elevator torque tube, by two shear bolts passing through the web.

The total elevator movement is 50° (30° up and 20° down) and with the elevator in the mid-travel position (not neutral) the servo motor drive lever movements to give full up and full down elevator are respectively $46\frac{1}{2}^{\circ}$ and 49° giving a total drive lever movement of $95\frac{1}{2}^{\circ}$.

A blister fairing has been added on the lower Starboard side of the tail cone and removal of this fairing provides sufficient access to enable the elevator servo motor to be removed. If required however, the tail cone itself can be completely removed when full all round access to both rudder and elevator installations, will be obtained.

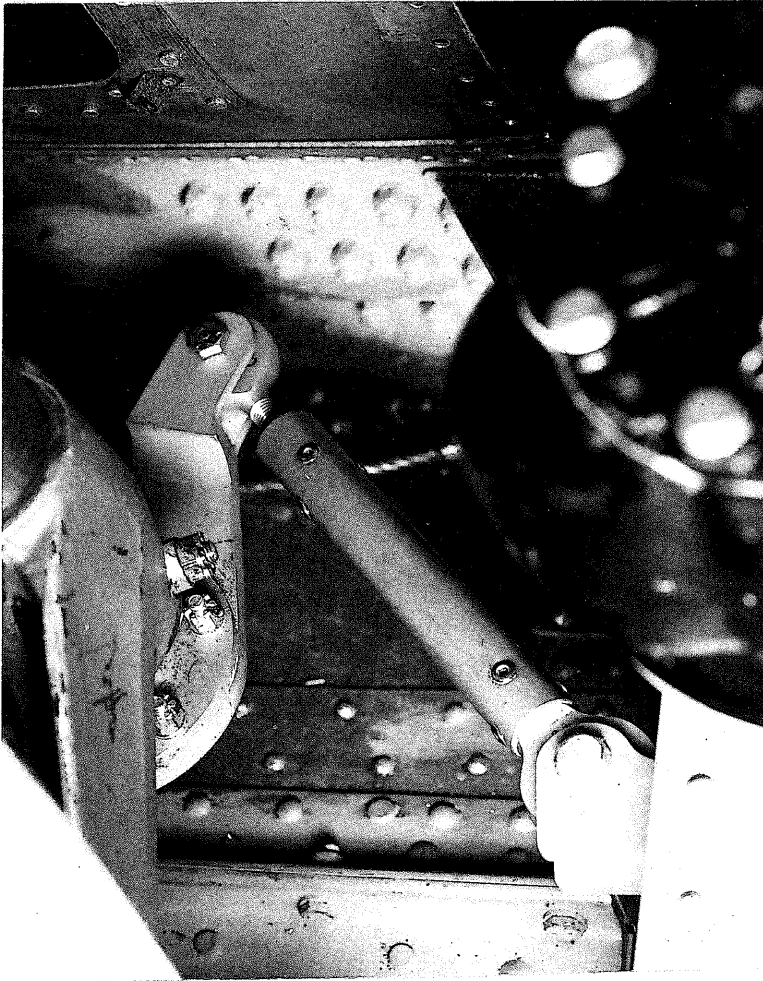
Fig. 7. Rudder Servo Linkage

On the upper of the two platforms, at the tail of the aircraft, is the rudder servo motor, which has been mounted on the C.L. of aircraft with its drive lever moving in the

horizontal plane. The drive is transmitted by a short connecting rod to a lever which is bolted on to the lower end of the rudder torque tube. The rudder travel is 30° Port & Starboard and measured from the neutral position, the servo motor drive lever movements are, $52\frac{1}{2}^{\circ}$ for Port rudder and $47\frac{1}{2}^{\circ}$ for Starboard rudder giving an overall lever travel of 100° .

An existing access panel on the upper Port side of the tail cone has been enlarged to enable routine maintenance to be carried out and to provide also for removal of the servo motor. As stated previously however the whole tail cone can be removed, if necessary, to provide the fullest accessibility.

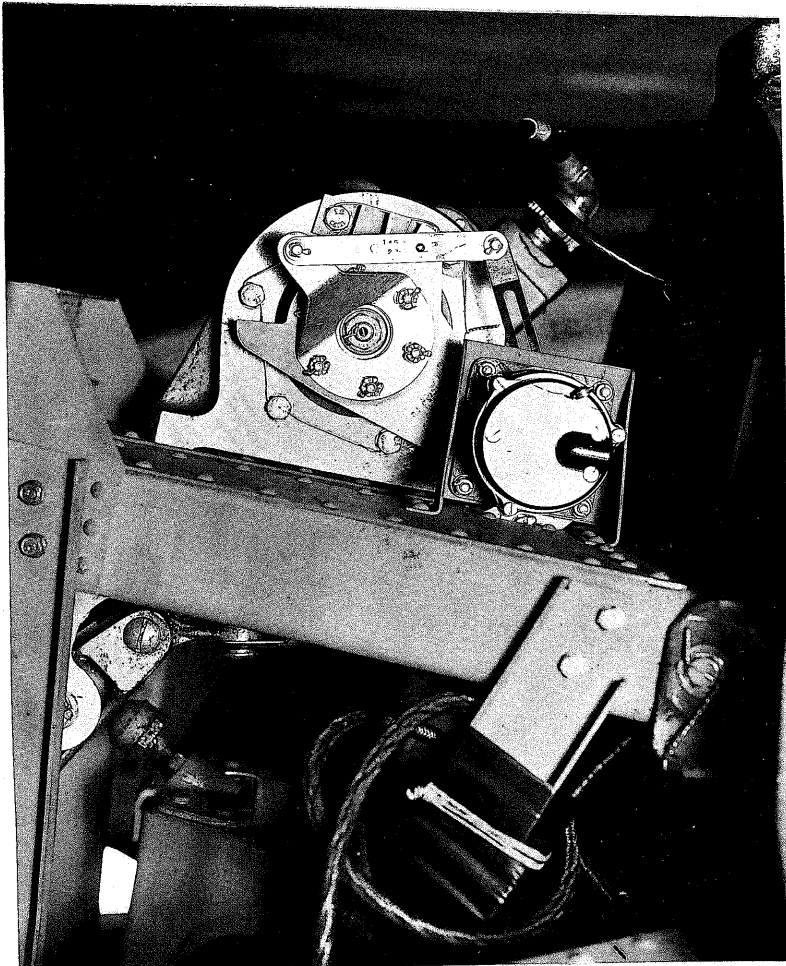
Fig. 8. Rudder Servo and Desynn layout

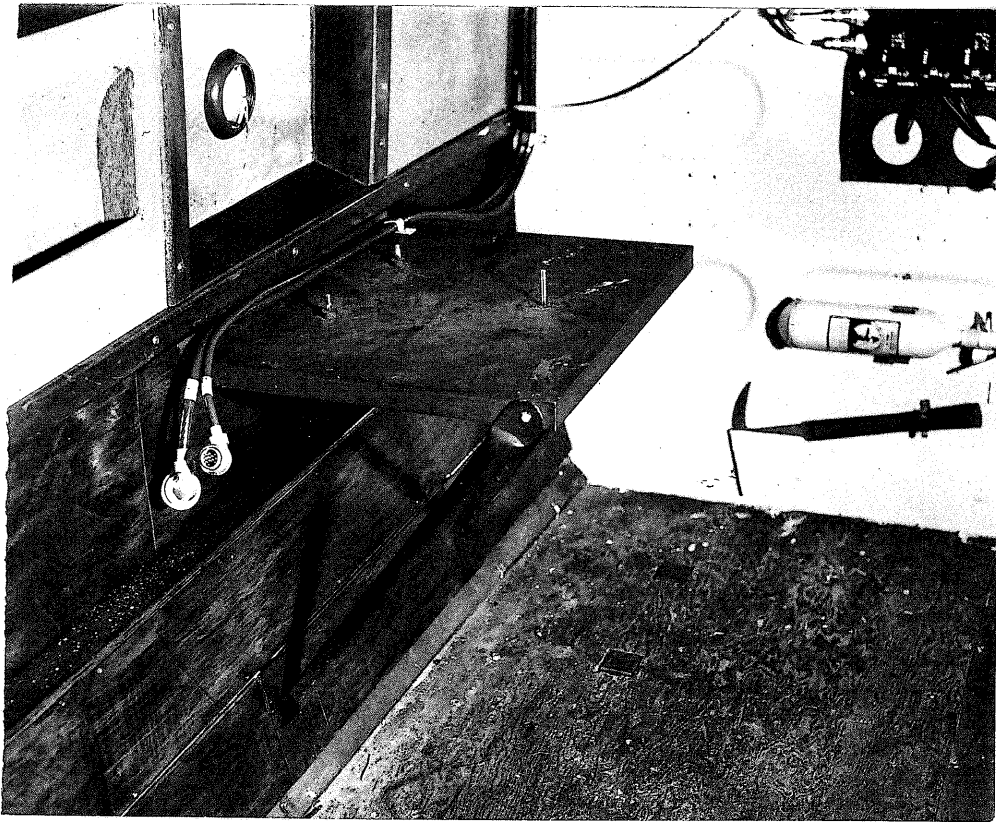
Fig.9. Auto Pilot Gyro Unit mounting table

In the aircraft cabin, on the Port side forward, a table has been erected to carry the Auto-pilot Gyro Unit. This table, which is bolted direct to the aircraft structure, is completely rigid and is provided with studs for mounting the Gyro Unit. The table is parallel to both fore and aft, and lateral datumms of the aircraft to within $\pm\frac{1}{2}^{\circ}$. The Unit is fully accessible.

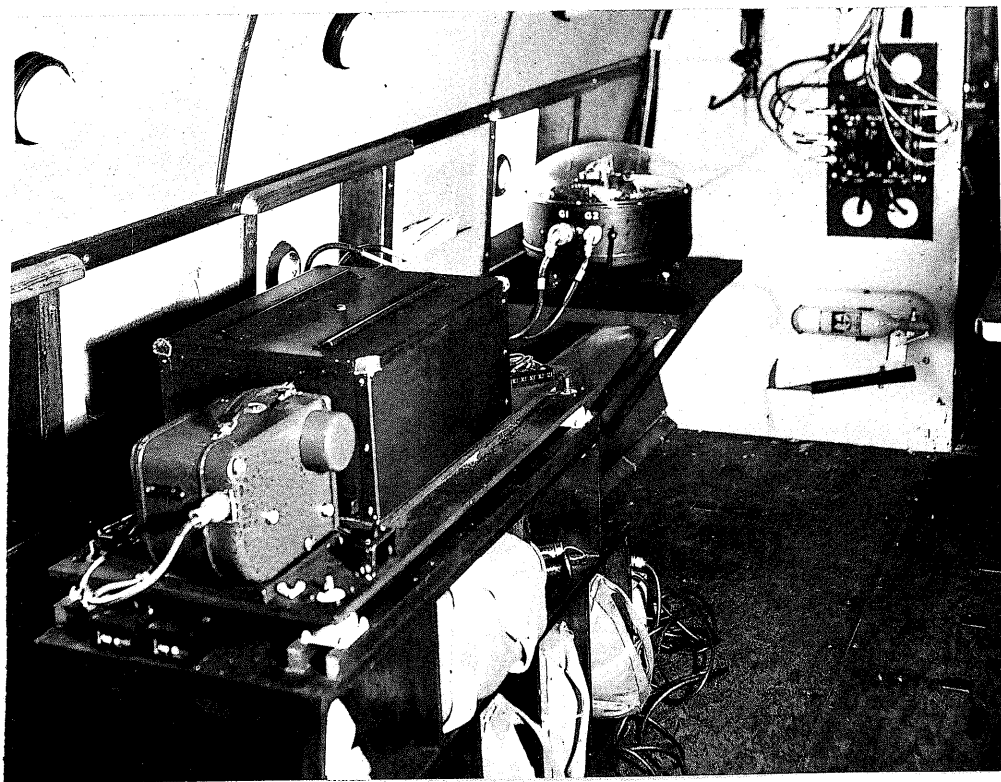
Fig.10. Parachute stowage with Auto Observer

When considering the design for this requirement it was agreed that it would be economical to embody the two items into one piece of equipment, i.e., to use the parachute stowage crate as the base on which to assemble the auto observer. A parachute stowage was constructed of plywood and

spruce with compartments to hold eight observer type parachutes. The method of attachment to the metal floor of the cabin is by top hat and right angled members rivetted to the floor, $\frac{1}{4}$ " bolts securing the stowage to these members.

Fig. 10 shows the type of box constructed; it will be noted that the back of the instruments are open to the cabin, thus allowing free access when making connections. The instrument panel is accommodated by two vertical slides lined with felt, thus it is retained in position by its own weight and is very quickly removable.

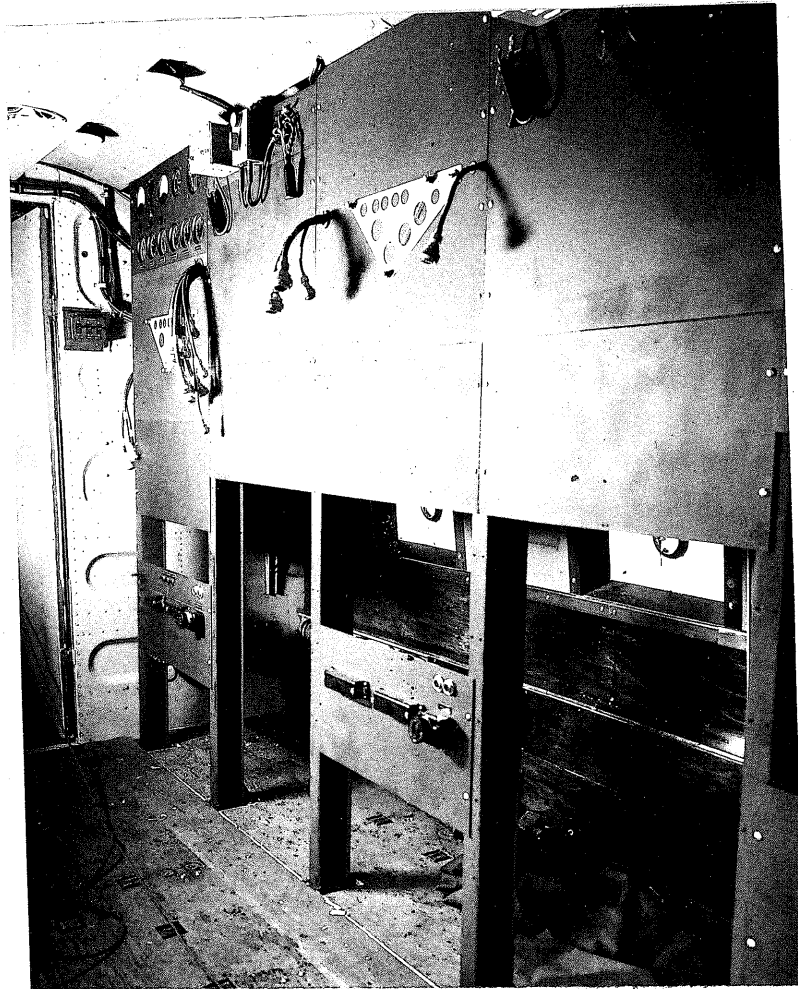
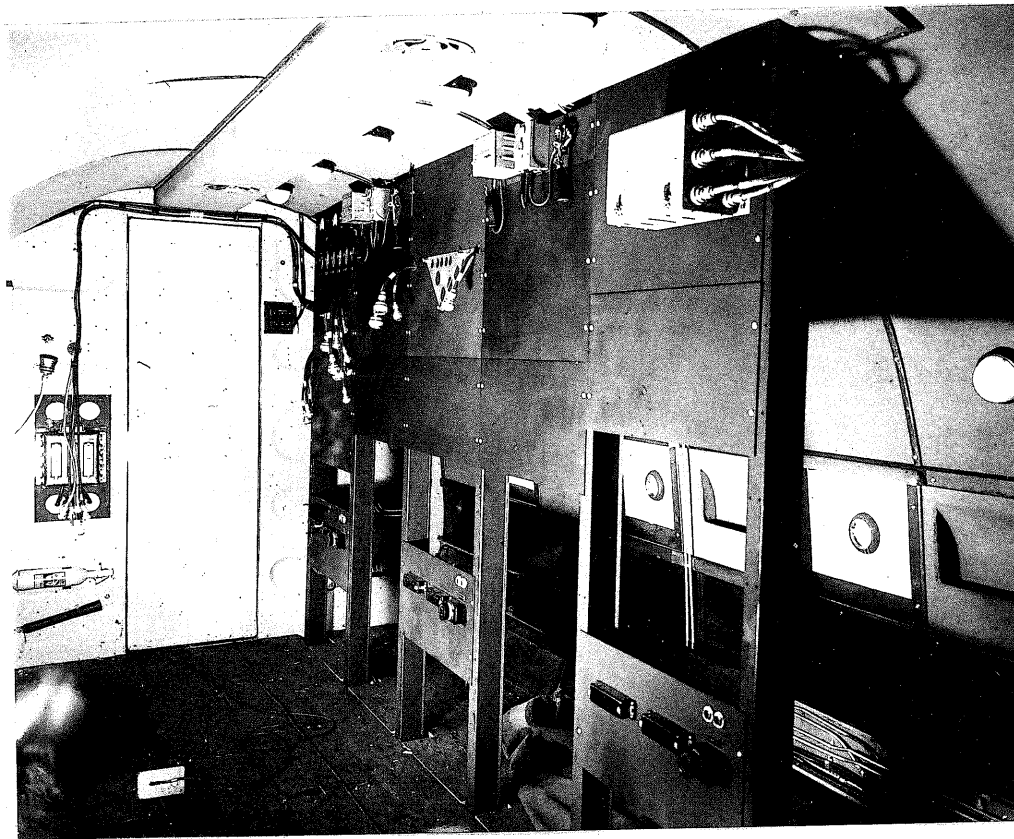
Fig.11. General arrangements of instrument panels

Fig.12. General arrangements of instrument panels

From the illustrations shown looking forward towards the cockpit, it will be seen that ample space has been allowed for operators to work at the front and rear of the panels, at the same time allowing free access to the cockpit area when the various units are mounted on the panels.

The six deep channel section vertical members are mounted to floor members at the bottom and to fuselage frame members and skin at the top, as shown in Drg.No.M146/1, the instrument panels being mounted by bolting to 2 BA Anchor Nuts attached at intervals to the channel section. Thus instrument panels may be added or deleted to Flight requirements with a minimum amount of work.

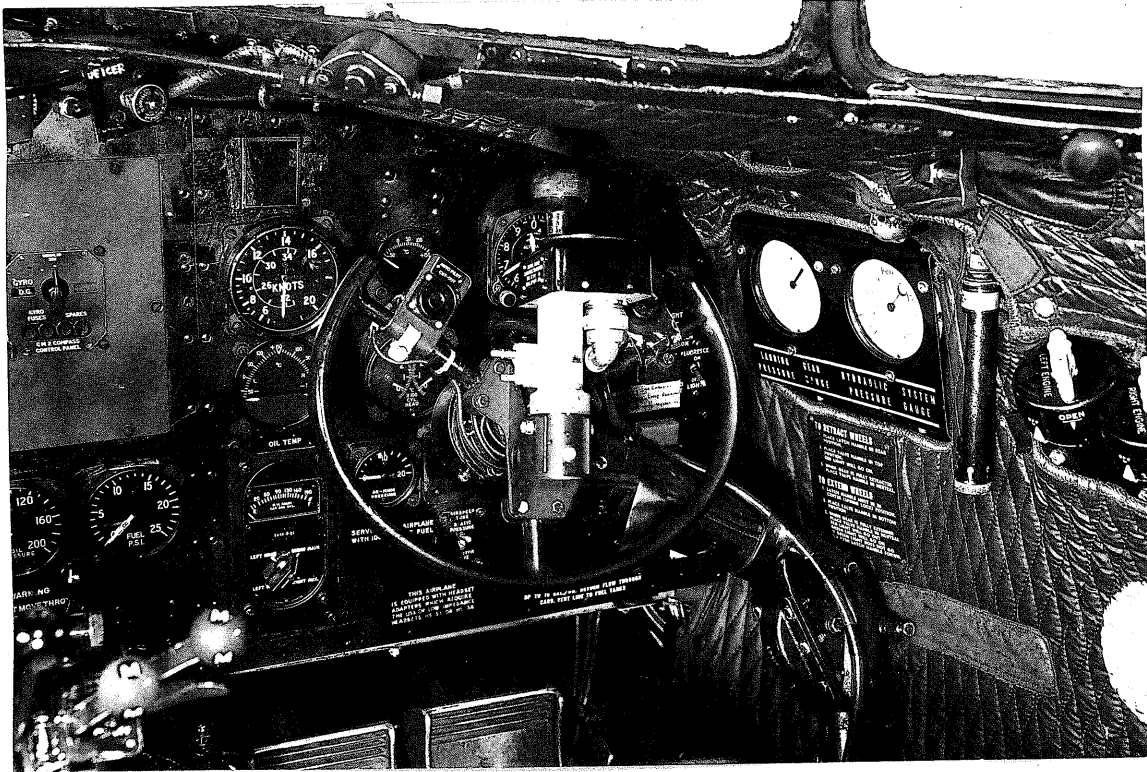
Fig.16 Stick Force Transmitter

A standard R.A.E. Two axis transmitter on aileron and elevator was supplied on loan from Smith's Aircraft Instruments. It was decided that the second pilot's control handwheel be used for installation, Figure 16 showing clearly the arrangements used for mounting. The Transmitter is easily removed from the control column for servicing by removal of two 2 BA Bolts and disconnecting the electrical connection.

All materials used in manufacture of the mounting are non ferrous owing to the close proximity of the magnetic compass.

Two desynn indicators are installed on the forward fuselage instrument Panel wired to the Transmitter through the aircraft 24 Volt D.C.system.

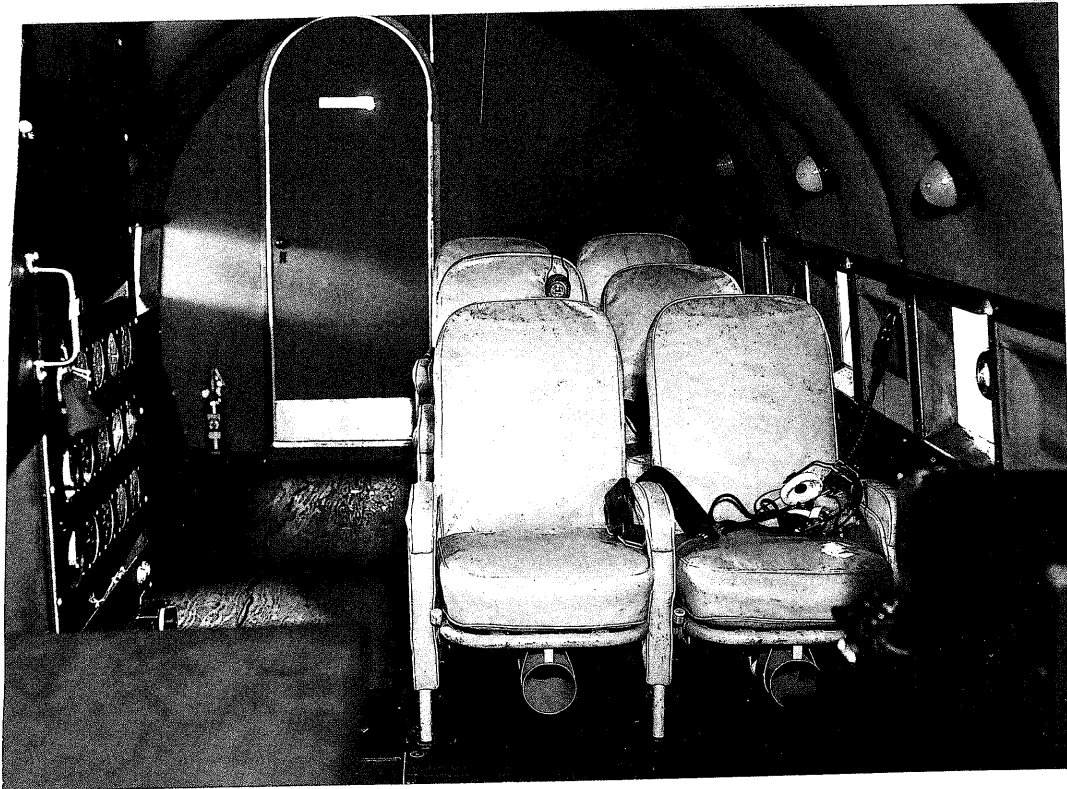
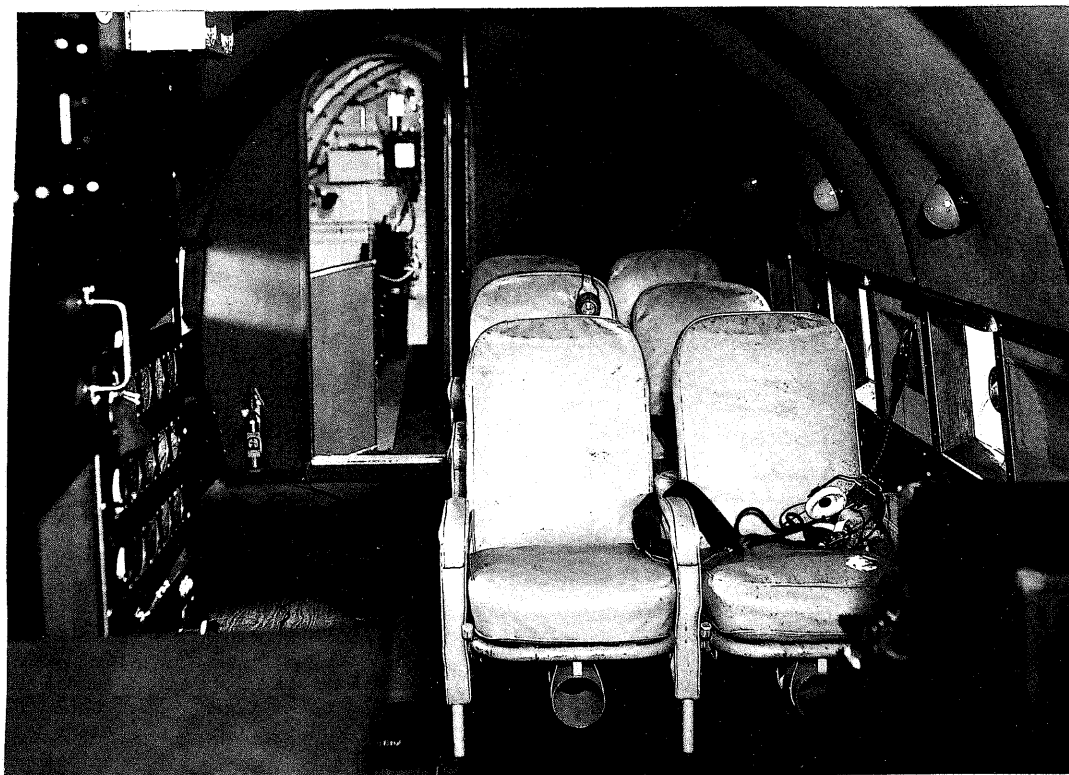
Fig.19(a) Interior of cabin looking aft

Fig.19(b) Interior of cabin looking aft

The aircraft as received was completely devoid of any sound proofing or furnishing and the floor was a standard metal type found in a military Dakota. The requirement for conversion was that the aircraft should be quiet to permit experimental flying under reasonable conditions at the same time improving the cabin heating qualities and lighting. The aircraft was therefore stripped of all Paratroop equipment, Troop seating, glider tow and stretcher carrying gear. It was then decided to divide the main cabin into two parts, the portion from the main entrance door aft to the rear fuselage bulkhead to house the inverters, and from the main entrance door to the front fuselage bulkhead to accommodate experimental equipment and seating.

- (i) A double walled bulkhead with door assembled just forward of the main entrance door, the crew operating portion could thus be segregated from the inverter station.
- (ii) A wooden floor assembled on top of the existing metal one
- iii) Sound proofing consisting of 1" thick felt covered by decorative fabric secured to wooden frames attached to fuselage members.

- (iv) From the window level to the floor the fuselage is covered with polished ply sections, all joints being covered with polished wooden beading.

Seating had to comply with A.R.B. requirements; this entailed purchase of three pairs of passenger seats from Scottish Aviation and installed to their approved drawings on the port side of the fuselage as illustrated.

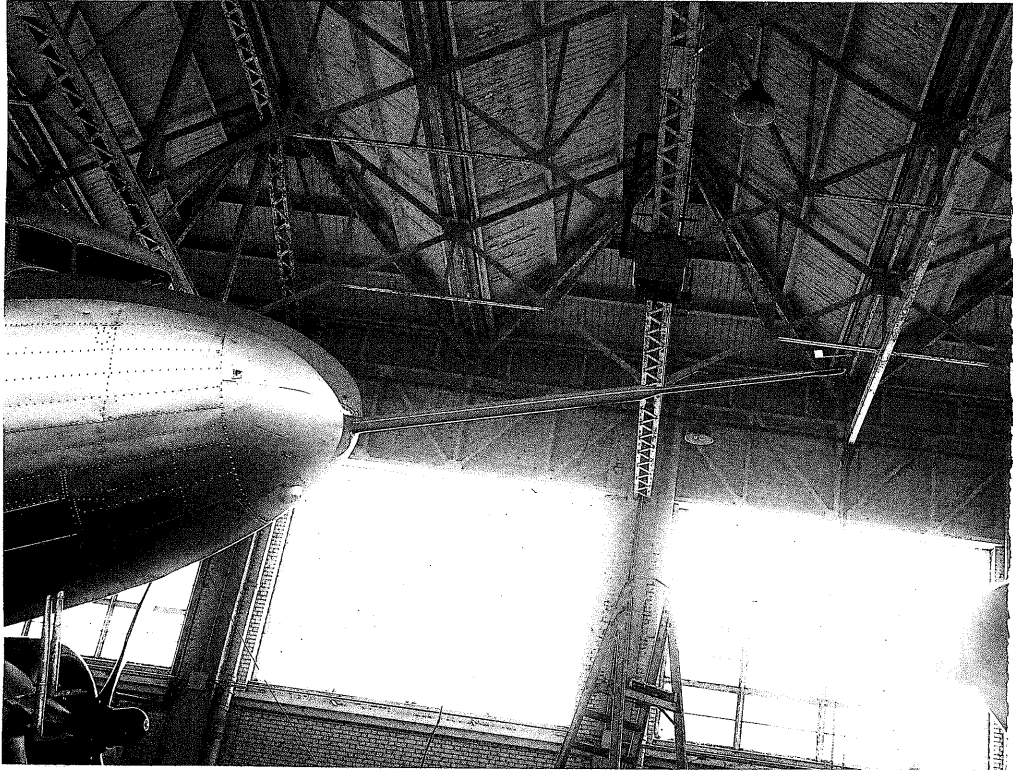
Fig.17. Yawmeter final assembly

One R.A.E. Mk.II Wind Vane was supplied by Smith's Aircraft Instruments. The installation of the wind vane pole was sited at the nose fuselage position immediately below the hinged portion, thus allowing free access. Method of attachment to the aircraft structure is by a light alloy socket secured radially by 2 BA Bolts and anchor nuts, the socket being secured to a back plate braced to fuselage Frame 20 by cross members and vertical channel members. Attachment to the nose skin is by a welded mild steel socket, the whole assembly being attached by 2 BA Bolts and Anchor Nuts. At the forward end a machined Light Alloy reduction fitting permits the fitting of the 1 $\frac{3}{8}$ " tube to the main 3" tube, the actual wind vane being attached to a light alloy machined fitting pressed into 1 $\frac{3}{8}$ " tube and secured by Pop Rivets. The whole assembly has been designed for quick removal of either the wind vane or the complete supporting tube. Wiring from the vane is led through the centre of the support tube and thence through the aircraft 24 Volt.D.C. system to the desynn indicator on the front fuselage Instrument Panel.

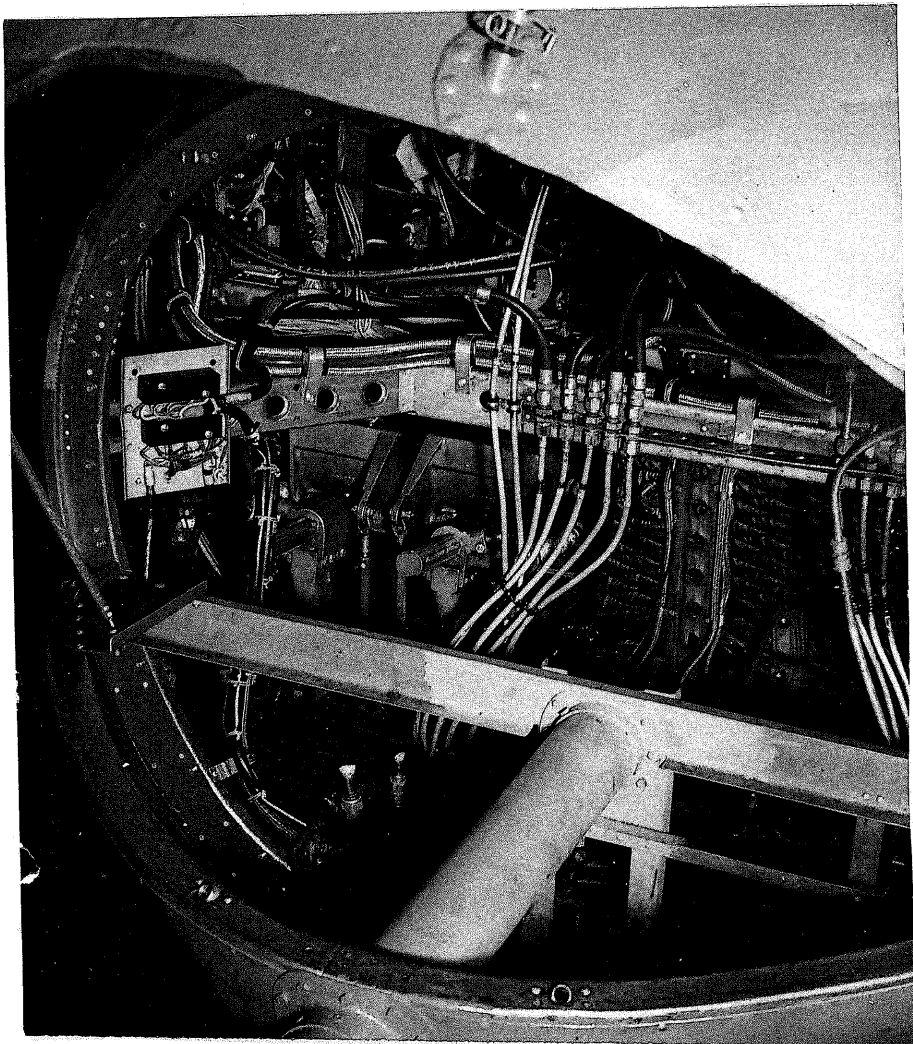
Fig.18. Mounting of Yawmeter pole
