Investigating accidents involving aircraft manufactured from polymer  
composite materials

School of Engineering

PhD

Supervisors: Prof. Graham Braithwaite & Dr. Matthew Greaves  
March 2013

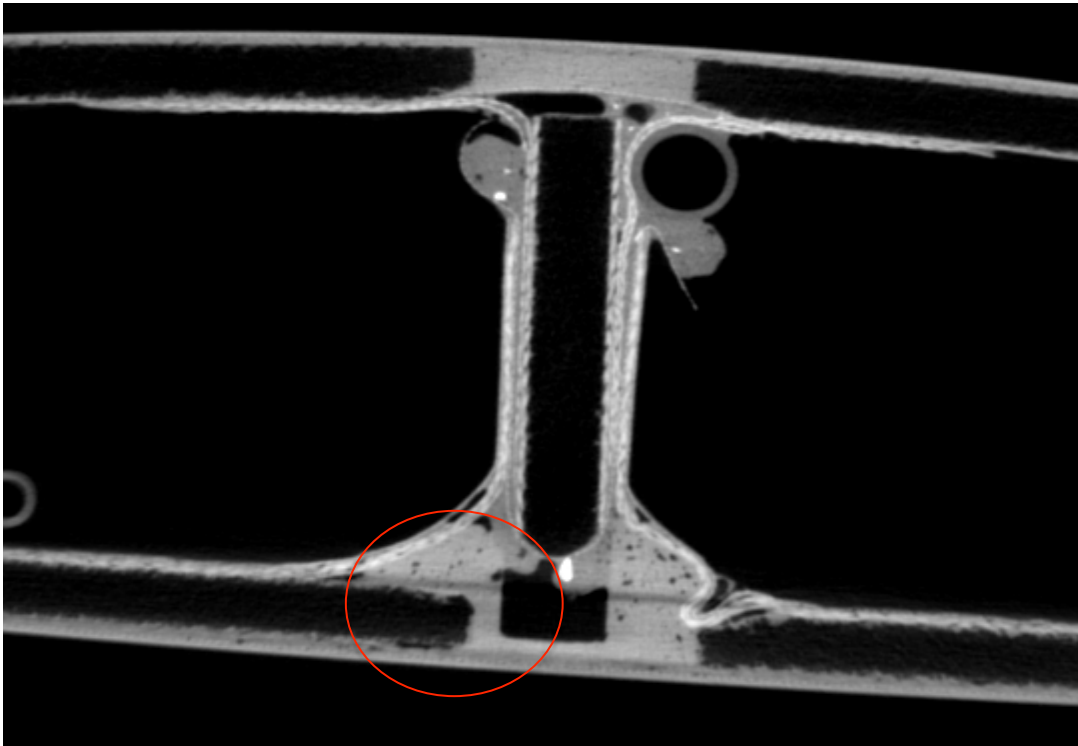
Figure 6-11 – CT slice through left hand wing tip section, lower spar cap anomaly highlighted (Source: Author)

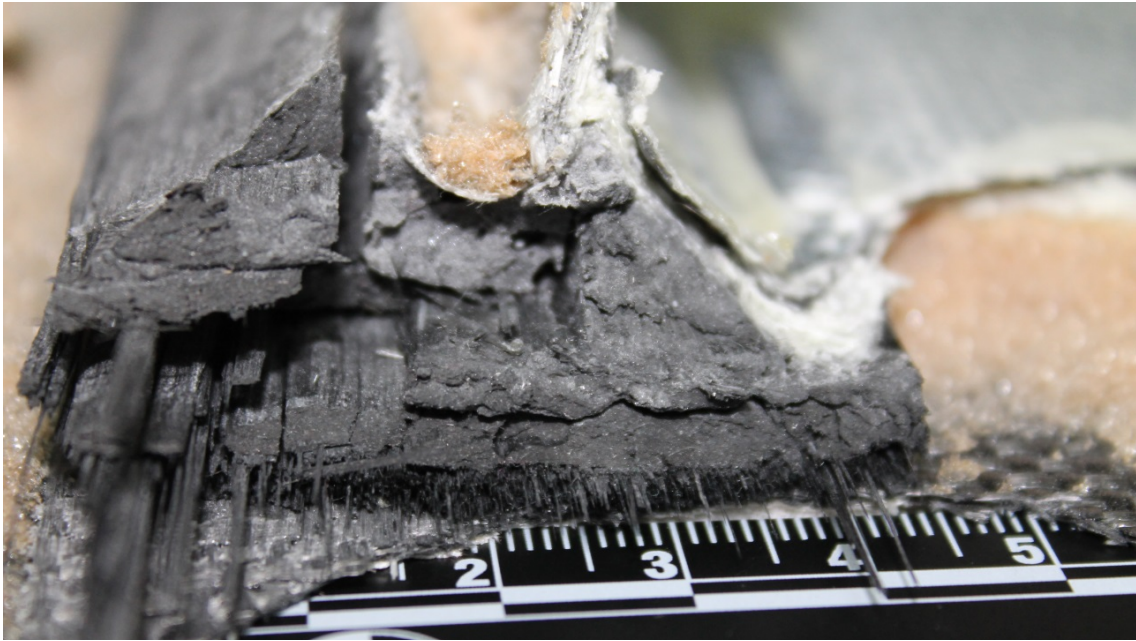
**Figure 6-21 – Lower spar cap from the left wing showing characteristics of flexural failure. Note the compressive fracture surface (Source: Author)**

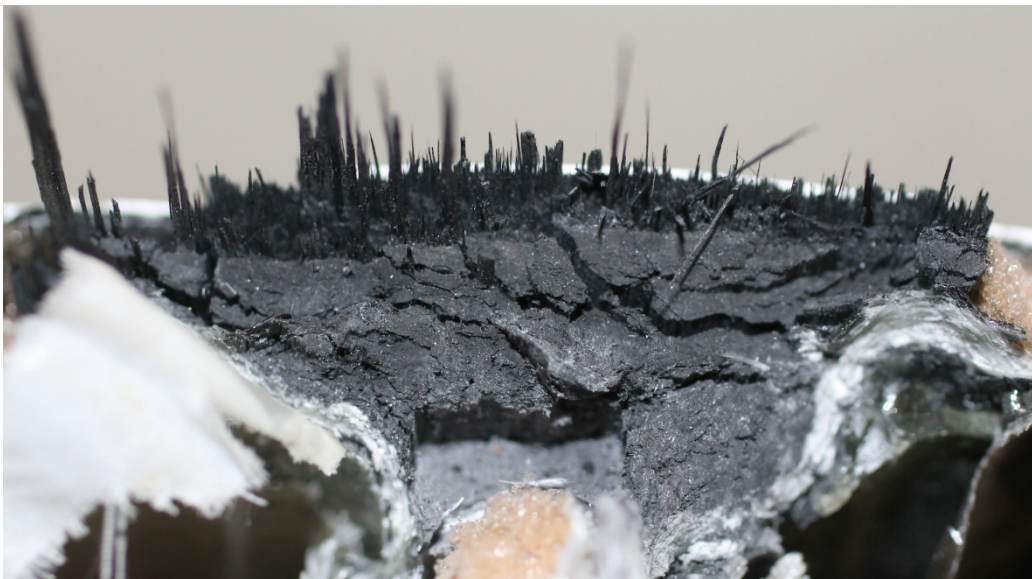
**Figure 6-22 – lower spar cap from the right wing (Source: Author)**

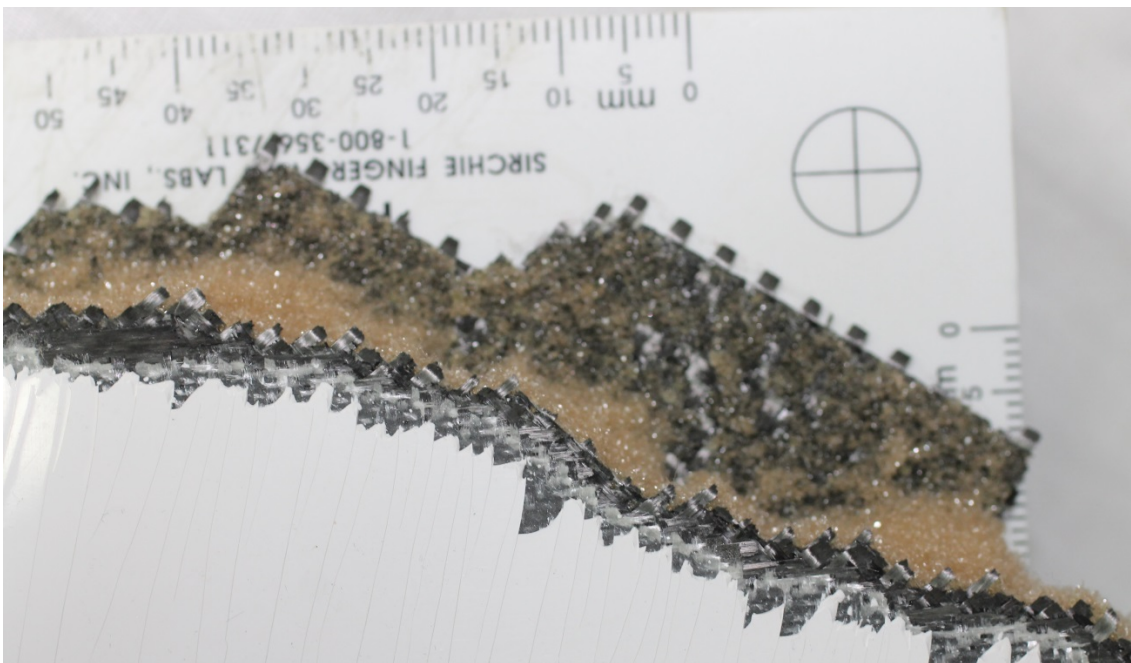
**Figure 6-23 – Lower sandwich structure from the right wing illustrating fibre pullout. The orientation of the protruding fibres are  $\pm 45^\circ$  (Source: Author)**

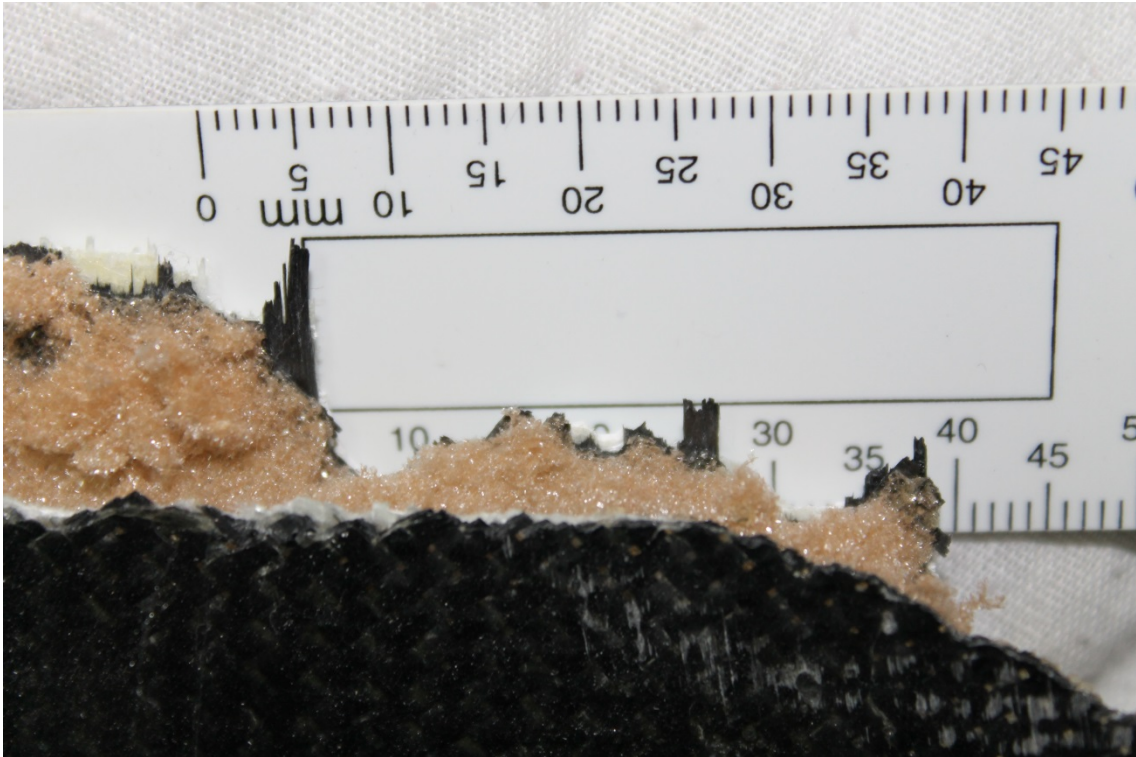
**Figure 6-24 – Lower sandwich structure showing evidence of tensile failure. The orientation of the protruding fibres are  $0^\circ$  (Source: Author)**

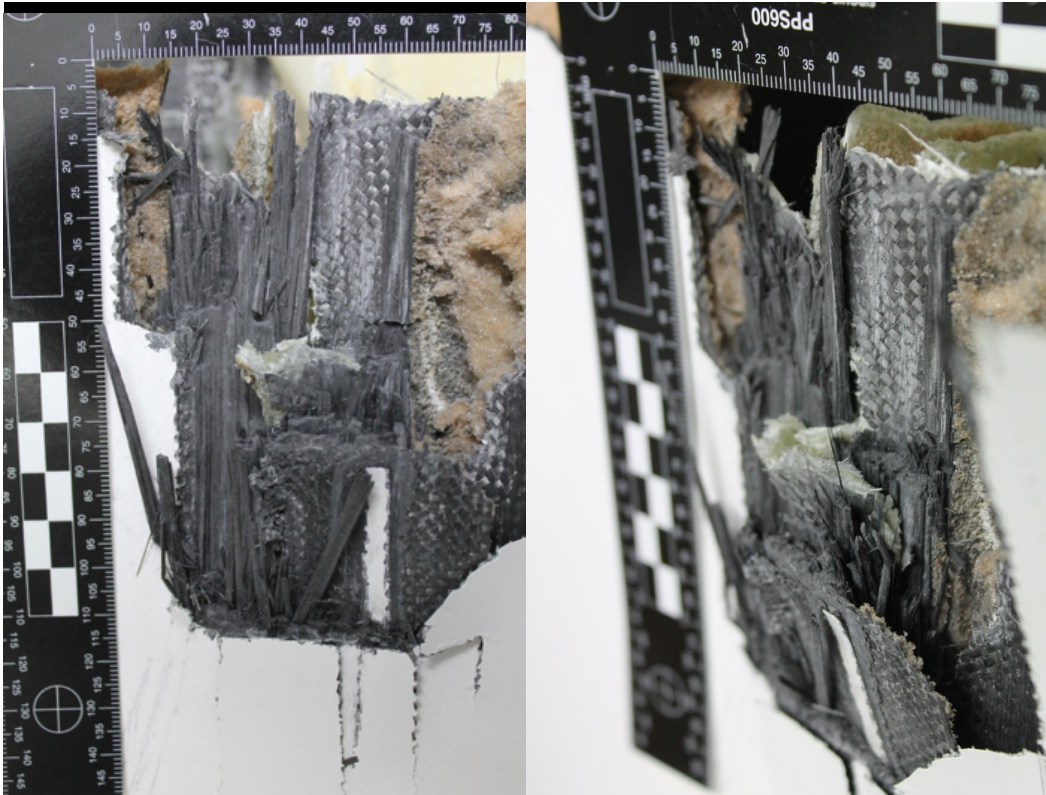
**Figure 6-25 - Upper wing spar from the right wing section, illustrating significant longitudinal splitting, translaminar fracturing, brooming and material loss (Source: Author)**

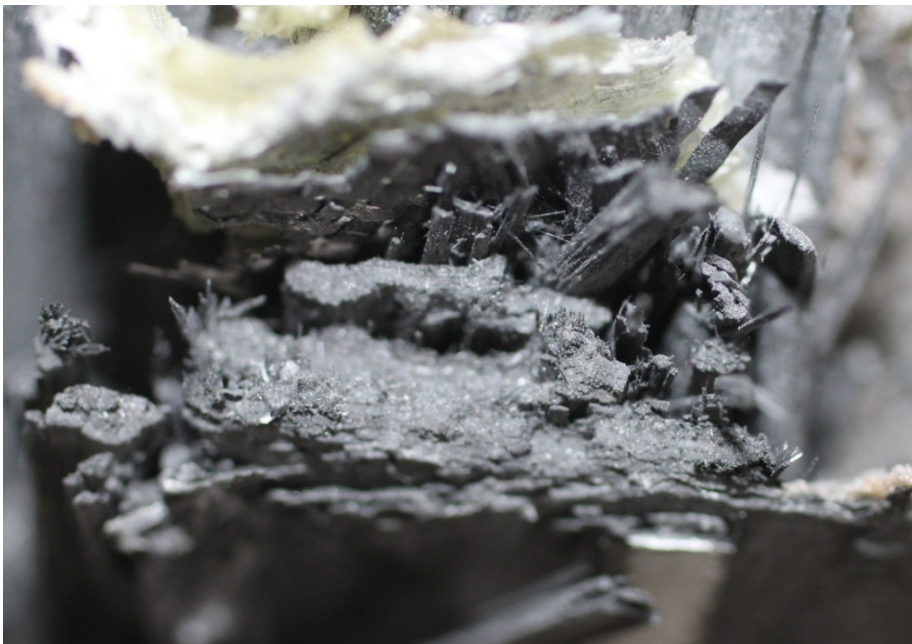
**Figure 6-26 – Section of the lower spar cap illustrating significant longitudinal splitting and evidence of compressive translaminar fracture (Source: Author)**

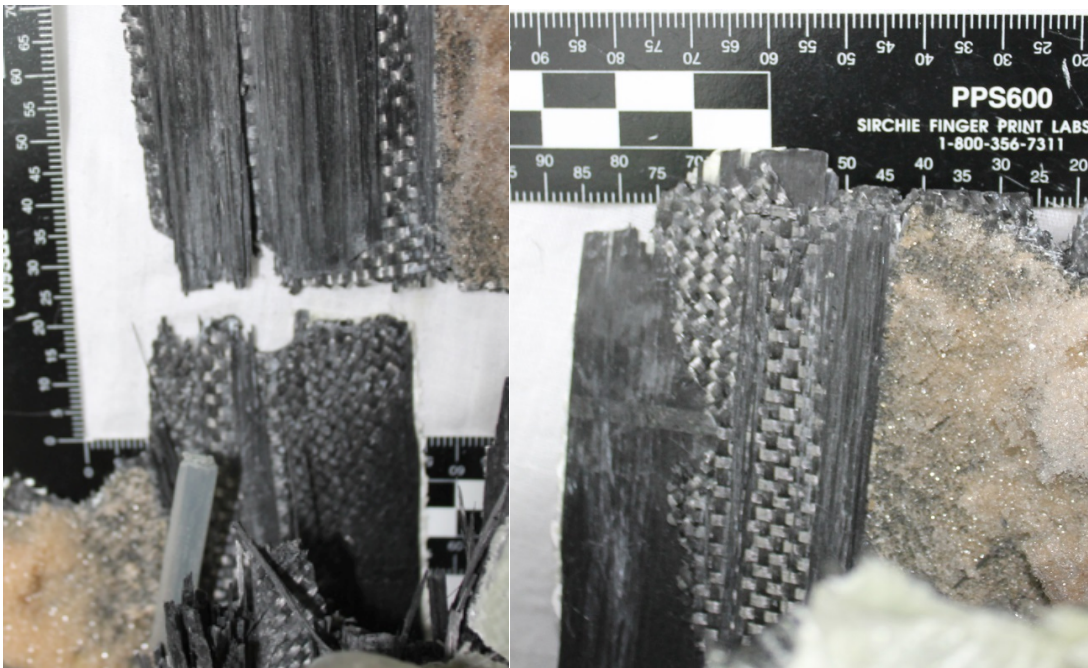
**Figure 6-28 – Regions of impact damage. The penetrating damage on the left wing (left image) and the blunt impact damage to the right wing (right image) (Source: Author)**

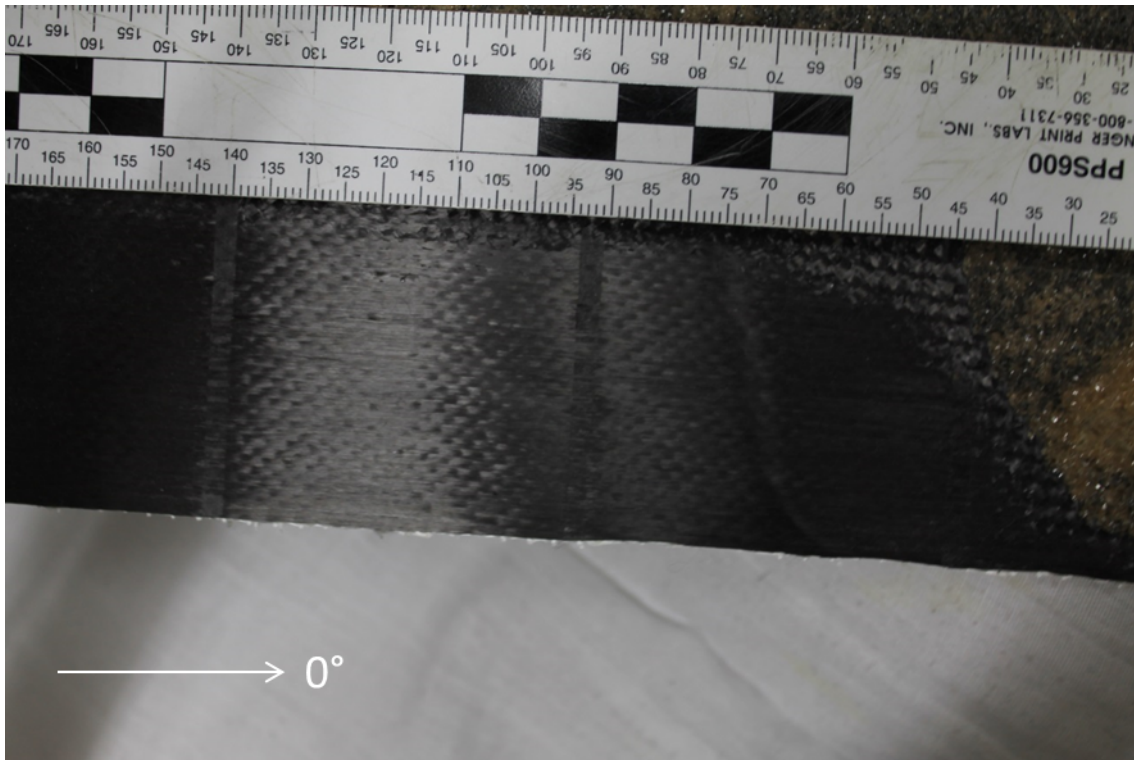
**Figure 6-29 – Glossy reflective appearance of an interlaminar failure. The failure plane is along the 0° orientation (Source: Author)**

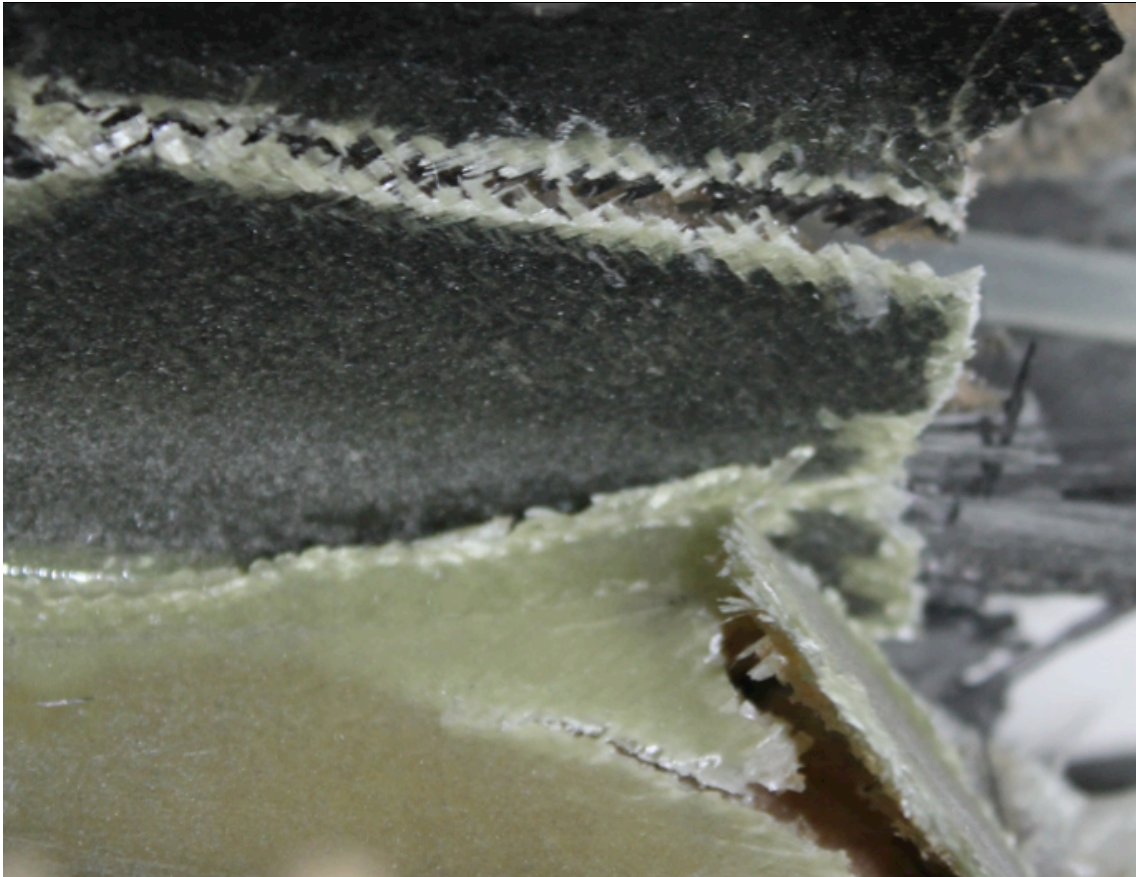
**Figure 6-30 – Internal fracture of the shear web (bottom of picture) and the upper laminate skin (Source: Author)**

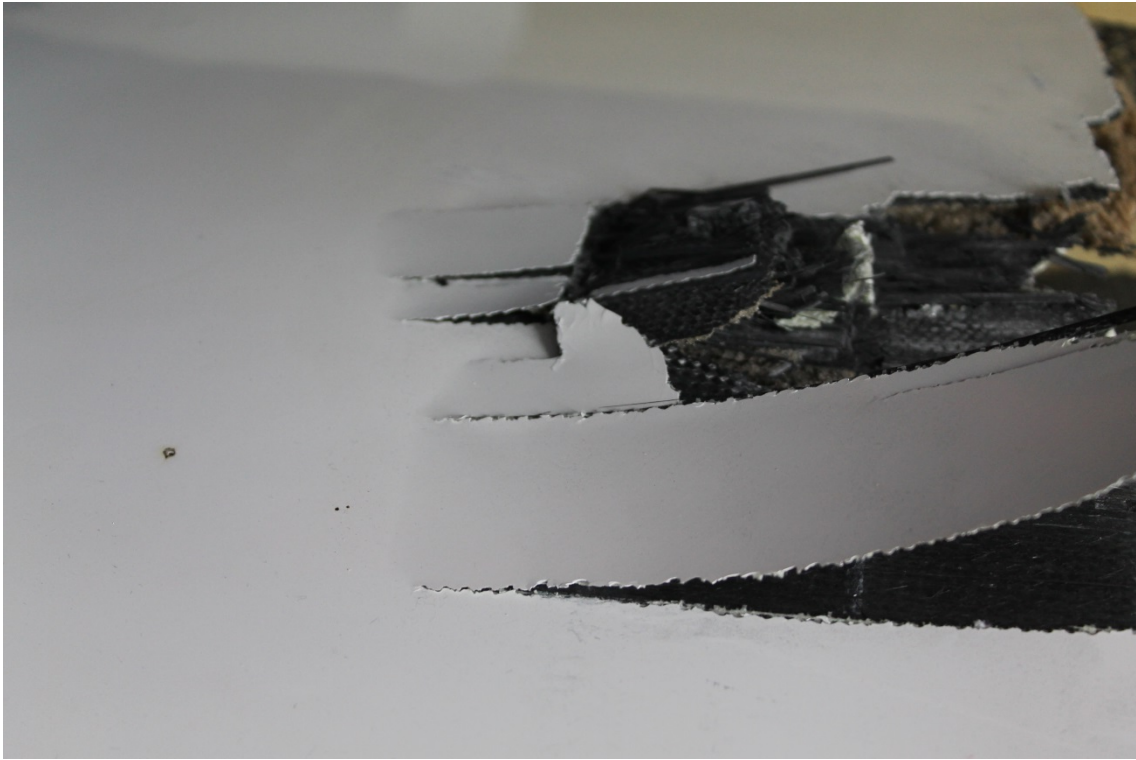
**Figure 6-31 – Left wing upper surface. The point of arcing is visible on the left hand side of the image (Source: Author)**

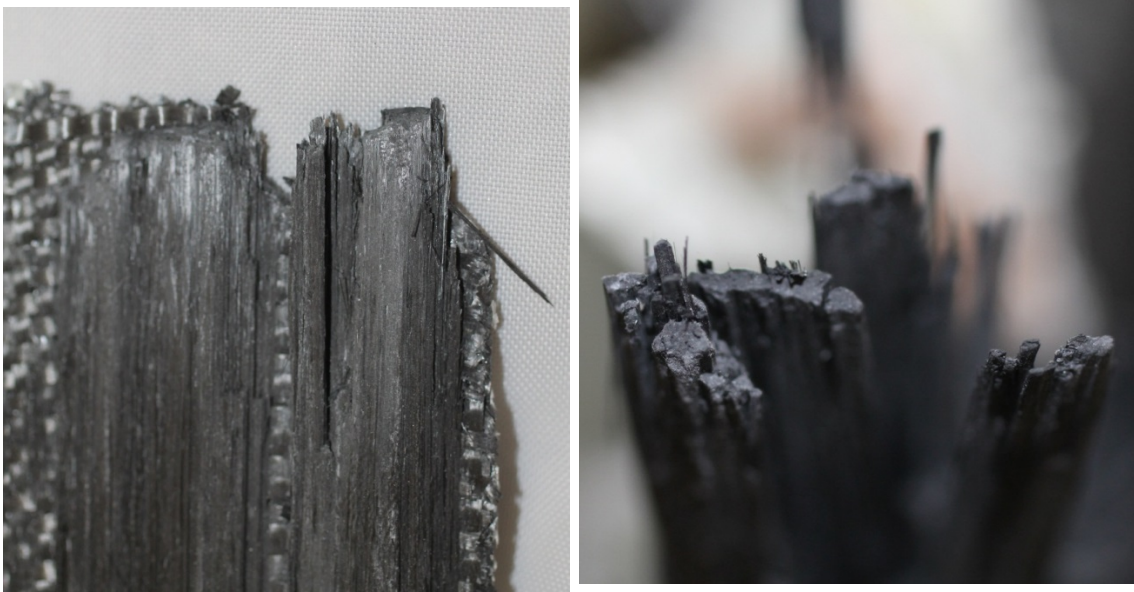
**Figure 6-33 – Translaminar fractures of unidirectional fibres identified as occurring on the primary fracture within the impact zone (Source: Author)**

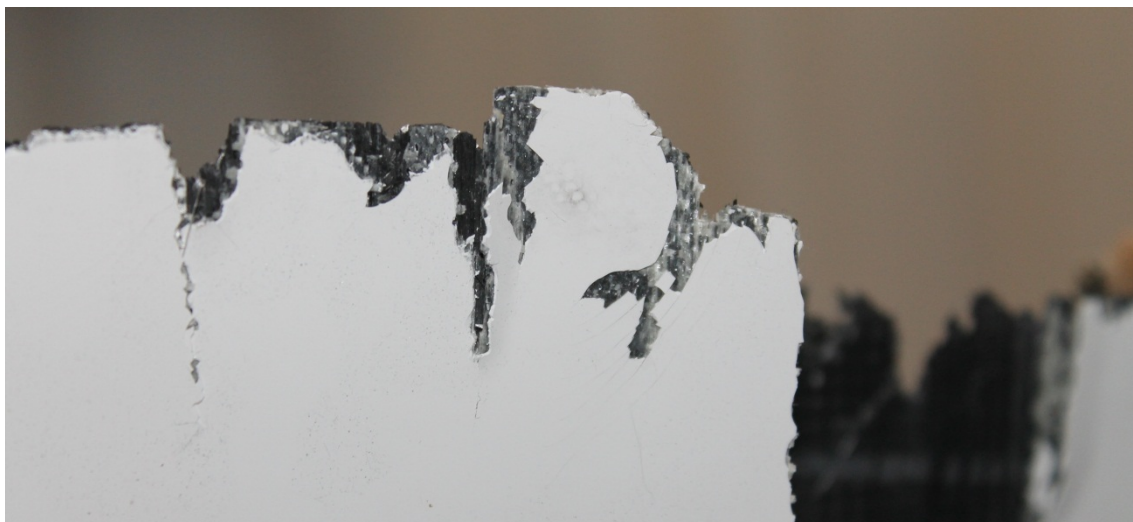
**Figure 6-37 – Deflection of the translaminar fracture induced by the impact (Source: Author)**

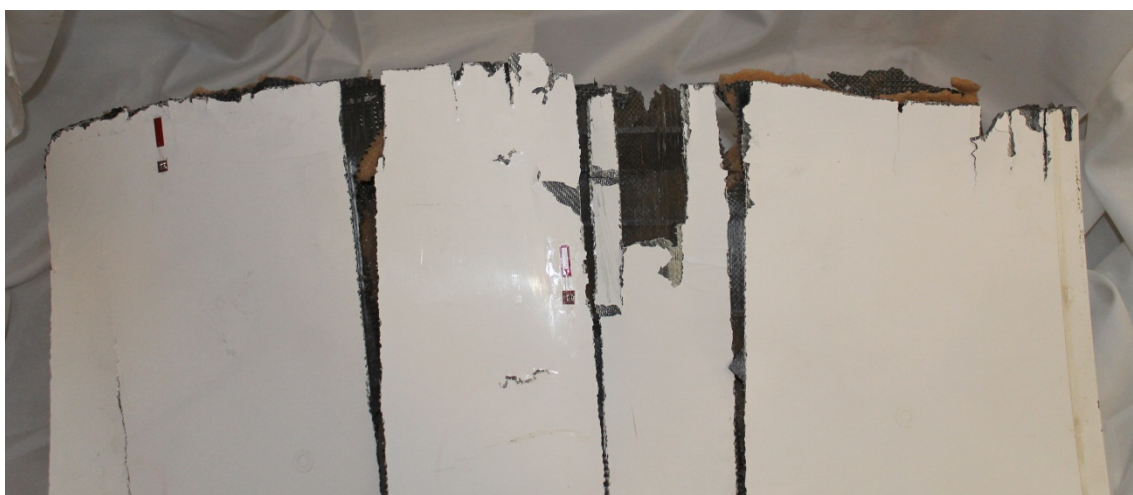
**Figure 6-38 – Right wing upper surface. The impact location can be identified as a semi-circular fracture deviation on the top centre of the image (Source: Author)**

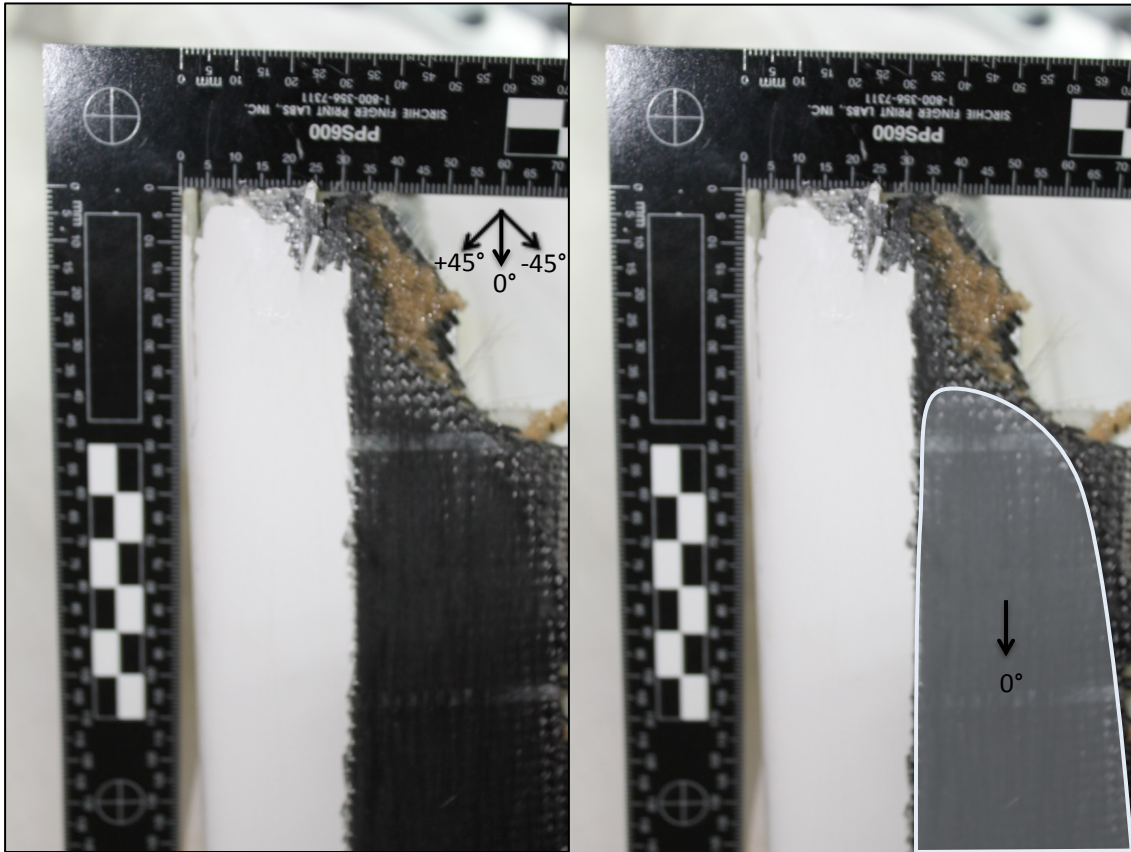
**Figure 6-40 – A fracture showing the tendency to move to a 0° laminate (Source: Author)**

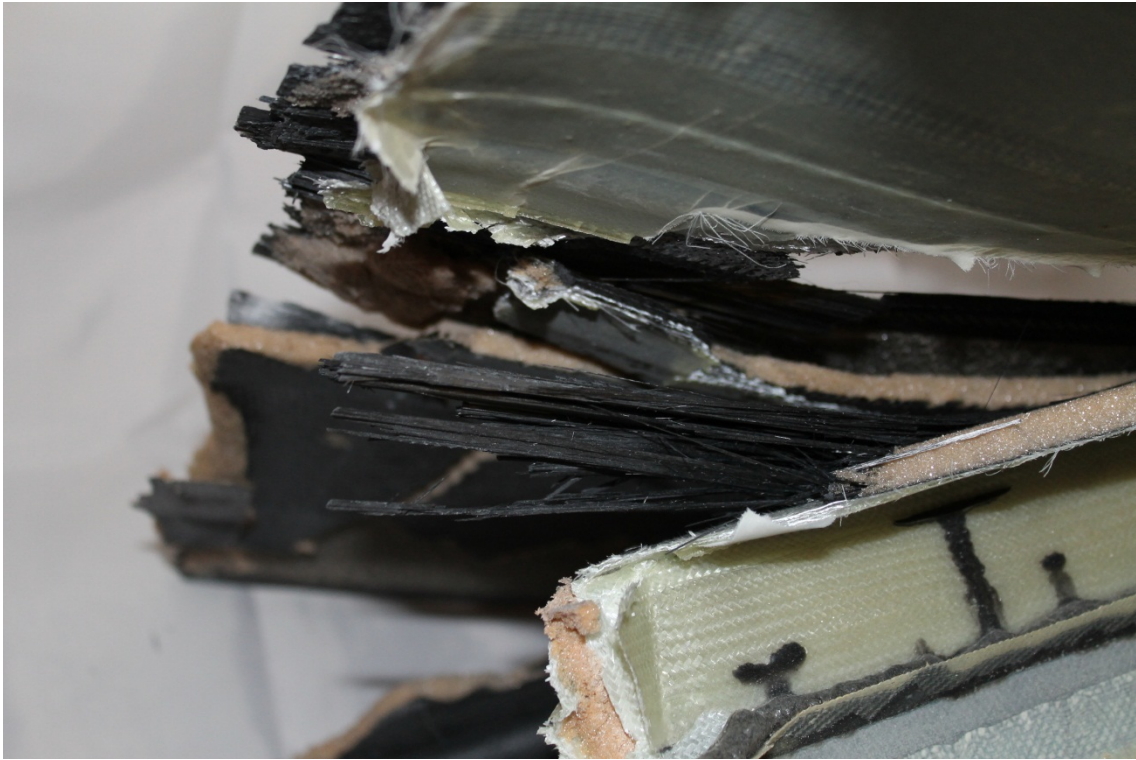
**Figure 6-45 – Deformation of the upper spar cap from the right wing (Source: Author)**

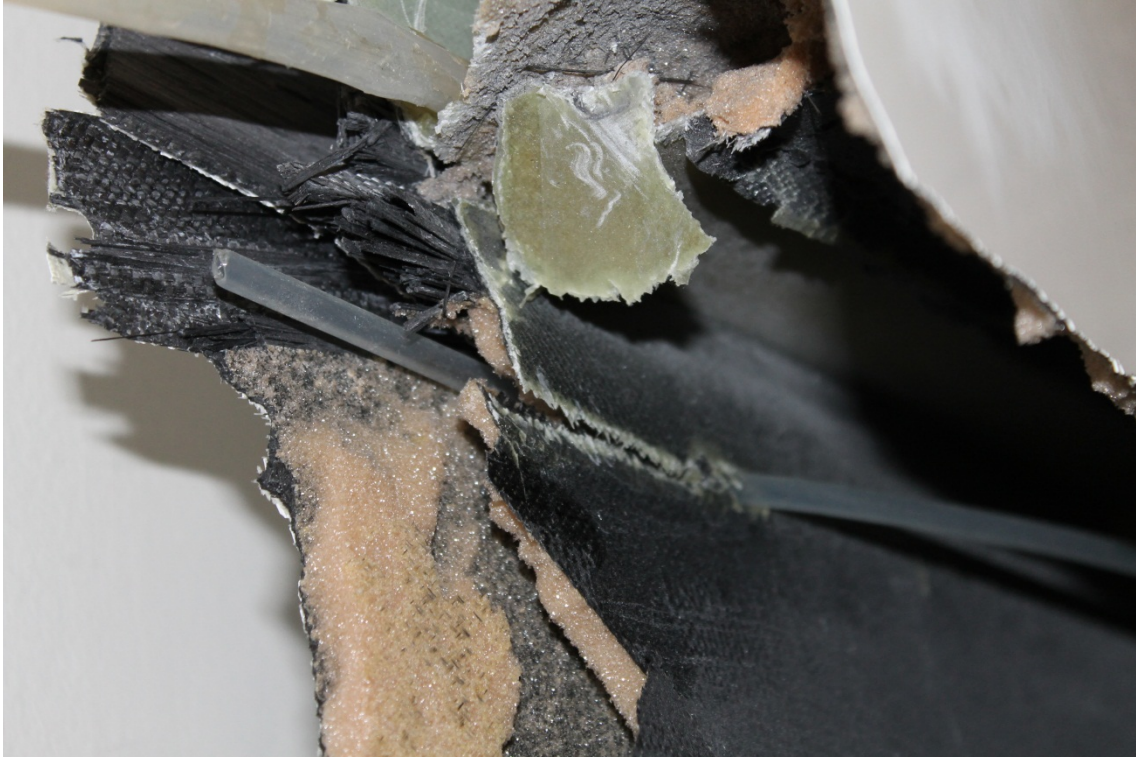
**Figure 6-46 – Pull through of a polymer tube inducing fracture of the upper skin lower laminate (Source: Author)**
