CoA Memo M and P No. 17

THE COLLEGE OF AERONAUTICS

Test Report No. PLB0/7

Evaluation of PERPRO tools grade RD 92 machining EN 9

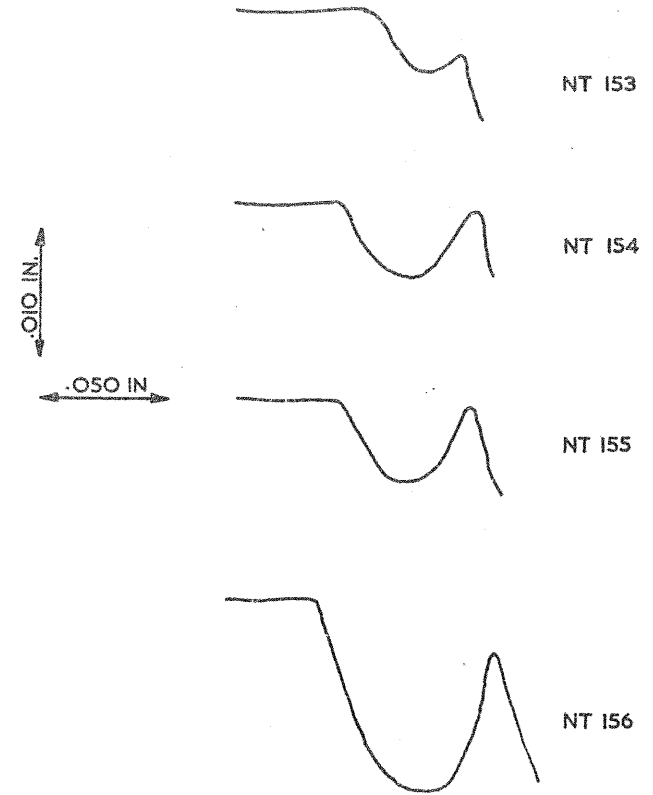
FIG. 3

Figure 3 shows the Tallysurf records of the crater wear of the tips at the end of the tests. Although not identical the crater wear in all cases was quite severe and the figure shows that the failure of NT153 was the result of the breakdown of the crater lip.

CRATER WEAR OF RD 92 TIPS AT END OF TEST

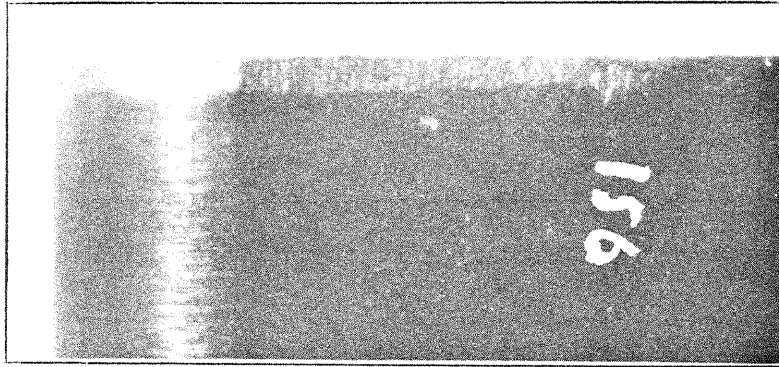
A

Figures 4 and 5 give photographs showing the growth of the crater and flankwear of NT156.

Fig. 4 Flankwear RD 92

a .010 in

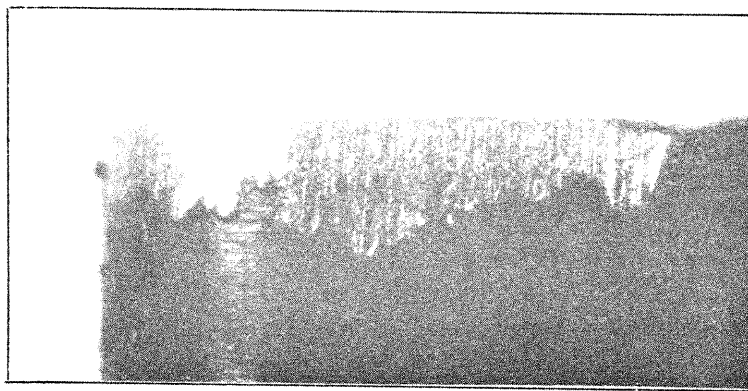
B

b .020 in

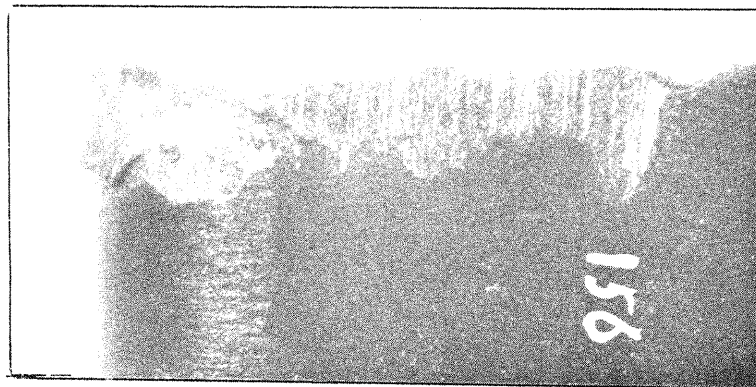
C

c .050 in

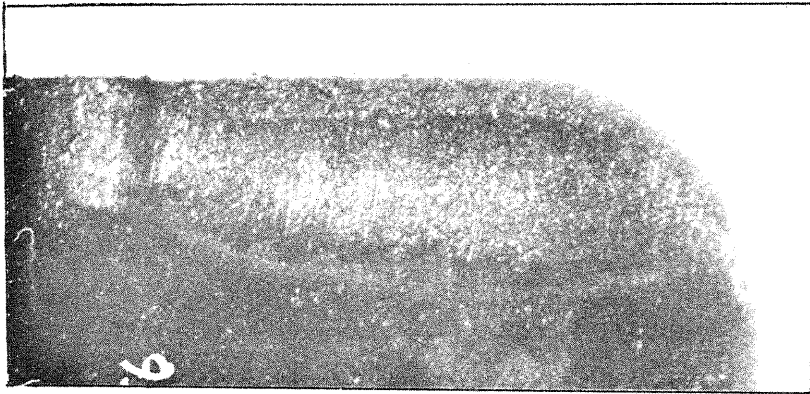
A

Fig. 5 Crater wear RD 92 corresponding to

- a .010 in flankwear
- b .020 in flankwear
- c .030 in flankwear
