CoA Memo M. and P. No. 55

THE COLLEGE OF AERONAUTICS

Test Report No. PLB0/15

Field tests of PERPRO tips grade RD107
copy turning steel B.S.4

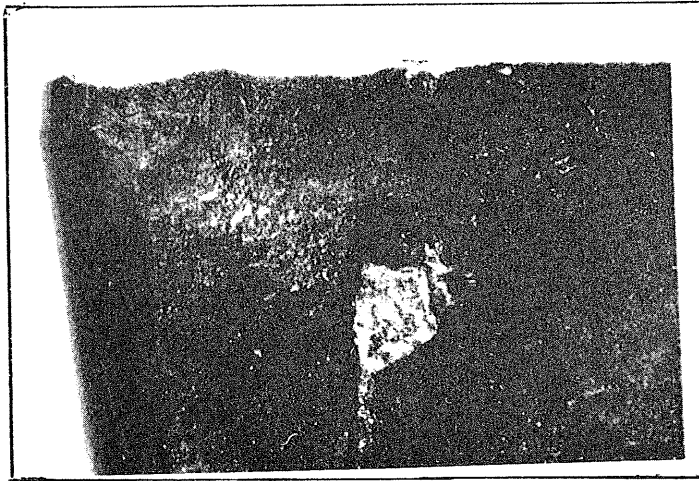
FIG. 3 FLANK AND CRATER WEAR RD107 TIP 1 .

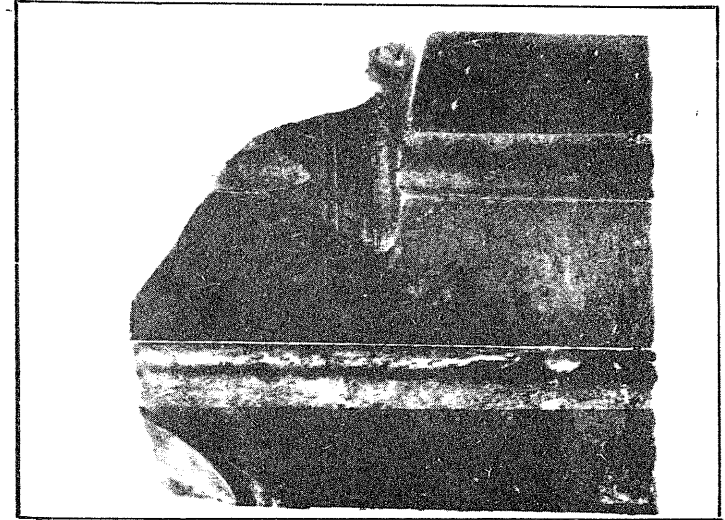
The machining of rammer butts is a fairly severe test of the toughness of tips in that as the tool reaches the apex of the tapered portions of the stem the swarf comes off as an annular ring which spins round the workpiece often causing the tip to fracture. It will be noticed that two of the S1P tips failed by breaking into two.

FIG. 4 FRACTURE OF S1P TIP 2

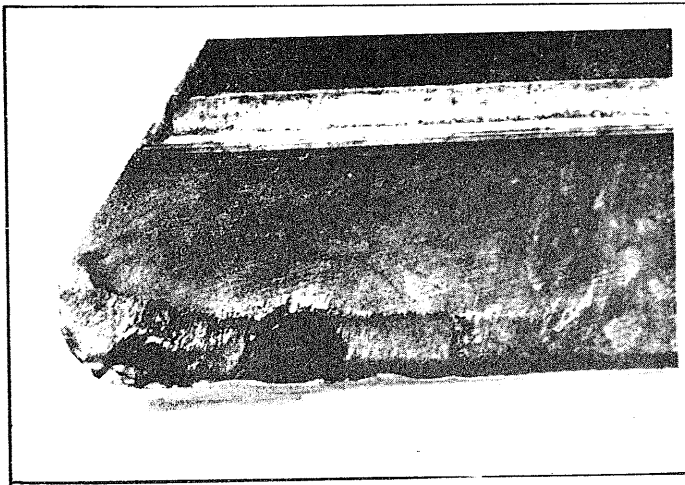
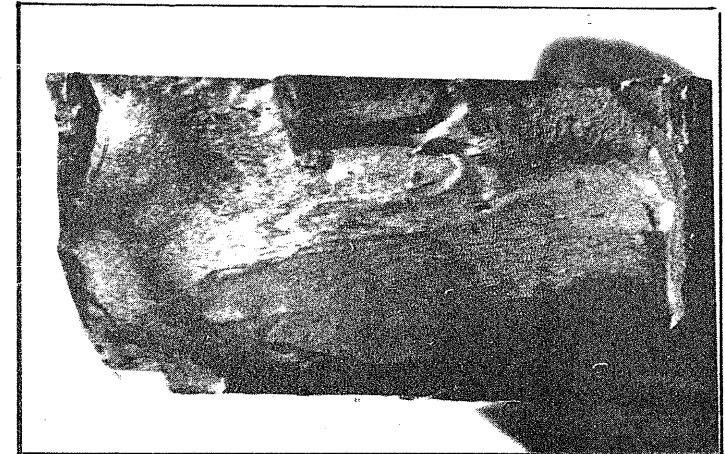
FIG. 5 FLANK AND CRATER WEAR S1P TIP 3.

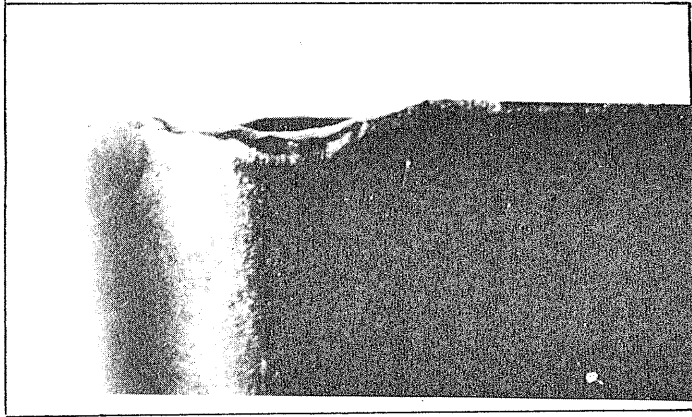
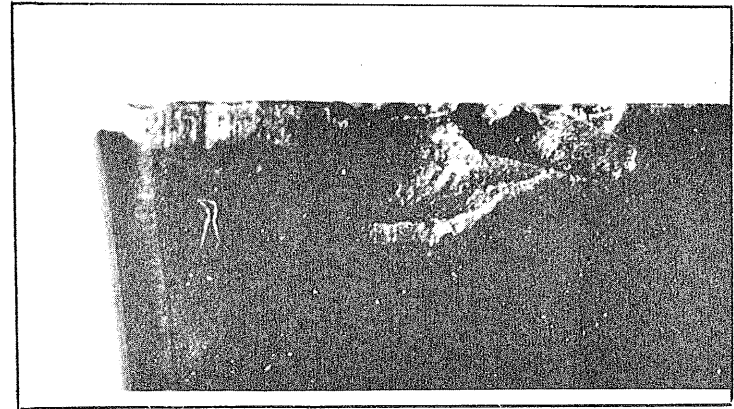
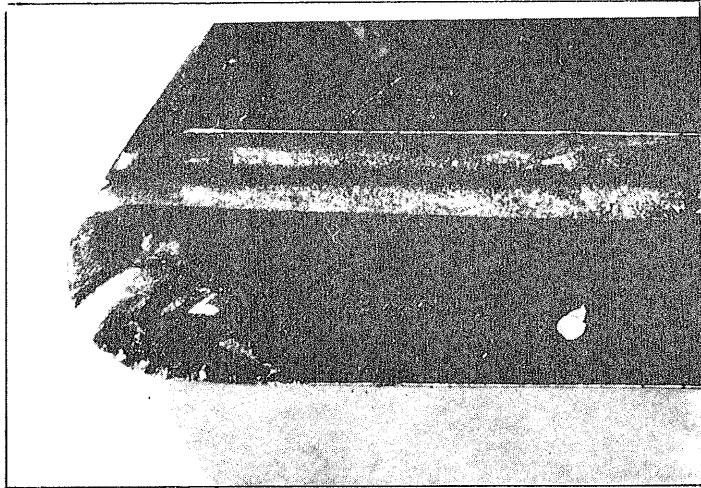
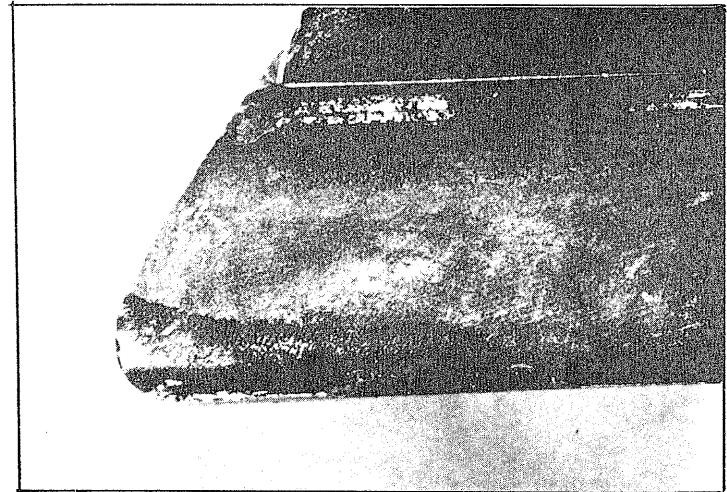
FIG. 6 FLANK AND CRATER WEAR RD 107 TIP 4a.

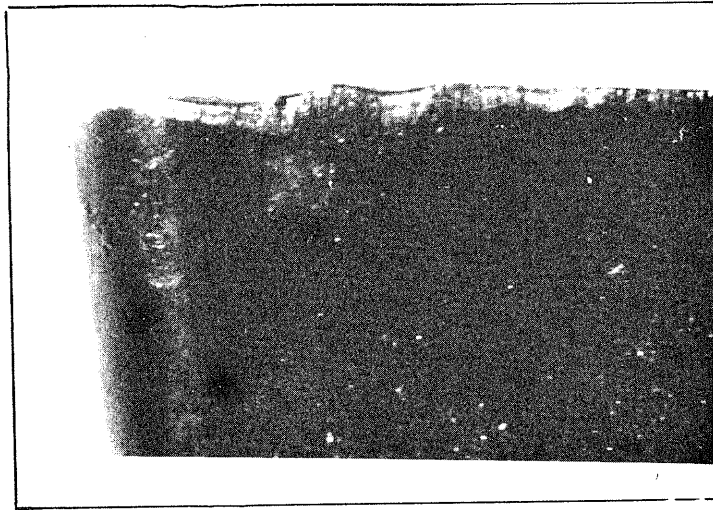
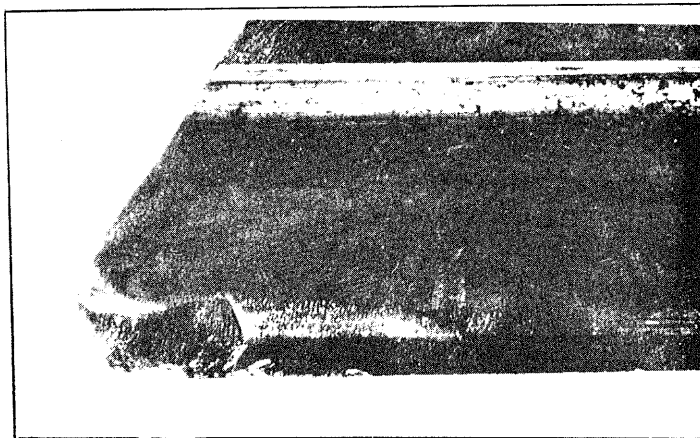
FIG. 7 FLANK AND CRATER WEAR RD 107 TIP 4b.

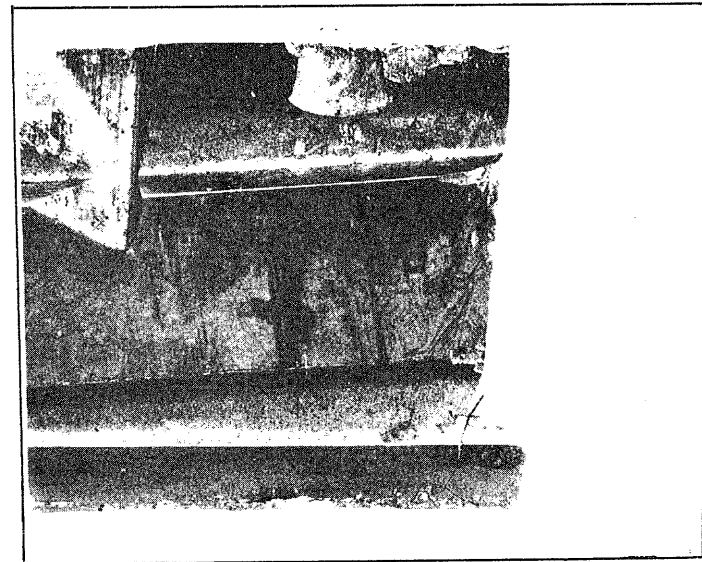
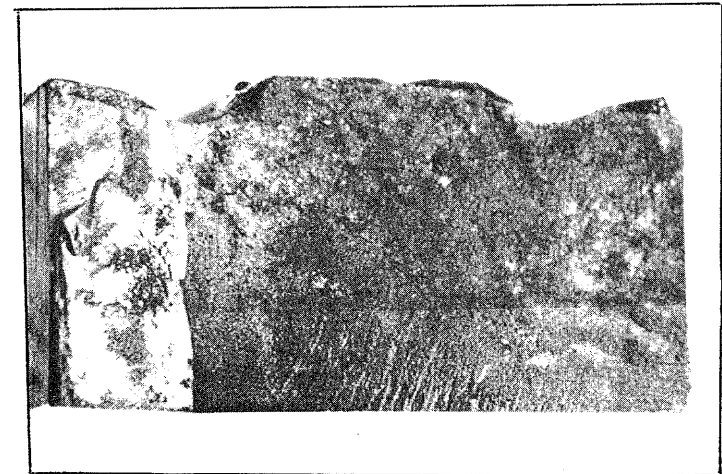
FIG. 8 FRACTURE OF S1P TIP 5.
