# Experimental observations of an 8 m/s drop test of a metallic helicopter underfloor structure onto water: part 2

**Abstract:** This is the second part of a two-part paper that describes the experimental observations for two similar sections of floor that were dropped onto both hard and water surfaces at 8 m/s, as part of one experimental campaign. The current paper provides an assessment of a simple box-beam under floor structure typically found in metallic helicopters and provides an overview of the failure modes and the collapse mechanism observed when dropped onto water at 8 m/s, as well as providing quantitative data for the skin deflections observed.

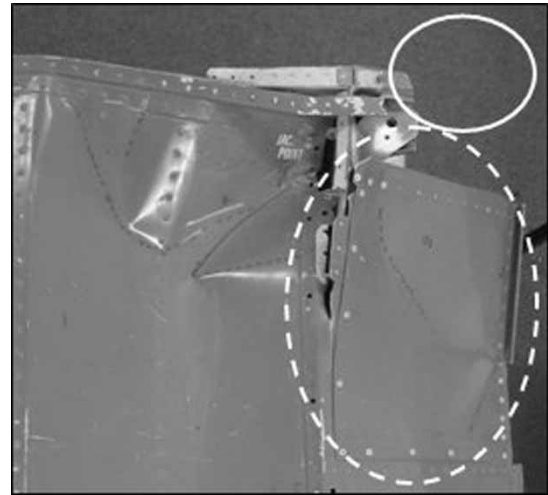
**Fig. 3** Underside view of the starboard landing gear assembly that shows the location of the replaced skin panel (dashed circle) and the missing landing gear attachment (solid circle)

in the post-test report, as a replacement panel was riveted to this section as shown in Fig. 3, together with the removal of the port landing gear attachment. This changed the localized stiffness at this location, so damage to this side of the floor was neglected.

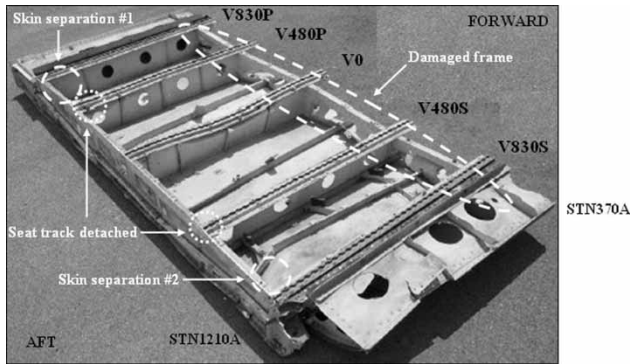
Figure 4 shows an overall view of the post-test article, where the instrumentation cables and passenger floor have been removed for clarity. As can be seen, the floor retains its global structural integrity, where the main features of damage and locations of material failure have been directly annotated onto this figure. One interesting feature concerns the different failure modes observed for the frame configurations used in its construction.

The main longitudinal frames, V830, V480, and V0, remain relatively undamaged, which is consistent with current understanding. The behaviour of the skin is

**Fig. 4** Summary of the main locations of damage of the recovered subfloor

also consistent, as it deflects in-between these undamaged frames, with the peak occurring at the midpoints. This behaviour is clearly highlighted when one considers the pre- and post-test response of frame STN370A that forms the front part of this component in Fig. 5. This frame is subject to quite severe deformation due to the deflections of the skin, resulting in several locations of material failure.

The skin panels located between the longitudinal frames are subject to large deformations, as failure was observed in two limited areas between V480 and V830, which are highlighted as locations #1 and #2 in Fig. 4. However, the levels of damage are not symmetric, as it is more severe on the starboard side. The failure at location #2 can be discounted, as it is the consequence of the replaced panel. Despite this fact, this failure still serves as a severe example of the damage that could be potentially experienced by the surrounding components.

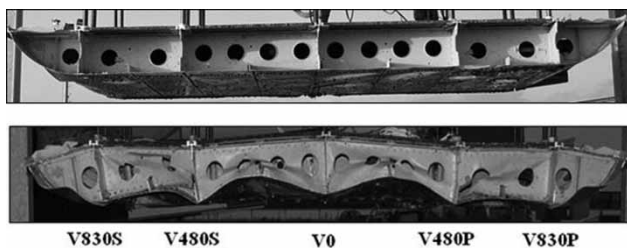
The location of skin failure on the port side (location #1) is the result of the surrounding structure being incredibly stiff in relation to the flexible skin. For example, the port landing gear attachment can be considered effectively rigid and its supporting effect on the surrounding structure results in the failure of the interconnecting rivets. This increase in skin deflection causes the propagation of material fractures along both lateral and longitudinal rivets lines, which in turn,

**Fig. 5** Pre- and post-test response showing the degree of deformation along STN370A at the forward section of the subfloor

permits further skin deflection and associated rivet failure.

Due to the distortion of STN370A, inward and outward deflections are also evident, which can be clearly seen in Fig. 5. The degree of skin deformation decreases in magnitude as one moves closer to V830P, due to the increase in strength of the construction and the lack of deformation observed. The midspan deflection is larger than STN370A when one compares lower locations 20 and 21. This difference is attributed to the fact that the increase in water pressure only has to overcome the structural rigidity provided by the reinforcing z-stringer, whereas frame collapse is required for STN370A.

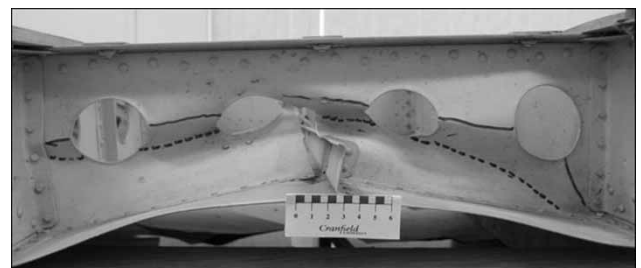
Due to the inward deflection of the skin, the single frame buckles at the midpoint, as shown by the continuous and dotted lines in Fig. 6, which represent an inward and outward hinge, respectively. The upward movement of the skin causes the central z-stringer to cut into the frame, causing localized material failure in Fig. 7.

**Fig. 6** The location of plastic collapse of STN370A located between V480S and V0

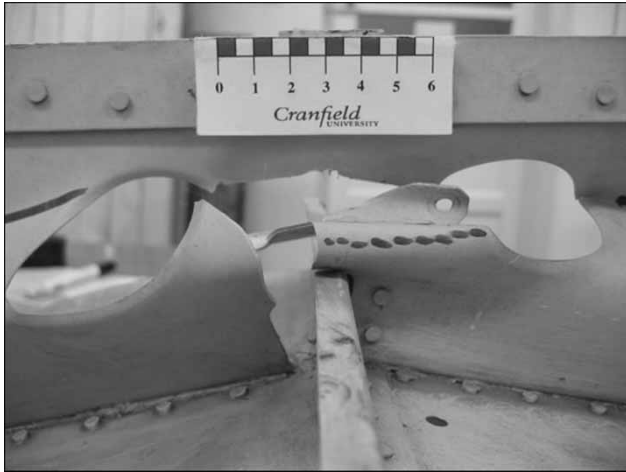
**Fig. 7** Close up of the material failure that occurs along the single skinned section of STN370A, located between V0 and V480P, due to the upward deflection of the skin

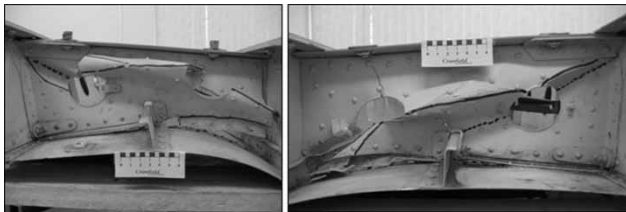
The double skinned frames between V830 and 480 do not fail in this way, as Fig. 8 demonstrates. This section of the floor is substantially reinforced by V830, coupled with the construction of the double skin, this means that very little deformation occurs in the vicinity of V830. Towards V480, severe frame deformation occurs due to the failure of the interconnecting rivets via tensile pull-out, resulting in a plastic hinge line that

**Fig. 8** The different failure modes observed for the double skinned frame of STN370A between V830 and V480 port (left) and starboard (right), due to the upward deflection of the skin

runs diagonally across this frame. The strong nature of this construction prevents the upward displacement of the central z-stringer, so no localized frame failure occurs.

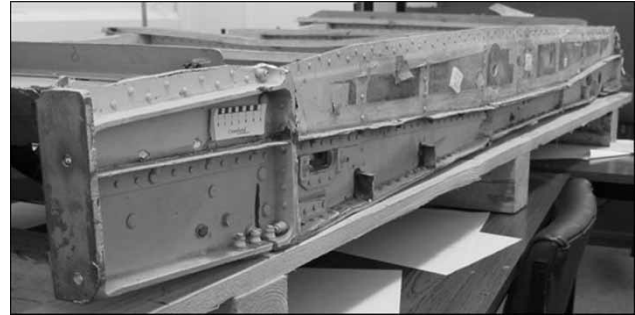
STN1210A forms part of lower aft bulkhead and is a substantial component due to the attachment of the port and starboard landing gear assemblies, and the reinforcing rail that runs along its length, as shown in Fig. 9. As expected, no significant deformation is observed as this frame retains its structural integrity, with only slight damage observed at the base of the z-stringers, together with slight plastic hinge lines forming at the intersections with the longitudinal v-frames.

**Fig. 9** Due to the high strength construction of STN1210A, no deformation is observed

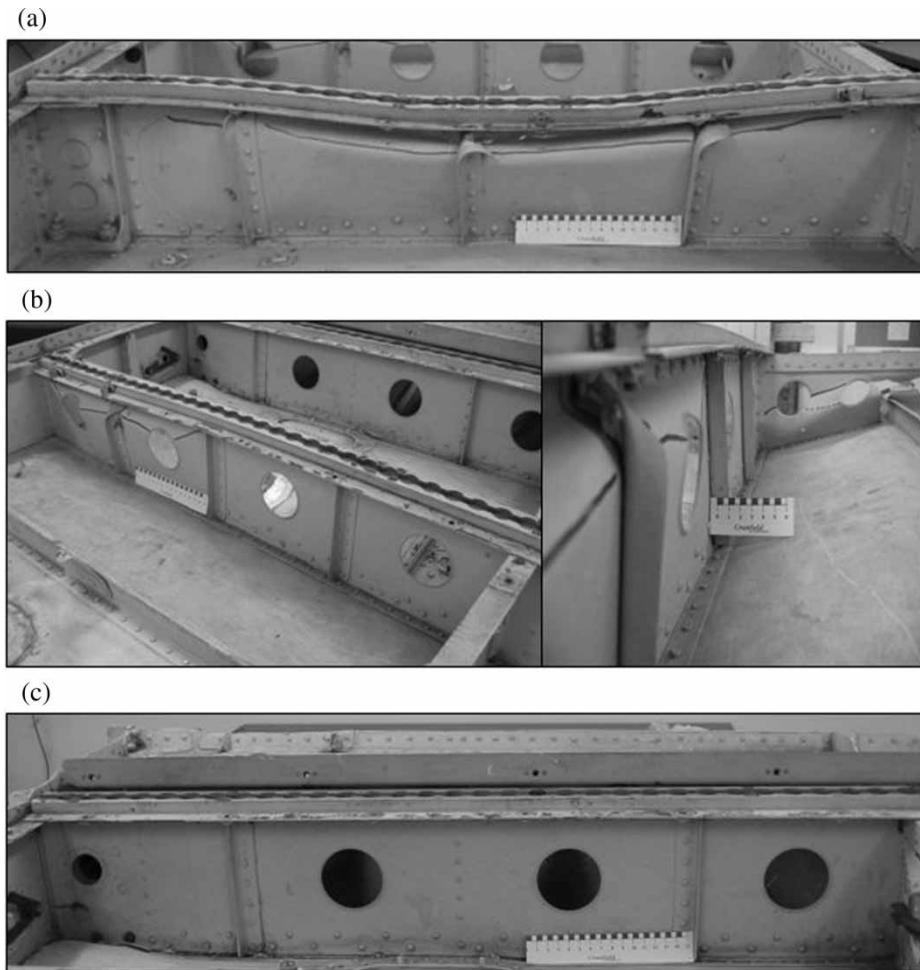
The aft part of V0, situated between stations STN-1210A and 370A, consists of a single metallic sheet that is reinforced by three evenly spaced L-section stringers. The failure mode for this frame consists of single hinge line that forms in the upper part of this frame as shown in Fig. 10(a), which is a direct consequence of the proximity of the applied loading that was attached either side of the central stringer. The outward buckle results in the stringers adopting this failure mode, causing small localized material fractures at the peak of this deflection.

This frame configuration can be found in Fig. 10(b) and is the most common, as it consists of a single metallic sheet reinforced with evenly spaced L-stringers and also contains four circular cut outs that act to reduce the weight of the frame. Limited deformation is observed, which is consistent with current understanding, as the current construction is not able to transfer the increase in water pressure to these energy absorbing components. Therefore, the available stroke is not utilized and very little energy is absorbed.

The deformation observed towards the aft part of this frame is caused by the failure of the upper seat track and STN1210A, due to the proximity of one of the pairs of attachment points located at the last two seat track positions shown in Fig. 11. This separation results in an upper hinge line that spreads to the mid-point of V480, as this frame now solely supports the loading. Also shown in Fig. 10(b) is the severity of the skin in relation to the height of the undamaged V480P,

**Fig. 10** Comparison between the different failure modes observed for (a) V0, (b) V480P, and (c) V830P. (The frame orientations are normal to the water surface)

which demonstrates quite succinctly the dominant behaviour of the skin for an impact on water.

The final frame configuration shown in Fig. 10(c) is similar in construction to configuration #2, except the frame does not have a vertical stringer located at the midpoint. Instead, this frame is directly riveted to a curved transverse end frame, which provides the vertical support. Due to the high strength nature of this construction in relation to the flexible skin, no deformation is observed.

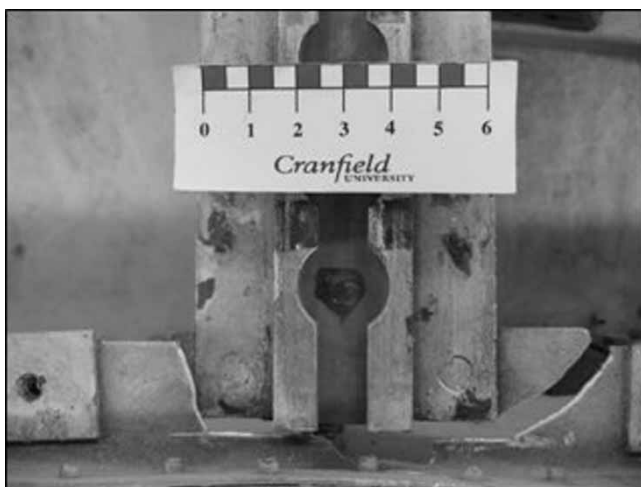
**Fig. 11** Top down view of the shear failure of the upper seat track at the intersection between V480 and STN1210A

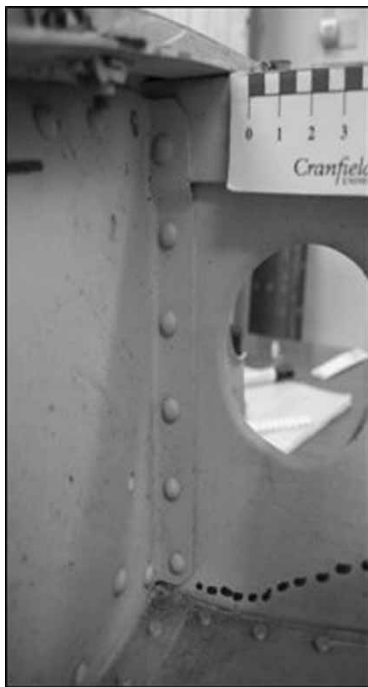
**Fig. 13** A lack of intersection joint collapse is a common feature observed during a water impact, as the intersection between STN370A and V0 orientated normal to the water surface demonstrates

surface impact, the membrane loads generated are insufficient to cause collapse as no deformation is observed [18]. The stabilizing effect of these joints will reinforce and support the frames, resulting in very little energy being absorbed, as shown in Fig. 13. Progressive collapse needs to be encouraged for the water impact case, if improvements in energy absorption are to be gained.

The first recommendation concerns the very stiff sections of the subfloor that are too strong from a water impact point of view. This includes the intersection joints that form between the frames and the frames themselves. Consideration should be given to encourage frame collapse at lower loads through the use of geometry, material type, and the inclusion of triggers. The caveat with this approach is that if the failure strength is optimized for a water impact, a poor crashworthy response may occur during an impact onto a hard surface.

The second area for improvement concerns the development of the stiff intersection joints, as the collapse of a typical box-section is heavily dependant upon the failure of these joints. A proposed concept demonstrator solution to this problem can be found in reference [18]. This area of research is closely linked with the development of the skin, as successfully transferring the water pressure will be essential to encourage progressive collapse.

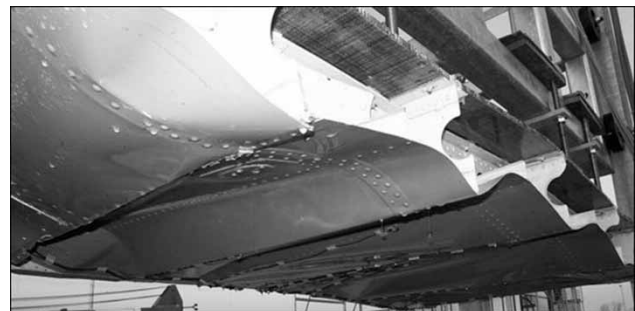
The membrane behaviour of the skin is of paramount importance for an impact on water, as the deflections form part of the energy absorbing process, due to the kinetic energy imparted to the water. An underside view of the skin response can be found in Fig. 14, which shows the port deformation in the region surrounding SNT370A.

**Fig. 14** Underside view of the port side taken after the drop test. Picture courtesy of CIRA [10]
