Characterising the level of crashworthiness for impacts on hard ground and water surfaces for a metallic helicopter under floor structure: What lessons can be learned?

K. Hughes

Crashworthiness, Impact and Structural Mechanics Group (CISM),
School of Engineering, Cranfield University, Cranfield, BEDS, MK43 0AL, UK

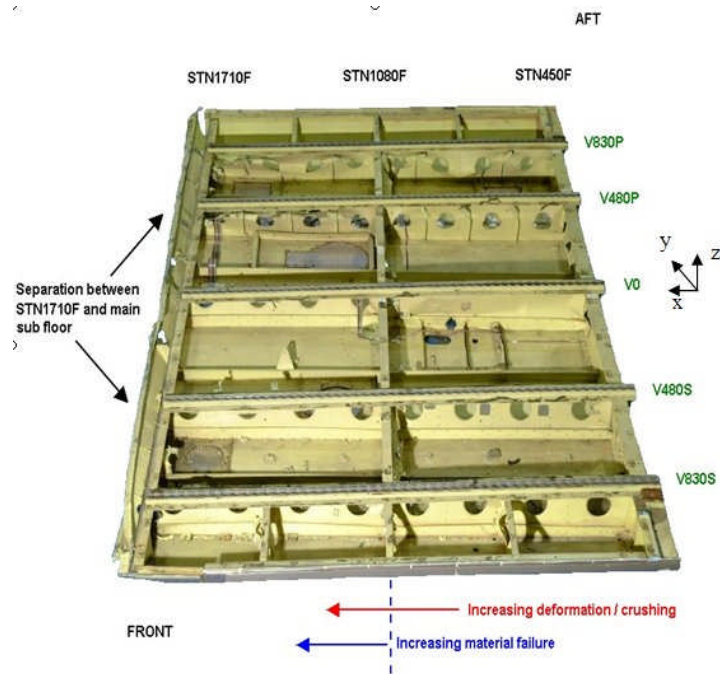
The floor was dropped via a guided descent at 8ms^{-1} , to which a 1 ton ballast plate was added. Instrumentation included eight accelerometers positioned on the main longitudinal frames, together with strain gauges and three force transducers. The main features of damage can be found in figure 2, where the passenger floor has been removed for clarity. As can be seen, all the frames contribute to energy absorption, as failure in the form of hinge lines in both transverse and longitudinal frames is observed. The skin plays no part in the energy absorbing process. Good agreement was obtained for the locations of frame collapse and force-time histories with the numerical results. The existing structure is capable of absorbing the impact energy, but achieves this in an inefficient manner due to the limited use of the available stroke.

Figure 2 Overall view of the post test specimen, where the floor has been removed for clarity

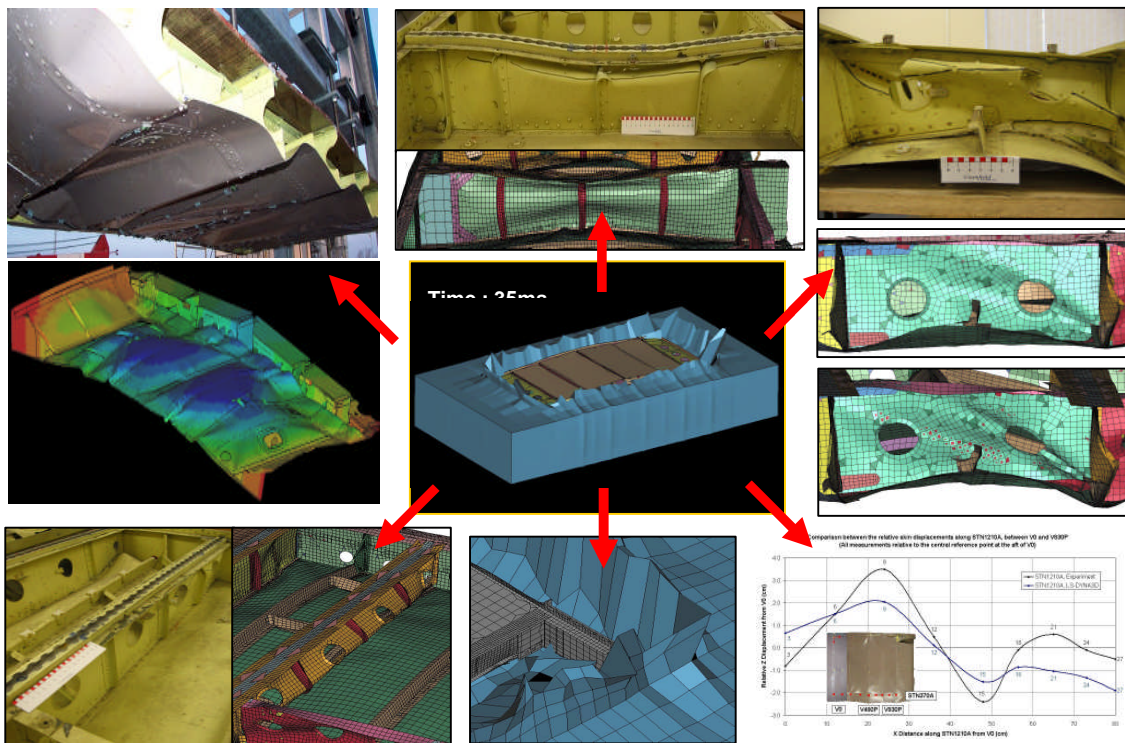
The post impact specimen can be found in figure 3, where the passenger floor has been removed for clarity. As can be seen, the floor retains its global integrity, as the main longitudinal frames remain undamaged, with the skin deflecting quite significantly in between these longitudinal frames. There are two main locations of skin and rivet failure, which would result in the ingress of water and the resulting secondary damage. The curved end sections remain relatively undamaged, as their shape minimises loading at these locations, due to the redirection of the water.

Figure 3 The finite element analysis allowed detailed comparisons with experiment for hinge location, skin deformation and collapsed height of the frames

To recreate numerically, a purely Lagrangian approach was used. The code was able to predict a representative response when compared to test, as good agreement for limited frame collapse, the deflections of the skin (within 10% of test), together with the locations of potential skin failure. Limited joint collapse is predicted, which is also consistent with test. The skin deflects in-between the frames, causing localised material and rivet failure, in the form of tensile pull-out from the surrounding frames.
