Private Sector Participation in Low Cost Water Well Drilling

Knowledge and Research (KAR) Project R7126

Water Quality Data for Five Pounder Well and Five Hand-
Augured Wells in Katabi Sub County, Mpigi District, Uganda.
[Including June 2001 Data for Two Wells in Mukono and Jinja Districts]

Rwamwanja R, Danert K and Carter R C
2001

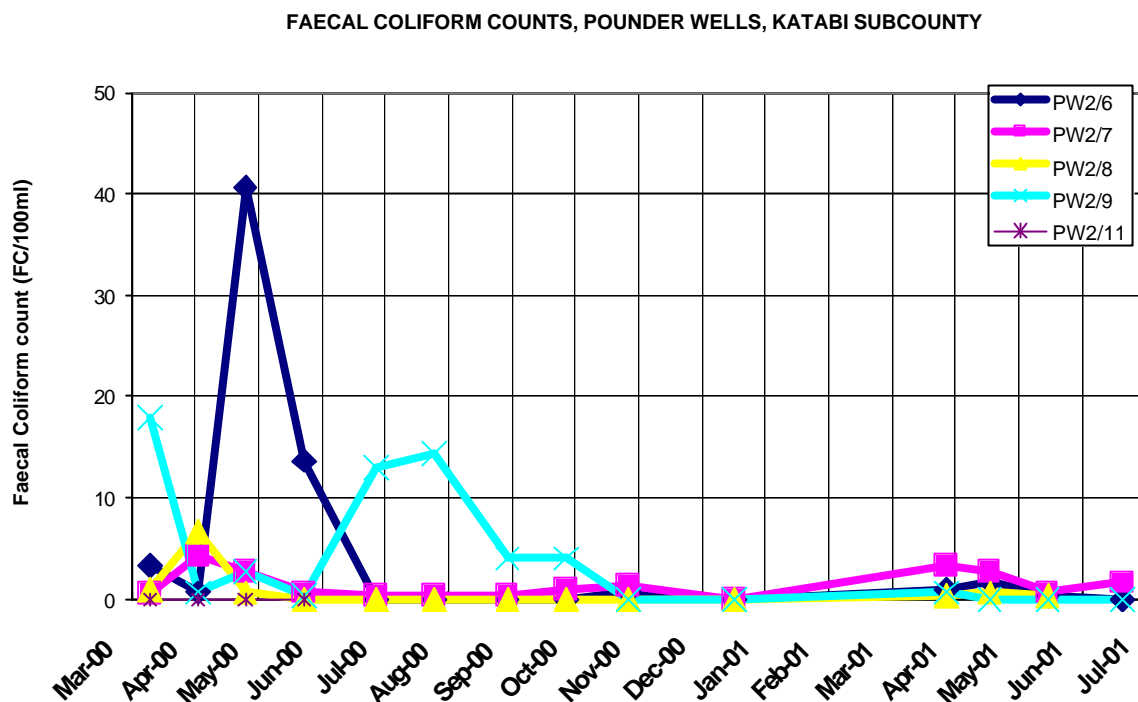
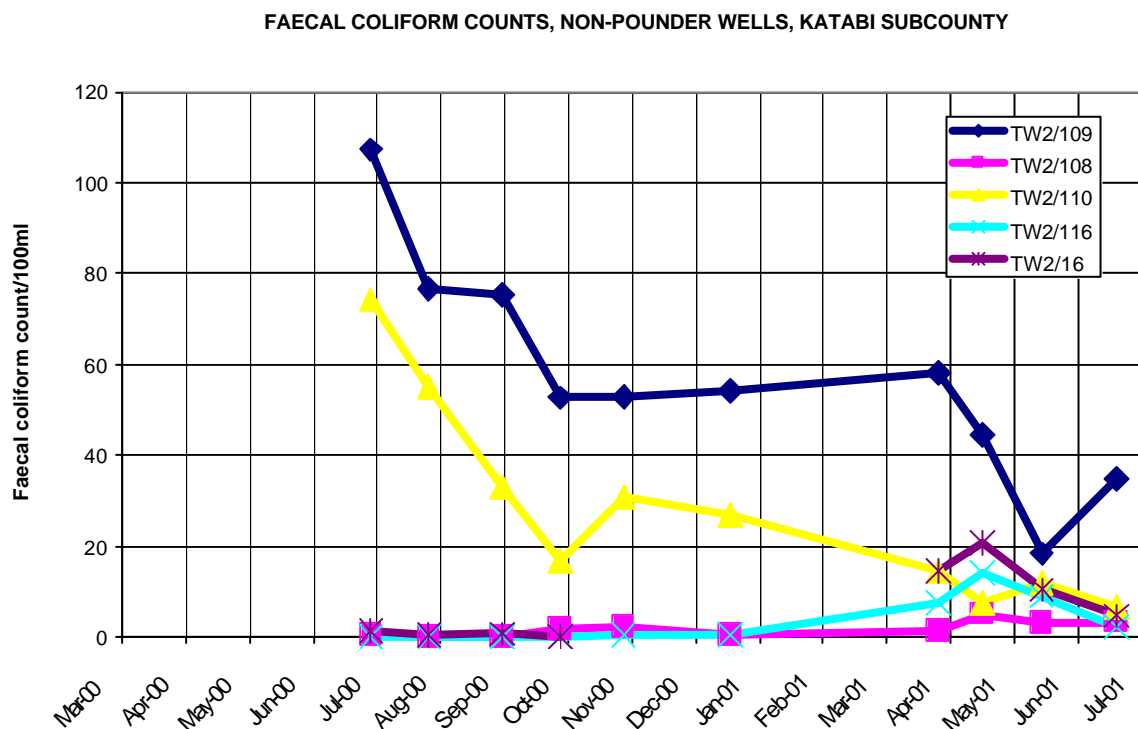
Figure 4.1 Faecal coliform counts of Pounder (upper) and hand augered (lower) wells [Note same time scales, but different y-scales]

- All Pounder well data gives faecal coliform counts well within the GoU standard.
- Faecal contamination of Pounder wells is no worse than that experienced by other shallow wells. The data in fact show Pounder wells to be better in this regard than their comparison group of hand-augered wells.
- Groundwaters can have quite low pH values, which can cause severe corrosion of galvanised below-ground pump components. This corrosion can lead to rapidly increasing dissolved iron contents. Replacement of GI rods with SS causes iron levels to drop.
- Turbidity values in both groups of wells are generally low, and in this sample give no cause for concern.

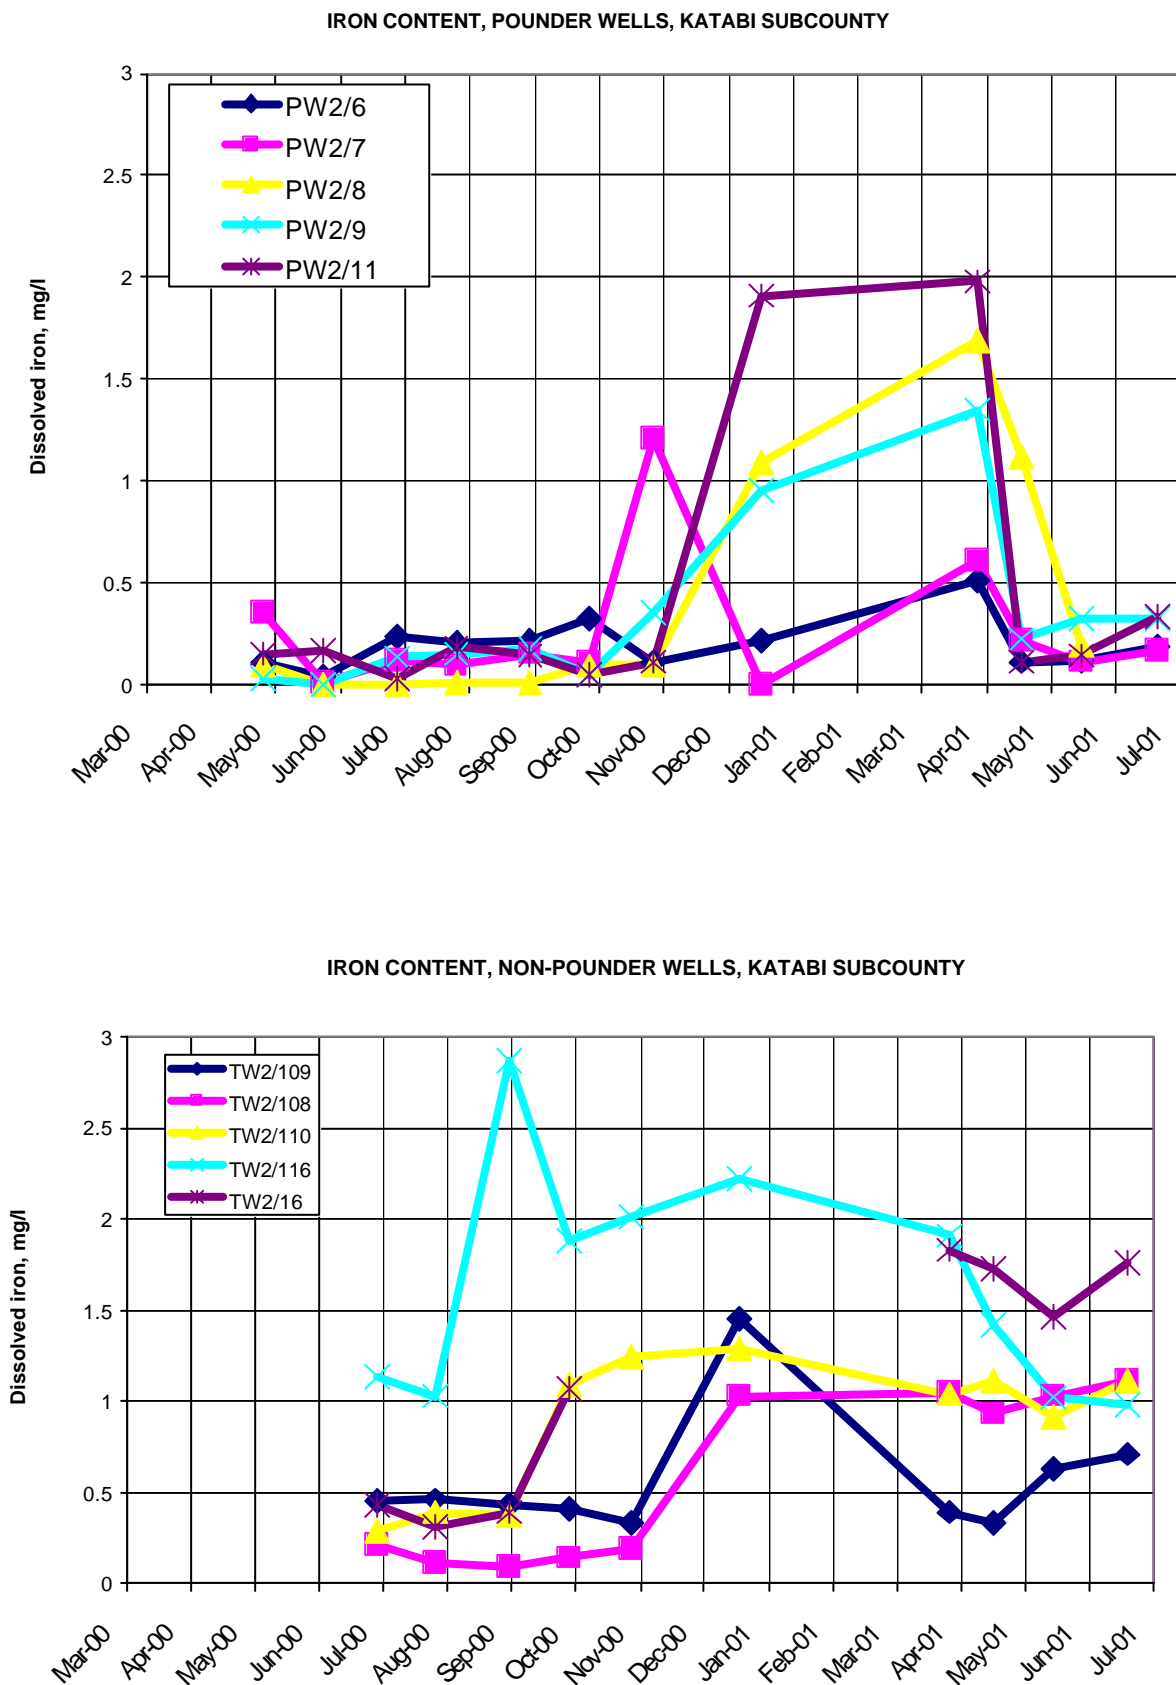
Figure 4.2 Iron contents of Pounder wells (upper) and hand-augered wells (lower)

The dissolved iron content of the Pounder wells (Figure 4.2) shows a very interesting pattern. Values are generally low (less than 0.5 mg/l) up to about December 2000, but from January through April 2001 iron levels rise to 1-2mg/l. After April, levels drop again. This pattern is consistent with the fact that heavy corrosion was observed in below ground pump components (galvanised pump rods) in April 2001, when the GI rods were replaced with stainless steel. The April water samples were taken immediately after replacement of the rods, when the borehole still probably contained a lot of iron which had originated from corrosion of the old rods.
