**Pulsed Electron Beam Treatment of MCrAlY Bondcoats for EB PVD TBC Systems
Part 2 of 2: Cyclic oxidation of the coatings**

R. G. Wellman¹, A. Scrivani², G Rizzi², A Weisenburger³, F.H. Tenailleau¹ and J. R. Nicholls¹

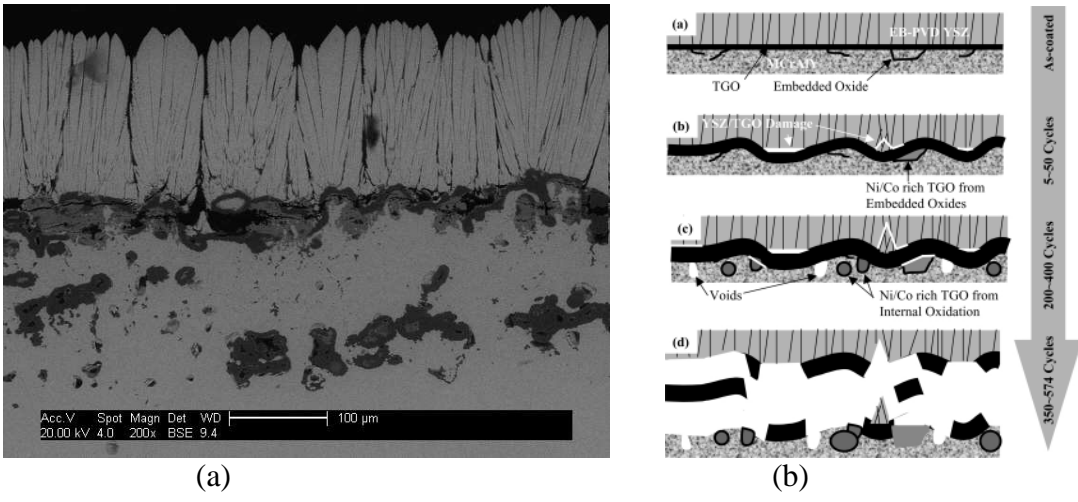
Fig 1

The untreated HVOF sample shows typical failure characteristics of thermal barrier coatings with the formation of an alumina TGO which appears to have undergone extensive rumpling followed by the formation of breakaway oxides (Figure 1a). A high degree of internal oxidation was also observed in this sample. This behavior is very similar to that observed by Sohn et al[8] and illustrated schematically in Figure 1b[8]. On the other hand the HVOF sample with the PEB treatment shows a smooth continuous oxide layer (Figure 2).

Clearly, there is noticeable difference between the cyclic oxidation performance of the HVOF bond coat system. Without the PEB treatment the bond coat has a much thicker thermally grown oxide (TGO) and shows extensive internal oxidation, after 471 x 1h cycles of oxidation as illustrated in Figure 1 (sample from test 1 in Table II). The TGO formed on the non PEB

treated samples generally consisted of an outer alumina layer, over an inner region of oxide that was predominately chromia. Cracks are generated in this layer, as a result of thermal cycling, passing in a tortuous manner through the middle of this mixed oxide scale. Internal oxidation and nitridation are observed, with extensive oxides formed at prior particle boundaries and at porosity in the coating. Internal oxidation and nitridation depletes the coating alloy of scale forming elements and contributes to the early cyclic failure of this TBC coated, HVOF sprayed bondcoat.

Figure 1: (a) Micrographs of the as sprayed HVOF bond coat system after cyclic oxidation testing at 1150°C (b) Schematic illustrating the evolution of damage during cyclic testing [8]

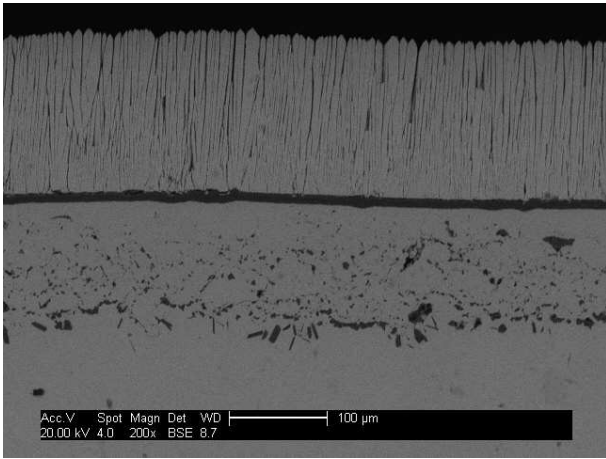
Fig 2

On the other hand the PEB processed sample, shown in Figure 2, had a thermally grown oxide that was much more uniform and was purely alumina, with no evidence of chromia or nickel, cobalt spinel subscales. This more ideal structure, as illustrated in Figure, was observed after 921 x 1h hot cycles. Less internal oxidation was observed, but there was extensive nitride formation within the lower part of the MCrAlY bondcoat. These nitride phases have been analysed and were found to be AlN, with a small solubility of chromium. Such nitride phases were embryonic in the as-sprayed and PEB processed coating, which raises the question whether significant nitrogen is introduced into the MCrAlY bondcoat as part of the HVOF spray process, as it is unlikely that the nitrogen was transported through the alumina scale during oxidation.

Figure 2: Micrographs of the HVOF bond coat system with PEB treatment after cyclic oxidation testing at 1500°C.

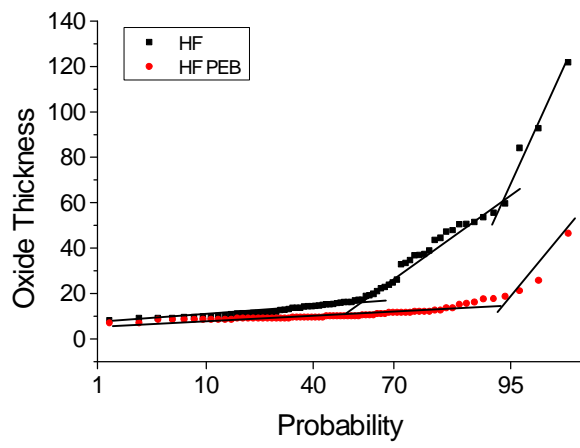
Fig 3

Furthermore there is a significant difference in the oxide thickness of the samples at failure as shown in Figure 3. The oxide thickness measured for the HVOF sample is significantly higher than the sample with the PEB treatment even though the sample with the PEB treatment was at temperature for twice as long (for these particular samples). This difference in oxide thicknesses is attributed to the large areas of breakaway oxidation in the HVOF sample whereas the PEB treated HVOF bond coat had far fewer areas of breakaway oxidation and no evidence of peg formation was observed.

Figure 3: Probability plot of oxide thickness for the HVOF and the HVOF PEB samples at 1500°C [Note: different hot cycle times to failure: 471 cycles for HVOF and 921 cycles for PEB-HVOF sample].

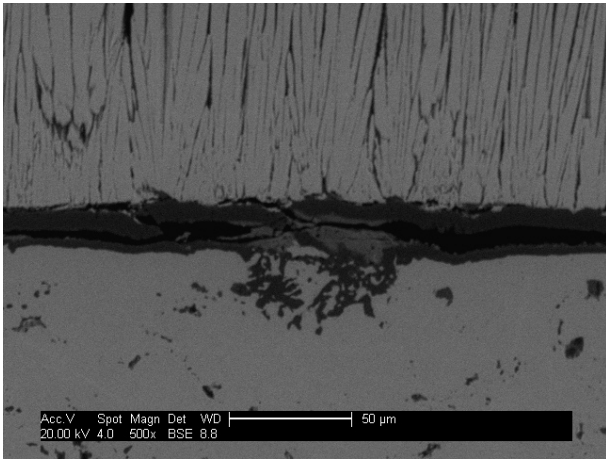
Fig 4

The SEM micrograph in Figure 4 shows a region of breakaway oxidation in the HVOF PEB bond coat which has initiated cracking in the continuous alumina scale. This failure appears to be a type of jacking failure mechanism similar to that which has been described previously by other researchers [10-12]. Whereby, highly localised breakaway oxidation appears to jack up the coating in the region immediately above it as it grows. As the break away oxidation grows and the coating is jacked up, cracking will initiate at the TGO bond coat interface and as this crack propagates spallation of the top coat will occur.

Figure 4: SEM micrograph of the HVOF PEB bond coat showing the continuous alumina scale and a region of breakaway oxidation, consisting of Cr/Ni spinells.

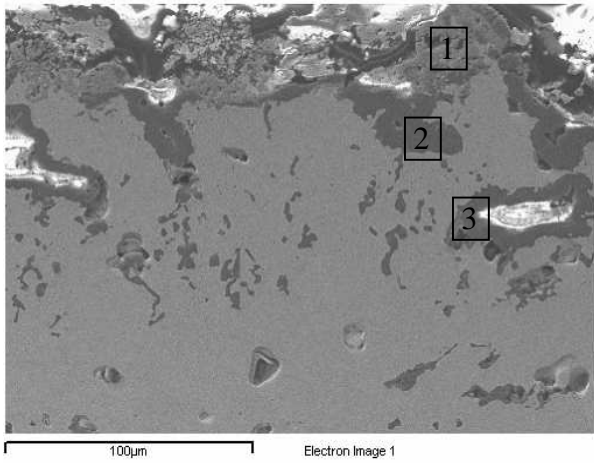
Fig 5

In order to verify some of the compositions of the various oxides that were observed in the two coating types, SEM EDX analyses were used. The SEM micrograph in Figure 5 shows where three point analyses were conducted on the HVOF sample, see Table III, identifying the internal oxidation as alumina and the TGO as alumina and a predominantly chromia mixed oxide.

Figure 5: SEM micrograph of the TGO and the bondcoat of the HVOF sample showing the areas where point analyses were conducted.

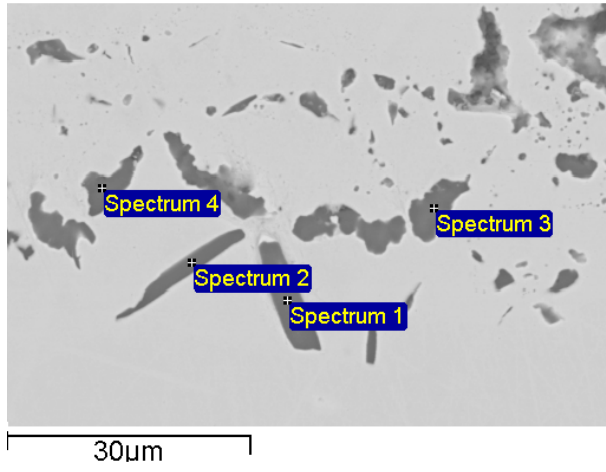
Fig 6

A significant number of inclusions can be observed within the lower part of the bond coat of the HVOF PEB treated sample as illustrated in Figure 6, which shows the four inclusions that were analyzed. The results of the analyses are given in Table IV and show that all inclusions are essentially aluminium nitride, with small traces of some of the bond coat constituents. Although these trace inclusions could be due to the analyzing beam penetrating slightly into the bond coat.

Figure 6: Local analysis on nitrides precipitates in HVOF PEB bond coat.

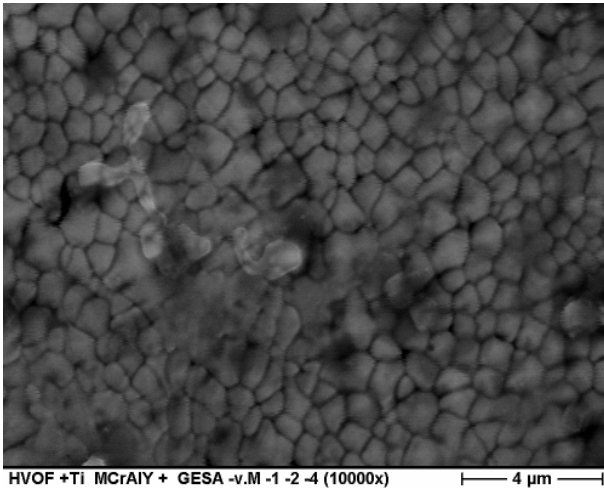
Fig 7

The PEB process leads to a re-melted MCrAlY surface layer, resulting in an extremely smooth surface as shown in part 1 [9] and a very fine grained microstructure as shown in Figure 7. During this process yttrium in the coating can oxidise forming a dispersion of yttria in this re-melted layer. Re-solidification leads to a much finer $\beta+\alpha$ microstructure and seals any prior particle boundaries, but may result in the solution of nitrogen from these pores and channels into the coating.

Figure 7: SEM micrograph of the top view of the PEB treated HVOF bond coat showing the small grain size of the recrystallised PEB treated surface.
