**Monitoring of masonry historical constructions:
ten years of static monitoring of the world’s largest oval dome.**

This paper presents the analyses conducted on data acquired by the monitoring system of the “Regina Montis Regalis” Basilica of Vicoforte in the decade 2004-2014. The Basilica is a building of great historical, architectural and structural significance, owing its fame to its impressive masonry oval dome, the world’s largest of this shape (internal axes of 37.23 by 24.89 m).

Monitoring of masonry historical constructions: 10 years of static monitoring of the world's largest oval dome

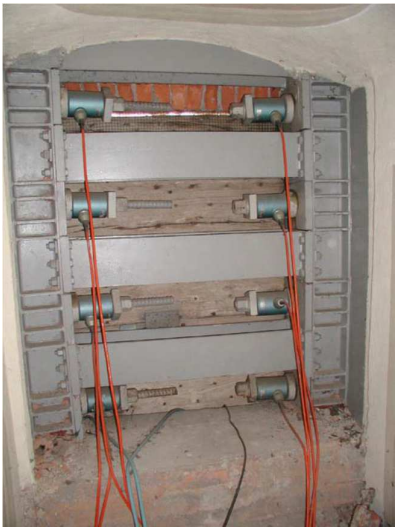
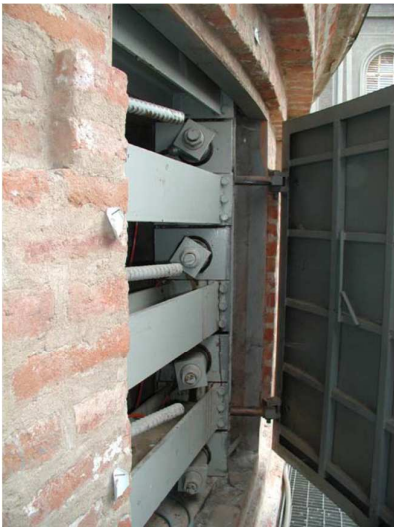
Figure 4. (a) Tie-bar ends equipped with load cells and (b) tie-bars end with the anchorage system.
