# Three-dimensional subsurface defect shape reconstruction and visualisation by pulsed thermography

Defects detected by most thermographic inspection are represented in the form of 2D image, which might limit the understanding of where the defects initiate and how they grow over time. This paper introduces a novel technique to rapidly estimate the defect depth and thickness simultaneously based on one single-side inspection. For the first time, defects are reconstructed and visualised in the form of a 3D image using cost-effective and rapid pulsed thermography technology. The feasibility and effectiveness of the proposed solution is demonstrated through inspecting a composite specimen and a steel specimen with semi-closed airgaps. For the composite specimen, this technique can deliver comparatively low averaged percentage error of the estimated total 3D defect volume of less than 10%.

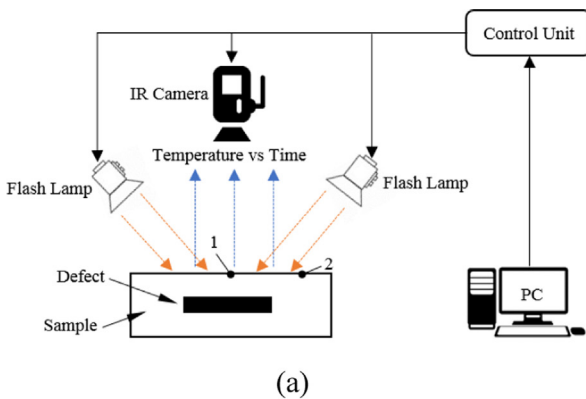
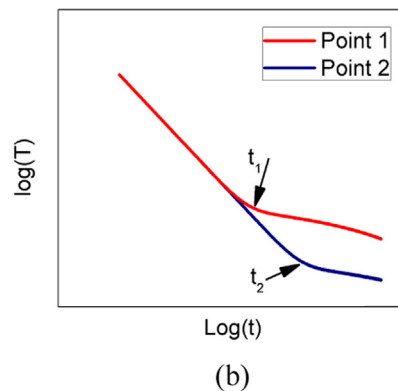
**Fig. 1.** (a) Experimental configuration of the pulsed thermographic inspection under the reflection mode, where point 1 denotes a surface location with a defect underneath and point 2 denotes a location on the sample surface with no defect underneath; (b) Typical observed time-temperature decay curves in the logarithmic domain for the point 1 and 2, respectively, where the time of  $t_1$  and  $t_2$  is the key to measure the thickness of local materials [7].

In a pulsed thermographic inspection in reflection mode, a short and high energy light pulse is projected onto the sample surface through one or two flash lamps (see Fig. 1(a) for typical experimental setup) [33].

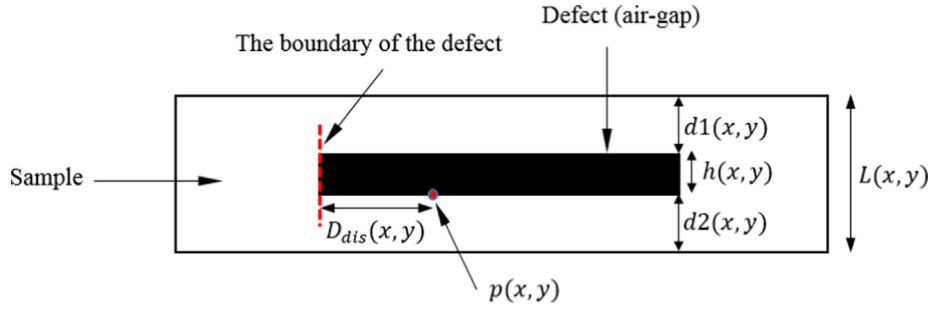
Fig. 2. The side view of subsurface defects.

The method of double-side inspection reconstructs the 3D structure of defects by evaluating the defect depth from both sides of the sample. As seen in Fig. 2, the defect thickness ( $h$ ), at the position of  $x$  and  $y$ , can be calculated by

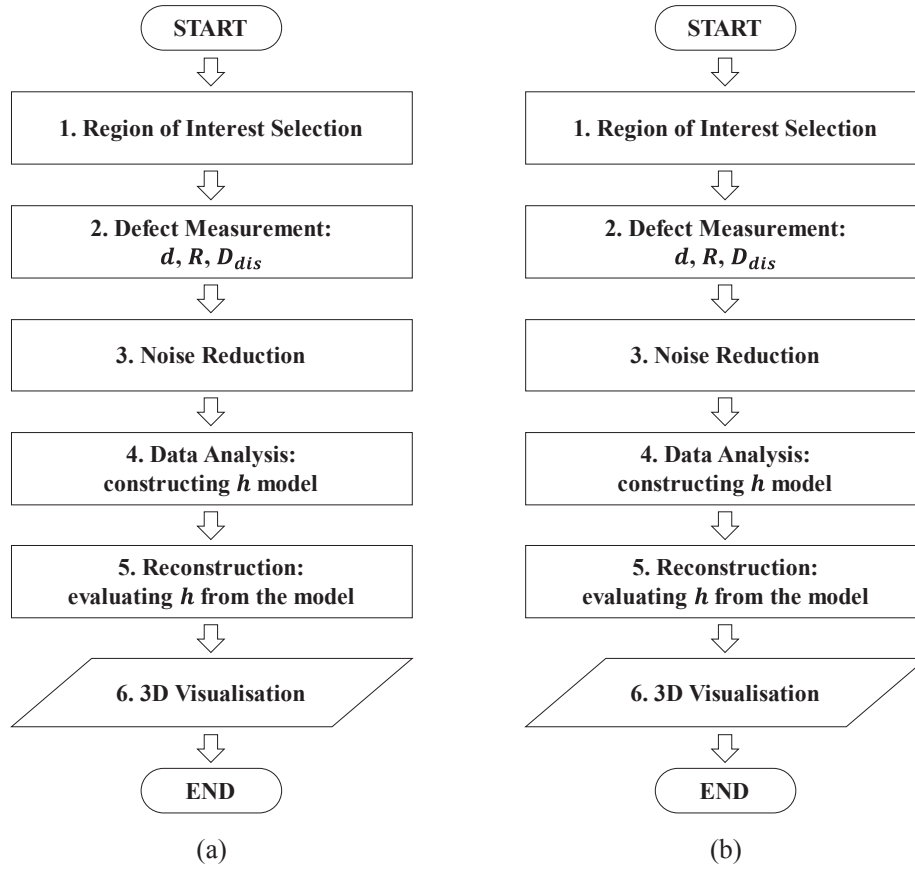
Fig. 3. Inspection process for (a) the single-side inspection and (b) the double-side inspection.

The single-side inspection and the double-side inspection can be described in the flowcharts as shown in Fig. 3. For the single-side inspection, the first step is to select the region of interest (ROI), which aims to select a region for defect estimation and visualisation to reduce overall processing time. The ROI was selected manually in this paper. The second step is defect measurement to obtain subsurface

information of ROI including defect depth ( $d$ ), the shortest distance from the boundary of the defect to the inspecting point ( $D_{dis}$ ), and thermal wave reflection coefficient of the defect ( $R$ ), which are achieved by the NLSF method. The third step is noise reduction to enhance image quality ( $R$  image and  $d$  image), which is achieved by the application of a Median Filter [35] in this paper. The fourth step is to establish the relationship model between  $h$ ,  $R$ , and  $D_{dis}$ , shown in Eq. (3), based on the estimated parameters in the second step. The fifth step is to estimate the defect thickness based on the established model. The last step is to visualise the defect in the form of a 3D image, where the reconstructed defect (size, depth, thickness, and location of the defect) is fused with the dimension (width, length and thickness) of the sample to produce a volume image. This volume image is then rendered and displayed in the form of a 3D image. For the double-side inspection, most steps are similar to the single-side inspection except the second, the fourth, and the fifth step. In the second step, the sample's thickness and defect depth of the both side of the sample are required, whilst the defect depth from the single-side inspection requires one side only. The fourth step is to align the position of the defect region between the front side and the back side and the fifth step is to estimate the defect thickness from Eq. (8).

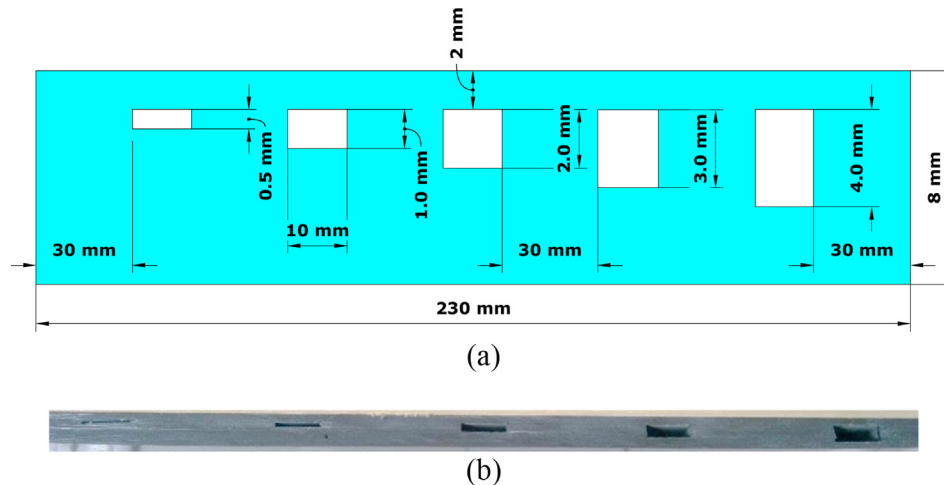
Fig. 4. Illustration of Sample 1 (a) Sample design (b) Side view.

A flat plate of carbon fibre reinforced polymer (CFRP) material was used in this study. The plate was made of unidirectional Toray 800 carbon fibres pre-impregnated with Hexcel M21 epoxy resin and manufactured in a traditional autoclaving process. The dimension of Sample 1 is 75 mm  $\times$  230 mm  $\times$  8 mm. As illustrated by Fig. 4(a), it includes five block defects with a thickness ( $h$ ) of 0.5 mm, 1.0 mm, 2.0 mm, 3.0 mm, and 4.0 mm, respectively, named Defect1 to Defect5. The width ( $r$ ), length, and depth ( $d$ ) for all defects are 10 mm, 75 mm, and 2 mm respectively. The distance between two adjacent defects is 30 mm, which aims to reduce the influence from the adjacent defects on the thermal behaviour. A side view of the produced sample is shown in Fig. 4(b). It should be noted that these defects are not fully closed because two sides of the defects are open. This sample is aimed at studying the relationship between  $R$ ,  $h$ , and  $D_{dis}$  when  $d$  is fixed.

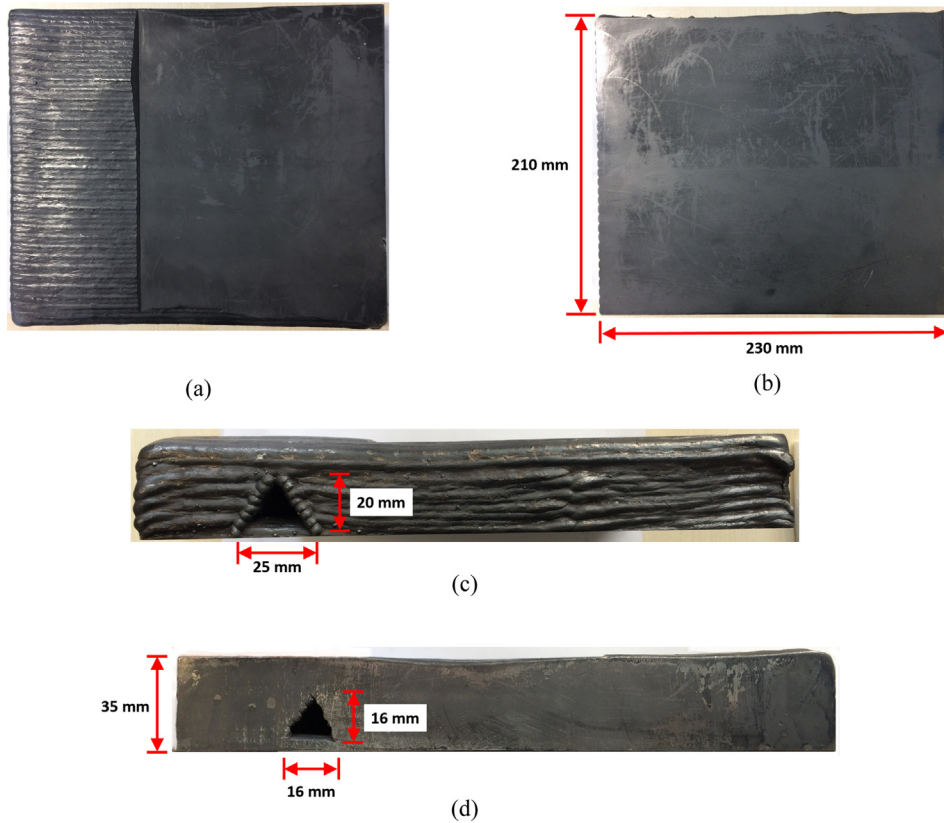
**Fig. 5.** Snapshots of Sample 2: a steel plate with triangle air-gap defects (a) the back side of the sample (b) the front side of the sample and inspected side (c) the top side of the sample (d) the bottom side of the sample.

As a use case, Sample 2 was made from steel with a dimension of 210 mm  $\times$  240 mm  $\times$  35 mm, as shown in Fig. 5. There is an 'S' shape triangular air-gap through the sample. By measurement, at the top side of the sample, the defect is estimated to be triangular in shape, which has the base about 25 mm and the maximal thickness about 20 mm, illustrated in Fig. 5(c). At the bottom side of the sample, the defect is also estimated to be triangular in shape, which has the base about 16 mm and the maximal thickness about 16 mm, illustrated in Fig. 5(d). The sample was inspected at the flat side using the proposed single-side thermographic inspection, illustrated as Fig. 5(b).

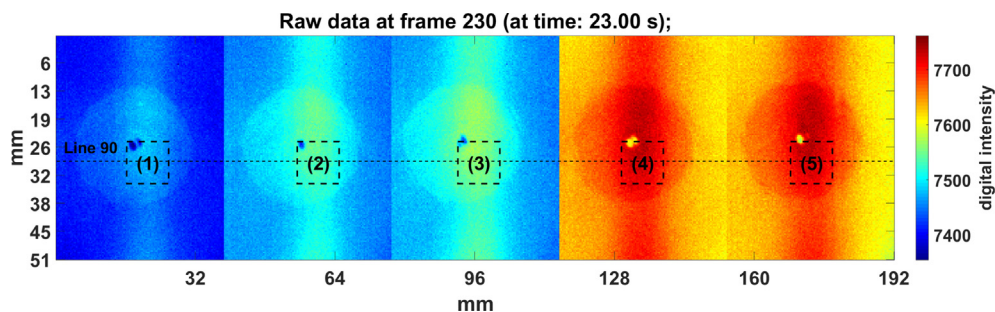
**Fig. 6.** The raw thermal image at the frame 230 for Sample 1 after combining 5 inspections, where the regions of interest are highlighted.

Due to the large width of Sample 1 (230 mm), the defects of this sample suffer non-uniform heating for a single inspection, which could lead to unreliable results [36]. To reduce this effect, in this study the sample has been inspected five times, where each defect was placed on the centre of the camera's view once. An area of the centralised defect with the size of  $160 \times 120$  pixels for five data files was then cropped and merged into one file with a size of  $160 \times 600$  pixels for easier analysis. Fig. 6 shows a snapshot of the raw thermal image at time 23 s. The defects are labelled as “(1)”, “(2)”, “(3)”, “(4)”, and “(5)” to represent the defect thickness of 0.5 mm, 1.0 mm, 2.0 mm, 3.0 mm, and 4.0 mm, respectively. The ROI of each defect is about  $10 \text{ mm} \times 10 \text{ mm}$  (around  $30 \times 30$  pixels), as highlighted in Fig. 6, which are used for evaluating the performance of the proposed technique.

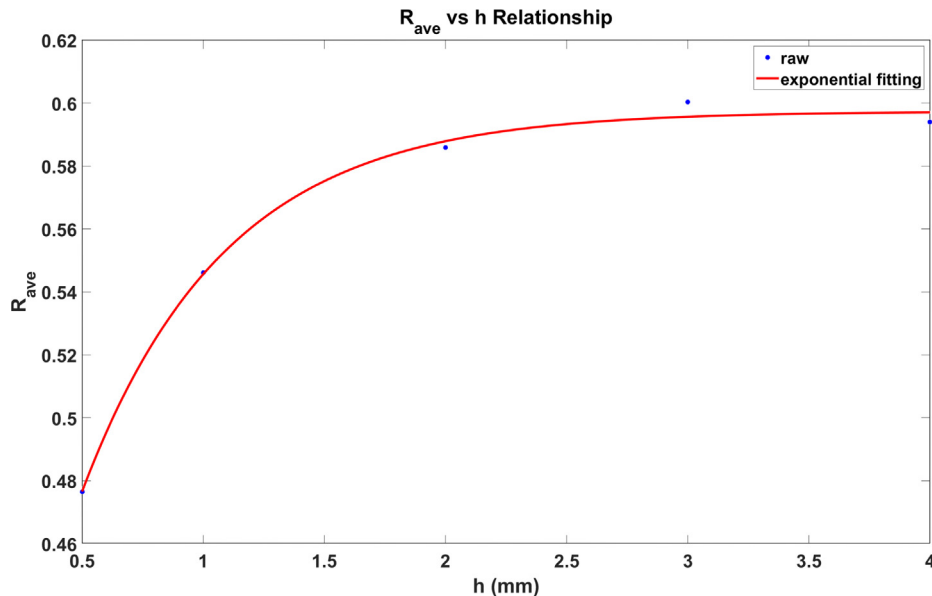
Fig. 7. The plot of  $R_{ave}$ - $h$  curve of Sample 1.

reflection coefficient ( $R$ ) requires to be established before prediction of  $h$ . To reduce the influence of the heat leaked to each opened side on the results, only a region of  $6 \times 30$  pixels on the middle area of each defect were sampled to establish the model. Estimated  $R$  values were averaged and are shown in Table 1. The averaged  $R$  values, denoted by  $R_{ave}$ , in the middle area were used as the representative of  $R$  to establish the  $R_{ave}$  vs  $h$  relationship. It is observed that the averaged value of  $R$  increases following the increase of defect thickness. This observation is expected because the heat is more difficult to be leaked through the 3D conduction around air-gap if the defect is thicker. As can be seen from the plot between  $R_{ave}$  and  $h$  in Fig. 7, the associate is not linear but approximately exponential. An exponential fitting was applied on them, and the relationship between  $R_{ave}$  and  $h$  can be written as

$$R_{ave} = -0.2820e^{\frac{-h}{0.5898}} + 0.5974 \quad (9)$$

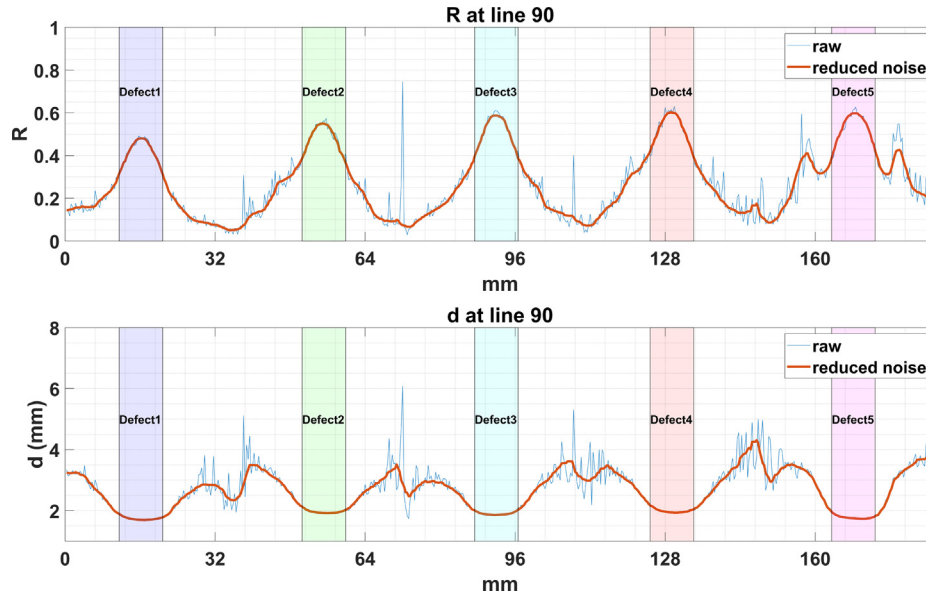
Fig. 8. Plots of estimated  $R$  and  $d$  of the cross-section at line 90.

Fig. 8 shows plots of estimated  $R$  and  $d$  of the cross-section at line 90, where it can be clearly seen that the  $R$  values are not consistent for one defect even though the five defects have a consistent thickness. It indicates that there are some other factors affected the  $R$  value. It is suggested in Fig. 8 that  $R$  value at both sides of defect's boundary is less than the middle region. This observation could be caused by the fact that the heat around the middle of the defect is more difficult to leak than that around the boundary of the defect. This issue must be addressed if the identified model from the regions of  $6 \times 30$  pixels is applied to the ROI of  $30 \times 30$  pixels. To improve the accuracy of  $R$  estimation, the shortest distance from the boundary of the defect to the inspected point ( $D_{dis}$ ), shown in Fig. 2, is taken into account to correct the  $R$  value. The re-calculated  $R$  ( $R_{new}$ ) is a function of  $R$  and  $D_{dis}$

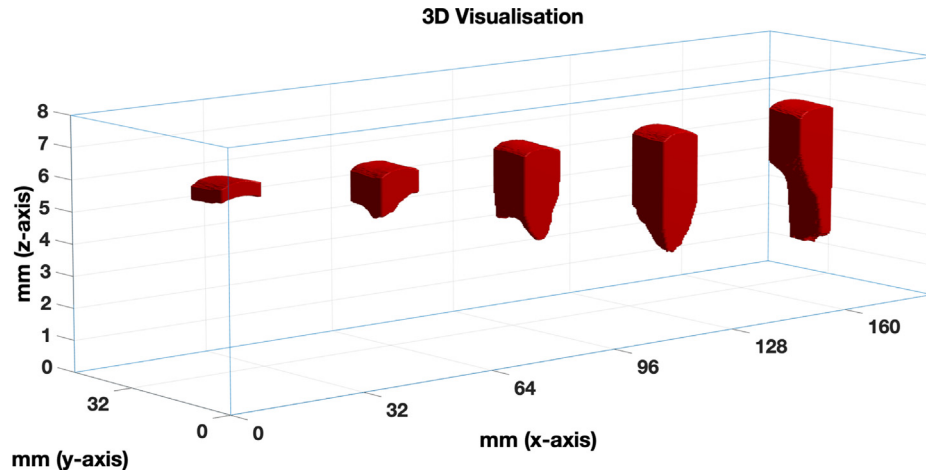
Fig. 9. The 3D visualisation of the five defects of Sample 1 using the proposed single-side inspection.

The reconstructed defects for the regions of  $30 \times 30$  pixels are visualised in Fig. 9, which suggests that the proposed technique can effectively reconstruct the 3D structure of simple defects. The estimation of the bottom surface has an increasing error following the increment of defect thickness.

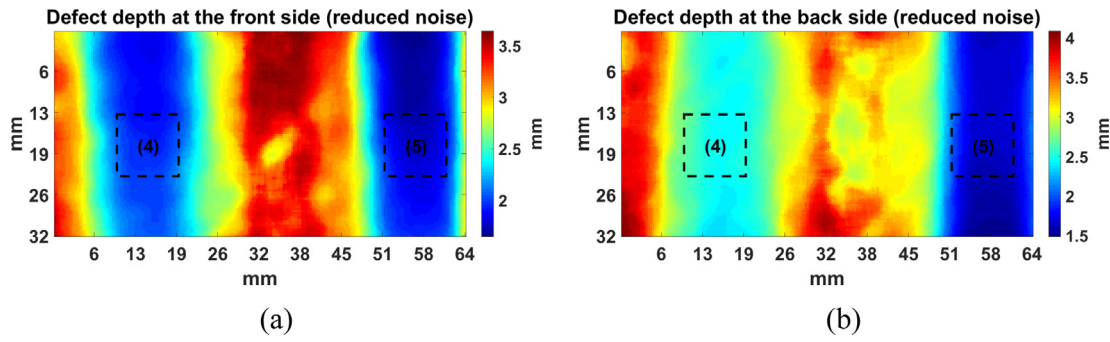
Fig. 10. The estimated defect depth image of Sample 1 after reducing noise (a) at the front side (b) at the back side, where the left defect is Defect 4 and the right one is Defect 5.

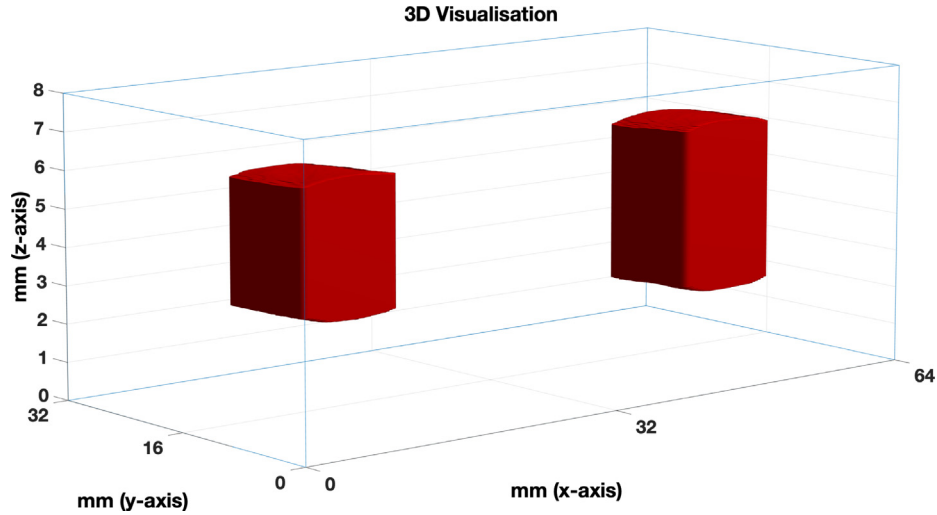
Fig. 11. The 3D visualisation of Sample 1 from the double-side inspection.

volume image and visualised in the form of 3D image, as shown in Fig. 11. It is clearly visible that Defect 5 is thicker than Defect 4, and the estimated 3D volume for both defects is close to the design shown in Fig. 4. It should be noted that the z-axis is scaled up to better visualise the detail of the defect surface.

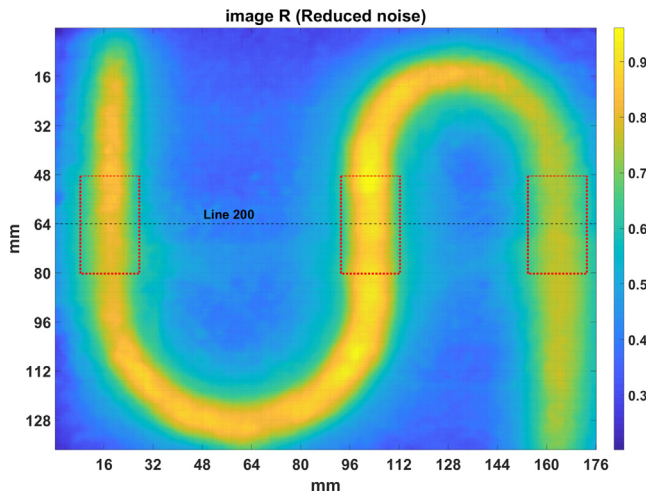
Fig. 12. The averaged  $R$  region over the top side triangle defect area for Sample 2.

Sample 2 was inspected by the single-side inspection because the defect was too deep to measure from the other side. To find the relationship between  $R$  and  $h$ ,  $R$  values in three areas with a size of

$100 \times 60$  pixels were sampled as highlighted in Fig. 12. It should be pointed out that the  $R$  values of 100 vertical pixels were averaged. Fig. 13 plots the cross-section at line 200 of the estimated  $R$  and  $d$ , where the three selected areas are highlighted. It can be observed that the middle area has the highest value of  $R$ , then the left one and the right now. Proven in the experiments of Sample 1, a higher value of  $R$  suggests a thicker defect. As illustrated in Fig. 5, the maximal thickness of the left defect is about 20 mm, and the right one is about 16 mm. Based on the observation of the  $R$  values, the maximum thickness of the middle area is assumed to be 24 mm. A numerical model was then established to represent the relationship between  $R$  and  $h$ , written as

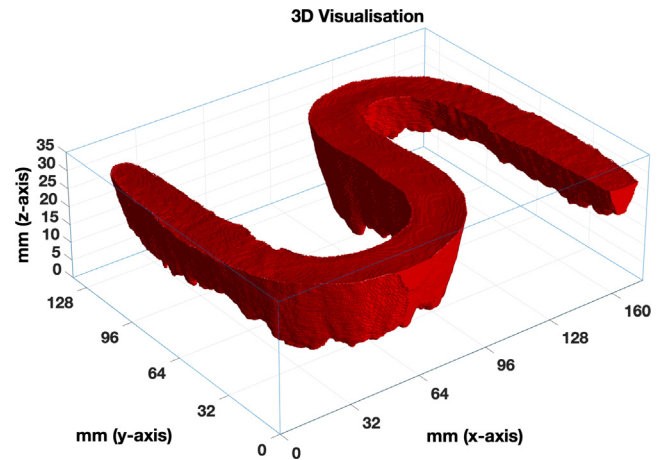
Fig. 14. 3D defect visualisation of Sample 2 defects using the proposed single-side inspection.

As the last step, the 3D volume image was reconstructed by combining the surface dimension (size and thickness of the sample) and subsurface information (defect depth and defect thickness) and result is shown in Fig. 14. The triangular 'S' shape defect can be clearly observed which matches the appearance of the defect shown in Fig. 5(c) and Fig. 5(d). To validate the result using other NDT methods, Fig. 15 shows the comparison of the 2D image of the defect from pulsed thermography and X-ray. It can be seen that the defect shape of both images is similar. A quantitative comparison between these two imaging modalities in terms of 3D defect reconstruction was not conducted in this paper due to the distortion of thermal images caused by the lens. A further study is required to correct this distortion before conducting a comprehensive comparison.

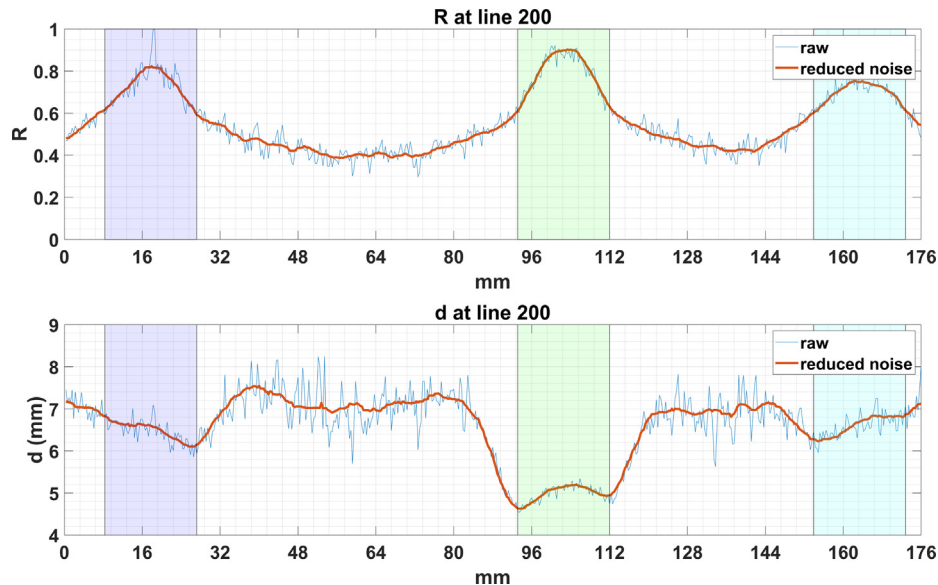
Fig. 13. Plots of estimated  $R$  and  $d$  of the cross-section at line 200 of Sample 2.

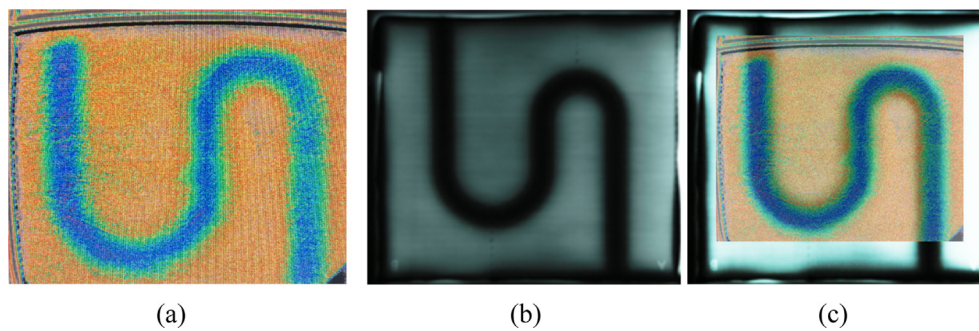
Fig. 15. The inspection result in the form of a 2D image for Sample 2 from (a) pulsed thermography, (b) X-ray and (c) overaly of two modalities.
