Improvement in hot corrosion resistance of dissimilar alloy 825 and AISI 321 CO₂-laser weldment by HVOF coating in aggressive salt environment at 900°C

This study investigated the hot corrosion performance of a dissimilar weldment of Ni-based superalloy and stainless steel joined by CO₂ laser welding and improved by high-velocity oxy-fuel (HVOF) coating in a Na₂SO₄–60wt%V₂O₅ atmosphere at 900°C. A dissimilar butt joint of AISI 321 and alloy 825 was fabricated by CO₂ laser welding with low heat input after obtaining the optimum welding parameters by bead-on-plate trials. The metallurgical and mechanical properties of the laser weldment were evaluated. The tensile test results indicated the occurrence of fracture in the base metal AISI 321 side. The HVOF process was employed to coat Ni–20wt%Cr on the weldment. To evaluate the surface morphology of the corrosion products formed on the uncoated and HVOF-coated weldments, scanning electron microscopy (SEM) analysis was performed. Energy-dispersive spectroscopy (EDS) was used to determine the different elements present on the surface scales. The existence of oxide phases on the weldments was determined by X-ray diffraction (XRD). The cr

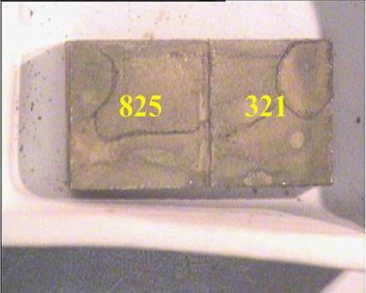
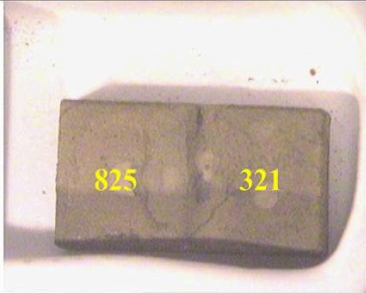
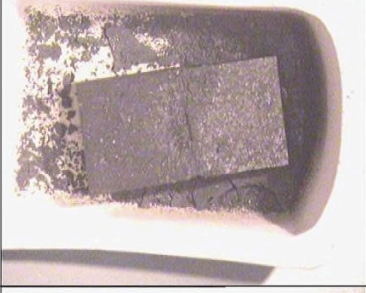
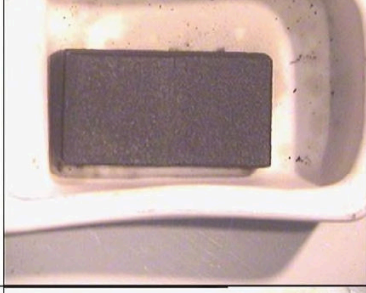
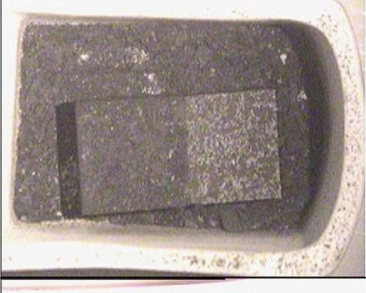
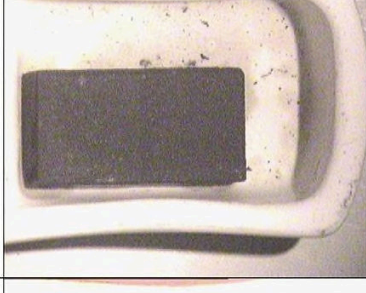
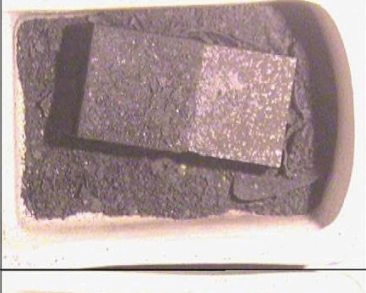
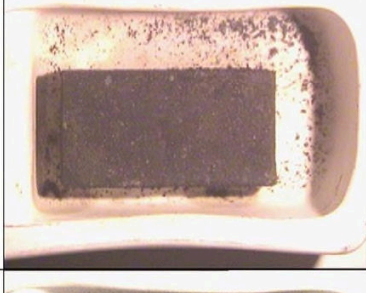
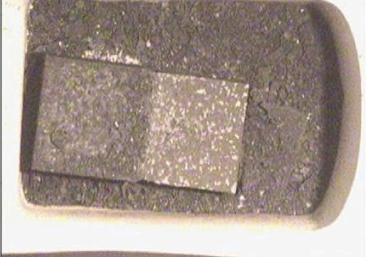
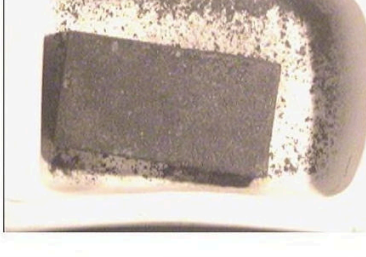
Fig. 7. Macro-images of uncoated and HVOF-coated hot-corroded weldments during exposure to molten salt at 900°C.

Macro-images of the uncoated and coated weldments during exposure to the salt environment are depicted in Fig. 7. The macro-images show the presence of oxide scales on the surface, spallation, and sputtering. In the uncoated weldment, from the initial stage onward, the scales started to spall on both the weld and base metal regions. This could be attributed to the extensive corrosion at the AISI 321 region and the weld zone caused by the development of the Fe_2O_3 scale. The spalling rate of scales increased with an increase in exposure time, as shown in Fig. 7. A minor oxide scale spallation was observed in the coated specimen.
