## **Application of the finite element method to predict the crashworthy response of a metallic helicopter under floor structure onto water**

K.Hughes\*, J.Campbell, R.Vignjevic

*Crashworthiness, Impacts and Structural Mechanics Group,*

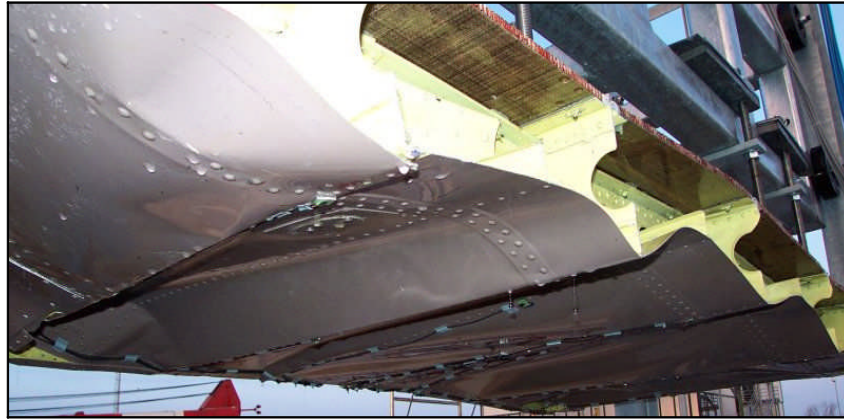
Figure 16 Underside view of the port side taken after the drop test. Picture courtesy of *CIRA* [11]
