Normalised Root Mean Square and Amplitude of Sidebands of Vibration Response as Tools for Gearbox Diagnosis

P.J. Rzeszucinski¹, J. K. Sinha¹, R. Edwards¹, A. Starr², B. Allen³

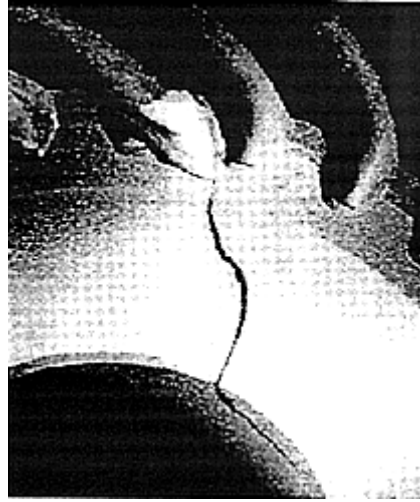
Figure 2. A severe gear crack that led to termination of the test [10]

The dataset comprise a total of 85 samples. After recording the last file the test was stopped due to a severe pinion gear crack. Inspection revealed that the fault initiated from the tooth root, extended through the gear web and stopped at a bearing support diameter. A photograph of the gear taken after the test is shown on Figure 2.
