Fusion Insights from Ultrasonic and Thermographic Inspections for Impact Damage Analysis

Muhammet E. Torbali*, Muflih Alhammad †, Argyrios Zolotas ‡, Nicolas P. Avdelidis §
Cranfield University, Bedford, UK, MK43 0AL

Torbali ME, Alhammad M, Zolotas A, et al., (2023) Fusion insights from ultrasonic and thermographic inspections for impact damage analysis. In: 2023 AIAA Aviation and Aeronautics Forum and Exposition (AIAA AVIATION Forum), 12-16 June 2023, San Diego, CA

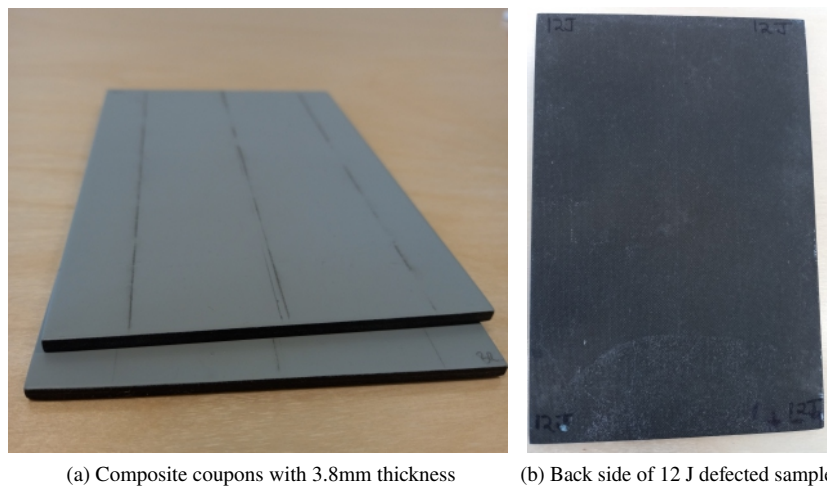
Fig. 1 Image of composite samples that exhibit no surface defect

A set of CFRP composite laminates formed by 18 plies, 3.8 mm thickness and 100x150 mm size have been used (representing composite material in aerospace structures). The coupons were made from UD pre-preg IMS-977-2 material with $[45/-45/90/0/90/0/90/-45/45]_{2s}$ layup commonly found in aviation composites. Samples have been impacted under ASTM standards with three different energy levels (8J, 12J and 20J) to compare the visibility of different-sized defects. Figure 1 shows an example of composite coupons from both sides to observe thickness and dimensions. Both surfaces seem sound and smooth, meaning there is no visible damage on the surfaces.

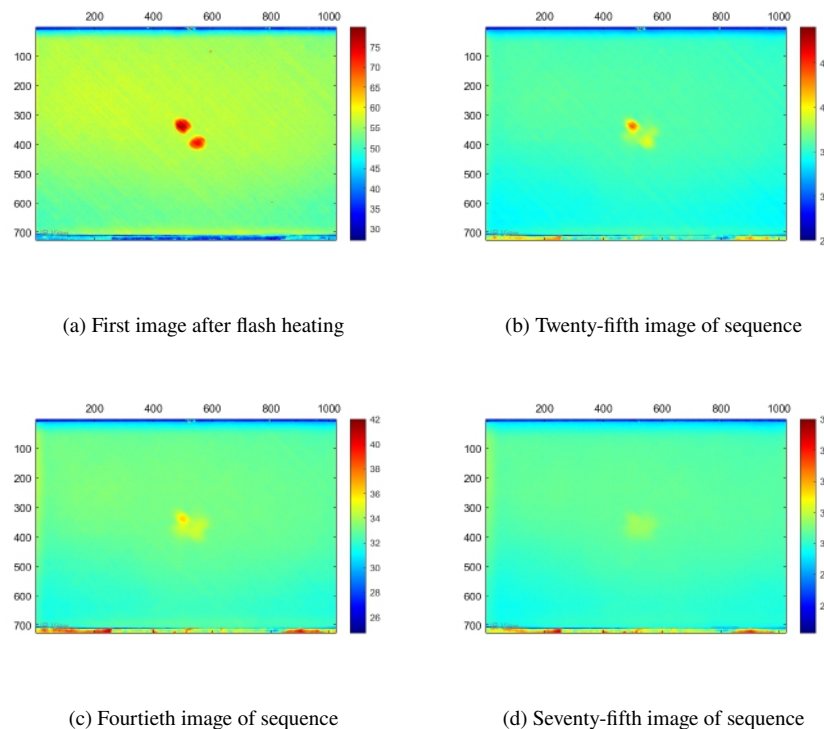
Fig. 2 Raw thermograms in different orders to indicate the defect at various stages of cooling period

The thermal inspection was performed by pulsed thermography, and samples were subjected to two 6.2 kJ output energy heat sources, Xenon arc flashes, for a duration of 2 ms, from a 50 cm distance and 45° angles to the surface of the samples. Thermal images have been recorded by X6900 FLIR infrared camera, from 100 cm distance and 90° angles to the sample surface, with an InSb-CCD Matrix Sensor and image resolution of 640 × 512 pixels. Thermal data has included an image sequence with more than a thousand images during the cooling period. The acquisition setup has been arranged to get images from the entire surface to ease the registration step. Figure 2 shows the thermograms in various orders after heating. As can be seen in the thermograms, the defect shape is altering according to cooling time. Early images have defect clues that seem more solid and sharp; however, later images look blurred and shady. The basis behind this imaging method is having discontinuities caused by the defect, which makes the heat transmission slower over the voids generated by the defect rather than the sound area. Thus, the thermal difference is able to display the defective regions. Although it has a wide range of application possibilities thanks to rapid and contactless nature, pulsed thermography is strongly affected by reflections from the environment, emissivity variations and nonuniform heating [12, 13].

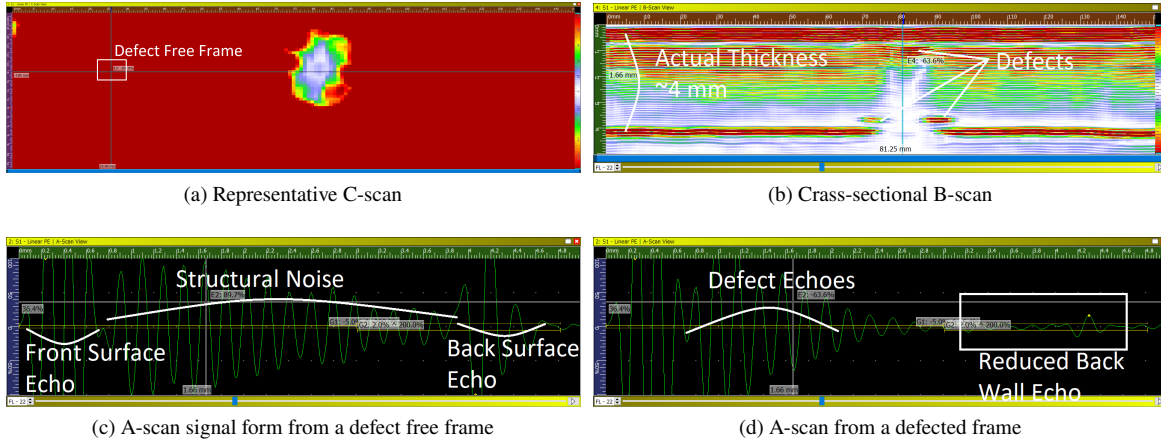
Fig. 3 A snapshot of raw defect detection on PA ultrasonic equipment for 8J impacted composite coupons

Ultrasonic inspection of these composite samples was performed by Sonatest Veo+ equipment and a 10 MHz phased array probe, including 64 element transducer with an appropriate wedge for ultrasonic wave transfer to the sample. The higher frequency probe provides better axial resolution through the thickness with the lower Signal-to-Noise ratio (SNR) due to the blind zone effect of the surface than the lower frequency probe [14]. The probe was moved on the surface of the sample, using sprayed water as a coupling mechanism, and an encoder followed the probe to measure the scanning distance. The PA ultrasonic data includes A-scan, cross-sectional form B-scan images and top-view C-scan images with depth information. Figure 3 presents these concepts for an 8 Joule-impacted sample to investigate ultrasonic signals that is originated from defect-free (non-defective) and defective regions. It should be noted that the PA scanning covered the full area (dimension) of the coupon (sample) to make it easier to align different source images.

From the PA viewpoint, the obtained data comprises several signals for each frame of, per mm, dimension throughout the sample sizes. As it can be seen from the previous Figure, i.e. the A-scan signals snapshot, defect echoes need to be extracted by eliminating other echoes. This provides a location-based defect identification by applying smart thresholding method. Thresholding is carried out by trimming the peaks over the threshold, and finally, the amplitude values of defect signals were derived associated with their depth information. After thresholding operations and obtaining the binary defect images, the source images require an alignment process to provide accurate combination outcomes. Spatial referencing is a process used in image registration to align multiple images spatially in order to compare or merge these. This process involves identifying corresponding points or features in different images and then transforming the images to align them based on those points. Spatial referencing can be accomplished using a variety of techniques, including manual methods, feature-based methods, and intensity-based methods. In manual methods, corresponding points are identified manually by a user, whereas feature-based methods use automated algorithms to identify common features such as edges or corners. Intensity-based methods use the similarity of image intensity values to align images. Here, images have been aligned manually using the entire surface imaging and defect edges. Figure 4 schematizes the overall structure, including pre-processing, registration and fusion stages.

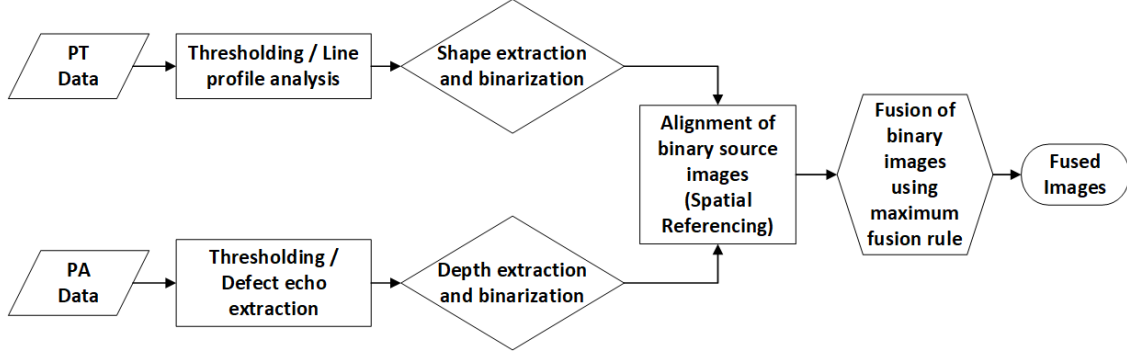
Fig. 4 Flow diagram of the proposed decision-level fusion approach

NDT fusion is a challenging subject given the dissimilar data acquisition environment of uni-modal inspections; there is some work on combining NDT techniques by fusion rules such as generic maximum, minimum or average merging by pixel-wise, principle component analysis (PCA) and wavelets, as well as AI-based approaches [10, 18–21]. In this study, we use the maximum combination rule, given in equations (1), as a simple yet effective synergistic approach to retrieve defect edges.

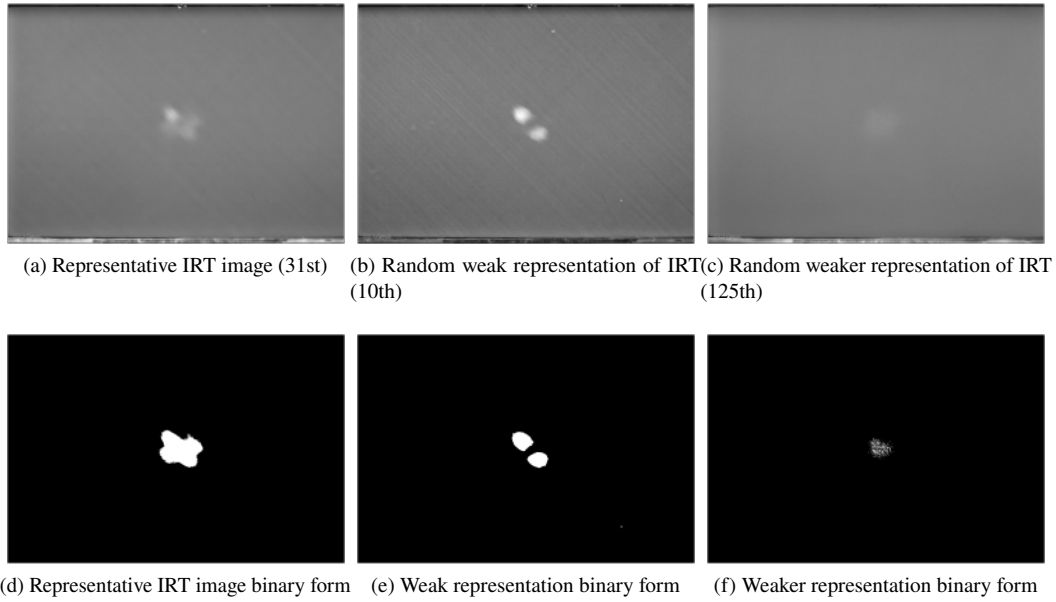
Fig. 5 The best representative IRT image and two randomly selected images during cooling period and their binary forms

Figure 5 shows PT inspection images in grey form with different levels of representativeness and their binarized states for 8J impacted specimen. As mentioned before, a significant step is to find the most representative image from the sequence of thousands of images. Here, the highest score of representation belongs to the image in the 31st row (Figure 5a). It should be stated that this image is not coming just after flash heating rather than the 10th image, which has evident pieces of defect clues but missing. Considering the three images in Figure 5b, 5a and 5c, it can be noted claimed that the degree of representation first increased after the heating and then decreased with the increase in cooling. The 125th image looks almost indistinguishably cloudy. This is also evident in binary images. While the 31st image has an apparent defect shape which is better than 10th, the 125th image has highly poor defect clues.

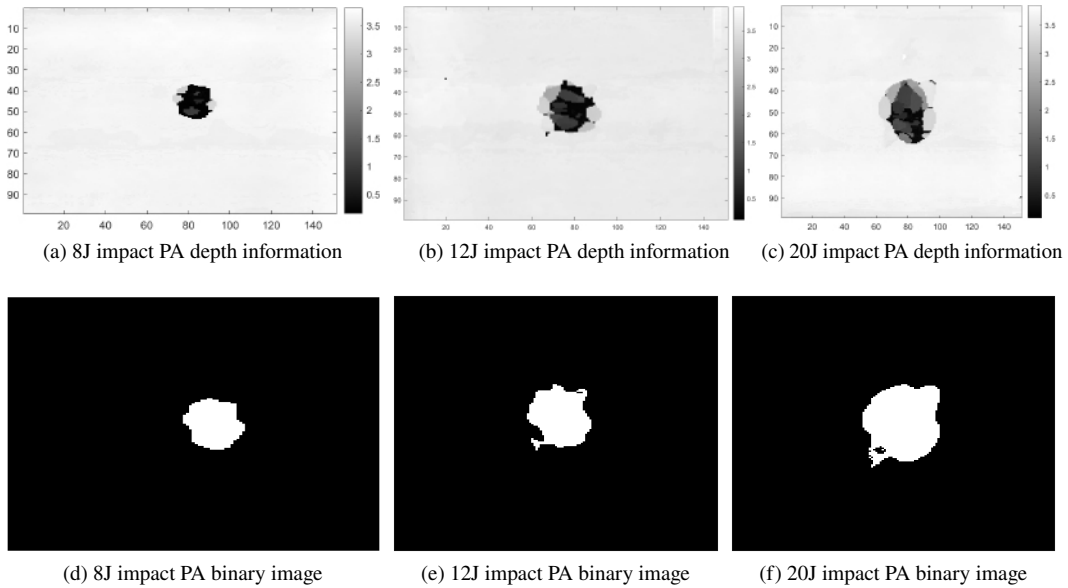
Fig. 6 Depth information of the samples extracted from PA inspection and binary forms after thresholding

Figure 6 presents the depth information for three levels of impact damage, i.e. black color indicates regions close to the surface and white color indicates features deeper from surface. It should be emphasized here that damaged areas are seen not only in the area close to the surface but also deeper in the composite closer to back wall. It is noted that the defect sizes are increasing with the higher level of impact energy. Binary images of PA inspection emphasize the gradual increment in the defect size. Small distortion of the shape in binary images may require further investigation in selecting threshold values for related images.

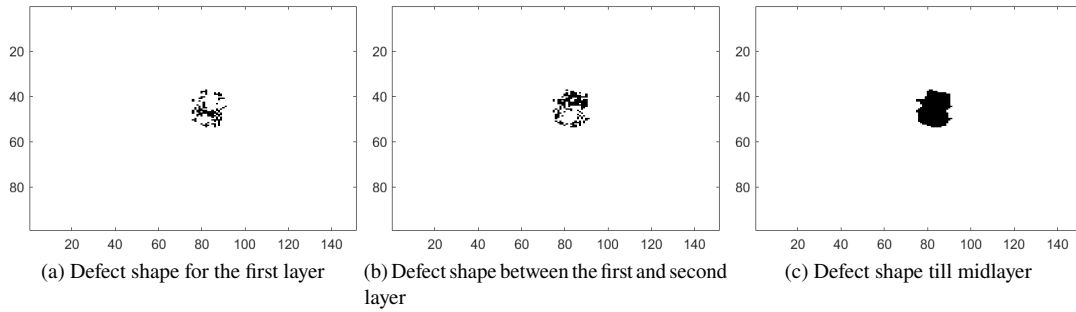
Fig. 7 Defect shapes for different depths, at first, second and up to middle layers

Additionally, PA ultrasonic inspection is able to provide defect information layer by layer. Simply, Figure 7 has given defect marks for the first layer, second layer and up to middle layer of the composite structure. Images seem that the

defect on the first layer is beginning outward from the inside; however, more concentrated at the edges in other layers.

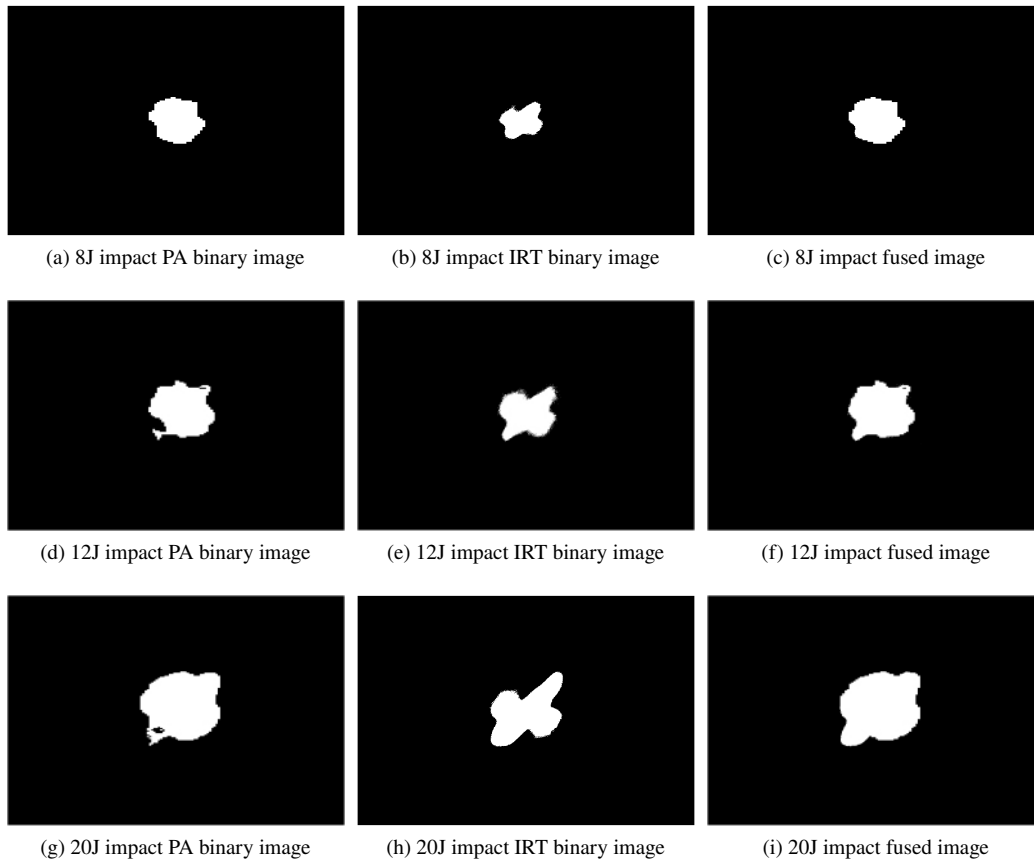
Fig. 8 Processed source images and fused images for growing impact level using maximum rule

The fused image showcases the combined information and the resulting shape, and to improve the visualisation of the damage the images are binarized (see Figure 8). Fused images for all levels of impact energies have shown a more circular (round) and continuous form, unlike the sources. Inspection outputs obtained by both methods, although having minor morphological differences, provide consistent results that are mostly in agreement. The fused result combines information from both inspection approaches. It is clearly shown that the fusion approach can offer more efficient defect detection by combining the advantages of both inspection methods. This enhanced sizing of defect mechanisms can enable improved repair operations such as removing and patching [22].

Table 1 presents the calculated defect size. For all three cases, PA inspection outputs a larger defect area compared to IRT (PT). The fused images provide a more informative output by covering the wider area of the possible defect.
