# An evaluation of the comprehensibility of graphical exit signs for passenger aircraft Phases 1 & 2

COA report No.9706  
April 1997

Human Factors Technology Group  
College of Aeronautics  
Cranfield University  
Cranfield  
Bedford MK43 0AL  
England

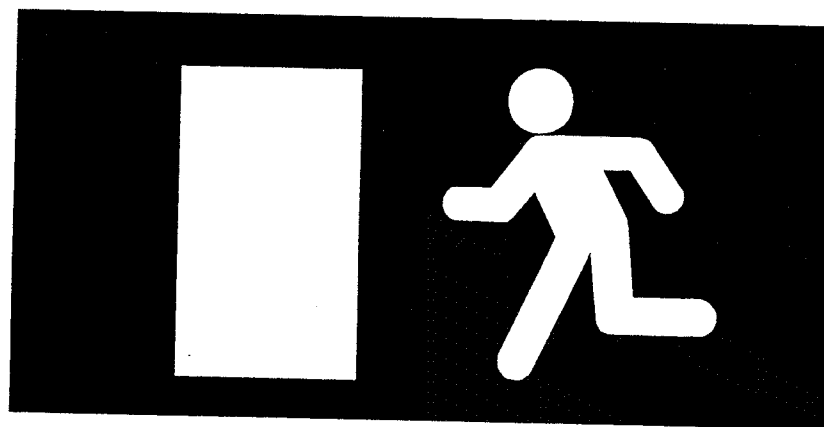
Sign	Meaning
1a	Actual location of emergency exit
1b	Actual location of emergency exit
2a	Emergency exits are located in both directions
2b	Emergency exits are located in both directions
3a	Emergency exit(s) located further down aisle
3b	Emergency exit(s) located further down aisle
3c	Emergency exit(s) located further down aisle
3d	Emergency exit(s) located further down aisle

As can be seen from table 4, the actual differences between the comprehensibility score for signs 1a and 1b are, in real terms, actually quite small (3%). The two signs differ in the way they depict the exit, or door, and the location of the person in relation to the door. Sign 1a, which has a slightly higher comprehensibility rating, depicts the door by a white square, and the person approaching it. Sign 1b also depicts the door as a white square but shows the person in the doorway itself.. The difference in comprehension rates is small enough, however, that we may conclude that either sign would be acceptable for use. However, the symbol used should be consistent with other symbols in use throughout the aircraft. As such, the results of the examinations of signs 2 and 3 should be considered before making a decision with respect to this sign.

In conducting the coding of the responses, it was noticed that some participants inferred meaning from the direction that the person on the sign was facing. Answers included, move to the left, or to the right for the exit despite the fact that a door was shown in the picture directly below the sign. As such, the depiction of a person moving in one direction should be paid particular attention. It is possible that comprehension rates for sign 1a for example could be increased if a person were depicted on either side of the door facing inwards (i.e. two people depicted, both facing the door from different directions).

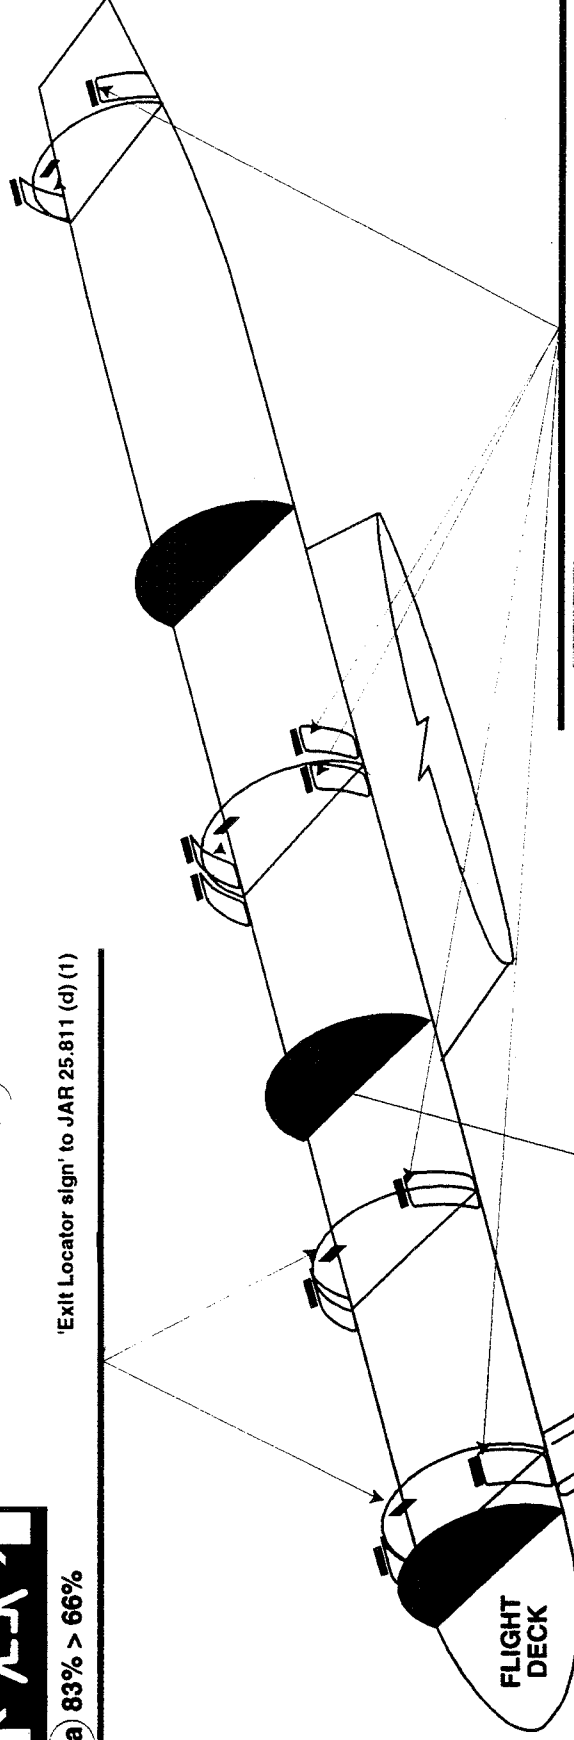
**Annex C: Typical exit signage locations in an aircraft cabin; conclusions from  
Phases One and Two**

(2a) 83% > 66%

'Exit Locator sign' to JAR 25.811 (d) (1)

(1b) 73% > 66% acceptable alternatives to
