## EFFECTS OF OXIDATION AND HOT CORROSION IN A NICKEL DISC ALLOY

Keywords: Oxidation, Hot corrosion, Alloy RR1000

In this paper, the results of laboratory experiments to characterise oxidation and hot corrosion of Ni disc alloy, RR1000 [5], are reported.

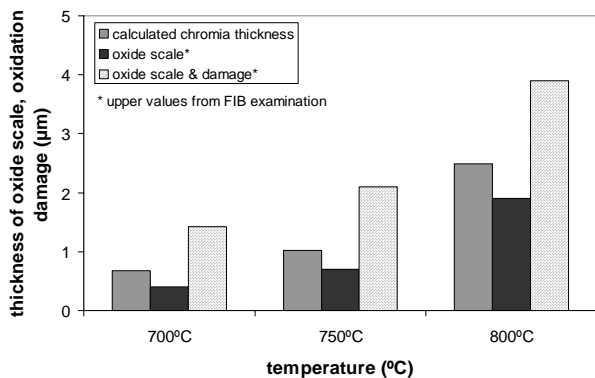
Figure 11 Oxide scale and oxidation damage in RR1000 after 200 hours exposure in air. Measured values from FIB observations are compared with calculated values for the thickness of chromia scale.

Focused ion beam examinations have been used to confirm the low rates of oxidation and the calculated thickness of oxide scale. As oxide scale develops as nodules, the thickness of oxide scale and depth of oxidation damage have a range of values. Figure 11 compares the upper measured values of oxide scale and near-surface oxidation damage from FIB examinations with calculated values of chromia scale. It indicates that the calculated values for the thickness of oxide scale show good agreement to the measured values, despite the results of energy dispersive X-ray analyses in Table II, which have identified that scale contains Ni and Co oxides, particularly at 700°C, as well as Cr and Ti oxides. Figure 11 also suggests that calculated values of oxide scale from TGA or cyclic oxidation testing underestimate the damage from oxidation, and that FIB examination of exposed surfaces may offer the best approach to characterise thin oxide scale and oxidation damage in nickel disc alloys.

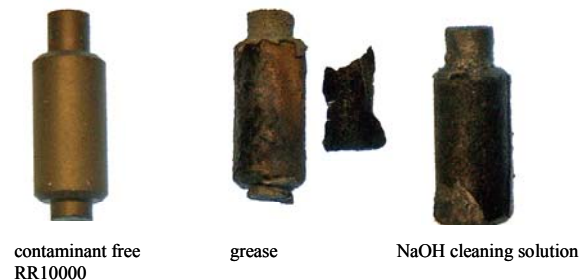
Figure 17. Appearance of samples exposed after 200 hours in air – 300 vpm SO<sub>2</sub> at 700°C (screening test).

The images in Figure 17 show the appearance of the samples after 200 hours of exposure, in a screening test, which was undertaken in a horizontal furnace, similar to the one shown schematically in Figure 2. In this test, the samples were not subject to salt deposit re-coats but were just exposed at 700°C in air with 300 vpm SO<sub>2</sub>. Whilst the contaminant free RR1000 exhibits few indications of hot corrosion, the contaminated samples show significant corrosion damage and spallation.

The observed increase in corrosion damage shown in Figures 17 and 18 as a result of the cleaning solution and lubricant is quantified in Figure 19 with metal loss data from dimensional metrology. These data indicate that the contaminants, rich in Li and Na, have increased the median pit depth in RR1000 by a factor of approximately 2 and 3 respectively.
