CRANFIELD UNIVERSITY  
&  
ROLLS-ROYCE

Engineering Doctorate Thesis  
Sandra Goergen

Cracking Behaviour, Failure Modes and Lifetime  
Analysis of M320 Abradable Compressor Seal Coating

EngD THESIS

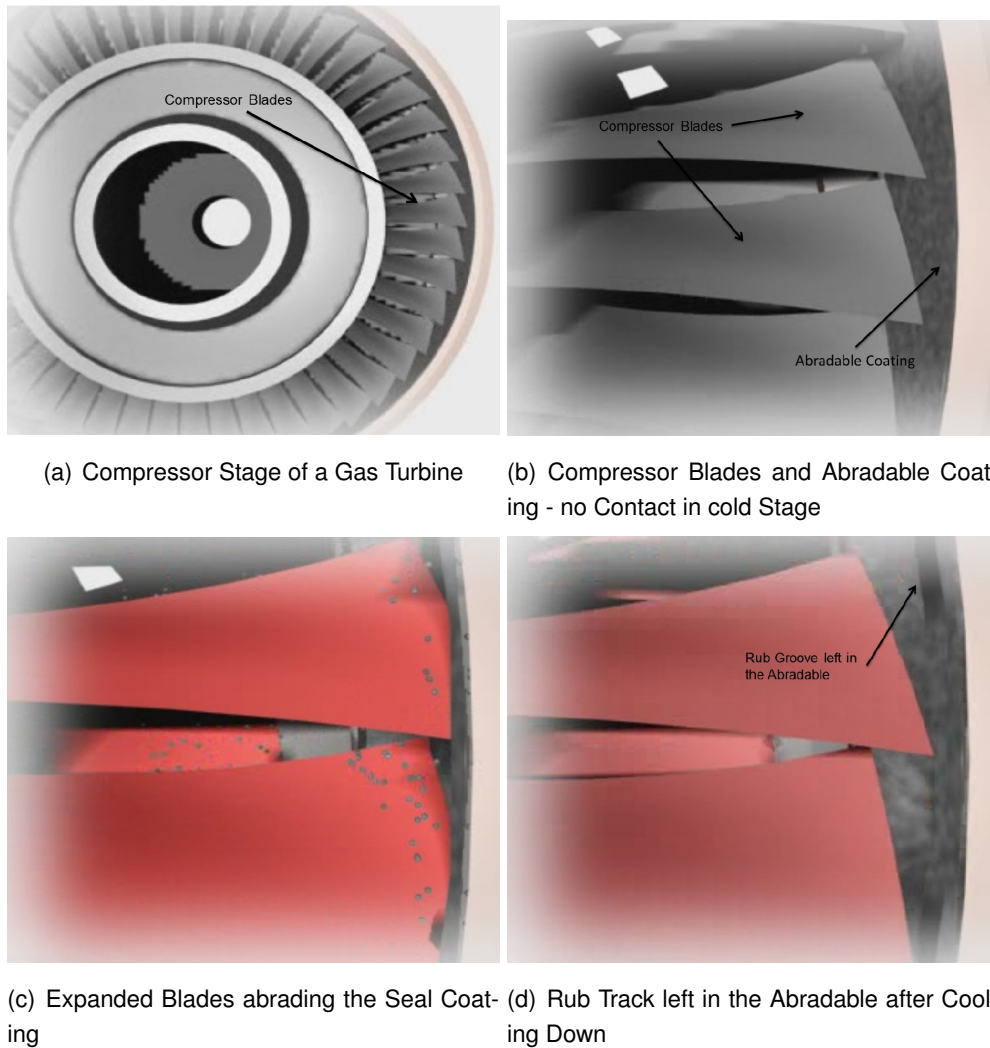
Figure 1.5: Interaction of Compressor Blades and Abradable Seal during Service

taking place during service. With increasing temperature, the blades expand and make contact with the abradable (b), followed by further blade expansion and the abrasion of the seal coating (c). Once the engine cools down, the blades shrink, leaving behind a rub path, which can be seen in the abradable (d).

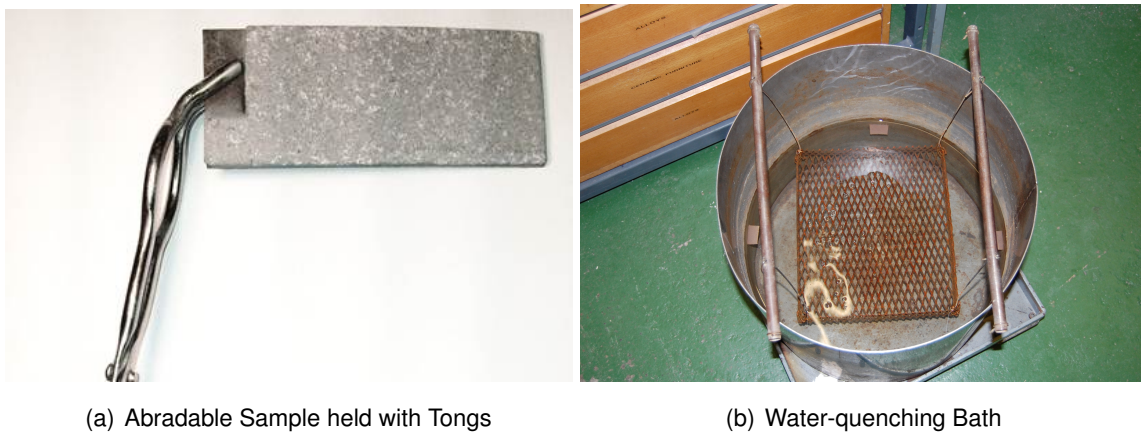
Figure 2.5: Individual Quenching of Abradable Samples

Once the samples had been in the furnace for  $90 \text{ min}$ , they were removed individually, using tongs, and placed into the sieve of the water-quenching bath. Figure 2.5 shows a sample being held with tongs and the water-quenching bath used at Cranfield University.

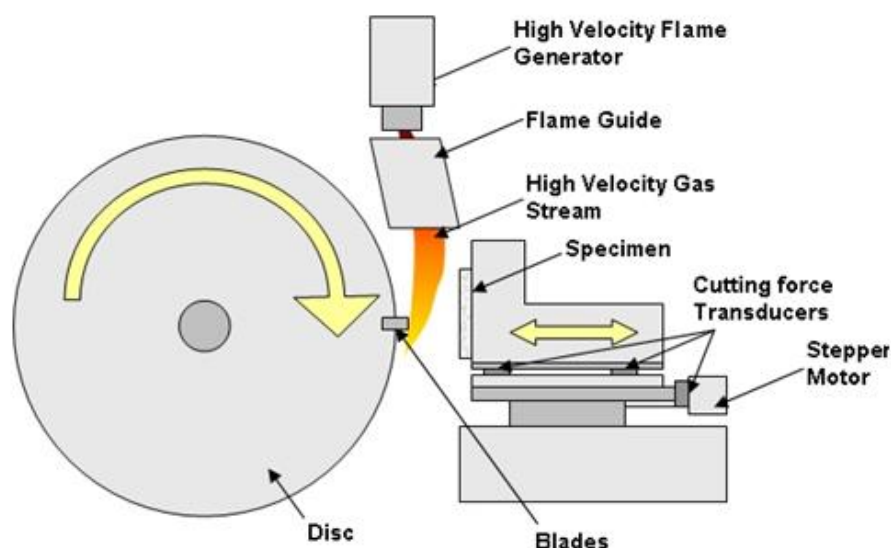
Figure 5.1: Schematic of the Working Mechanism of the Rig in Rapperswil

The blades used for the tests were  $15\text{ mm}$  wide, so two tracks could be cut into each sample of the abradable seal. For each test a new blade had to be used and some tests may reveal completely different failure mechanisms, depending upon test parameters. A schematic drawing of the rig in Rapperswil can be seen in Figure 5.1.

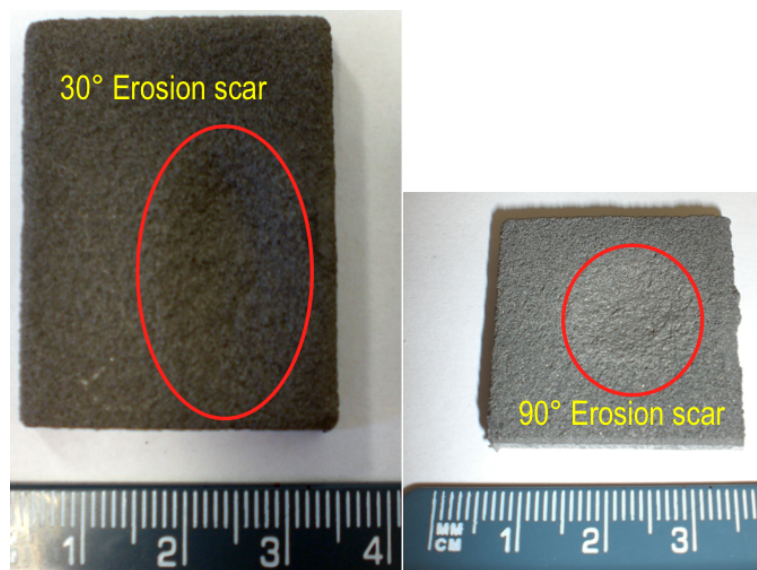
Figure 5.4: Erosion scars on the surface of the abrasible after  $30^\circ$  and  $90^\circ$  impact angle

In Figure 5.4 samples of the impact angles  $30^\circ$  and  $90^\circ$  are shown. The red circles indicate the shape of the eroded area on the samples.

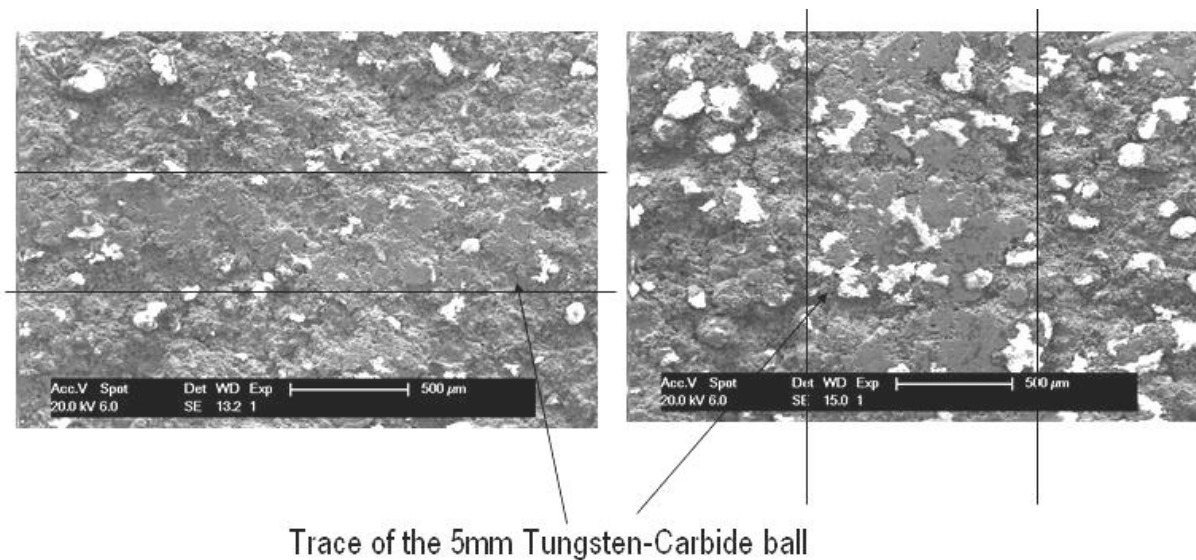
Figure 5.7: Traces left on the Surface of an Abradable Coatings by the Scratch Tester; showing the Hard Coating on the Left and the Soft Coating on the Right

Scratch testing at Cranfield University with a load of 20 N and a scratch length of 10 mm was carried out on hard and soft M320 samples. The scratch trace on the soft coating is about twice the width of the trace on the hard coating. The indenter ball can compress the softer coating more, resulting in a wider track.

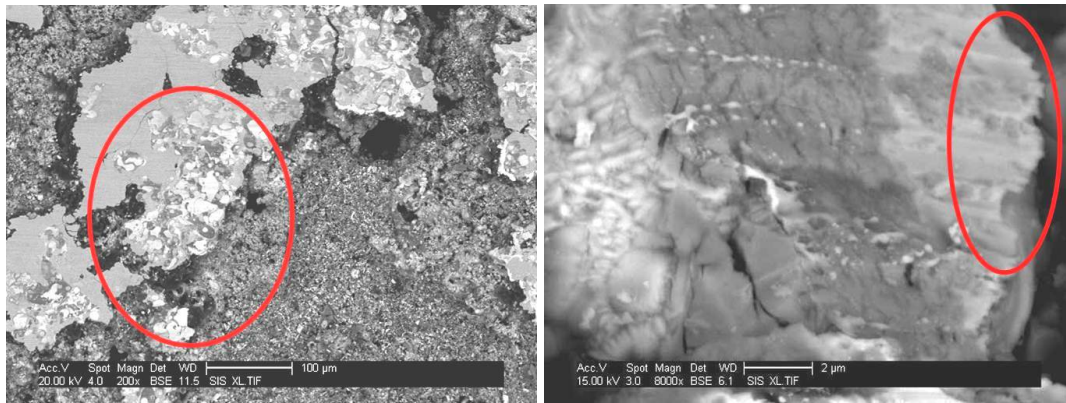
(a) Traces of Cutting through the Abradable during Testing (b) Traces of Smearing of the Abradable during Testing

Figure 5.14 shows the abrasion modes found using the electron microscope (Scanning Field Emission Gun - SFEG). In the red circles the damage caused during the interaction with the blade can be seen.

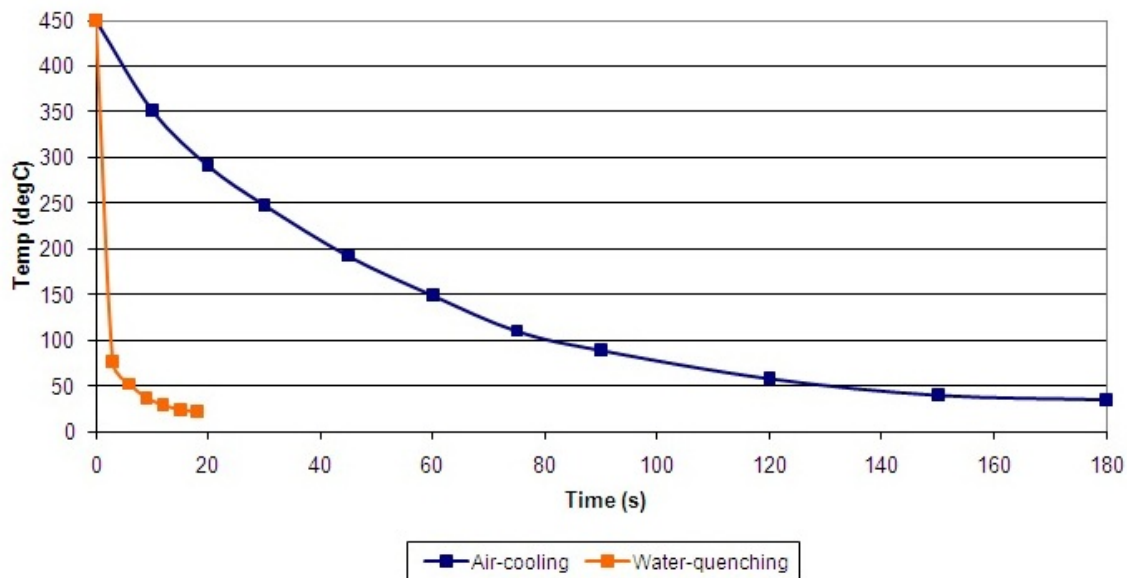
Figure 6.2: Cooling Rates applied to the Material during Air-cooling and Water-quenching

thought that even though higher cooling rates are applied to the material, the cracking will still be comparable to that happening in the engine. This was supported by observation made during testing, where micro-cracking after 2 water-quenching cycles was comparable to those cracks observed after 750 air cooling cycles.

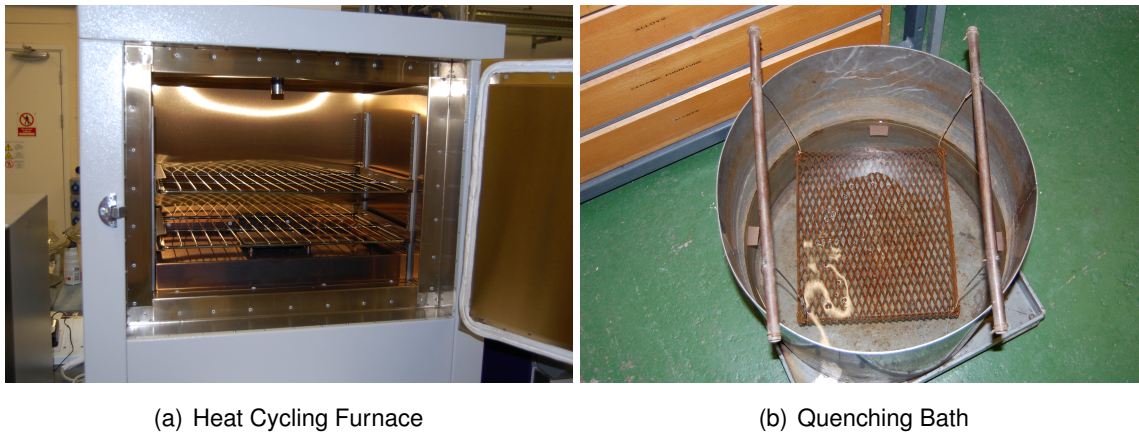
Figure 6.3: Furnace and Bath for Heat Treatment

To evaluate the cracking mechanisms occurring during service, a new furnace was installed, more suitable for the testing below 500°C. Two trays were available inside the furnace (see Figure 6.3a), so up to 28 samples could be tested at the same time. The quenching bath, including the sieve to rest the samples on, is shown in Figure 6.3b.

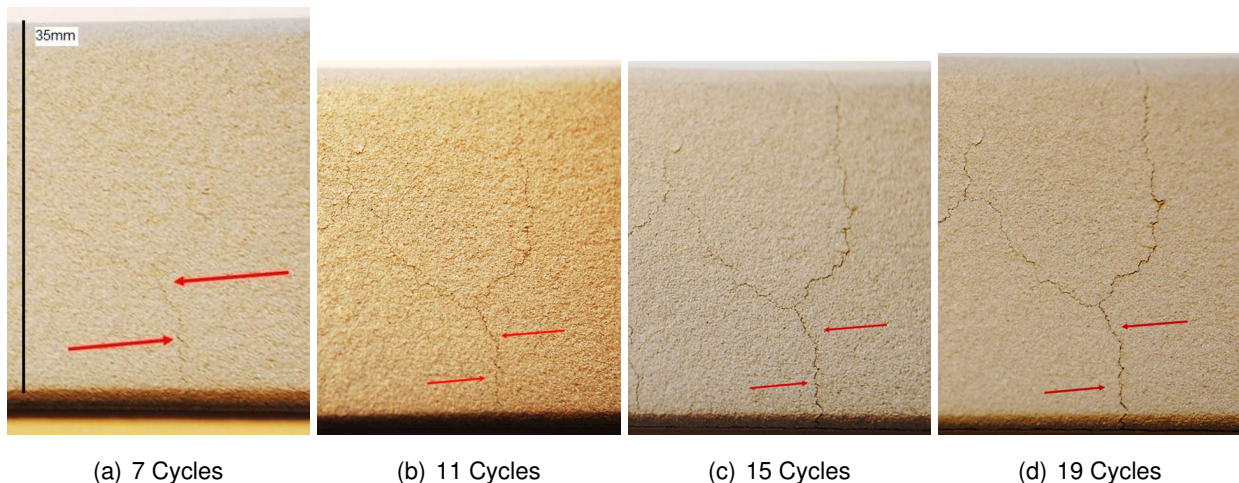
Figure 6.5: Example of Crack Growth of M320 on a 35 mm wide Sample

Cyclic heat treatment of abradable samples introduced cracking into the material. Cracks developed on the surface and grew downwards towards the substrate. Figure 6.5a shows a magnified image of a sample after 7 cycles. The onset of cracking can be seen on the bottom edge, indicated by the arrow. The following pictures document the very same area through the material's lifetime. First an increasing number of cracks can be seen, which then slowly grow into a network.

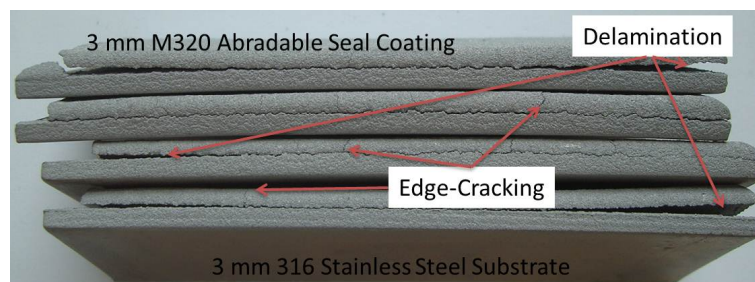
Figure 6.6: Material Failures due to Heat-Cycling

(a) Delamination of the Abradable during Heat-Cycling

Along with the observed cracking of the abrasible's surface, delamination was documented as an ongoing failure mechanism (see Figure 6.6a). Some of the samples cracked and delaminated until the stresses in the system were lower than the Yield Stress and therefore, remained in that position for the rest of heat cycling. Other samples delaminated and came off the substrate in chunks, leaving behind the bond coat surface (see Figure 6.6b).

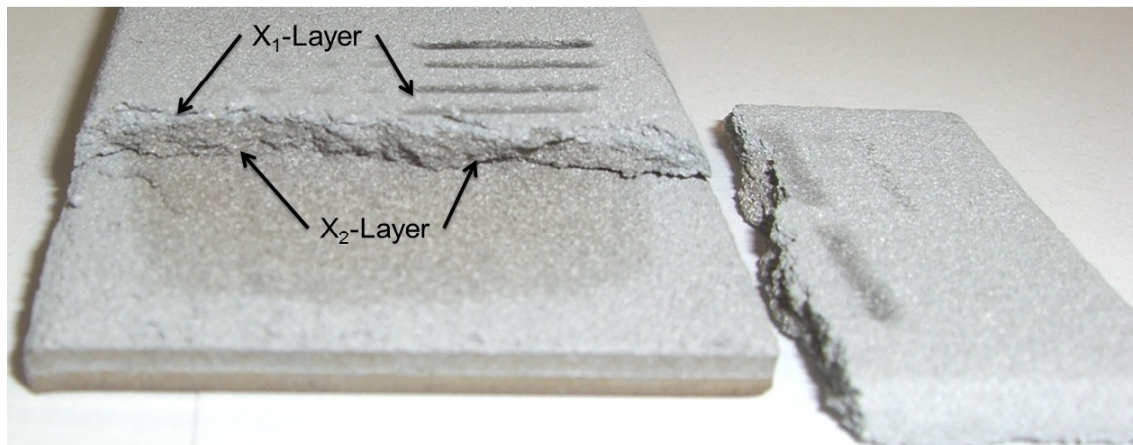
Figure 6.7: Formation of Two different Material Layers

Looking at the failed material, the formation of a lighter surface layer ( $X_1$ ), and a darker bottom layer ( $X_2$ ) was observed for all the samples subjected to heat-cycling. Figure 6.7 shows the different layers after the abrasible had failed due to delamination.

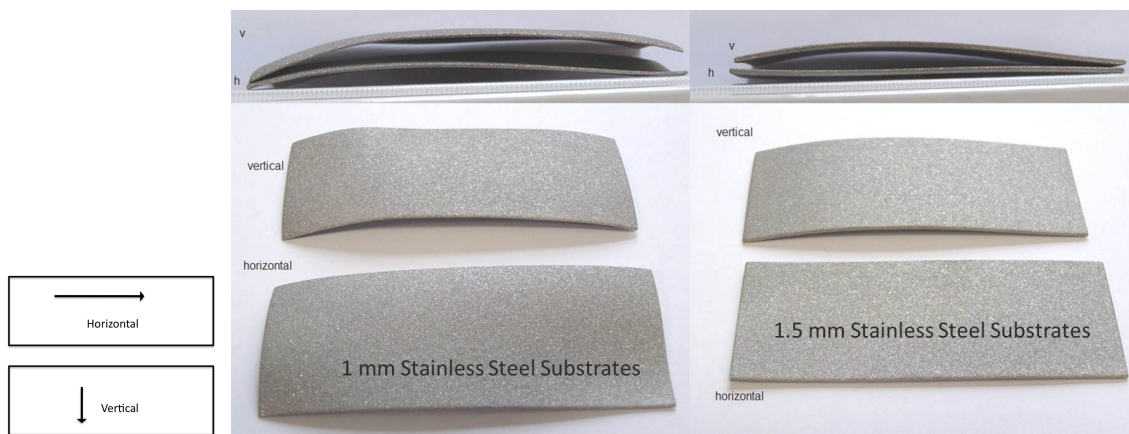
Figure 6.18: Grit-Blasting Procedure and Results

(a) Schematic of Horizontal and Vertical Grit-Blasting

(b) Deflection of 1 and 1.5mm Substrates after Grit-Blasting

As a trial to assess the grit blasting influence upon the stresses in the substrate, 1 mm and 1.5 mm stainless steel plates of 100x40 mm were grit blasted along the short axis (vertical - v) and along the long axis (horizontal - h) respectively. Figure 6.18 shows a schematic of the grit-blasting process (a) and the effects upon the substrate (b).

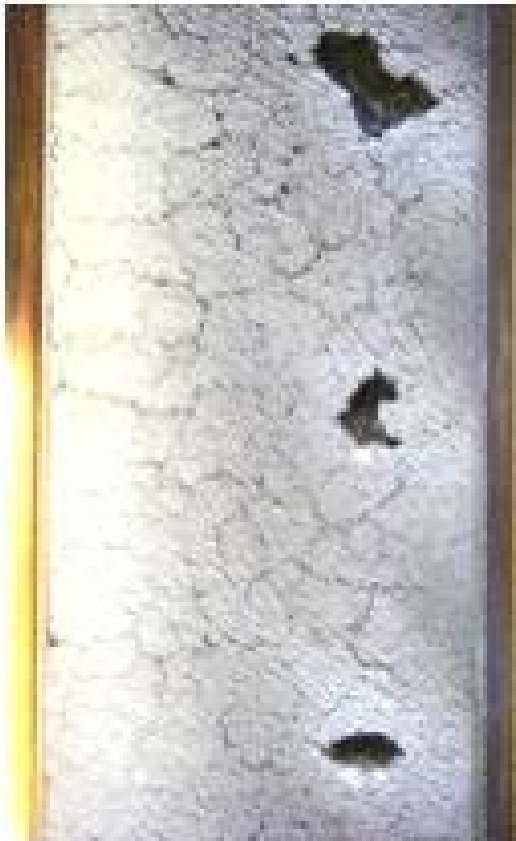
(a) Service Failure - Mudflat Cracking and Spallation

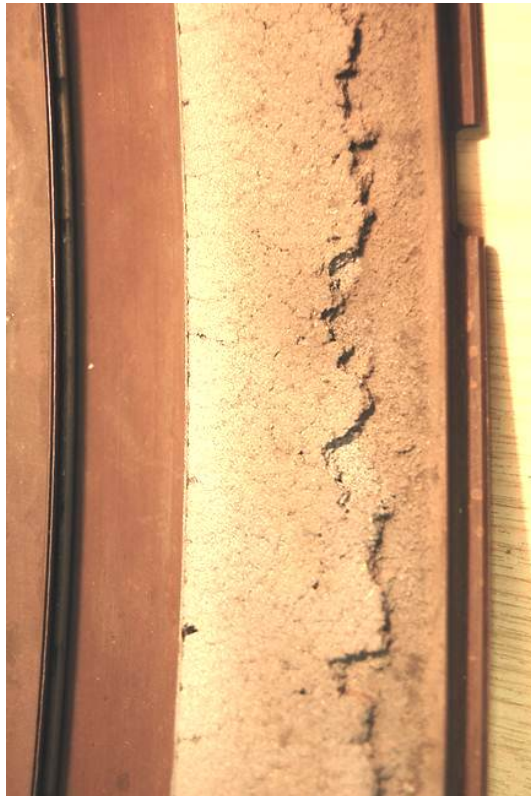
(b) Service Failure - Mudflat Cracking and Delamination

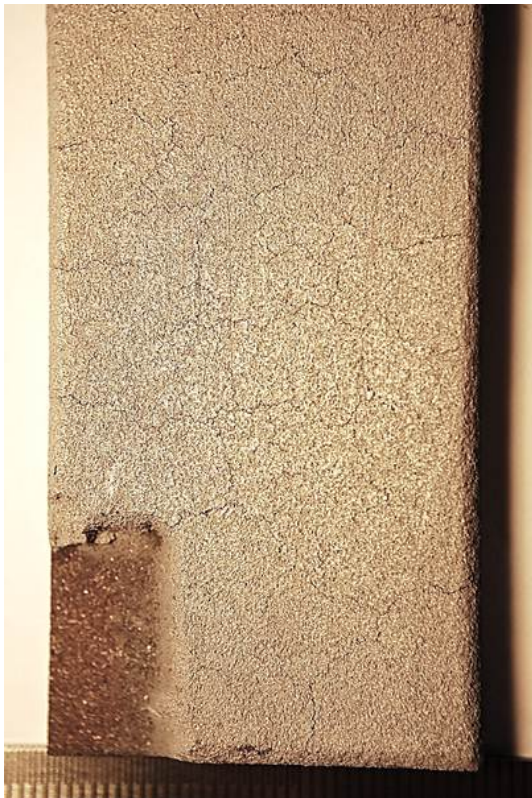
(c) Mudflat Cracking on a Test sample in the Laboratory

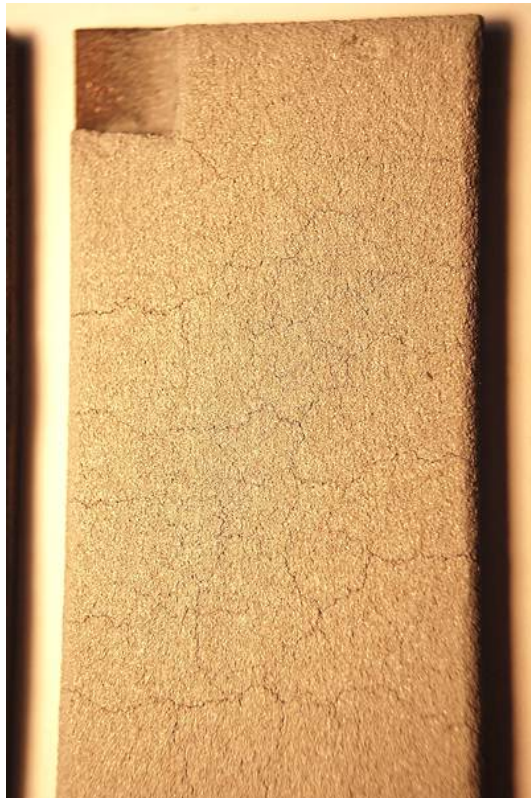
(d) Fine Mudflat Cracking on an Abradable Sample

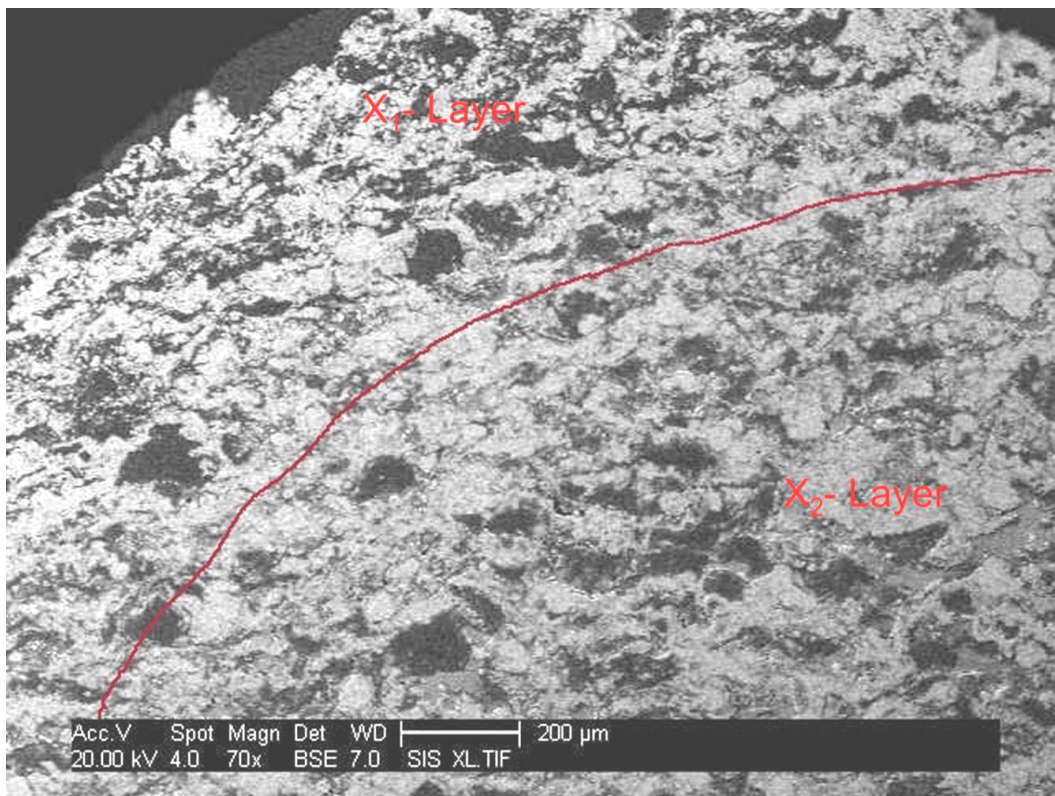
(a) Sintering of the Top Coat along Edge of the Sample

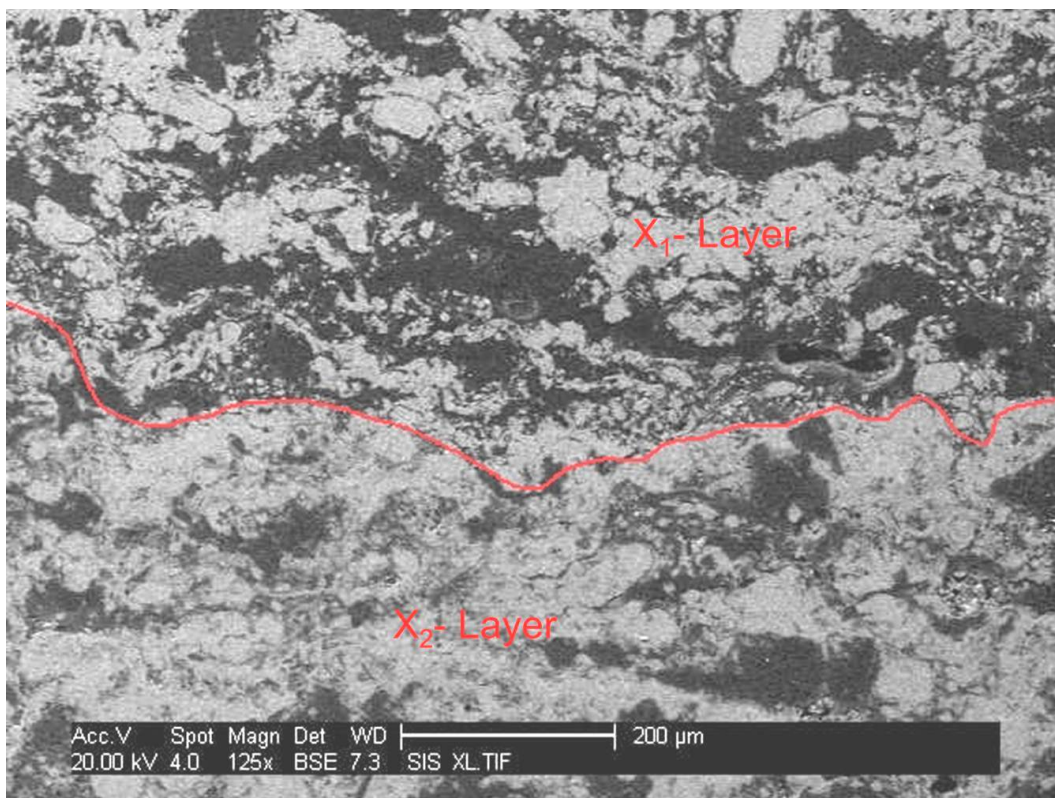
(b) Sintering of the Abradable Microstructure

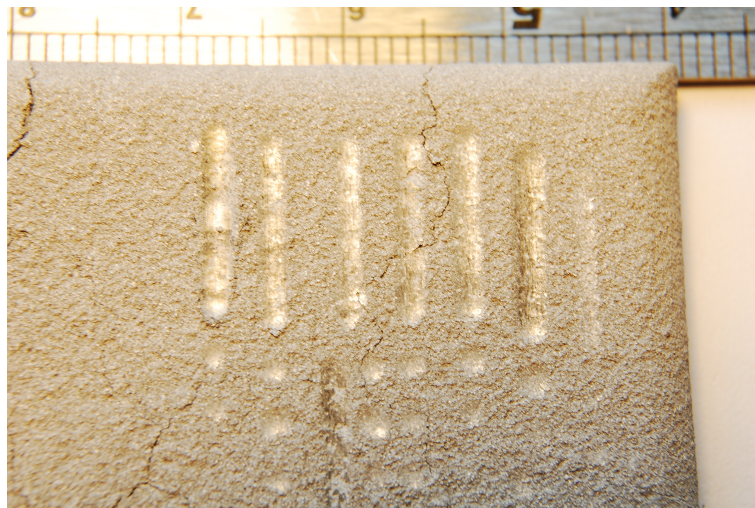
Figure 10.25: Surface of an Abradable Sample after Scratch and Indentation Testing

This structure made the assessment of layers very difficult, since the thickness of the  $X_1$ -layer could not be measured. Because scratching and indenting was carried out at the same time, the surface damage on one line was excessive and the areas of potential  $X_1$  assessment was limited. Figure 10.25 shows how much space was taken up for testing, compared to the areas left untouched on the surface.
