CoA Memo M. and P. No. 26

THE COLLEGE OF AERONAUTICS

TEST REPORT NO. PLB0/9

Comparison of PERPRO tools RD92 against Sanvik S1P  
under roughing conditions

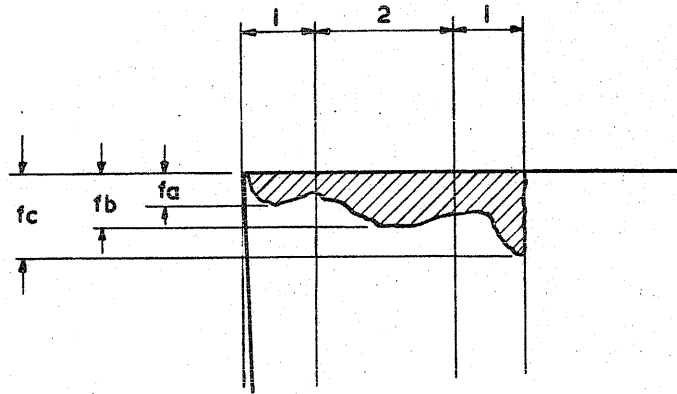
FIG. 1

FLANKWEAR MEASUREMENT

The flank wear was measured at suitable intervals as in figure 1 and the results are given in Tables 1 - 7.

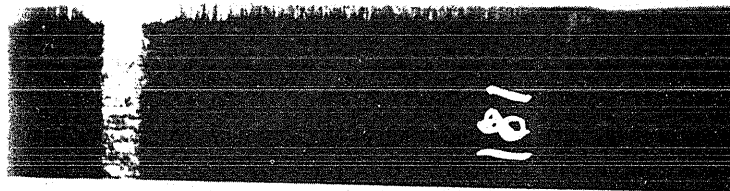
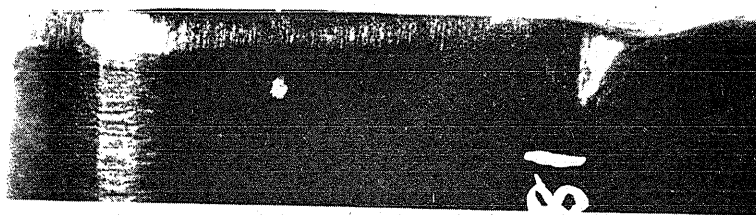
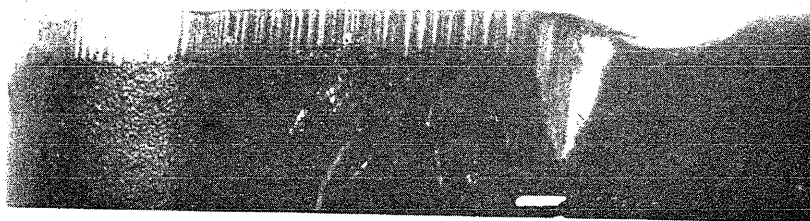
Fig. 4 Flankwear grade SIP  
A .010 in wear  
B .020 in wear  
C .030 in wear

Photographs of the flank and crater wear are given in figure 4 - 7.

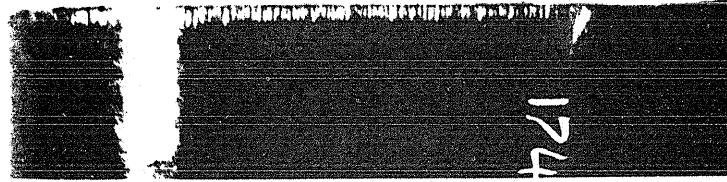
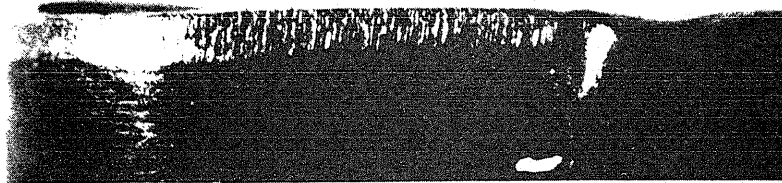
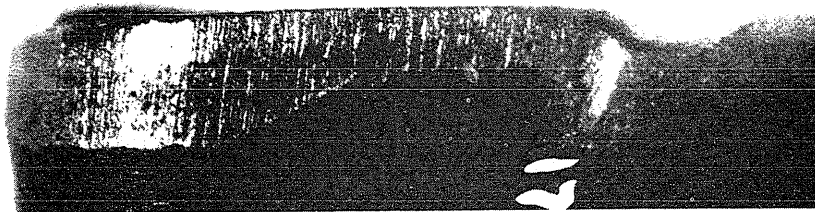
Fig. 5 Flankwear grade RD92  
A .010 in wear  
B .020 in wear  
C .030 in wear

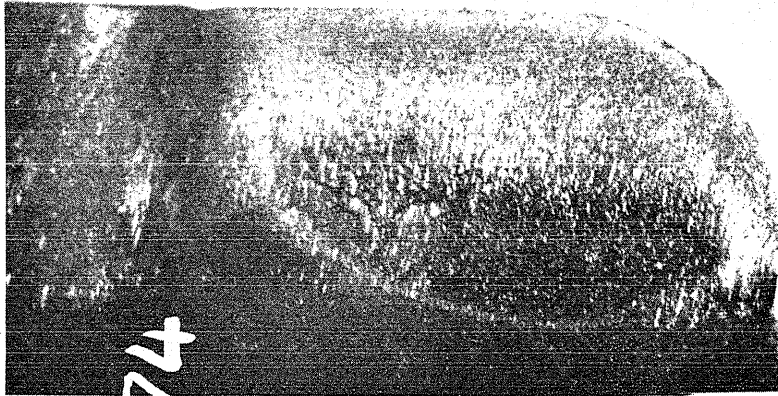
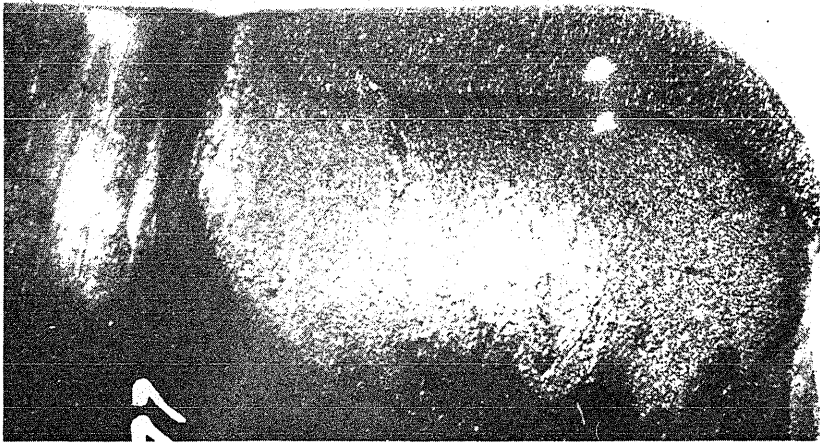
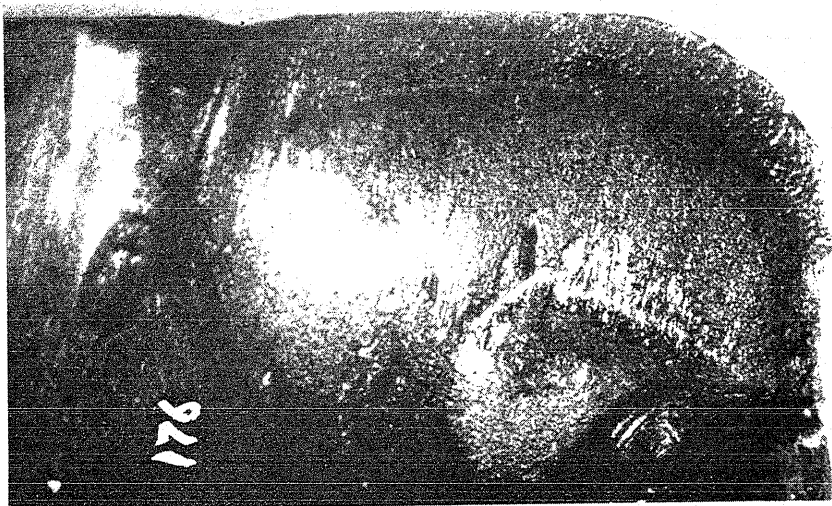
Fig. 7 Crater wear grade RD92

Corresponding to    A .010 in flankwear  
                              B .020 in flankwear  
                              C .030 in flankwear
