The Fourth International Conference on Through-life Engineering Services

Review of Non-destructive Testing (NDT) Techniques and their applicability to thick walled composites

MR Jolly*, A. Prabhakar, B. Sturzu, K. Hollstein, R. Singh, S. Thomas, P. Foote & A. Shaw

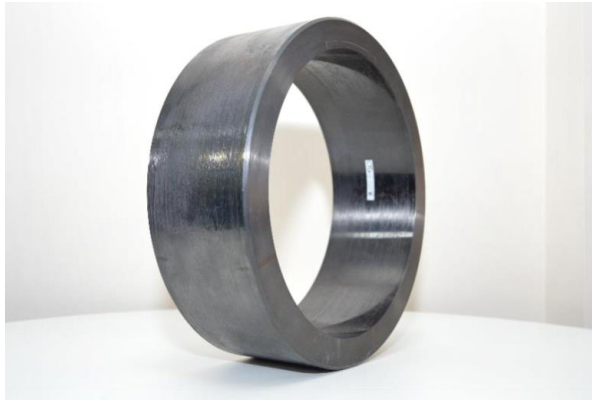
Fig. 1. Composite component under consideration

The component under consideration is an integral part of the flywheel. It is cylindrical in shape and is made out of CFRP intermediate modulus and approximately 30 mm thick (see figure 1).

The cylinder is manufactured by filament winding with an outer diameter of about 350 mm and a height of 119 mm.

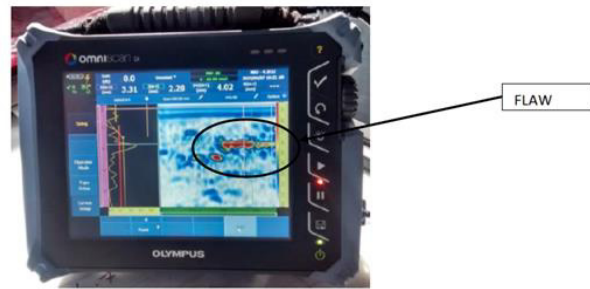
Fig. 5. Result of experiment and analysis of sample showing flaw characteristics.

The experiment with 5MHz frequency probe detected back wall echo of material. At the same time with a 2MHz frequency probe echo signal received with larger amplitude. However, the known flaw's present in material was not noticed. There was another flaw, which was detected in C-Scan and flaw characterization shows a crack of length (figure 5).

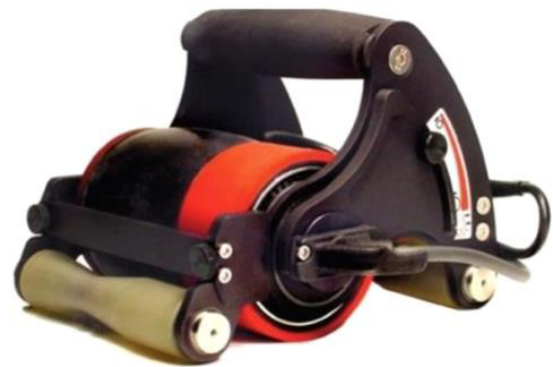
Fig. 6. Sonatest RadiusWheel Probe. [14]

The front wall echo was visible on the scanner screen. There was too much attenuation due to surface feature of the sample. The back wall echo was not detected on the screen. There could be several reasons for the lack of penetration. This could be failure of proper contact between RadiusWheel probe and flywheel due to geometry of part. The use of water as a coupling agent might have proved to be ineffective due to low viscosity and hence less adherence in between two surfaces. These factors could have led to large attenuation that were shown as near surface flaws.

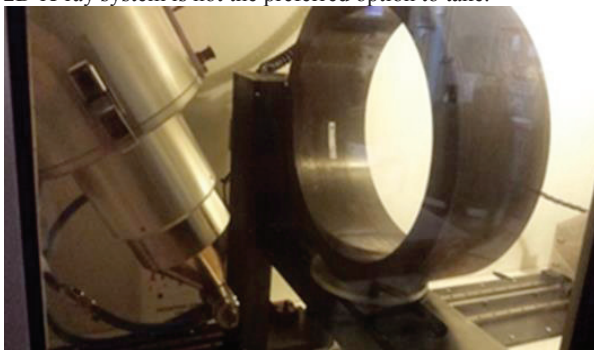
Fig. 7. Experimental set-up of a 2D X-ray system.

Initial tests with radiographic X-Ray equipment generating two-dimensional images have been made, figure 7 shows the experimental set-up.

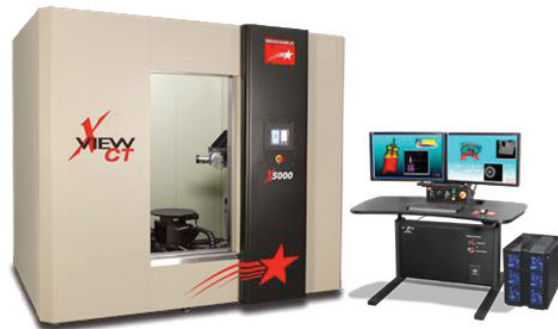
Fig. 9. North Star Imaging X5000 CT scanning system with workstation. [16]

will be presented below. Most of the companies recommended to use cabinet systems for an industrial production environment (like the one shown in figure 9). All products are state-of-the-art machines and are already used in the manufacturing industry. The price for CT scanning machines ranges from £200k to £600k, depending on precise requirements and resolution.

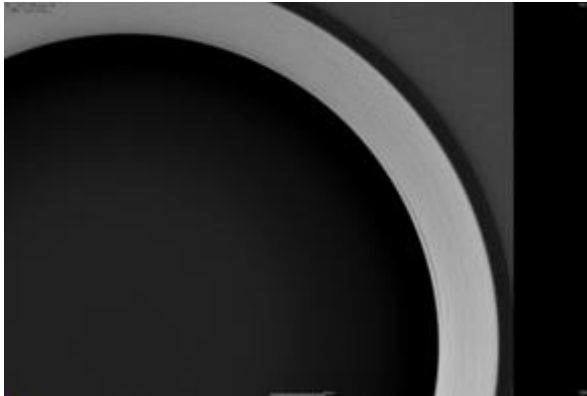
Fig. 10. Slice through the volumetric model acquired by CT scanning; the delamination on the inner side can clearly be detected

Several cabinet systems from various suppliers have been tested. Figure 10 shows results acquired with a NSI X5000 machine. A delamination on the inner side of the flywheel can clearly be seen on the right side of the picture. The data has been captured within 15 minutes with a resolution of approximately 200 μm .

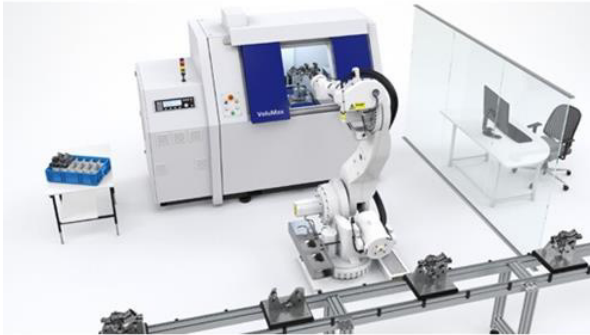
Fig. 13. Fully automated in-line CT system. [19]

All the machines can be operated using a robotic handling system (figure 13). Opening/closing the door, starting the machine etc. can also be automated and adapted to the final production line.
