CRANFIELD UNIVERSITY

PhD. THESIS

FACTORS AFFECTING THE EXFOLIATION CORROSION
OF ALUMINIUM ALLOYS

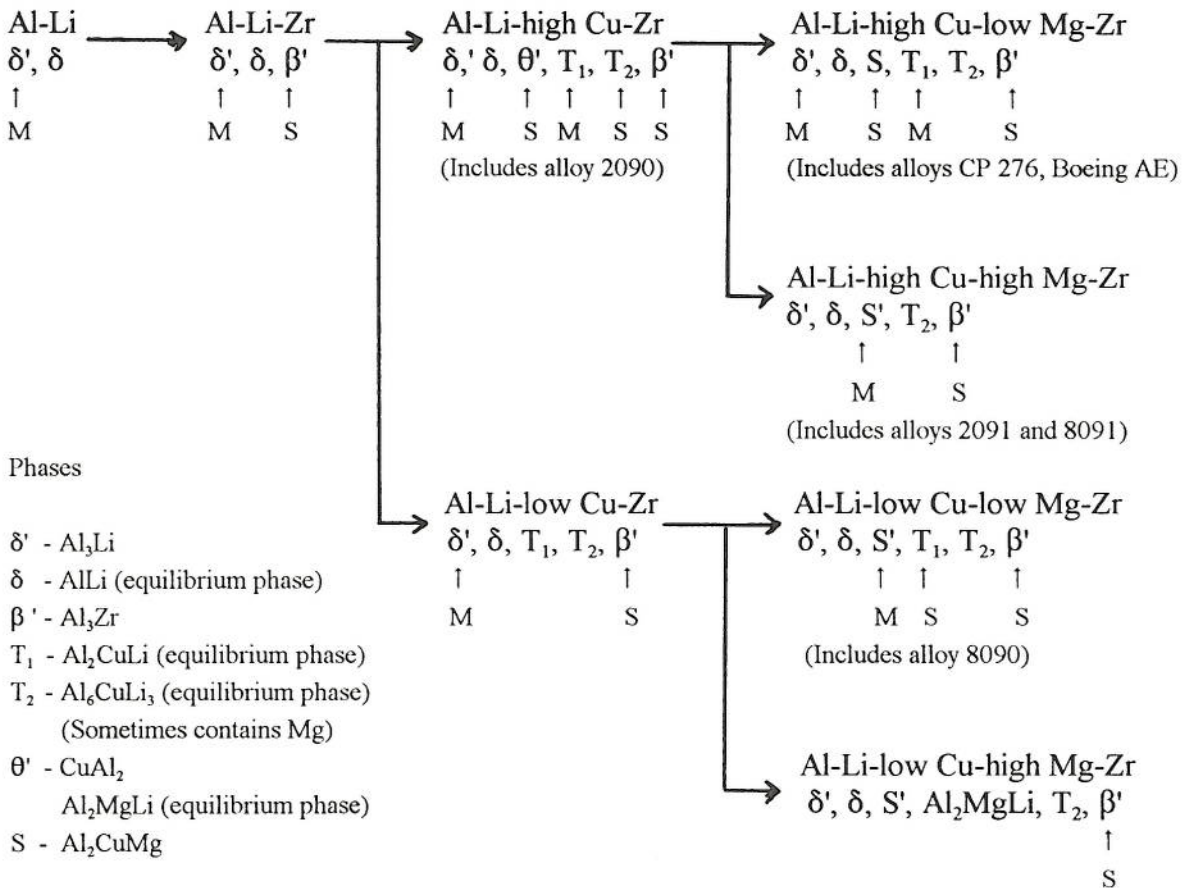
Figure 2.9. : A schematic illustration of the precipitate phases that form in $AlLiX$ alloys (14).

the major precipitates present in alloys such as 8090, 2091 and 2090. Precipitates present are T_1 (Al_2CuLi), T_2 (Al_6CuLi_3), θ' (Al_2Cu), S' (Al_2CuMg) and β' (Al_3Zr). In alloys where a secondary precipitate is present (apart from the δ' matrix precipitate) heterogeneous nucleation of θ' , S' and T_1 occurs on low angle grain boundaries.

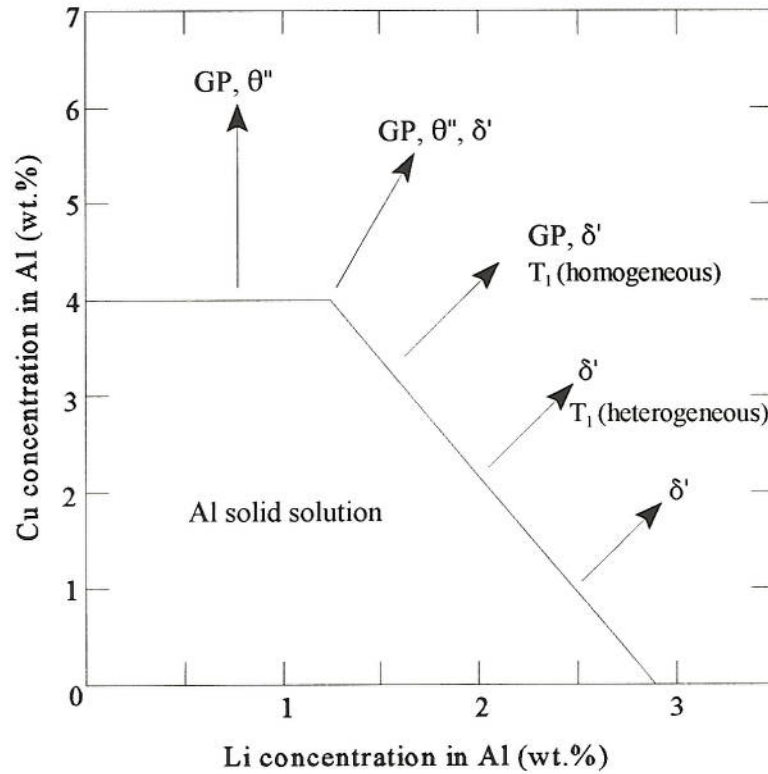
Figure 2.10. : The solvus line at 500°C at the aluminium - rich end of the AlLiCu system showing the strengthening phases at various copper and lithium contents (65).

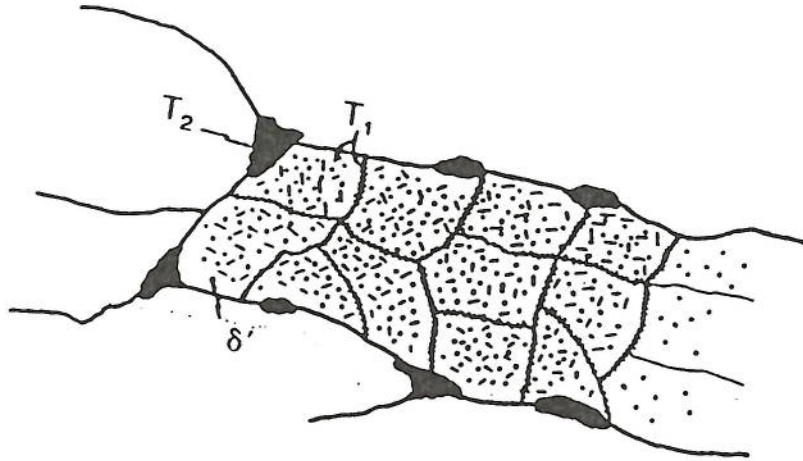
Figure 2.11. : Microstructure of 2090 after ageing to the peak - aged condition (67).

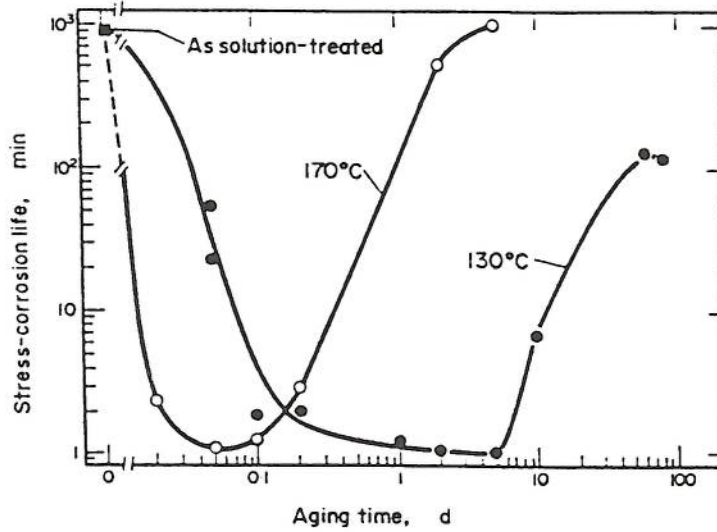
Figure 2.19. : Graph showing the effect of ageing time at 130⁰C and 170⁰C on stress corrosion life of Al-4Cu (75).

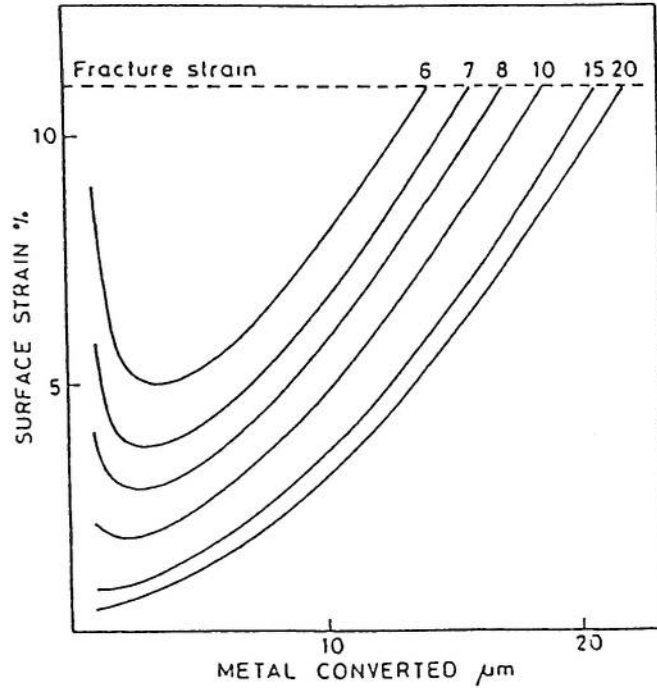
Figure 2.24. : Graph showing the theoretical effect of grain sensitivity on development of surface strain during exfoliation corrosion where 6, 7, 8, 10, 15 and 20 represent different corrosion product aspect ratios (164).

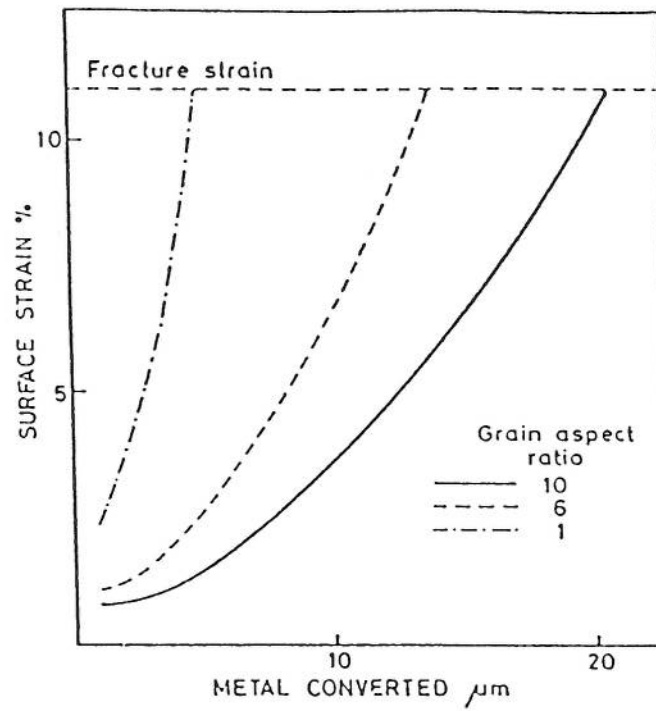
Figure 2.26. : Graph showing the theoretical effect of grain aspect ratio on development of surface strain during exfoliation corrosion (164).

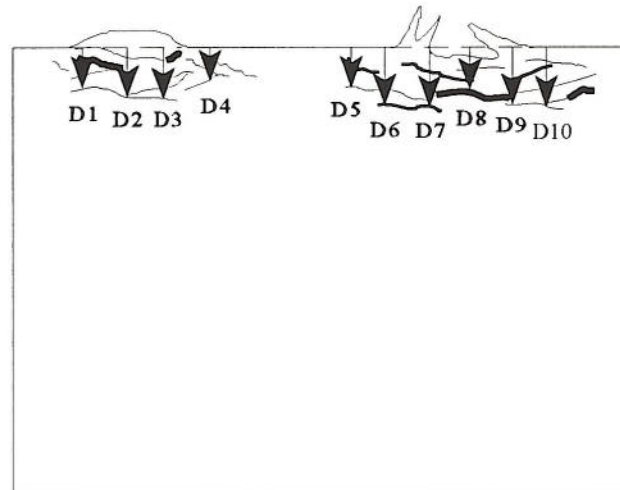
Figure 4.33. : Diagram of cross - section during the early stages of corrosion.

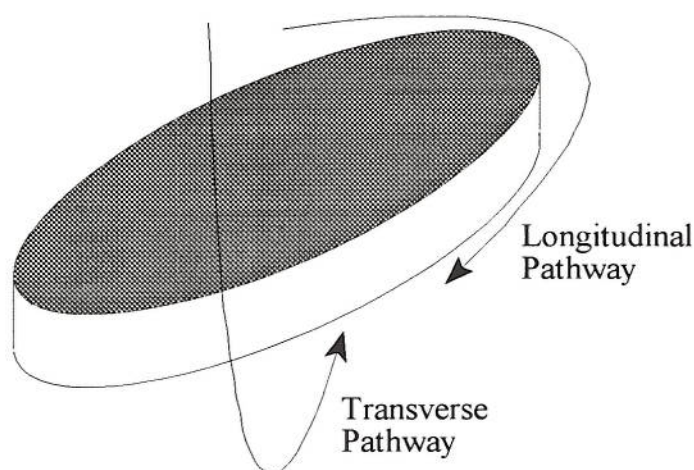
Figure 6.1. : Schematic diagram showing attack along the longitudinal and transverse directions around a typical elongated grain.

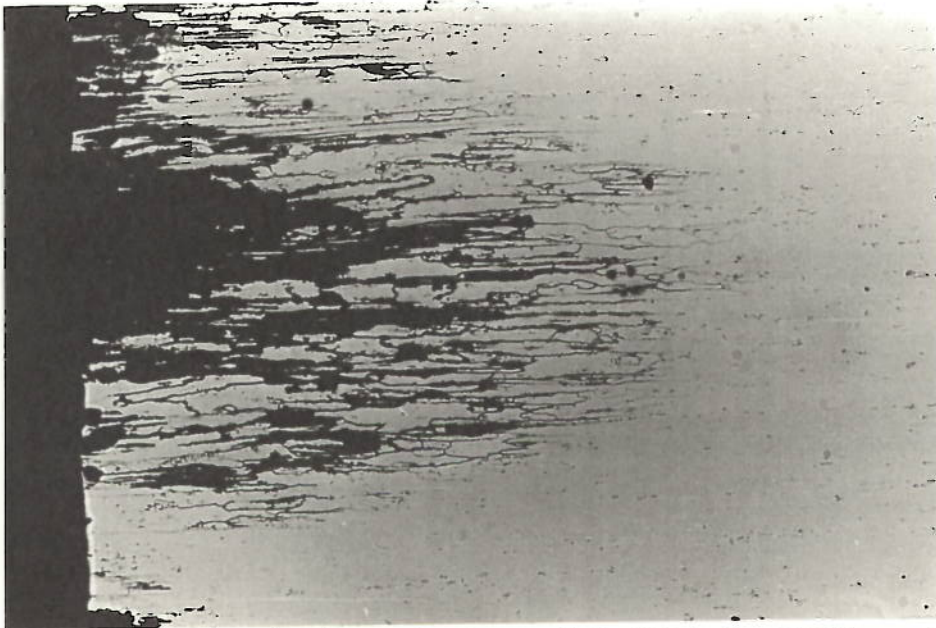
Figure 6.3. : Cross - section showing end grain attack for 2024 after 2000 hours (X50).
