Monitoring of masonry historical constructions: ten years of static monitoring of the world's largest oval dome.

This paper presents the analyses conducted on data acquired by the monitoring system of the “Regina Montis Regalis” Basilica of Vicoforte in the decade 2004-2014. The Basilica is a building of great historical, architectural and structural significance, owing its fame to its impressive masonry oval dome, the world's largest of this shape (internal axes of 37.23 by 24.89 m).

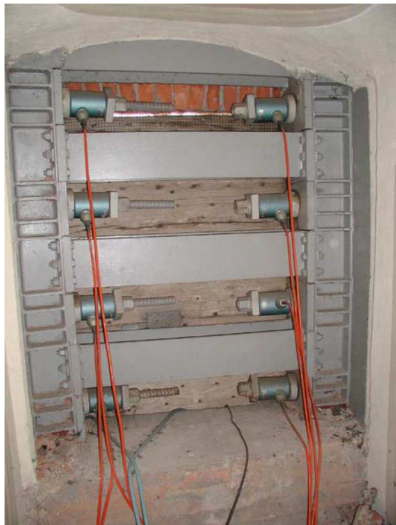
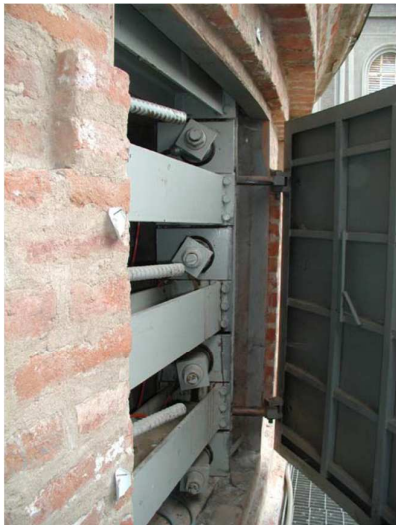
Figure 4. (a) Tie-bar ends equipped with load cells and (b) tie-bars end with the anchorage system.

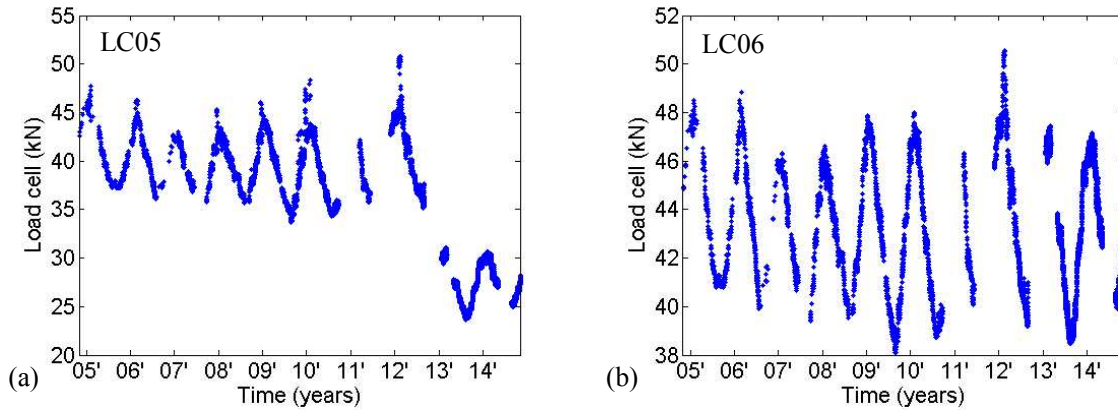
Figure 15. Time-histories of the load measured by (a) cell load LC05 and (b) cell load LC06.

42
43
44 Figure 13 and Figure 14 suggest the presence of important annual trends in correspondence of
45 LC05 and LC44. The visualisation of the LC05 time-history, reported in Figure15(a), shows a
46 discontinuity at the beginning of the 2013. In detail, the load dropped approximately of 20 kN
47 assuming the value of about 30kN after 2013. A similar discontinuity was not observed in the other
48 tie-bars having the same position and belonging to the lower level. In these latter cases the load is
49 seen to decrease over time but without appreciable singularities at the beginning of the 2013, as
50 inferred for instance from Figure15(b) for sensor LC06. It is worth noticing that the tie-bar LC05 is
51 in correspondence of the crack CM02 that in the same year doubled its opening.
52
53
54
55
56
57
58
59
60
