Applied Acoustics

A study on helicopter main gearbox planetary bearing fault diagnosis

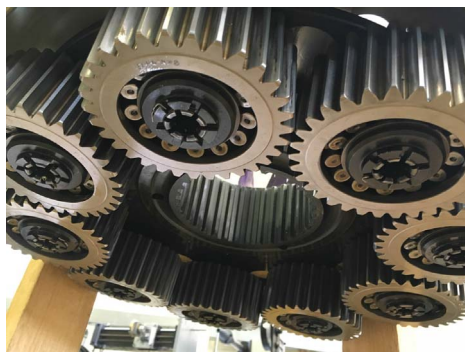
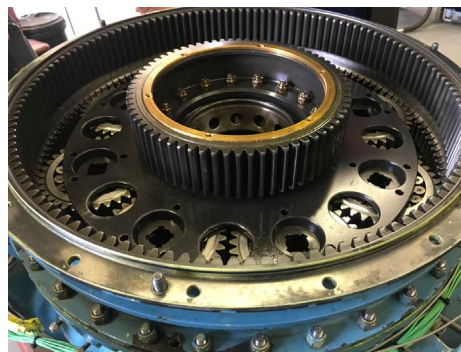
(a) 2nd Planetary gears/ bearings

(b) 2nd Epicyclic module ring and sun gears

Fig. 2. MGB 2nd epicyclic module.

To investigate planetary bearing fault diagnosis, defects were seeded on the outer race of the planetary bearing at 2nd epicyclic module in both test cases. Fig. 2(a) demonstrates 2nd epicyclic planetary bearings, which are driven by 2nd epicyclic sun gear and ring gear shown in Fig. 2b. Specifications of planetary bearings are documented in Table 2.

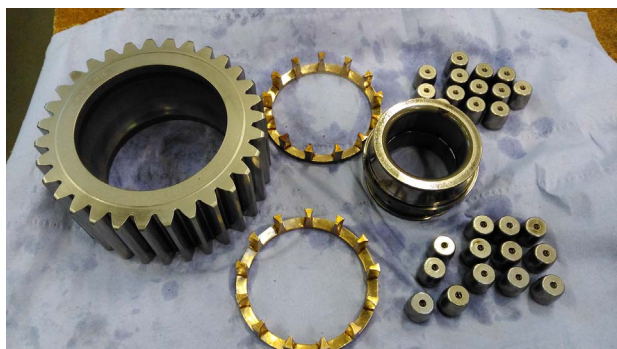
Fig. 6. The components of 2nd planetary bearing.

on the outer race of 2nd epicyclic planetary bearing, a 2nd epicyclic planetary bearing was disassembled (Fig. 6). The bearing had two layers of races, as well as two sets of rollers and cages.

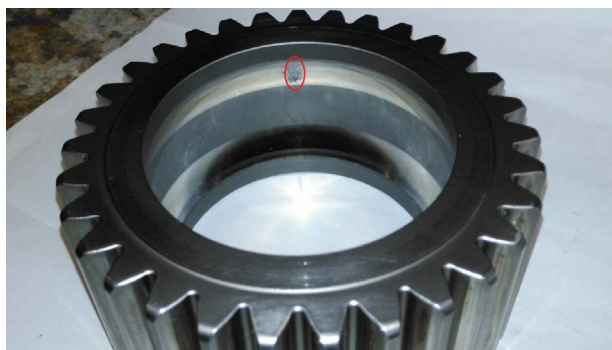
(a) Minor Defect

(b) Major Defect

Fig. 7. Demonstration of seeded defects in test case 1.

defect condition. The dimensions of seeded defects are detailed in Table 4. Pictures of minor and major defects are presented in Fig. 7. As introduced in Section 2.2.1, the maximum speed from speed-increasing gearbox to MGB was limited to 17,842 rpm. To comply with safety protocols, the maximum load and input speed in all test conditions were limited to 180 kW and 16,000 rpm respectively. Between each test, the MGB was stripped for 3 days to allow swapping the faulty bearing. Vibration data was recorded using NI 9234 data acquisition card and sampled at 25.6 kHz frequency.

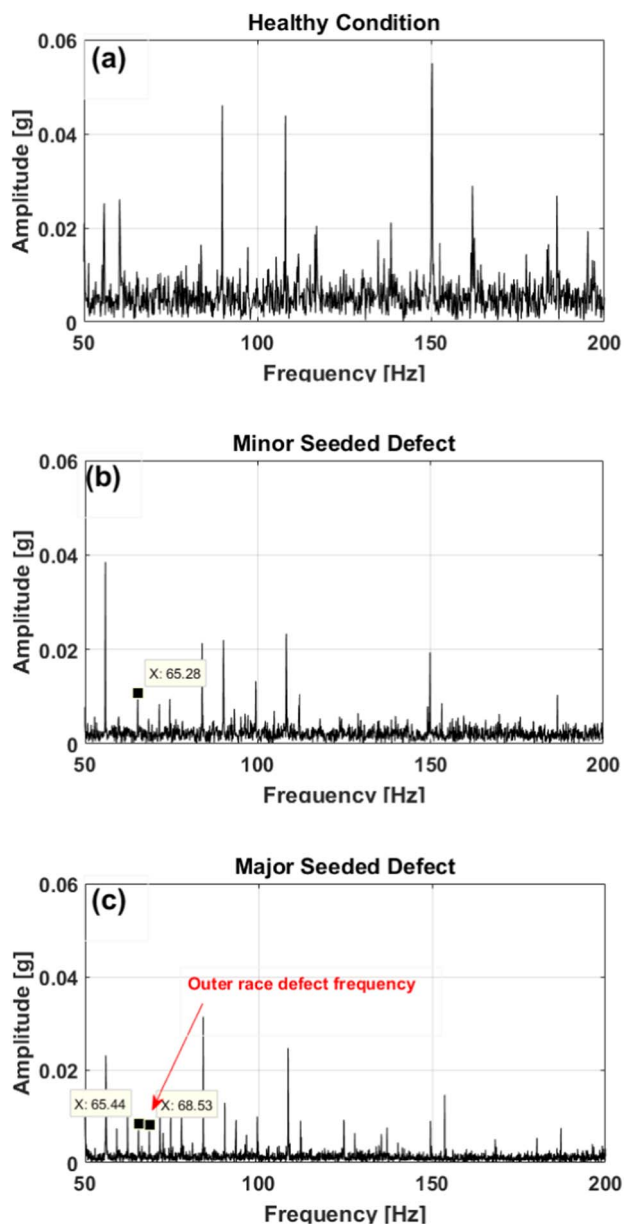
Fig. 12. Zoomed spectrum of raw data in test case 1, (a) healthy condition, (b) minor seeded defect condition and (c) major seeded defect condition.

Fig. 11 shows the amplitude spectrum of vibration data under three conditions. It is observed that the spectrum are very similar to each other, where the discrete periodic gear meshes and their harmonics are dominant. Fig. 12 is produced by zooming Fig. 11 into frequency range of 50–200 Hz, for identification of possible f_{ORD} near 68 Hz. It is discovered in Fig. 12 that f_{ORD} cannot be found in healthy and minor seeded defect condition. In major seeded defect condition (Fig. 12(c)), the defect frequency of 68.53 Hz is evident. The marked 65.44 Hz frequency component is resulted from the 3.09 Hz modulation of 2nd planetary carrier.

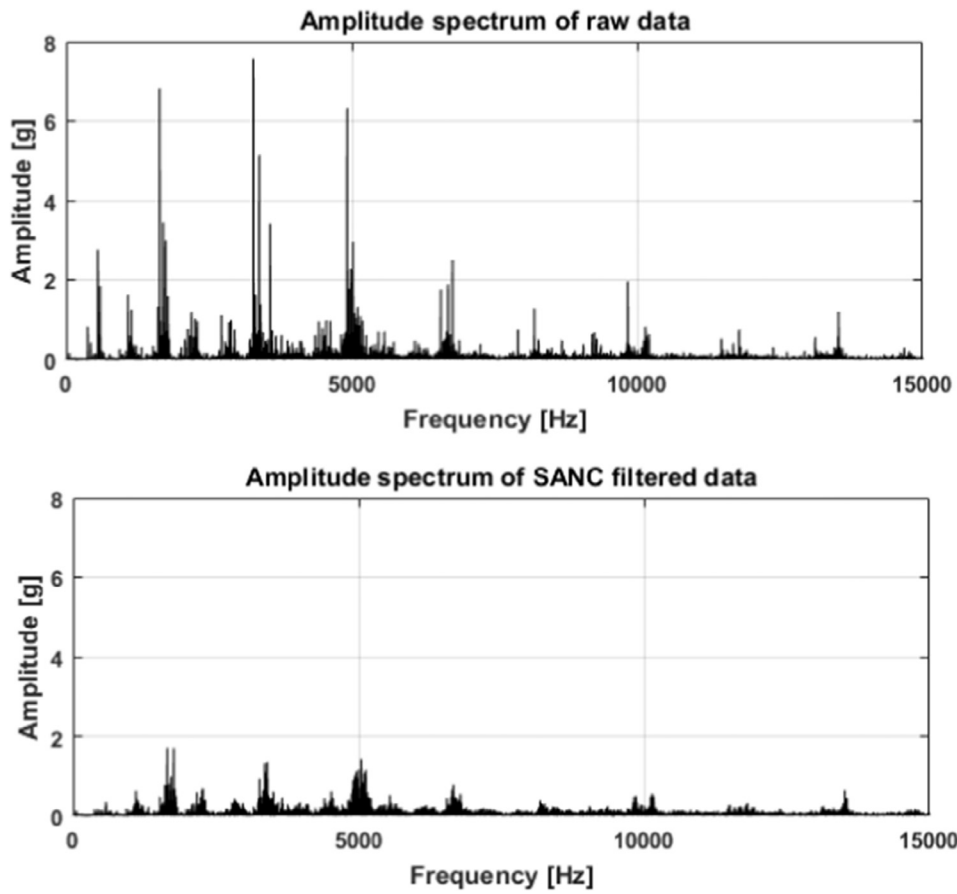
Fig. 13. SANC filter's effect of cancelling gear mesh frequencies.

In order to reveal distinct defect indications in minor and major seeded defect conditions, SANC was applied to process the data. Fig. 13 demonstrates the effect of applied SANC filter, where the large deterministic frequency components have been prominently eliminated. The filtered signal was further processed using kurtogram. The implemented kurtogram code was written in MATLAB by J. Antoni. Fig. 14 demonstrates the kurtogram of SANC filtered signal in minor seeded defect condition. Kurtogram indicates a candidate bandpass frequency at 8300 Hz with bandwidth of 200 Hz. However, this indication was discovered to be inaccurate. Fig. 15 shows the envelope spectrum of corresponding band-passed signal as suggested by the kurtogram result. No improvement of the signal-to-noise ratio was observed, compared with the result shown in Fig. 12(b). The same result was observed for data associated with the major seeded defect condition.

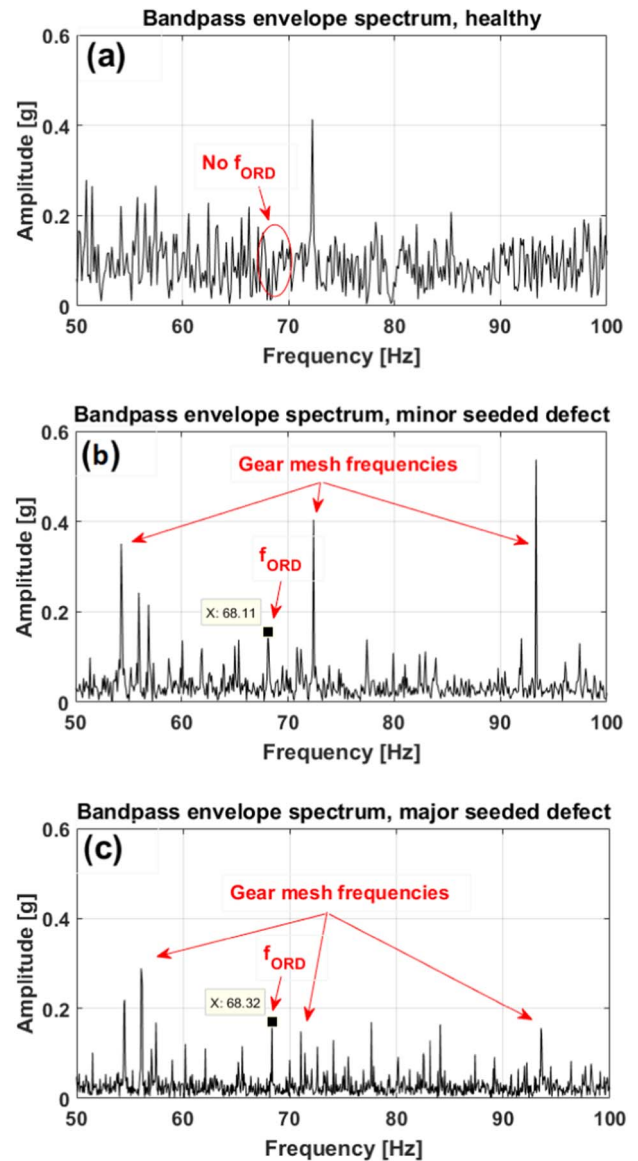
Fig. 16. Envelope spectrum of demodulated data in test case 1, (a) healthy condition, (b) minor seeded defect condition and (c) major seeded defect condition.

Envelope analysis was performed on demodulated data. The envelope spectrum of healthy, minor fault and major fault condition are illustrated in Fig. 16.

It is shown in Fig. 16 that the bandpass envelope analysis has given decisive diagnosis results. The calculated f_{ORD} which is at 68 Hz can be identified in both minor and major fault conditions directly, while no f_{ORD} is indicated in healthy condition. It is also observed that in major seeded defect condition, the frequency sidebands around 68.32 Hz defect frequency are more intensely spread from 60 Hz to 90 Hz, compared with that shown in minor seeded defect condition. However, the amplitude of envelope spectrum cannot reflect the severity of the seeded defect based on the observations, such phenomenon has also been found in other papers using real data [34–36]. With defect frequency evidently extracted, diagnosis of planetary bearing outer race defect in Test case 1 is successful.

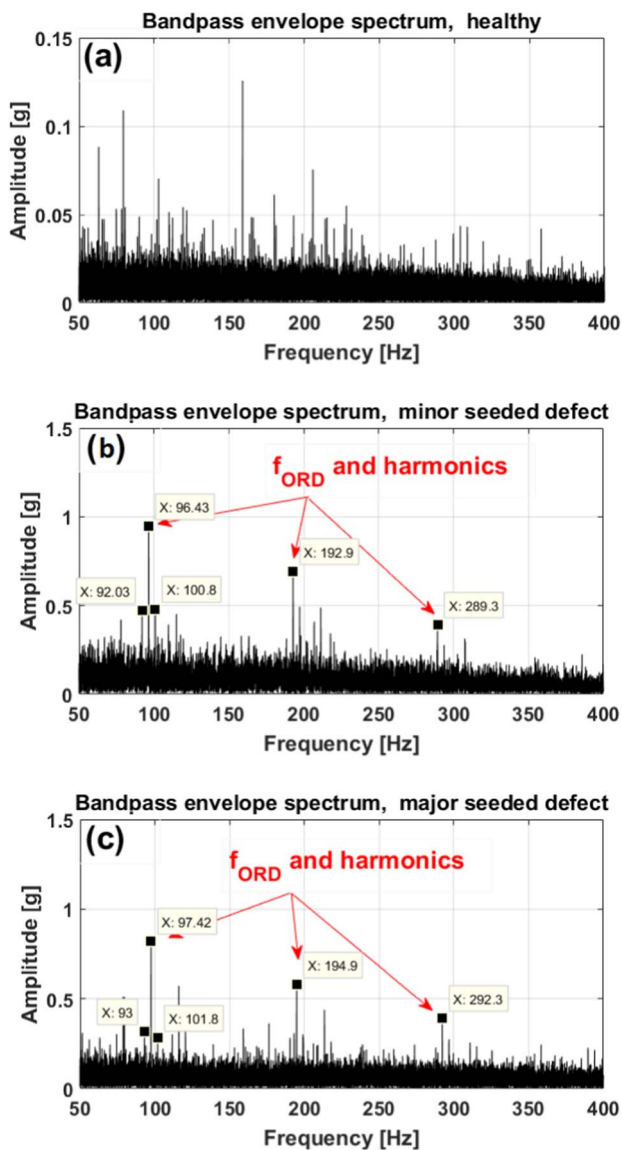
Fig. 19. Envelope spectrum of demodulated data in test case 2, (a) healthy condition, (b) minor seeded defect condition and (c) major seeded defect condition.

Envelope analysis was then implemented using parameters in Table 8. The envelope spectrum of demodulated data in healthy, minor seeded defect condition and major seeded defect condition are shown in Fig. 19. It is evident that the fault related frequency component f_{ORD} (near 97 Hz) along with its harmonics are distinct for both minor and major seeded defect conditions. In the meantime, the sidebands labelled near 93 Hz and 101 Hz in both the faulty conditions can also be identified. These sidebands are resulted from 4.4 Hz 2nd planetary carrier speed modulation. This indicates an indisputable success in diagnosing
