Application of NDT Thermographic Imaging of Aerospace Structures

To appear in: *Infrared Physics & Technology*

Keywords: active infrared thermography, pulsed thermography, vibrothermography, UAV, composite, kissing bond.

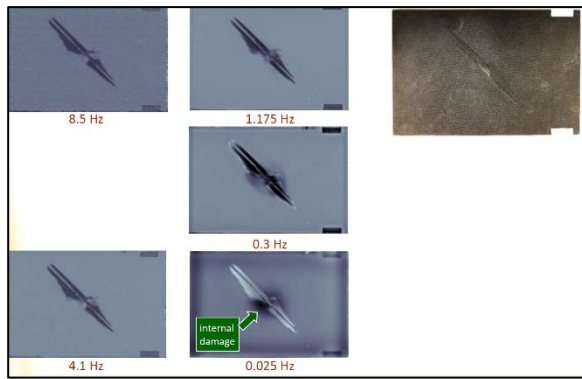
Figure 9: Sample 20 J Demo, Reflection rear face. PPT. The rear face has some substantial damage. The PPT locates the surrounding internal damage [5].

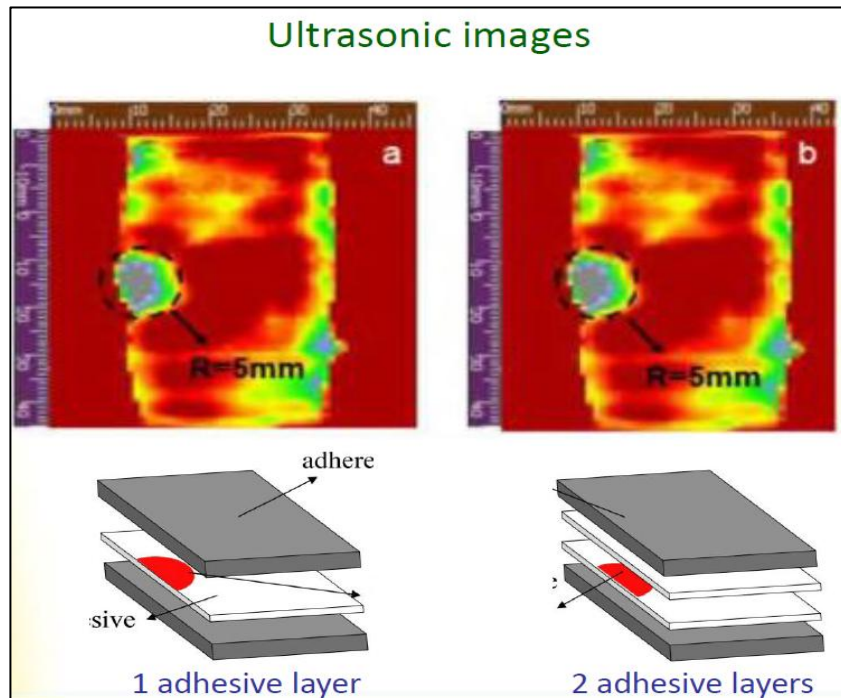
Figure 19: Past ultrasonic thermographic inspection from similar specimens as used in the before mentioned VT inspection [25].

Figure 19 is an ultrasound testing inspection. The defects are successfully located and are more visible than the PT results in figure 18. The size of the defect can also be measured during processing, the defect present has a radius of 5mm. The vibrothermography results are promising for the detection of kissing bond defects.

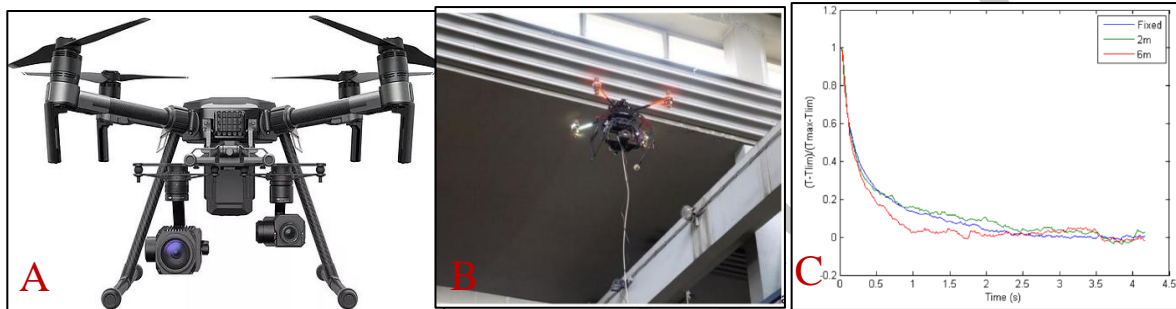
FIGURE 20 A: DJI M210 equipped with thermal camera [27]. **FIGURE 20 B:** UAV equipped with thermal camera [12]. **FIGURE 20 C:** Comparison of front face temperature responses to flash heating in the case of a large uniform irradiation with a fixed camera and a stabilized camera with UAV at two distances (2 m and 6 m) [12] [5].

Along with the liquid penetrant NDT method as mentioned in the introduction, a UAV thermographic inspection was tested for civil engineering applications (see Figure 20B). The UAV is equipped with a FLIR A320, this IR camera is connected to a computer via a cable, one is a power cable and the other provides real time radiometric thermal images, which will reveal heat patterns and thermal anomalies [12]. Transient thermography with flash and step heating where the methods used in this inspection. An inspection took place and gathered data on different distances between the camera and the samples (2, and 6 metres). Along with the UAV equipped with the IR camera, there was a fixed IR camera, therefore two sets of data could be acquired and compared. A thermally uniform area of a sample is delimited, and the IR cameras captured the data [12] [5].
