1 **Improving Pipe Failure Predictions: Factors Effecting Pipe Failure in Drinking Water Networks**

3 *Neal Andrew Barton<sup>a</sup>, Timothy Stephen Farewell<sup>a\*</sup>, Stephen Henry Hallett<sup>a</sup>, and Timothy Francis, Acland<sup>b</sup>*

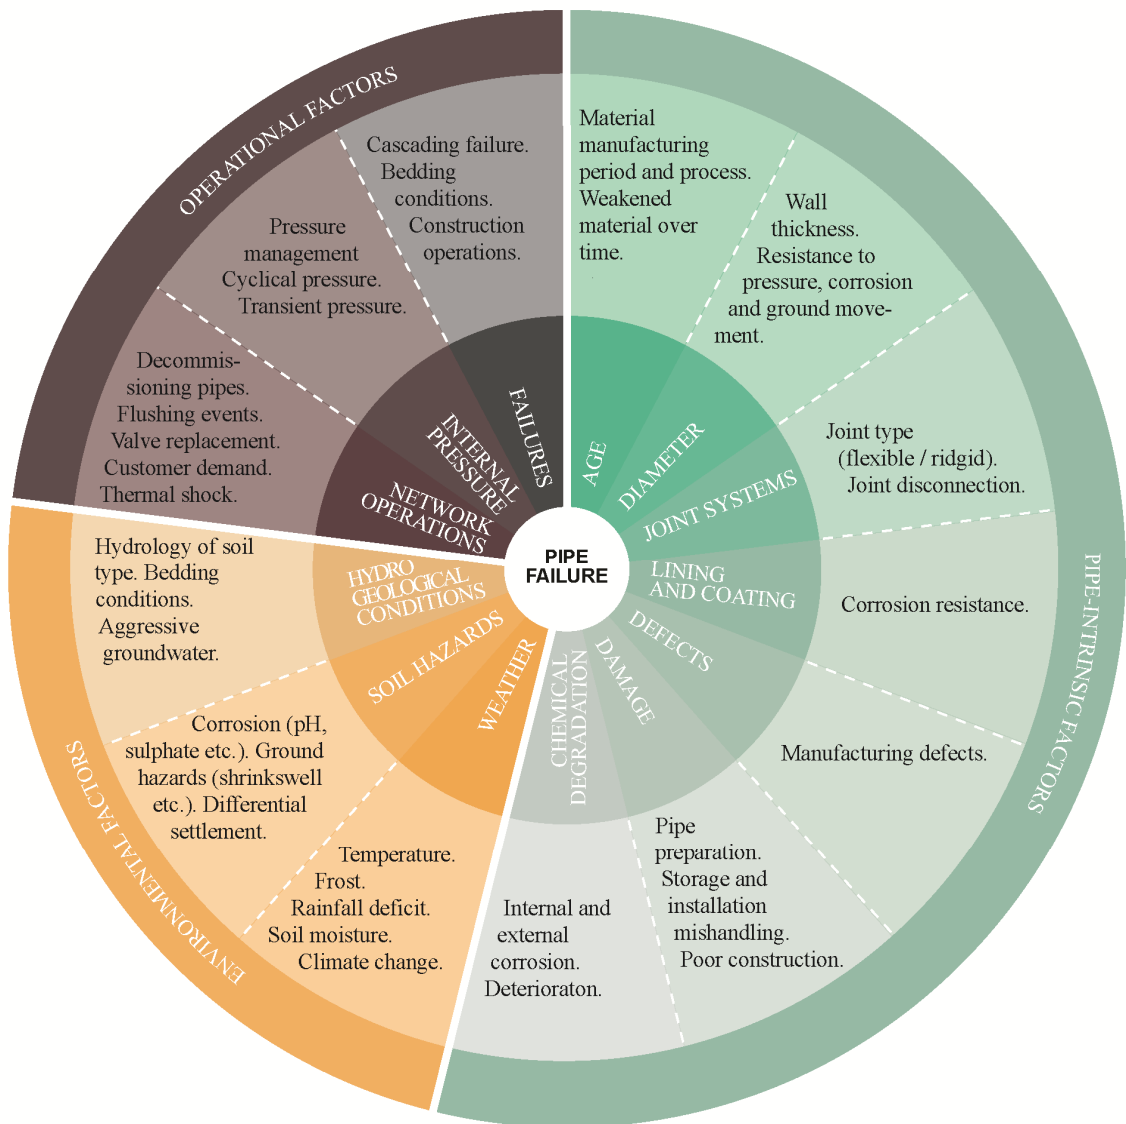
77 Figure 1. Factors influencing the failure of drinking water pipes.

71 There are many different modes and mechanisms for pipe failure. Complex relationships  
72 between factors and their relative contributions to the failure mechanism are unique for each pipe  
73 material and geographic region (Gould et al., 2013; Rajeev et al., 2014). Factors can be  
74 categorised to three groups: 1) pipe-intrinsic, 2) operational and 3) environmental. Figure 1  
75 presents the major factors affecting water pipe failure.

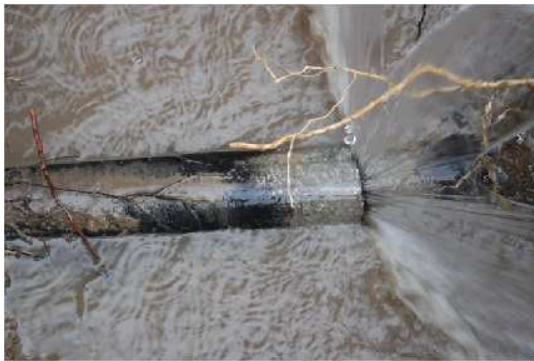
Circumferential break  
on an asbestos cement pipe.

94 Figure 2. Modes of failure (images courtesy of Anglian Water, 2018).

84 possibly in conjunction with a pre-existing defects acting as a point of weakness. Joint failures  
85 are typically caused by tensile or compressive forces, while holes are typically caused by radial  
86 forces in conjunction with corrosion (Hu and Hubble, 2007; Makar et al., 2001). Figure 2 shows  
87 different failure modes acting *in situ*.

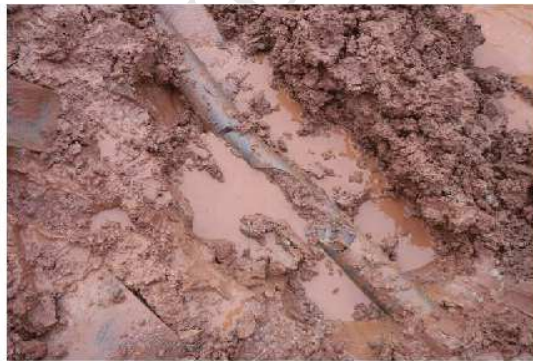
Longitudinal split  
on a polyvinyl chloride pipe.

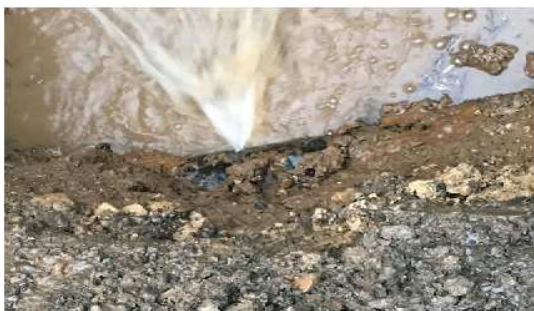
Corrosion pin hole  
on an iron pipe.

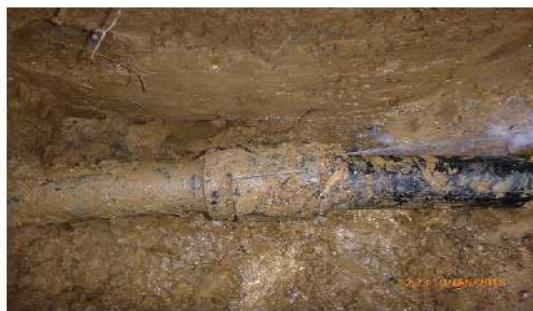
Joint failure (disconnection or gasket  
failure) on an asbestos cement pipe.

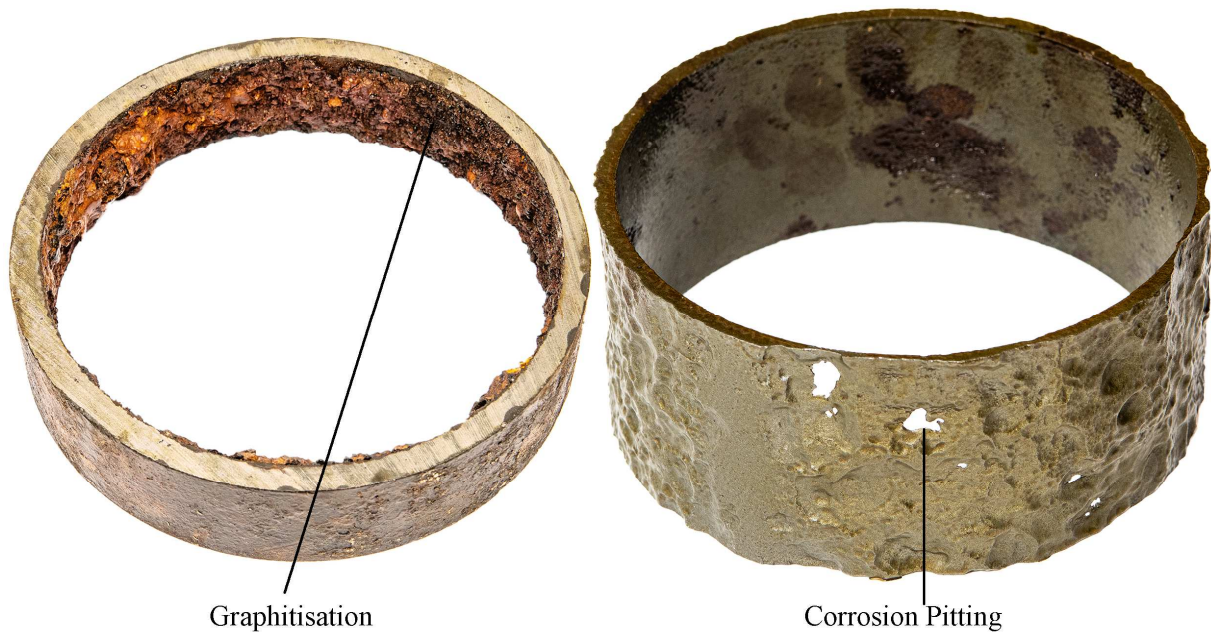
300 Figure 6. Cast iron pipe corrosion and chemical degradation.

288  
289 Highly corrosive soils can deteriorate pipes at faster rates, especially for older pipes without  
290 protection. Two main types of corrosion occur in metal pipes: 1) graphitization and 2) corrosion  
291 pitting (Figure 6). Graphitization, described by Makar, Desnoyers and McDonald (2001), occurs  
292 mainly in cast iron, and is a key corrosion process that occurs when iron oxide reacts with the  
293 graphite in the iron alloy, leaching the iron and leaving the graphite behind. In some cases of

294 aggressive graphitisation all iron is removed, significantly weakening the pipe. (Farrow et al.,  
295 2017; Rajani and Kleiner, 2001). Corrosion pitting occurs in all forms of metal pipes, from the  
296 presence of sulphate and chloride ions in the surrounding environment, causing deterioration of  
297 the pipe material from electrochemical and or chemical action corrosion (Volk et al., 2000).

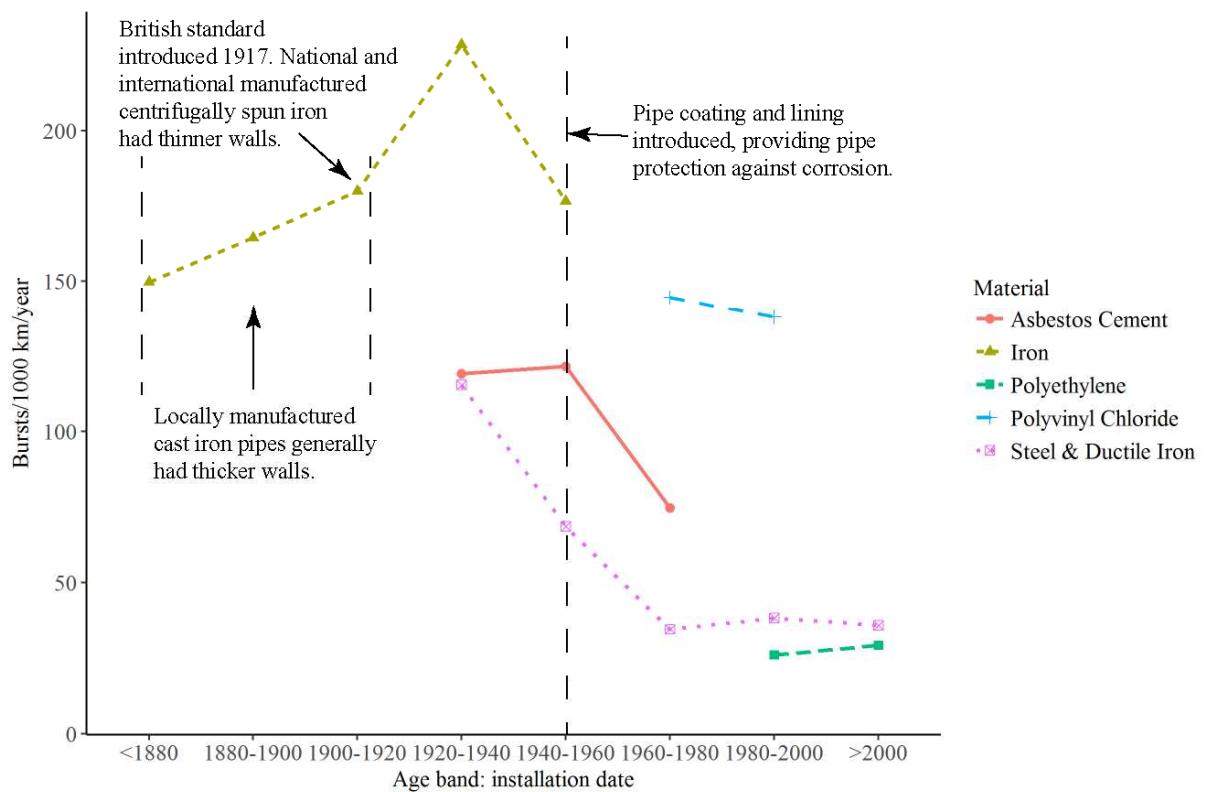
360 Figure 7. Summary of introduction year and successive failure rates by age by material type  
 361 (Utility Provider, 2018).

346 Failure rates for iron, DI and steel peak for pipes installed during the 1920s – 1940s, AC during  
347 the 1940s – 1960s. Both PE and PVC have steady failure rates by age. Iron shows that failure  
348 rates increase for newer pipes, up to the 1920s – 40s and then fall again which is unexpected.  
349 This could be due to manufacturing, where materials and standards have been manufactured  
350 differently, resulting in different quality of materials (Wols and van Thienen, 2016); early iron  
351 pipes were locally cast and had very thick walls Iron pipe standards were then introduced in 1917  
352 with BS 78 1917, where pipes were mainly spun to a specification which produced thinner walls  
353 that failed earlier than thicker pipes. Thereafter failure rates fall up to the 1960s, which is due to  
354 the shift towards centrifugally spun iron and pipe protection, constructional methods which

355 produced a more resilient pipe or the replacement of these lower quality pipes with newer  
 356 materials (Wols and van Thienen, 2016). All material failure rates start to improve after the  
 357 1940s – 1960s, perhaps due to the age of the installation, improved construction practices and  
 358 improved protection against corrosion.

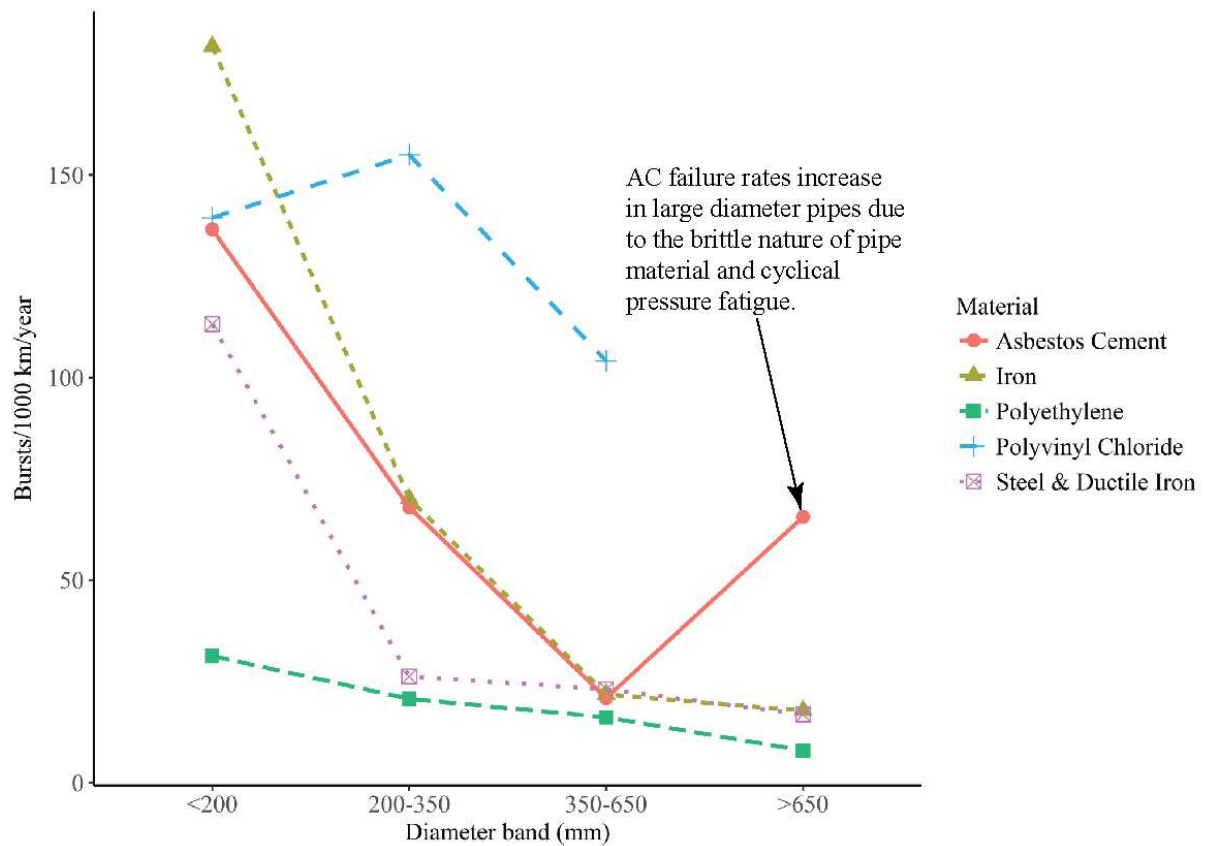
381 Figure 8. Summary of failure rates by diameter size and pipe material type (Utility Provider,  
382 2018).

374 Wengström, 1993). Where longitudinal failures occurred in smaller diameter pipes, Ruchti  
375 (2017) reported differential settlement as the common mechanism for failure. When researching  
376 large pipes Rajeev *et al.* (2014) found longitudinal failures and holes to be the common failure  
377 mode for larger pipes, typically > 300 mm in diameter; the evaluation suggesting corrosion and  
378 internal water pressure as the main causes. Typical failure rates by diameter size and material  
379 type are presented in Figure 8.

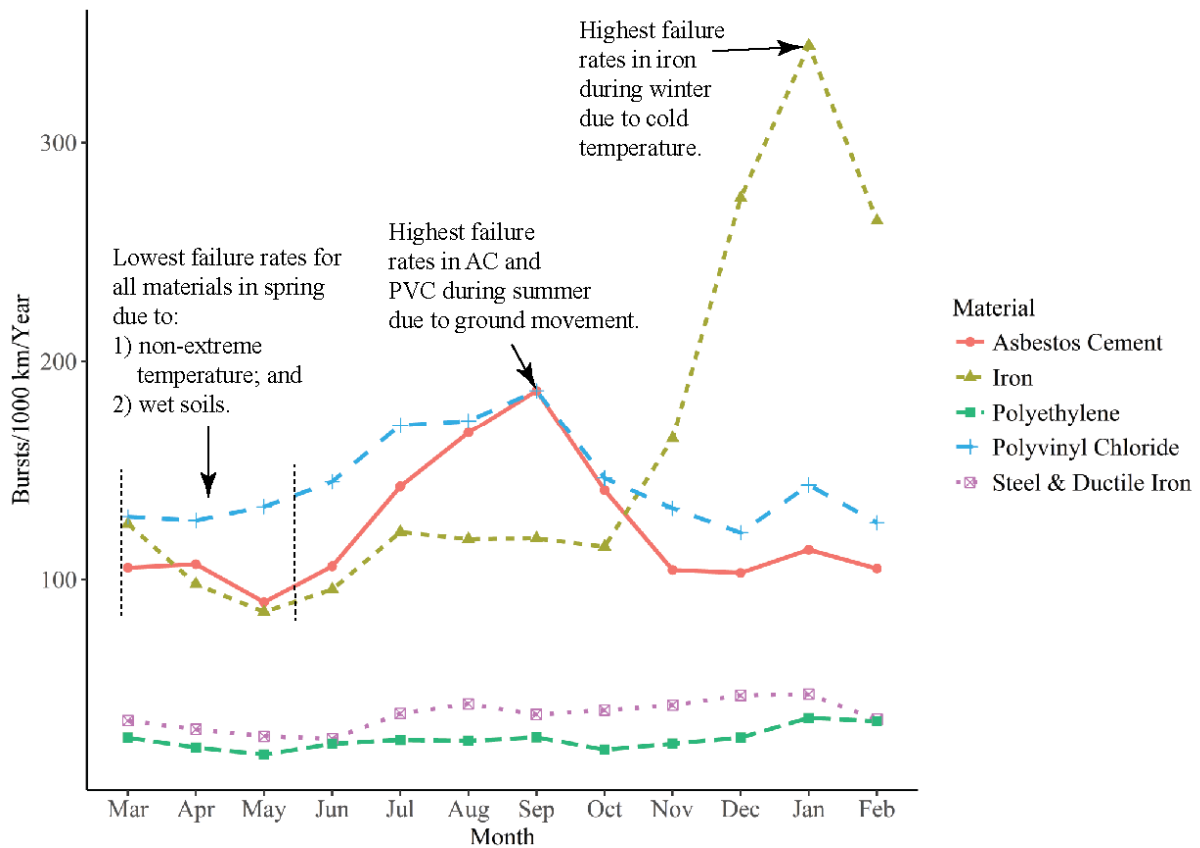
407 Figure 9. Summary of seasonal failure rates by material type (Utility Provider, 2018).

401  
402 A comparison of seasonal failure from the utility provider is shown in Figure 9. The results show  
403 that highest failure rates for iron are during the winter months, whilst AC and, to a lesser extent,  
404 PVC have higher failure rates during the summer. DI, steel and PE show little variation to  
405 seasonal change but can be seen to slightly increase during the winter.

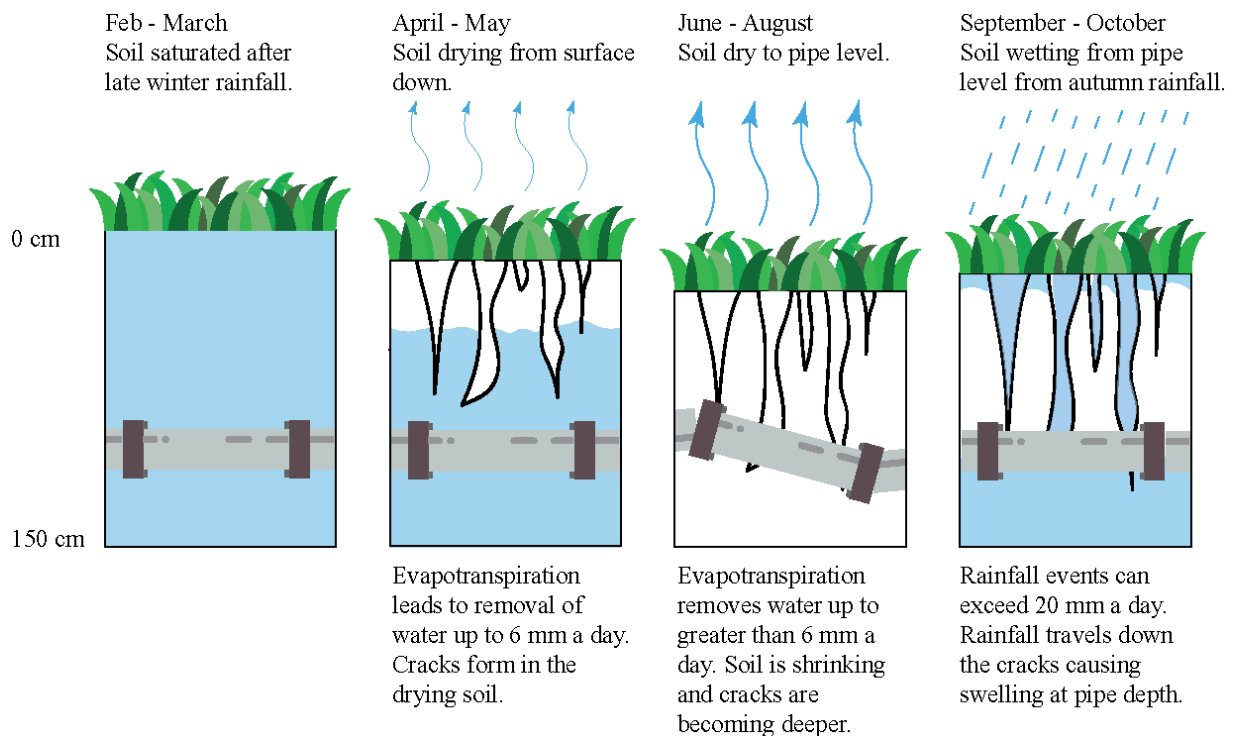
503 Figure 11. Seasonal shrink swell effect in clay-rich soils (after Farewell *et al.*, 2012, p. 10).

491  
492 Pipe failure is lowest during the spring when soils are consistently wet, so movement is unlikely.  
493 Chan, Gould and Davis (2005) suggested that the late summer and early autumn months are the  
494 most influential time of year for AC failure rates, since soil moisture and temperature varies the  
495 most during this period, increasing the shrink swell effect. This is also shown in the data from  
496 the UK utility provider in Figure 9. UK soils normally dry to 1 – 1.5 m (Pritchard et al., 2015a),  
497 but long periods of drought can result in deeper drying and higher failure rates (Farewell et al.,  
498 2012b). High failure rate in PVC push fit joints are associated with ground movement causing  
499 disconnection through joint rotation and axial pull (Arsénio et al., 2013). The effects of soil  
500 shrink swell on pipes from changes in soil moisture are shown in Figure 11.
