Improvement in hot corrosion resistance of dissimilar alloy 825 and AISI 321 CO₂-laser weldment by HVOF coating in aggressive salt environment at 900°C

This study investigated the hot corrosion performance of a dissimilar weldment of Ni-based superalloy and stainless steel joined by CO₂ laser welding and improved by high-velocity oxy-fuel (HVOF) coating in a Na₂SO₄–60wt%V₂O₅ atmosphere at 900°C. A dissimilar butt joint of AISI 321 and alloy 825 was fabricated by CO₂ laser welding with low heat input after obtaining the optimum welding parameters by bead-on-plate trials. The metallurgical and mechanical properties of the laser weldment were evaluated. The tensile test results indicated the occurrence of fracture in the base metal AISI 321 side. The HVOF process was employed to coat Ni–20wt%Cr on the weldment. To evaluate the surface morphology of the corrosion products formed on the uncoated and HVOF-coated weldments, scanning electron microscopy (SEM) analysis was performed. Energy-dispersive spectroscopy (EDS) was used to determine the different elements present on the surface scales. The existence of oxide phases on the weldments was determined by X-ray diffraction (XRD). The cr

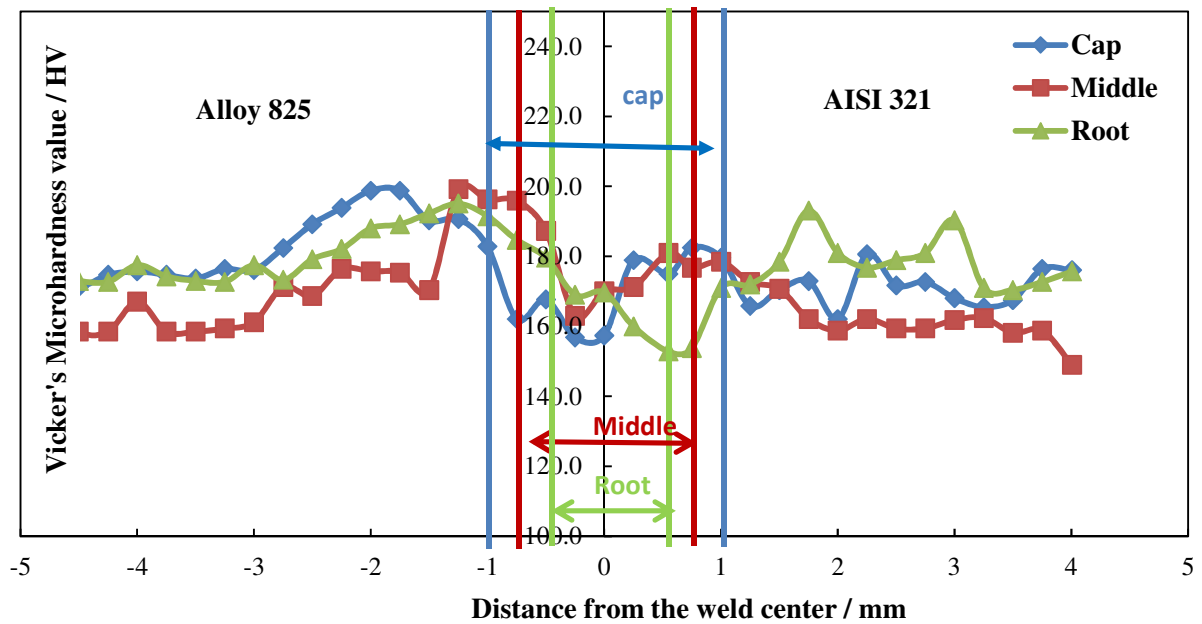
Fig. 3. Microhardness profile of 825-321 dissimilar CO₂ laser weldments.

Fig. 3 illustrates the microhardness profile of 825–321 dissimilar laser weldments. The hardness dropped comparatively while progressing toward the weld interface from the alloy 825 regions. The average hardness values of the alloy 825, weld zone, and AISI 321 were HV 170.8, HV 177.9, and HV 166.2, respectively. The microhardness profile shows that all the regions presented similar hardness values.

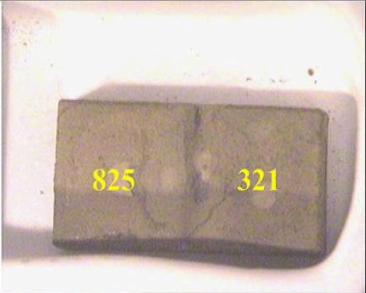
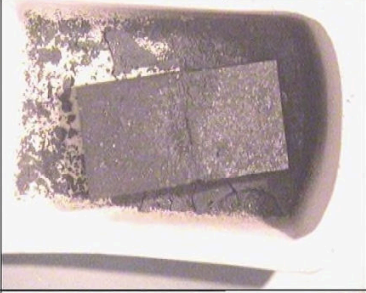
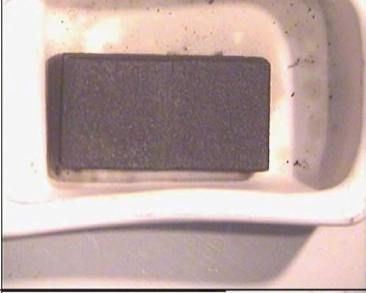
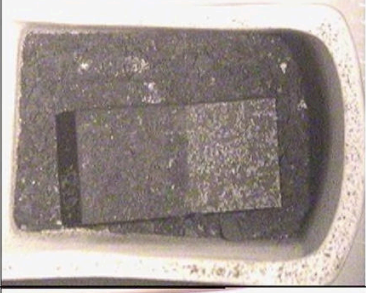
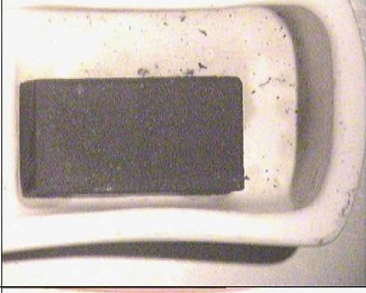
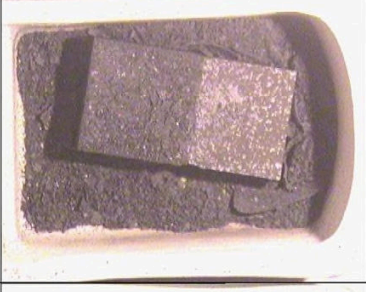
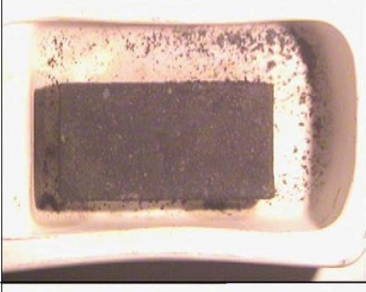
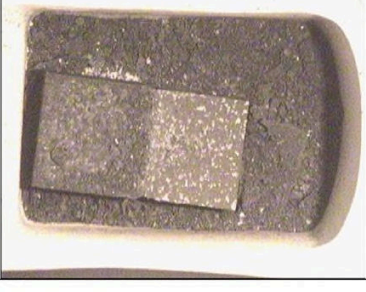
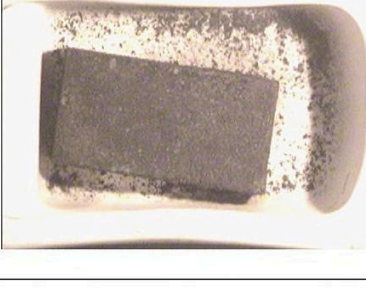
Fig. 7. Macro-images of uncoated and HVOF-coated hot-corroded weldments during exposure to molten salt at 900°C.

Macro-images of the uncoated and coated weldments during exposure to the salt environment are depicted in Fig. 7. The macro-images show the presence of oxide scales on the surface, spallation, and sputtering. In the uncoated weldment, from the initial stage onward, the scales started to spall on both the weld and base metal regions. This could be attributed to the extensive corrosion at the AISI 321 region and the weld zone caused by the development of the Fe_2O_3 scale. The spalling rate of scales increased with an increase in exposure time, as shown in Fig. 7. A minor oxide scale spallation was observed in the coated specimen.
