A scanning electron microscopy study of projectile entry fractures in cortical bone; genesis and microarchitectural features

Abstract

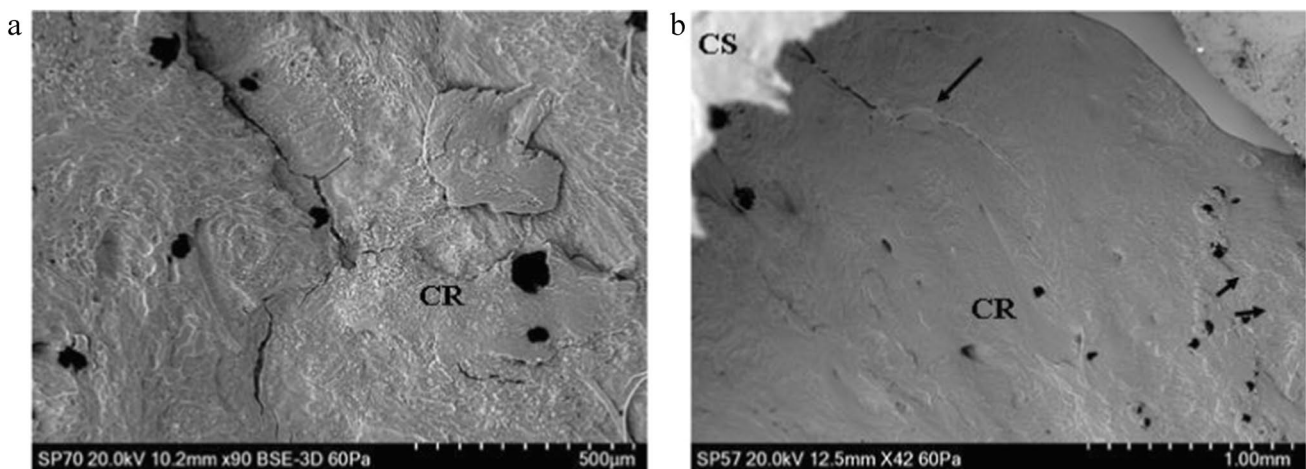
Fig. 4 Genesis of the cortical entry in sandwich bones; failure of the cortical roof (CS, cortical surface; CR, cortical roof); **a** \sim 57 m/s rebound impact (defleshed specimen); surface of cortical roof showing vertically orientated fracture dividing the roof into two halves; fracture resulted from tensile failure of the inner surface of the cortical plate under compressive loading; **b** 75 m/s perforating impact

($Ei=2.47$ J, $E'=0.09$ J/mm²), view of the cortical roof of a nearly intact conoid displaced downwards so it is beneath the cortical surface and protruding from the inner cortical plate; the surface has not been modified by impact but bears a fracture ending before the mid-section (arrow)

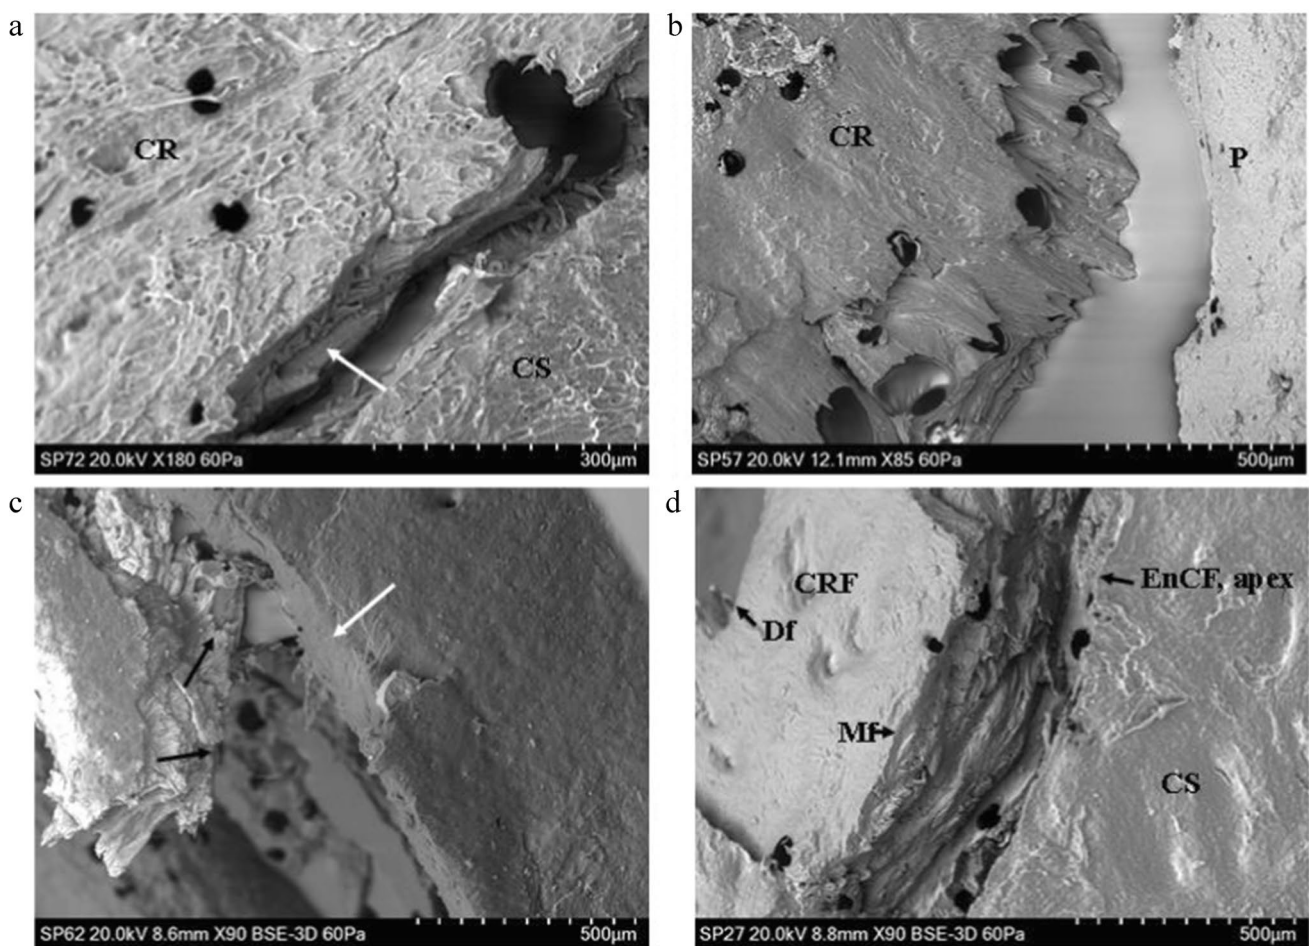
Fig. 5 Genesis of the cortical entry in sandwich bones; stepping of the cortical roof (CS, cortical surface; CR, cortical roof; CRF, cortical roof fragment; MF, medial fracture edge of cortical roof fragment; Df, distal fracture edge of cortical roof fragment; P, putty used to seal the cortical entry for negative moulding; EnCF, entry cortical fracture edge); **a** ~57 m/s rebound impact (defleshed specimen), mode I (tensile, crack opening) fracture mode indicated by stepping of the fracture edge across lamellar planes inside the cortical roof (arrow); **b** 75 m/s perforating impact ($E_i=2.47$ J, $E' = 0.09$ J/mm²) showing right fracture edge of the cortical roof of the nearly intact conoid

seen in Fig. 4b, complex stepped morphology resulting from mode I fracture across lamellae; fracture edge is angulated to match the corresponding angulation of the EnCF; **c** 94 m/s perforating impact (E_i 3.94 J, $E' 0.14$ J/mm²), cortical roof fragment with the distal surface facing upwards and displaying internal lamellae on the medial side orientated in different planes (highlighted by the small arrows); large arrow indicates an area of smooth bone consistent with being surface-modified plastic deformation; **d** 161 m/s perforating impact (E_i 11.44 J, $E' 0.40$ J/mm²) showing cortical roof fragment with pronounced stepping across the lamellae of the medial fracture margin

components (Fig. 5, b–c) or presented a more uniform stepped morphology (Fig. 5d). The pointed lamellar morphology is illustrated in Fig. 5b, which shows the lower right margin of the cortical roof of the intact conoid seen in Fig. 4b. In this part of the conoid, the stepped region was angled to match the corresponding angulation of the EnCF, and the overlapping pointed lamellar fracture edges produced a complex fracture surface. This morphology may have resulted from the plane of the crack in relation to the lamellar structure in that region or from a pull-out process as the conoid was compressed downwards. Stepped fracture margins with pointed fracture edges were also observed on a smaller scale in a fragment of cortical roof resulting from a 94 m/s impact; in this specimen, the pointed ends of the

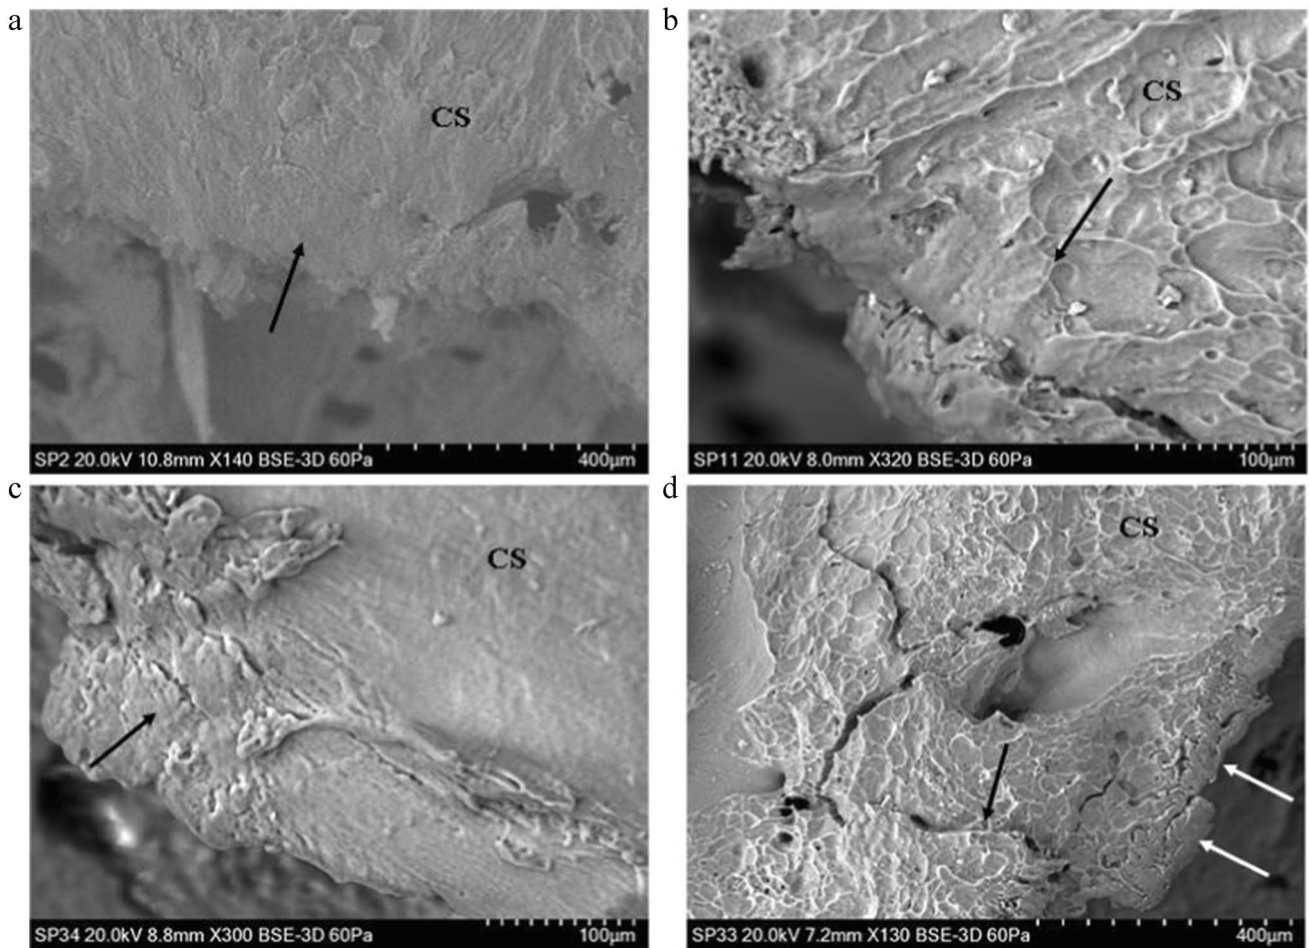
Fig. 7 Surface modified plastic deformation (SPD), 149–609 m/s perforating impacts (CS, cortical surface); **a** 149 m/s impact ($E_i=9.78$ J, $E'=0.35$ J/mm²) showing loss of surface detail (arrow); **b** 333 m/s impact ($E_i=49.07$ J, $E'=1.74$ J/mm²) showing SPD with transition of cortical sculpturing (arrow), **c** 591 m/s impact ($E_i=154.37$ J,

$E'=5.46$ J/mm²) showing SPD (black arrow) with small transverse fractures; **d** 609 m/s impact ($E_i=163.89$ J, $E'=5.80$ J/mm²) showing SPD along the apex of the EnCF (lower white arrows) in relation to the immediate cortical landscape; note the radial crack emanating from the EnCF (black arrow)

This transition zone is illustrated in specimens impacted at 74–75 m/s Fig. 6, a–b and in specimens impacted at 149–333 m/s in Fig. 7, a–b. Additional features of SPD, present to varying extents in each affected region, were a compressed, deformed cortex and down-bending in the absence of visible fracture. These features are illustrated in a 96 m/s impact in Fig. 6c and in a 591 m/s and 609 m/s impact in Fig. 7 c–d, respectively. The down-bending associated with SPD resulted in a ductile morphology at the apex of the EnCF. Figure 6d shows a cortical roof fragment where bending was extensive enough to allow it to descend into the cortical entry without visible fracture at the top edge (B in the image). Areas of SPD sometimes showed circumferential fractures running along the modified cortical surface (Fig. 7c); these were indistinguishable from ring cracks when they were of large size. The contrast between the cortical surface in the immediate cortical landscape and SPD

along the apex is illustrated in Fig. 7d. In this example, the cortical surface adjacent to the apex was markedly sculpted; this morphology contrasted greatly with the region of SPD which showed complete loss of sculpturing, bending without visible fracture and a compressed, smoothed appearance.

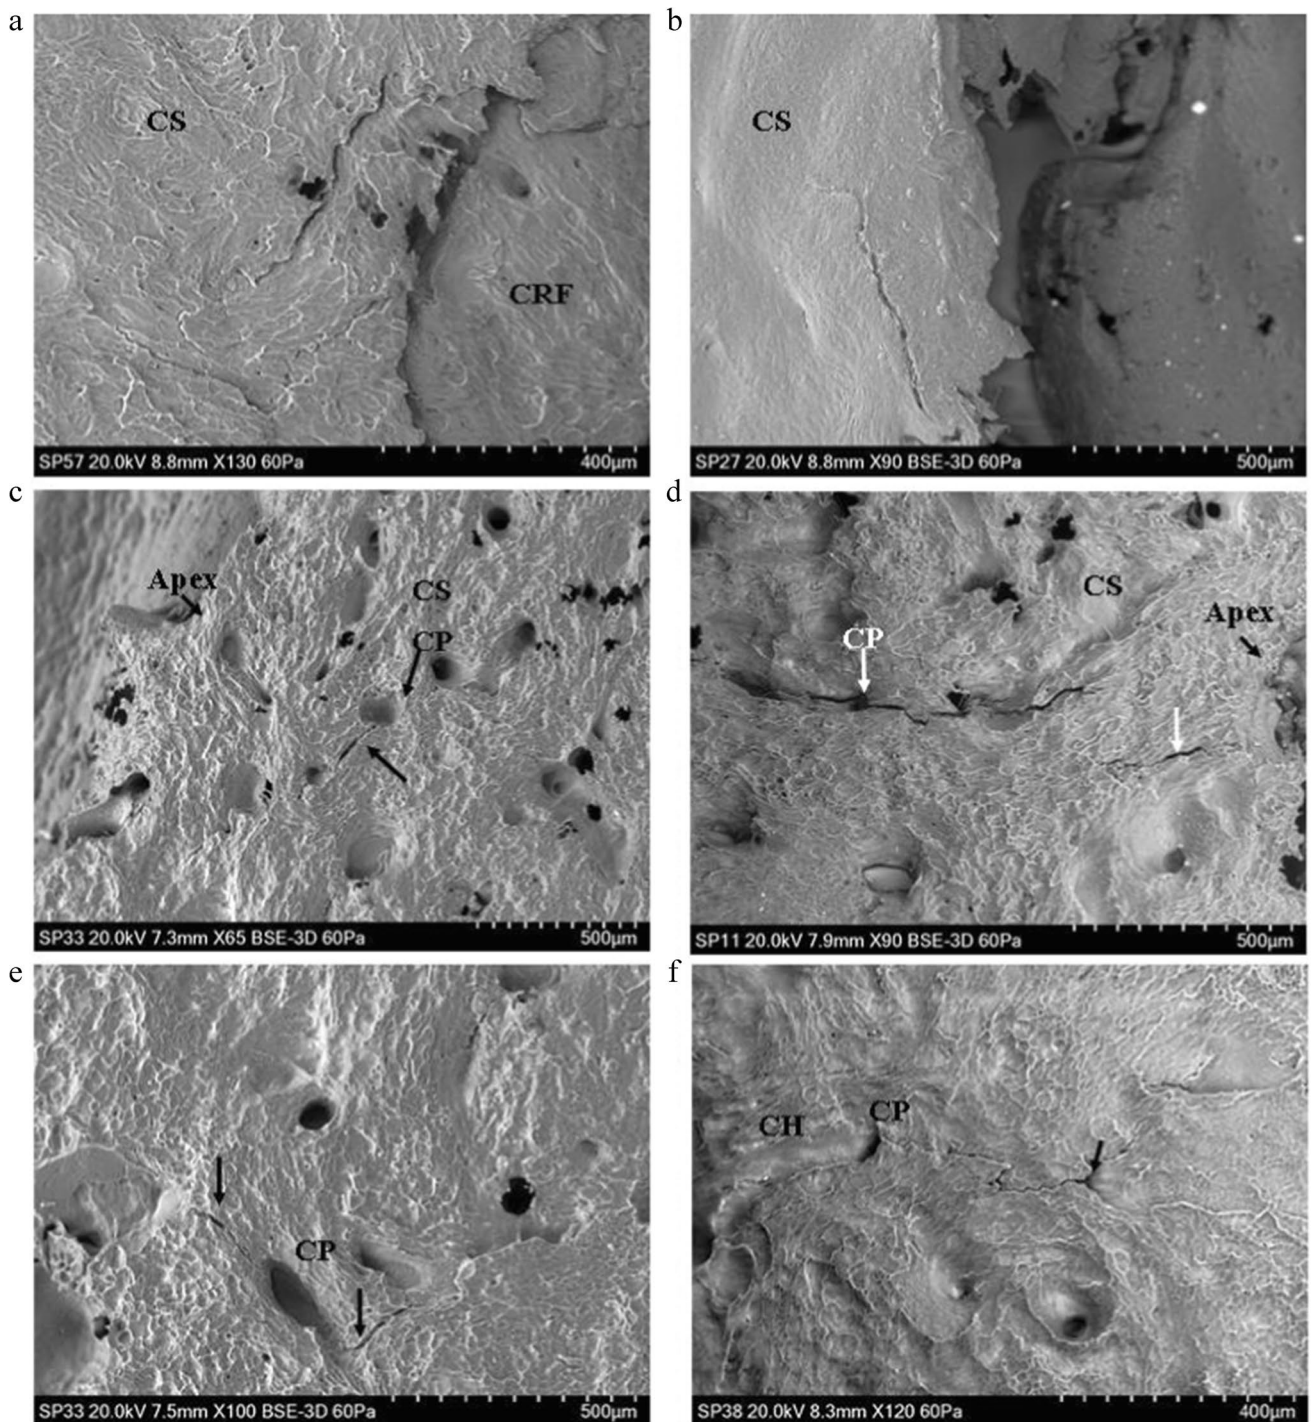
Fig. 11 Concentric cracking and cracks arising from cortical stress concentrators, perforating impacts (CS, cortical surface, CR, cortical roof; CRF, cortical roof fragment, CP, cortical pore; CH, channel); **a** 75 m/s impact ($Ei=2.47$ J, $E'=0.09$ J/mm²), showing concentric crack adjacent to a fragment of cortical roof; **b** 161 m/s impact ($Ei=11.44$ J, $E'=0.40$ J/mm²) with concentric crack near the EnCF; **c** 609 m/s impact ($Ei=154.37$ J, $E'=5.46$ J/mm²) showing concentric crack arising from cortical pit adjacent to the apex of the EnCF; **d** 333 m/s perforating impact ($Ei=49.07$ J, $E'=1.74$ J/mm²), large radially orientated crack adjacent to the apex and associ-

ated with a cortical pore; note the smaller radially orientated crack (lower arrow) that arises within the cortex not a pore; **e** same specimen as in **c**, showing elliptical cortical pore with the major axis running upwards from right to left; stresses acting normal to this axis resulted in stress concentrating at the tips of the elliptical cavity and resulted in cracking at both ends [34]; **f**, 871 m/s perforating impact ($Ei=335.71$ J, $E'=11.88$ J/mm²) showing figure crack associated with a cortical pore/channel complex and extending to a smaller pore-type structure at right (arrow)

Circumferential cracks were identified in a total of 9/14 impacts between 58 and 168 m/s and 4/7 impacts between 333 and 897 m/s. These cracks were found both near the apex of the EnCF (Fig. 11, a–b) and further away in the

cortical landscape; in one case, a concentric crack was found approximately 1.5 mm from the cortical entry. Unlike the rebound impacts, circumferential cracks in the perforating impacts did not appear to form concentric generations but were dispersed diffusely around the cortical entry. Cortical pits and pores acted as stress concentrators during impact and were detected as the origin for some circumferential (Fig. 11c) and radial (Fig. 11d) cracks. In elliptical pores, stresses acting normal to the major axis resulted in cracking at each end due to concentration of stresses there (Fig. 11e) [34]. Pore and pit cracks did not always occur in isolation, with an example of a linked pore-crack complex occurring in an 871 m/s impact (Fig. 11f). Cortical pore cracking occurs both near the apex of the EnCF (Fig. 11, a–b) and more distant, with the pore in Fig. 11e being over 1 mm away from it.
