Article

# Automated Impact Damage Detection Technique for Composites Based on Thermographic Image Processing and Machine Learning Classification

**Abstract:** Composite materials are one of the primary structural components in most current transportation applications, such as the aerospace industry. Composite material diagnostics is a promising area in the fight against structural damage in aircraft and spaceships. Detection and diagnostic technologies often provide analysts with a valuable and rapid mechanism to monitor the health and safety of composite materials. Although many attempts have been made to develop damage detection techniques and make operations more efficient, there is still a need to develop/improve existing methods. Pulsed thermography (PT) technology was used in this study to obtain healthy and defective data sets from custom-designed composite samples having similar dimensions but different thicknesses (1.6 and 3.8). Ten carbon fibre-reinforced plastic (CFRP) panels were tested. The samples were subjected to impact damage of various energy levels, ranging from 4 to 12 J. Two different methods have been applied to detect and classify the damage to the composit

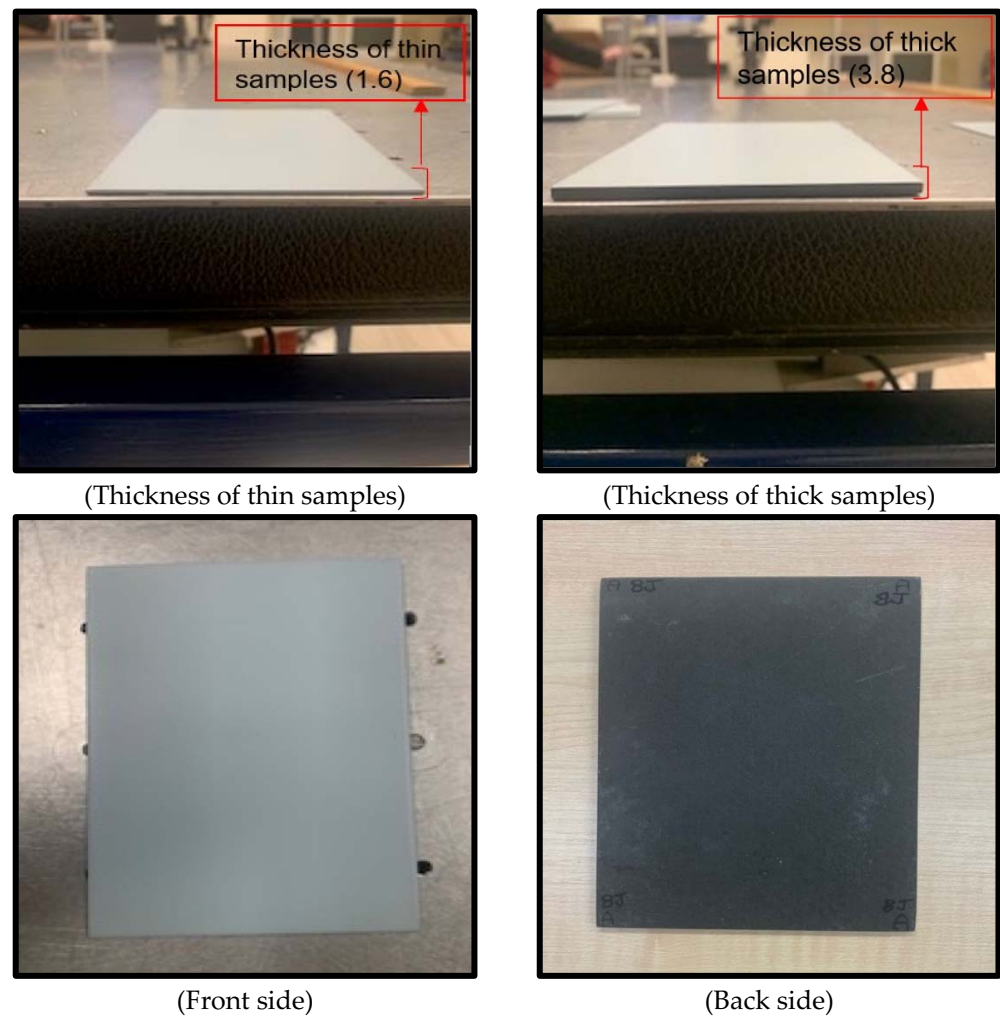
Two distinct laminates were manufactured with 9 and 18 plies and a ply layup similar to that found in a composite aircraft’s fuselage. The fibre was aligned along the longer dimension of these laminates, which were cut into coupons with diameters of  $100 \times 150$  mm. the coupons were affected using the American Society for Testing and Materials (ASTM) testing process with varying energy levels to produce Barely Visible Impact Damages (BVID).

- Laminate size:  $100 \times 150$  mm
- Theoretical cured ply thickness: 0.18 mm
- Material: UD pre-preg material IMS-977-2.

**Figure 1.** Samples feature.

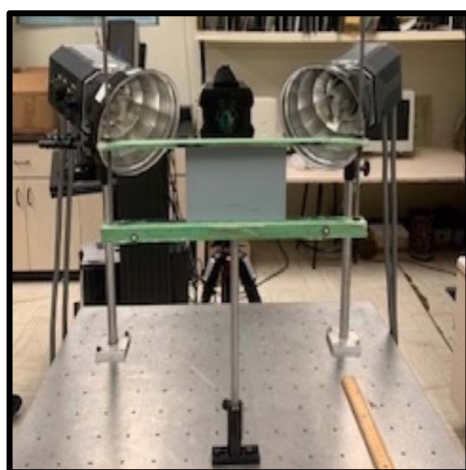
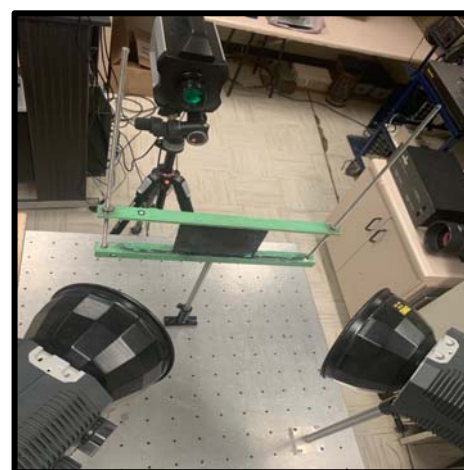
The data source location was as follows: Institution: Computer Vision and Systems Laboratory at Laval University City/Town/Region: Quebec City/Quebec/North America G1V 0A6 Country: Canada. Figure 2 shows the conducted experiments of a pulsed thermographic in different modes.

(Reflection mode)

(Transmission mode)

**Figure 2.** Methods for image capture.

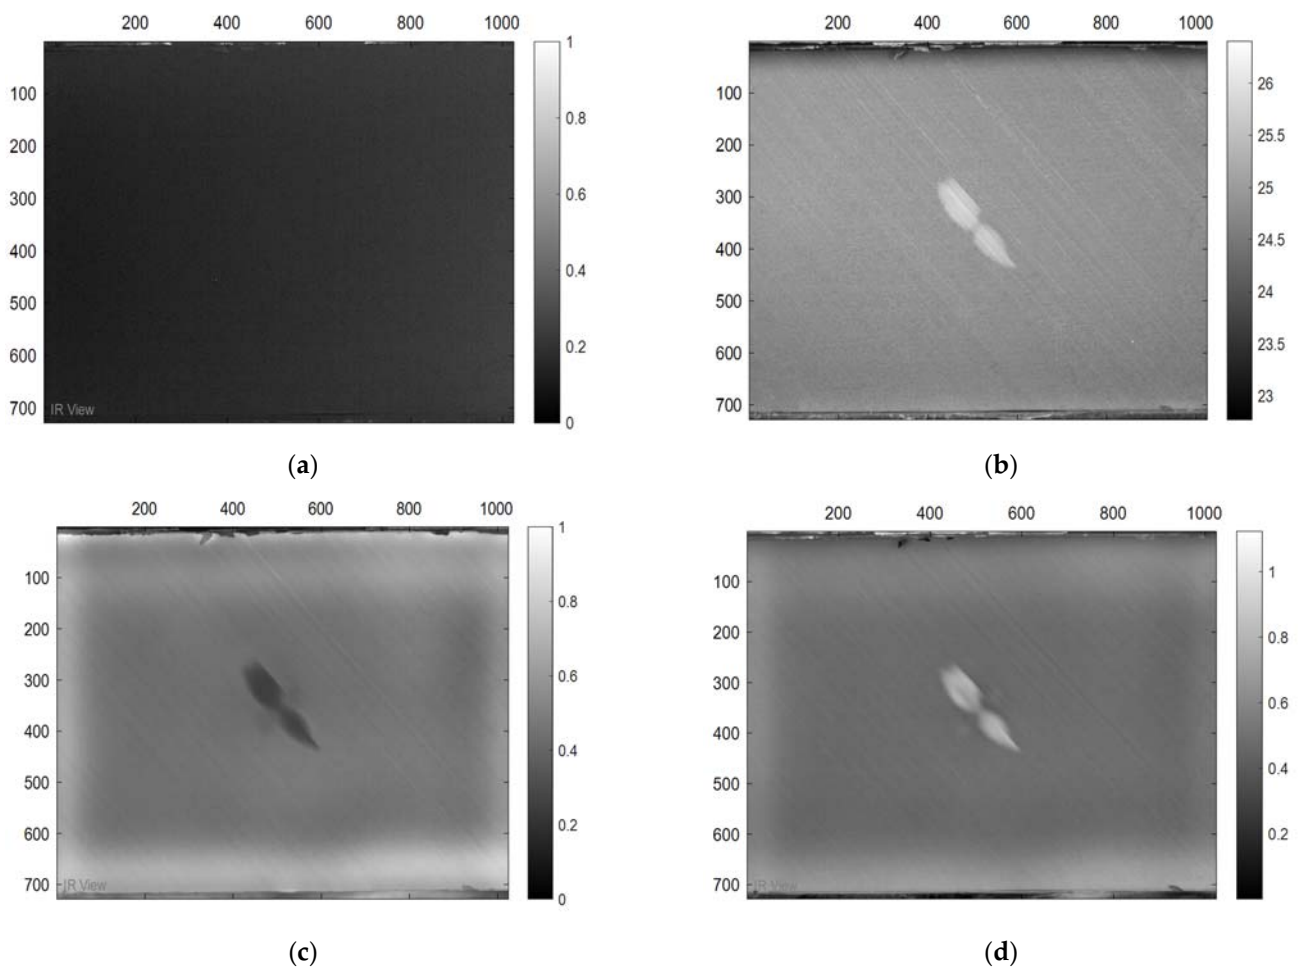
In this section, the results of the image processing based on the above-mentioned methods (PPT and PCT) are presented, where the final results proved that the tested samples were exposed to damage to varying degrees. Moreover, some damages in the tested samples could not be detected without image processing, which proves the importance of image processing. Figure 3 demonstrates the benefits of image processing, whether PPT or PCT, where the damage can be seen clearly compared to Figure 3a, which reflects the image before exposure to heat. Also, in a three-dimensional image (Figure 4), the damage can be seen clearly where the damage shapes an anomalous pattern on the surface of the 3D image.

**Figure 3.** Images Processing Results, (a) raw thermogram corresponding to  $t = 0.8$  s. (a) Cold image. (b) Raw Image. (c) BCT Image. (d) PPT Image.

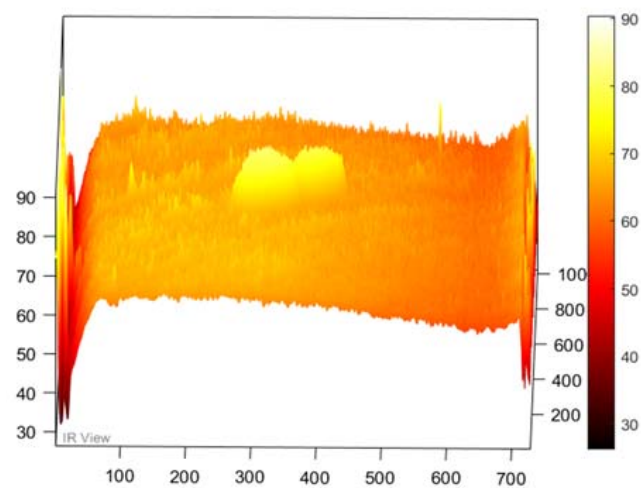
**Figure 4.** Three-dimensional image, corresponding to PPT.

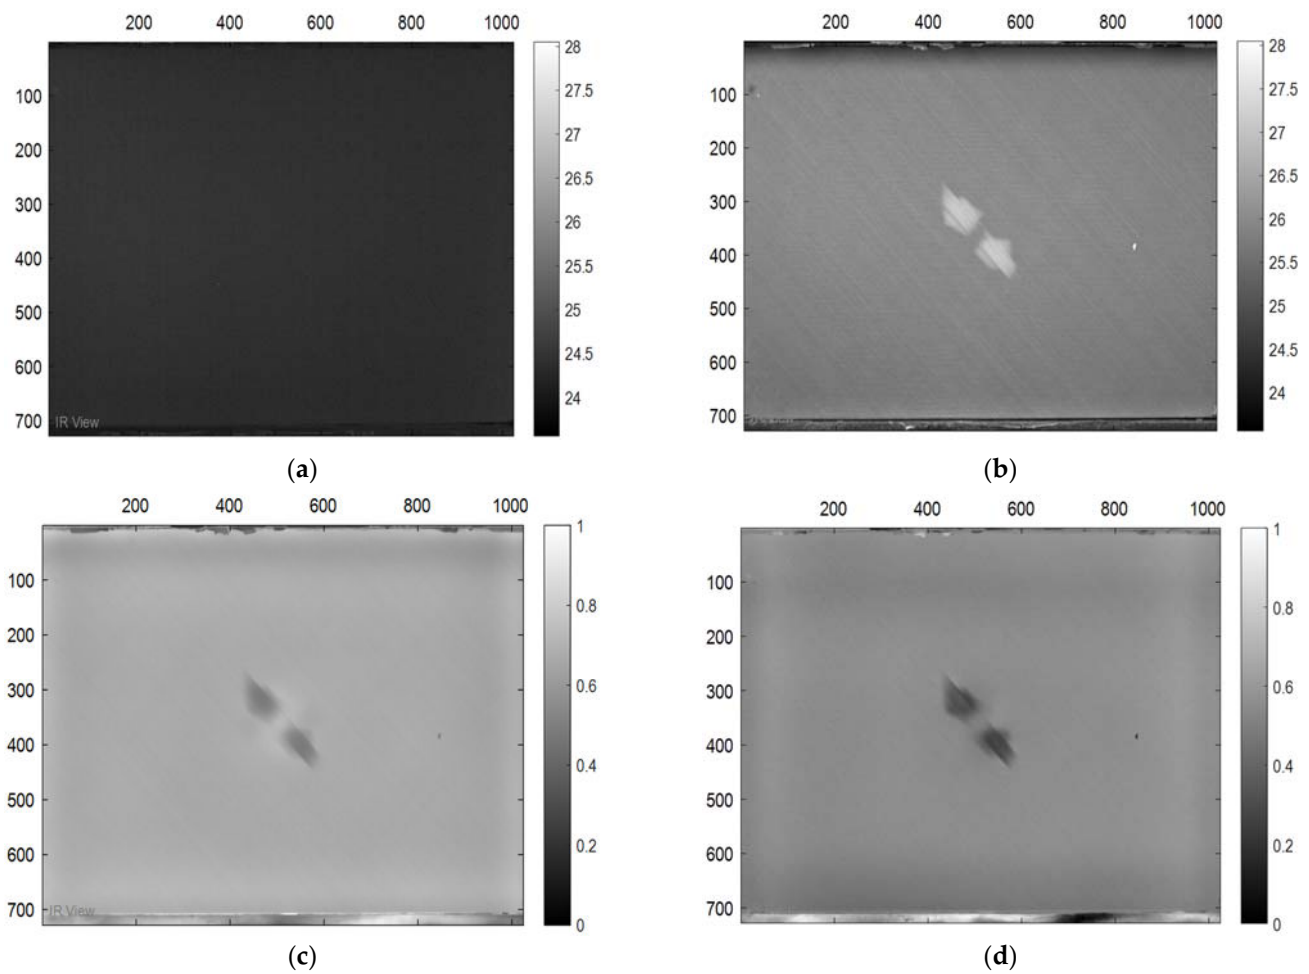
Also, in the case of the thick samples, the results of the image processing prove the possibility to detect the damage based on both methods (PPT and PCT), see Figure 5. Furthermore, in the three-dimensional image (Figure 6), the damage can be seen clearly on the surface of the samples after the exposure of the sample to heat.

**Figure 5.** Images Processing Results. (a) Cold image. (b) Raw Image. (c) BCT Image. (d) PPT Image.

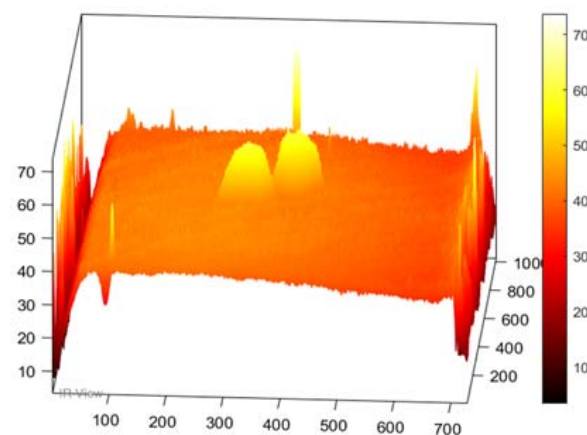
**Figure 6.** Three-dimensional image, corresponding to PPT.

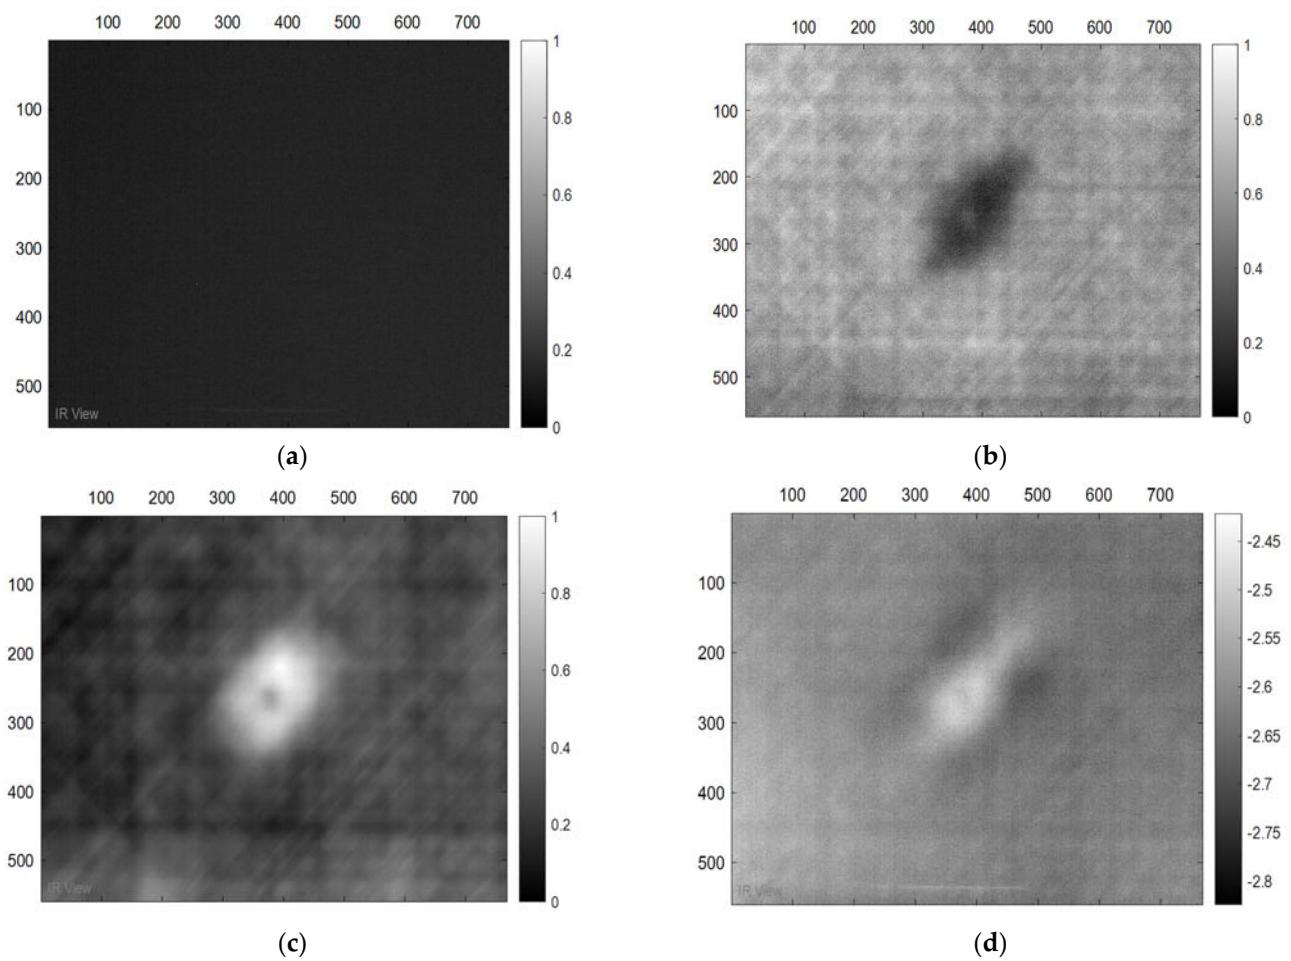
In this section, the focus will be on the results of the transmission mode instead of the reflection mode (previous section). As shown in Figure 7, the results of the image processing of the thin samples show internal damage on the surface of the tested samples, contrary to the results of the reflection mode, which show details of the surface and shallow damage. Moreover, in the three-dimensional image (Figure 8), the damage can be seen clearly on the surface of the 3D image after processing.

**Figure 7.** Image Processing Results. (a) Cold image. (b) Raw Image. (c) BCT Image. (d) PPT Image.

Another different sample (thick plate) has also been tested based on the transmission mode, and the results show the existence of the damage on the plate surface. Figure 9 demonstrates the final result of the image processing. Also, Figure 10 (3D-image) shows the abnormal pattern of the defective area in comparison to the healthy areas. In this case, damage appears with lesser contrast compared to Figure 7, since the plates are thicker.

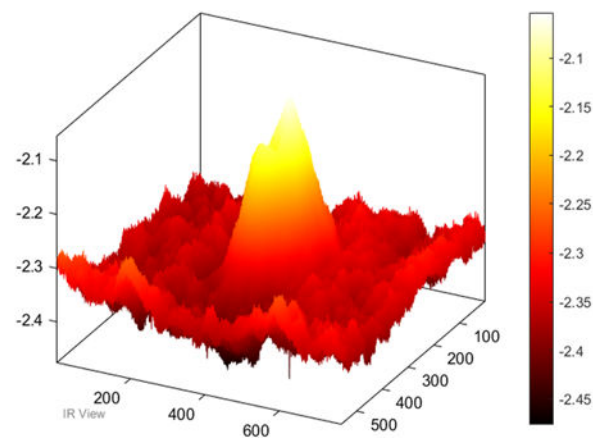
**Figure 8.** Three-dimensional image of the sample corresponding to PPT.

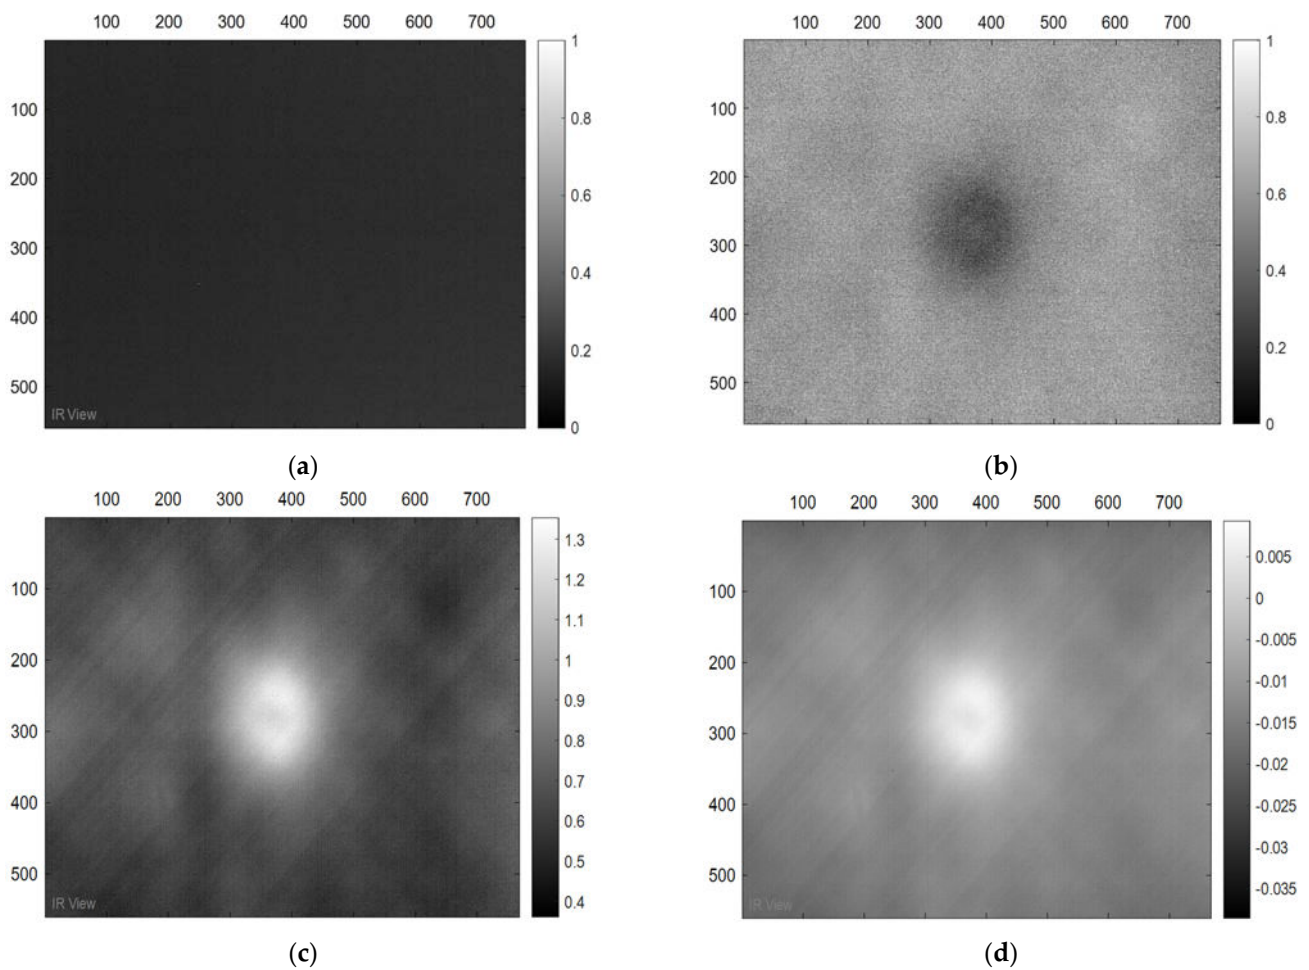
**Figure 9.** Images Processing Results. (a) Cold image. (b) Raw Image. (c) BCT Image. (d) PPT Image.

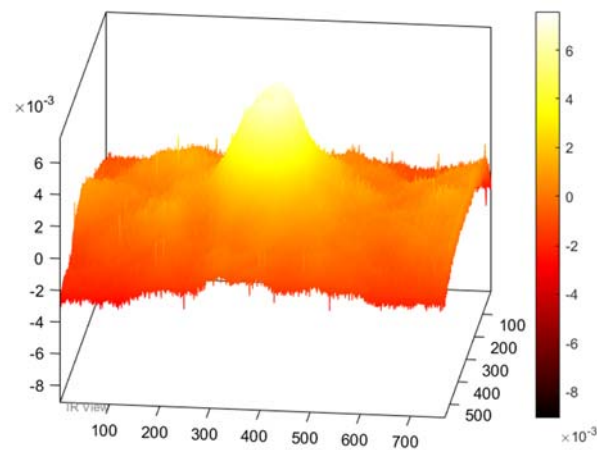
**Figure 10.** 3D of the sample corresponding to PPT.

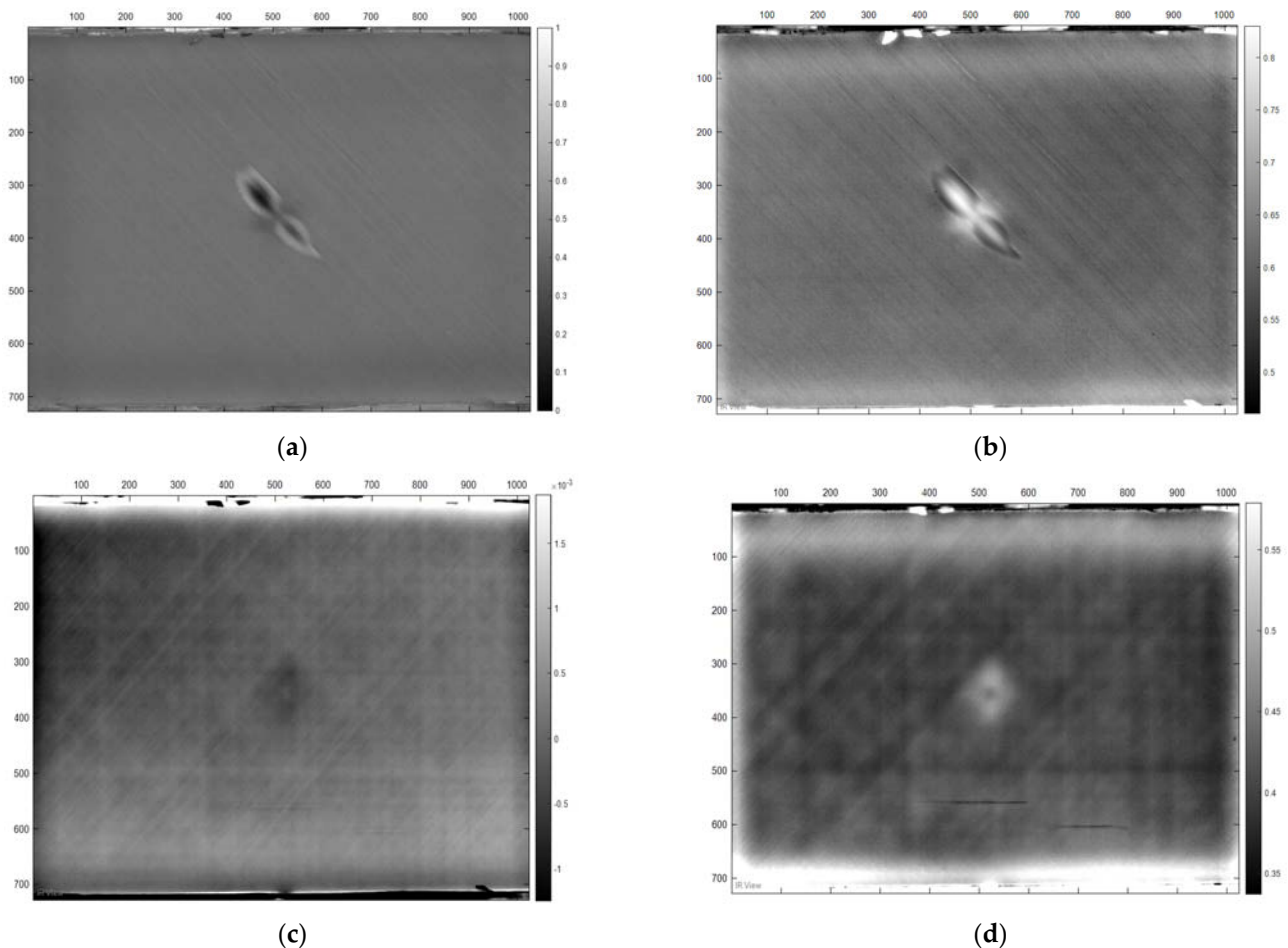
- There is a discrepancy in the raw thermograms because of the different energies to which the sample were exposed.
- Damage contrast varies according to the adopted configuration. i.e., reflection vs. transmission modes, as it is proven that the transmission mode offers more details

of internal damage, whilst reflection shows more detail on surface and near to the surface damage.

- The clarity varies in terms of the capturing position in the event of reflection mode or transmission mode. Figure 11 presents comparative results between reflection (a and b) and transmission (c and d) mode.

**Figure 11.** Image Processing Results. (a) reflection mood. (b) reflection mode. (c) transmission mode. (d) transmission mode.

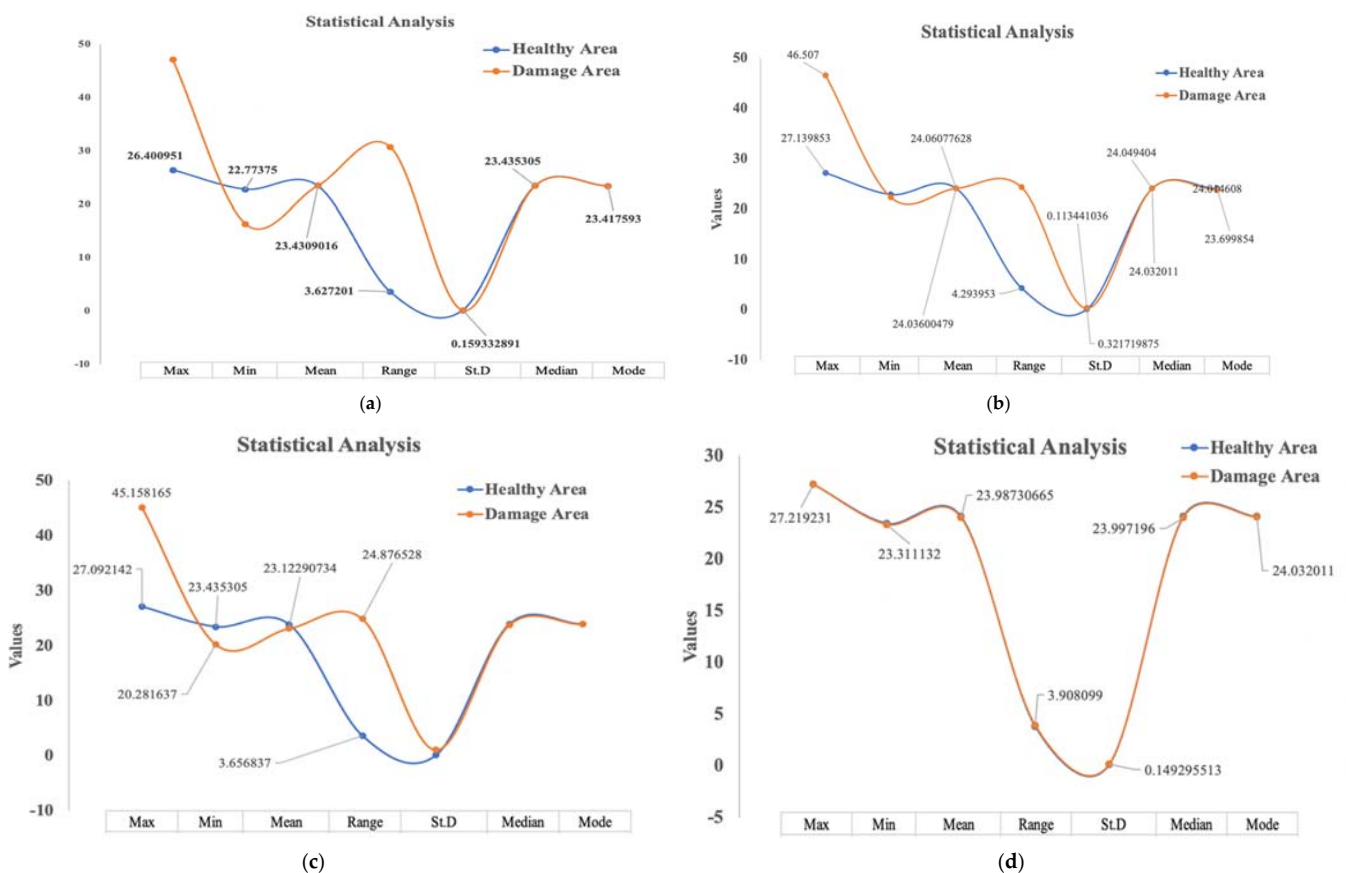
In this type of thermographic image of thin samples captured based on the reflection mode, the statistical analysis results showed the discrepancy in the final results between the healthy surfaces and the defective surfaces in terms of range rather than in terms of pattern. As shown in Table 6, the maximum value of the healthy surfaces was 26.4, while the value of the damaged surfaces was 47.13. Likewise, the minimum value for the healthy surfaces was 22.8, while the minimum value for the damaged surfaces was 16.4, and accordingly, these values were reflected in the range criterion. On the other hand, concerning the pattern of numerical values representing the image structure, the statistical analysis results showed a great convergence that is difficult to rely on in distinguishing the healthy surfaces from the damaged ones. Therefore, the statistical analysis method for this sort of thermal image captured based on the reflection mode is an effective method. Figure 12a depicts the curve of the statistical values of the healthy and damaged surfaces of the thin sample according to the reflection method.

**Figure 12.** Statistical Analysis results. (a) Healthy thin vs. damaged area based on reflection mode. (b) Healthy thick area vs. damaged area based on reflection mode. (c) Healthy thin area vs. damaged area based on transmission mode. (d) Healthy thick area vs. damaged area based on transmission mode.

With regard to the statistical analysis results for damage detection on thick samples based on reflection mode, the final results showed the possibility of detecting damage on the surfaces of the samples due to the variation in statistical criteria, whether in terms of range or pattern. As shown in Table 7, the maximum value of the healthy area was 27.14, while the maximum value of the damaged area was 46.16, and the minimum values were 23.43 and 20.28 for the healthy area and the damaged area, respectively. Therefore, this difference between the maximum and minimum values was reflected in the value of the range criterion. In addition, the values of the standard deviation and the mode values were different, as shown in Table 7, and this difference in the values of the statistical results enabled us to distinguish the damaged surfaces compared to the healthy surfaces. Figure 12b visualizes the statistical results.

This section will discuss the statistical analysis results of the numerical values of thermal images of thin samples captured based on the transmission mode. As shown in Table 8, the discrepancy was evident in four statistical criteria, which are the maximum, minimum, and range, as well as the standard deviation, which indicates the possibility of detecting the damaged areas in this sample type based on the statistical analysis method despite the convergence in the other statistical criteria, such as the (mode) value, where the value approximated in the healthy and damaged areas statistically. However, due to the significant difference in the maximum, minimum and range values, we were able to distinguish the damaged areas from the healthy areas. Figure 12c illustrates the statistical results of this case.

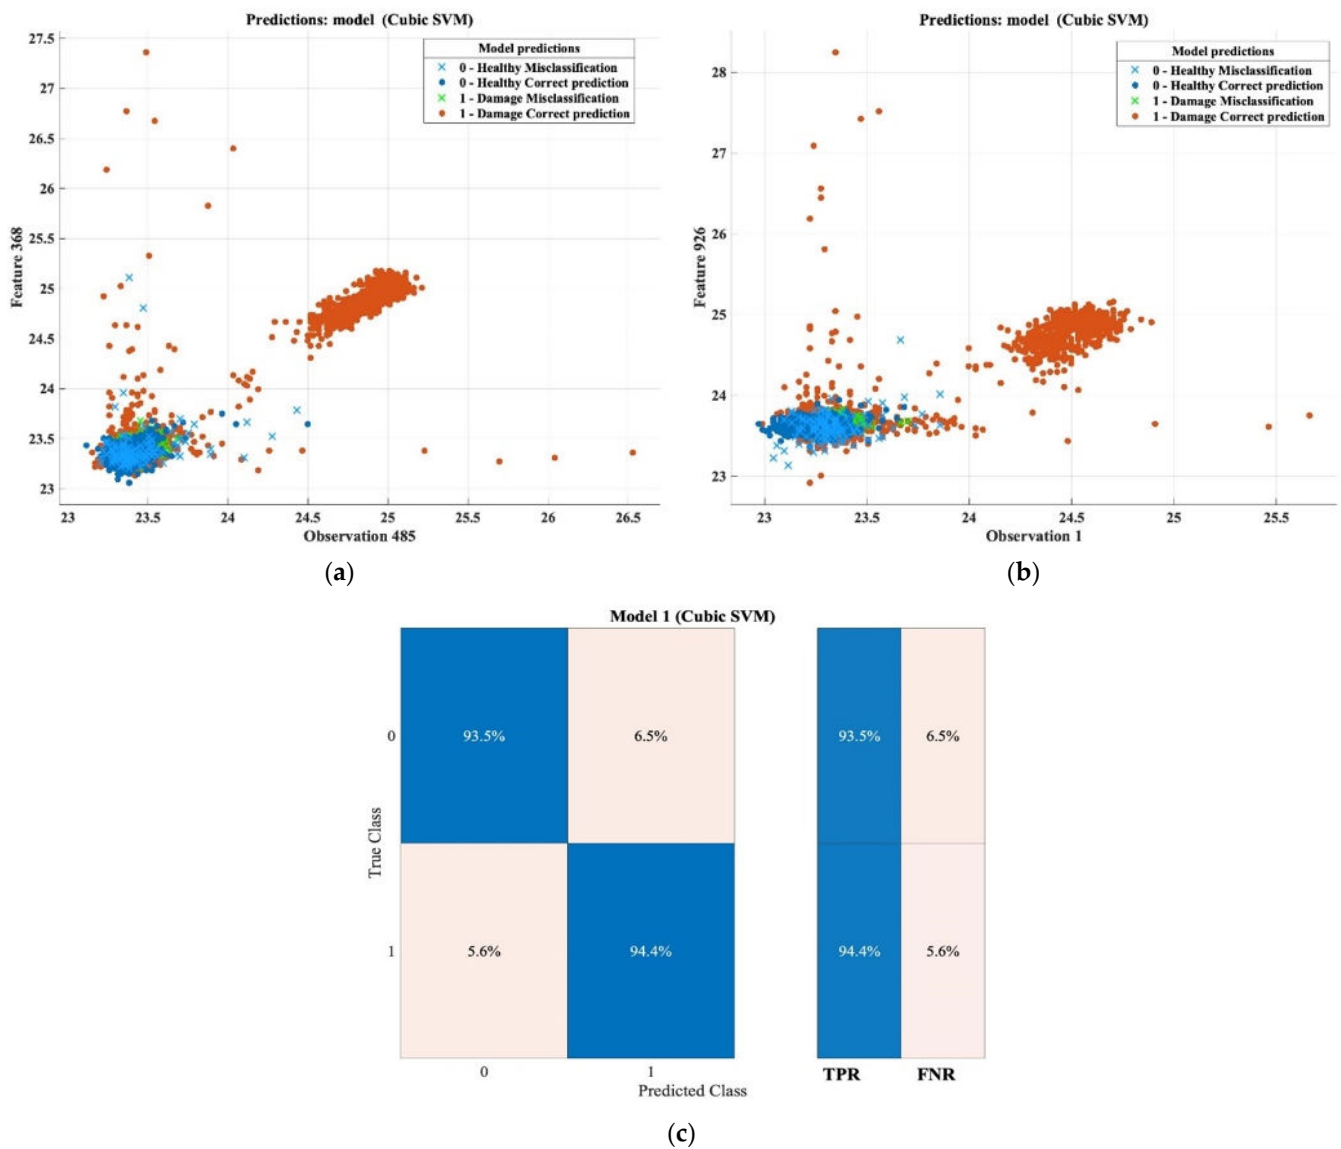
In reflection mode, the accuracy of prediction in detecting damaged reached 93%, with 189 misclassifications for thin samples. Figure 13 shows the features' patterns of the thermal images, and the healthy area versus the damaged area. The confusion matrix also shows the final results of prediction accuracy, where the accuracy of predicting a damaged area against a healthy area according to the true positive ratio (TPR) was 93.5%, with a false-negative ratio (FNR) rate of 6.5%, while the accuracy of determining the defective area based on the TPR was 94.4%, and the FNR was 5.6%. Overall, this high rate of detection accuracy proves the effectiveness of this method in detecting damage on the composite components of aircraft based on the pulsed thermography method and the machine learning classification technique, which paves the way toward building an automated approach to damage detection based on non-destructive testing (NDT). Table 13 summarizes the classification results.

**Figure 13.** Classification results and confusion matrix for thin samples based on reflection mode. (a) Feature patterns of classification results of the cubic SVM model (Observation 485 vs. Feature 368). (b) Feature patterns of classification results of the cubic SVM model (Observation 1 vs. Feature 926). (c) Confusion matrix.

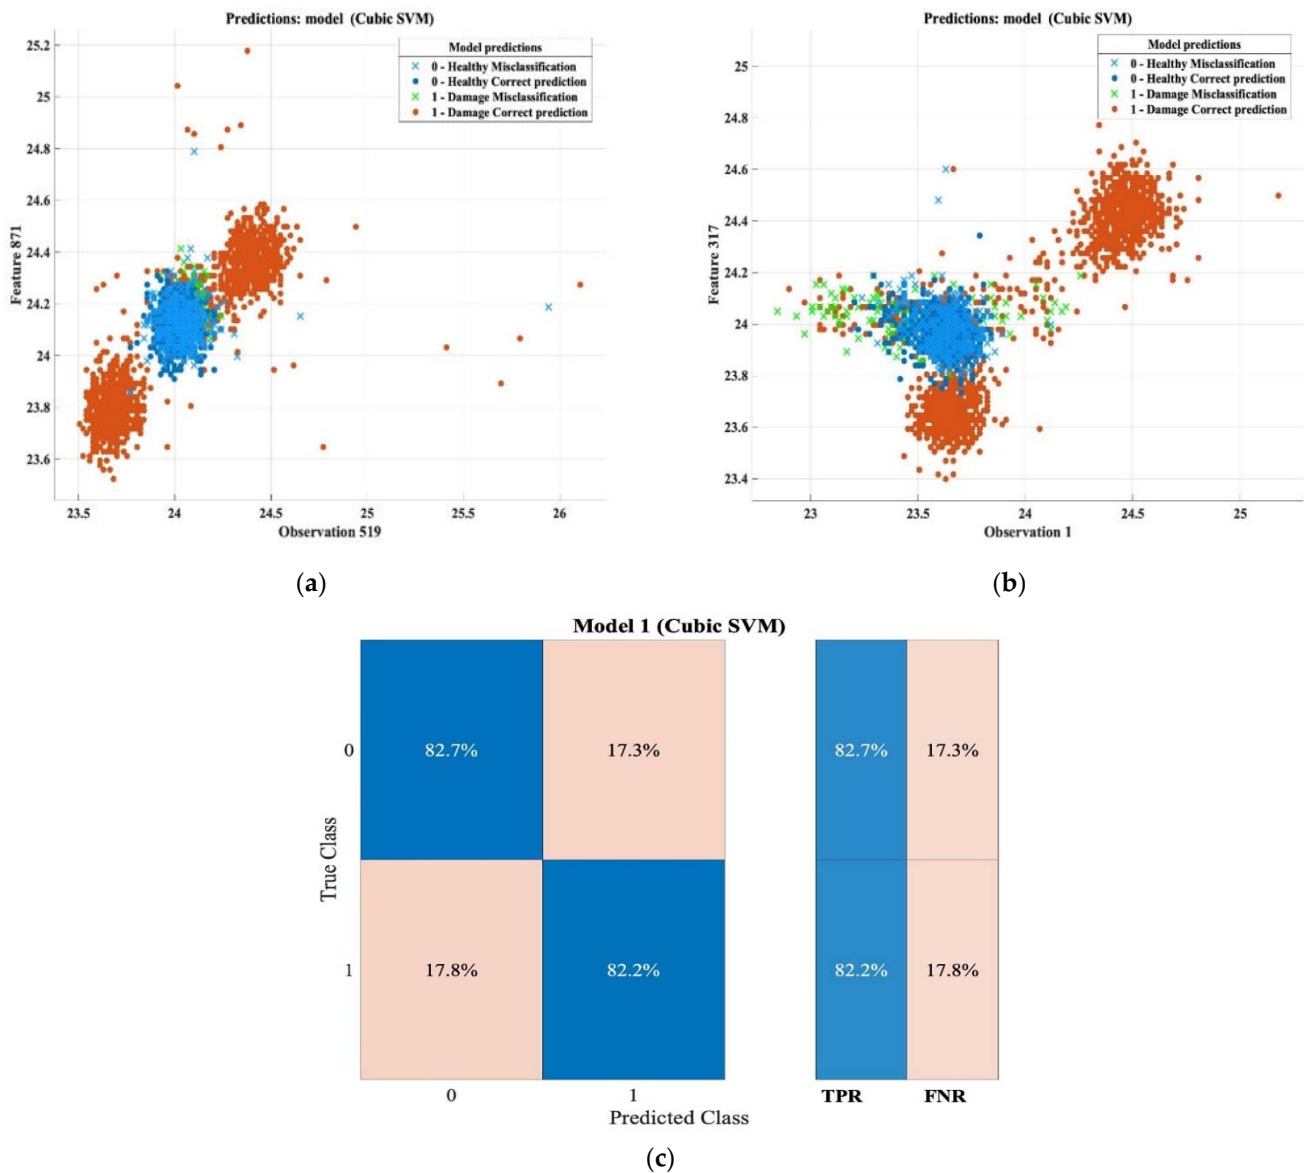
Regarding the prediction accuracy for detecting the damaged area in the thick samples according to the reflection method, the accuracy of the detection, in general, was globally 82.1%. Figure 14 depicts the characteristic patterns of the thermal images that were captured. As shown in the confusion matrix, the true positive ratio (TPR) and the false-negative ratio reached 82.2% and 17.8% respectively, and the total misclassification cost was 521. The final results of the training session are presented in Table 14.

**Figure 14.** Classification results and confusion matrix for thick samples based on reflection mode. (a) Feature patterns of classification results of the cubic SVM model (observation 519 vs. feature 871). (b) Features patterns of classification results of the cubic SVM model (observation 1 vs. feature 317). (c) Confusion matrix.

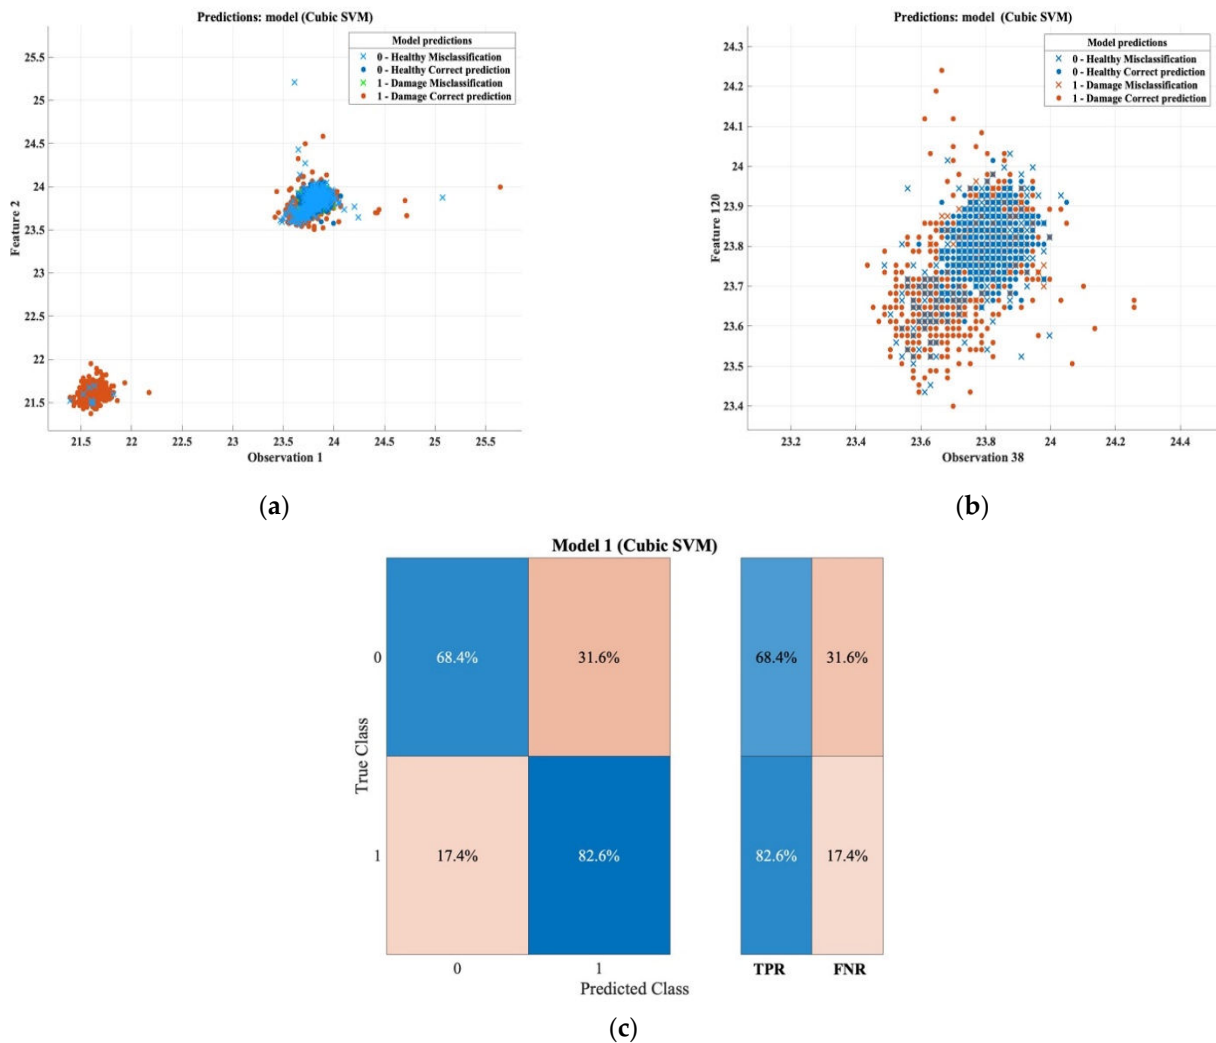
Moving on to the results that represent the damage detection for the thin samples in transmission, the overall prediction accuracy was 79.4%, the total cost of the misclassification was 462, and, in more detail, based on the confusion matrix, the true positive ratio percentage in determining the defective area was 82.6%, meaning that only 17.4% represents the true negative ratio percentage, which means that 17.4% of the defective

**Figure 15.** Classification results and confusion matrix for thin samples based on transmission mode. (a) Features patterns of classification results of the cubic SVM model (observation 1 vs. feature 2). (b) Features patterns of classification results of the cubic SVM model (observation 38 vs. feature 120). (c) Confusion matrix.

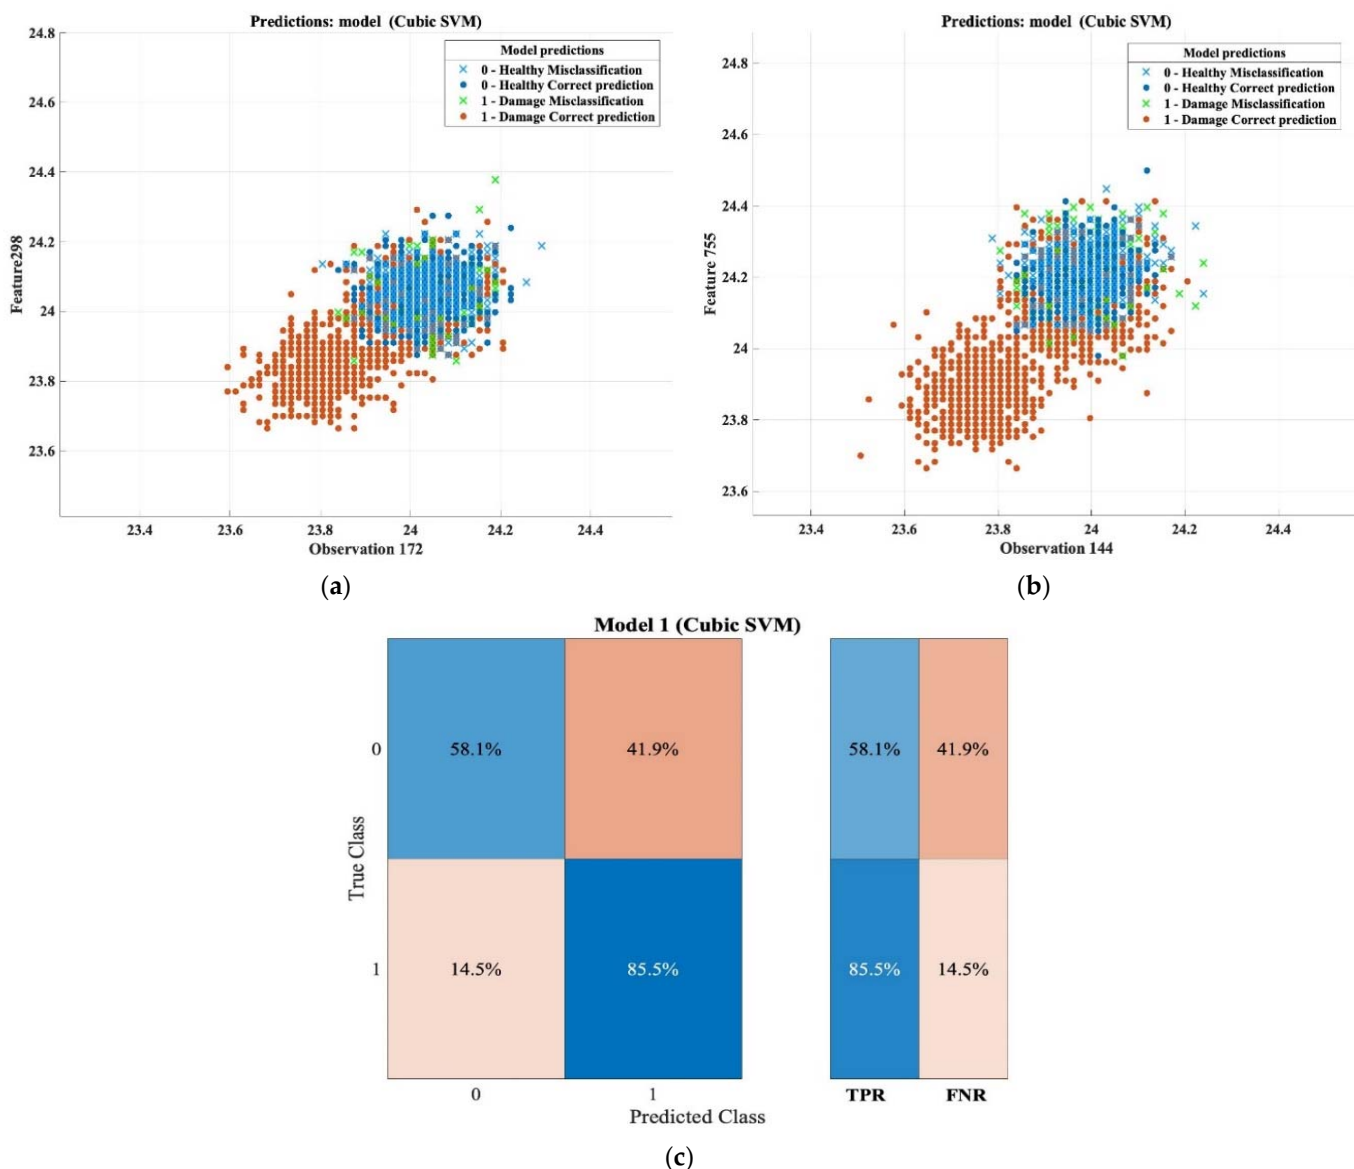
Regarding the results of predicting the damaged area in the thick samples whose thermal images were taken based on the transmission method, the overall prediction accuracy was 78.7%. The following confusion matrix summarizes the ratios of true positive and true negative, where the TPR reached 85.5% in terms of detecting the damaged area, and the FNR percentage was only 14.5%, while the total misclassification cost was 477. The

overall accuracy percentage, in this case, was the lowest percentage among other cases, but 78.7% is a good percentage that can be relied upon for detecting the damaged area in the thick composite components based on the transmission method. Table 16 and Figure 16 conclude the final outcomes of the machine learning analysis.

**Figure 16.** Classification results and confusion matrix for thick samples based on transmission mode. (a) Features patterns of classification results of the cubic SVM model (observation 172 vs. feature 298). (b) Features patterns of classification results of cubic SVM model (observation 144 vs. feature 755). (c) Confusion matrix.
