**Prediction of the Onset of
Detectable Multiple Site Damage in a
RAF VC10 Circumferential Butt Joint using Extended
Fatigue Specimen Testing of Retired Fuselage Structure**

MSc Thesis

School of Engineering
Department of Power Propulsion and Aerospace Engineering

Academic Year 2003/2004

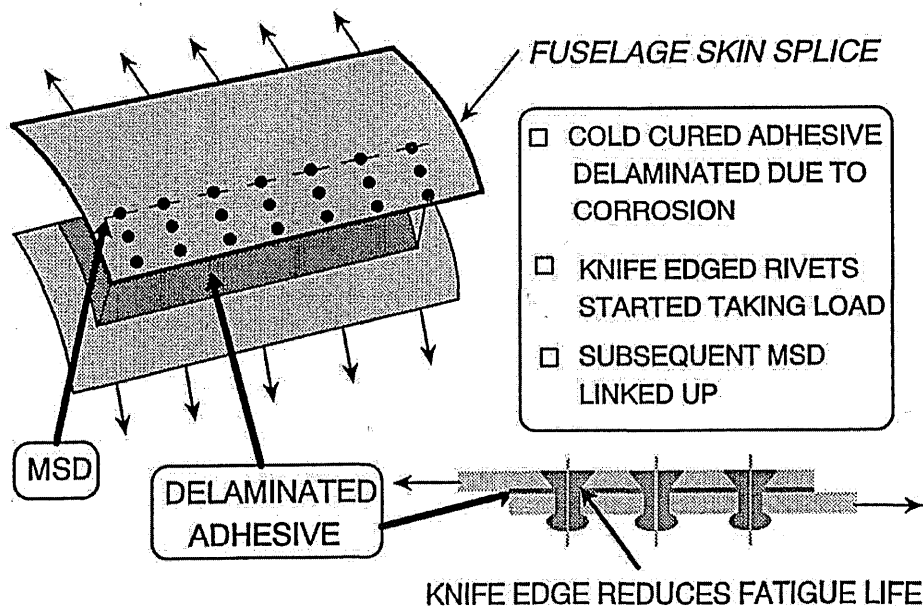
Figure 2-2: Probable Cause of Aloha 737 Accident (Reference 8)

on the left hand side of the aircraft. The rivets had been installed in knifed edged countersink holes, which have a notoriously poor fatigue life. The skin panels had, however, been bonded together at the joint using a cold cure adhesive. The purpose of the adhesive in the design of the joint was to reduce the bearing load on the rivets. Unfortunately, the joint began to delaminate due to corrosion of the metal in the faying surface of the joint and the rivets then had to react the hoop tension loads due to cabin differential pressure. This accelerated the onset of MSD and the cracks eventually linked up into a critical crack leading the catastrophic failure of the fuselage as illustrated at Figure 2-2.

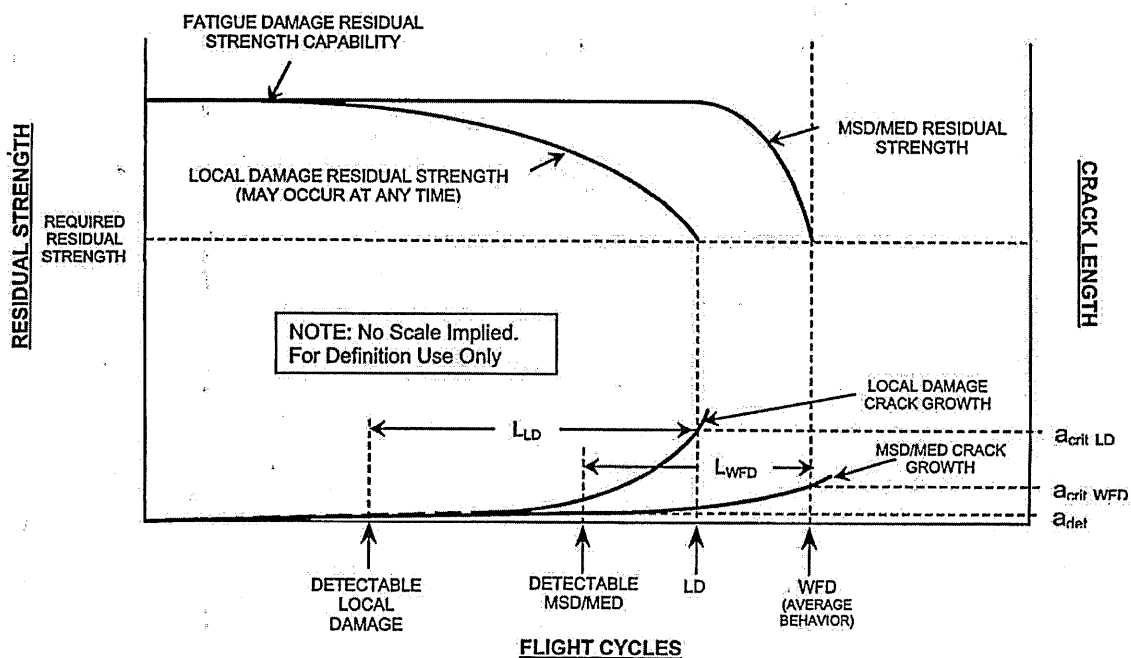
Figure 2-3: Difference Between Local Damage Behaviour and MSD/MED Behaviour for a Typical Detail (Reference 3)

The continued operation of aircraft beyond their service life goal exposes the airframe to the formation of WFD. The effect of MSD, in comparison to local damage single crack growth, is illustrated in Figure 2-3. The presence of MSD adjacent to a lead crack in a typical airframe detail drastically reduces the residual strength of the detail. The drop of the residual strength from the capability of the intact structure to the capability required to withstand the design loads occurs in a much shorter time compared with that of the single crack. This factor together with the reduced critical crack length ($a_{crit LD}$ in comparison to $a_{crit WFD}$) results in a significantly reduced crack growth period between the detectable and critical situation (L_{LD} in comparison to L_{WFD}).

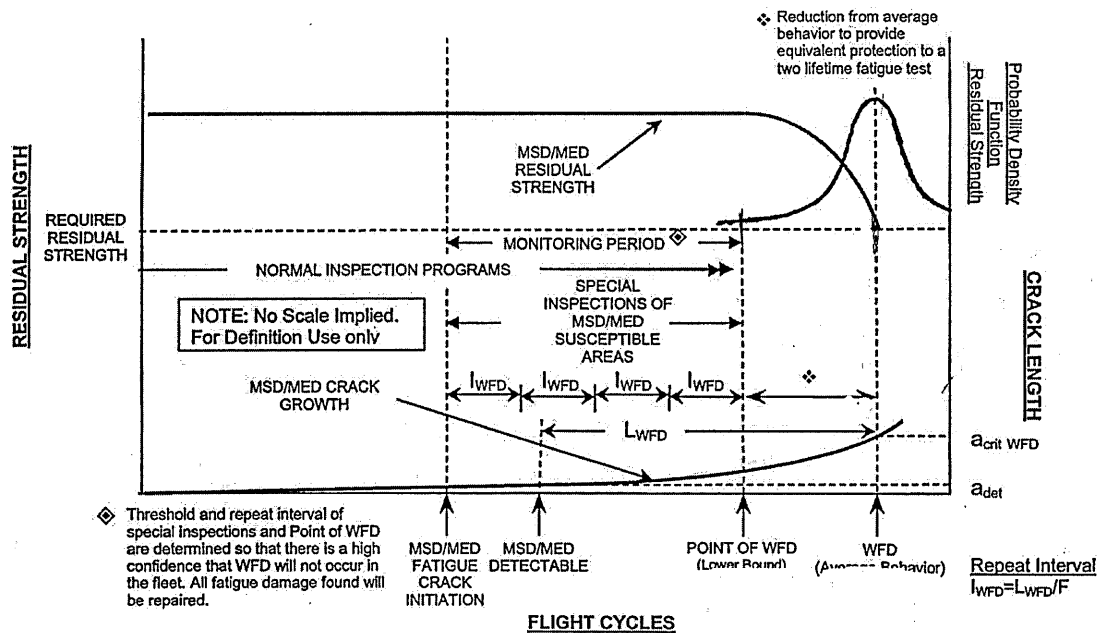
Figure 2-4: Determining the Monitoring Period (Reference 3)

For structure where the MSD/MED situation is reliably detectable before it becomes critical a monitoring period may be defined and applied before other means have to be taken, as illustrated at Figure 2-4. The monitoring period is the period of time when special inspections of the fleet are initiated due to the increased risk of MSD/MED and ending when the point of WFD is reached. The point of WFD is derived from the average expected behaviour. Beyond this point the aircraft may not be operated without further evaluation. The point of WFD is established so that operation up to that point provides the equivalent protection to that of a 2-lifetime fatigue test. Repeat inspection intervals are established based on the length of time from detectable fatigue cracks to the average WFD divided by a factor. Several opportunities must be provided to detect cracking between fatigue initiation and the Point of WFD (L_{WFD}).

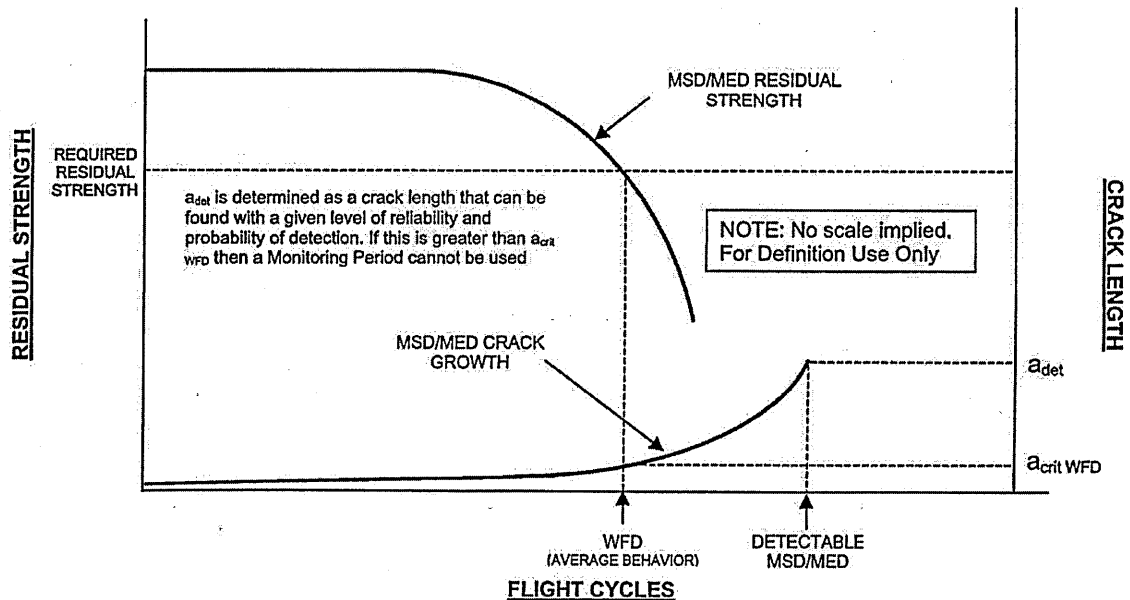
Figure 2-5: Condition Where Monitoring Period Cannot Be Used (Reference 3)

For situations where it is not possible to reliably detect MSD/MED before it becomes critical, as detailed at Figure 2-5, the aircraft may not be operated beyond the point of WFD without significant modification or part replacement.

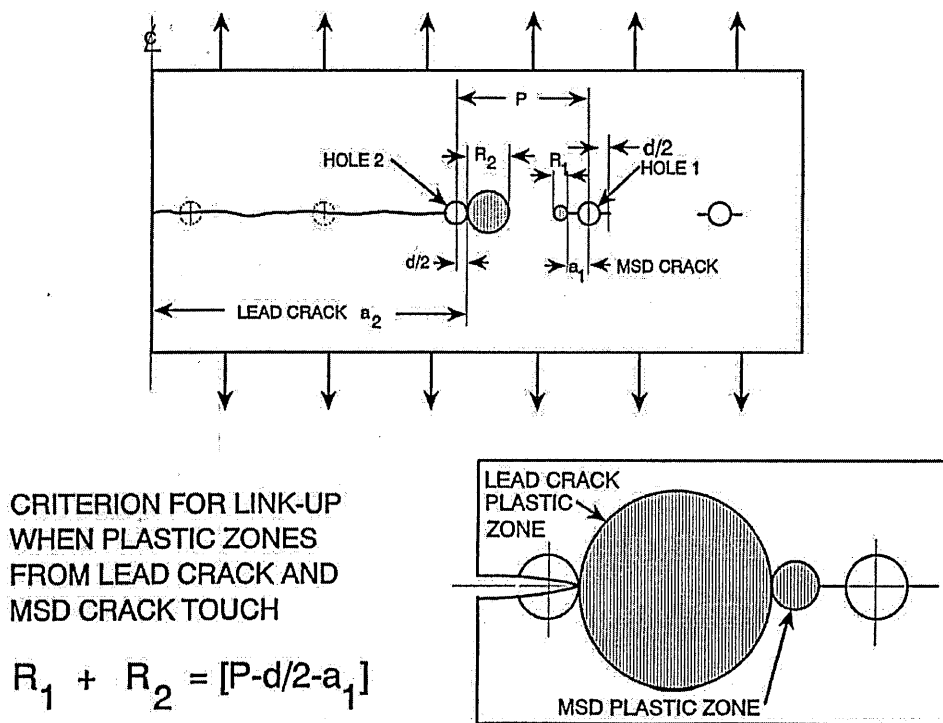
Figure 2-6: MSD & Lead Crack Link-up Criterion (Reference 2)

A considerable amount of research, as detailed below, has been conducted to determine how MSD causes the residual strength of the structure to decrease as detailed above. For ductile alloys, such as those used in airframe construction, Reference 2 explains this phenomenon by assuming that the link-up of the lead crack with the MSD crack will occur when the intact ligament stress between the 2 crack tips reaches the typical yield strength of the material. This leads to the intuitive link-up criterion illustrated at Figure 2-6. As the loads increase the plastic zones R_1 and R_2 will increase until they touch. Reference 2 then postulates that the link-up of the 2 cracks will occur when the 2 plastic zones touch. This approach is not considered analytically perfect but appears to be accurate enough to be able to make some judgements of the effect of MSD on lead crack residual strength.

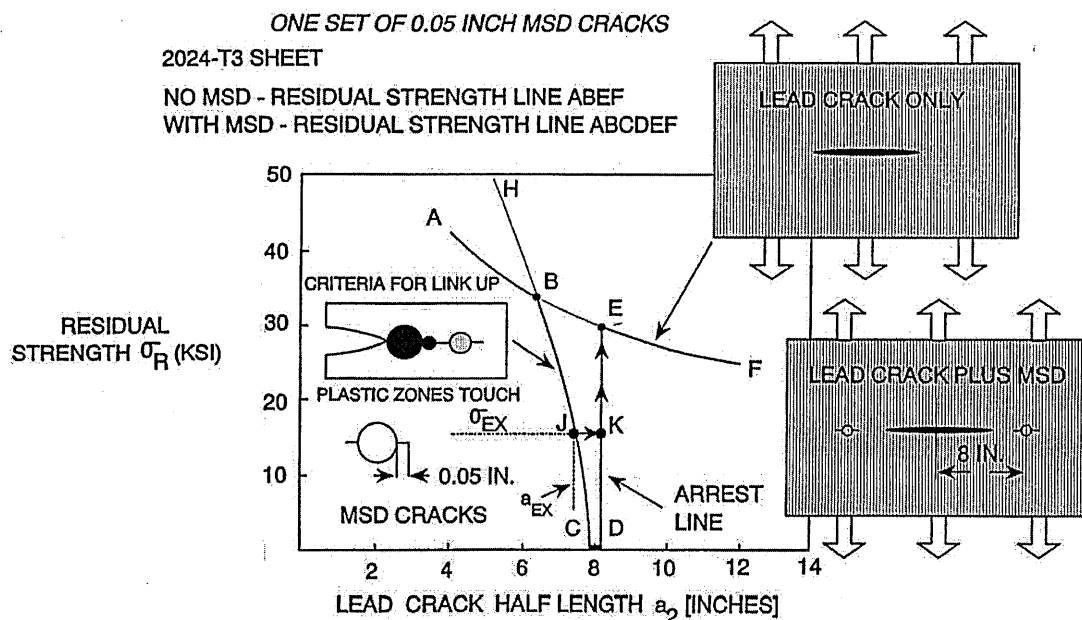
**Figure 2-7: Effect of MSD on Lead Crack Residual Strength
(single MSD crack either side of lead crack)
(Reference 2)**

σ_{EX} then the lead crack and the MSD crack would link up to a new lead crack half-length of K. The residual strength of the new crack is, however, at point E and the load would need to be increased to point E before failure. This means that the residual strength for any lead crack of half-length greater than E would automatically be reduced to point E in the presence of a single MSD crack.

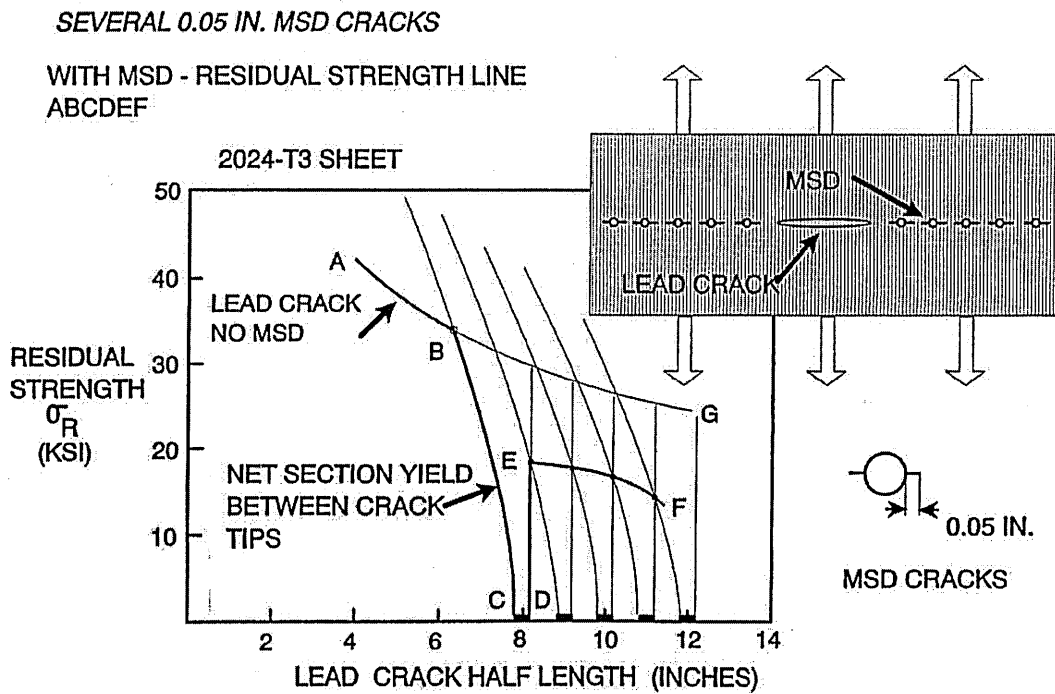
**Figure 2-9: Effect of MSD on Lead Crack Residual Strength
(several MSD cracks either side of lead crack)
(Reference 2)**

If the process is continued by adding MSD cracks, Reference 2 hypothesizes that after 4 or 5 MSD cracks the residual strength does not recover after link-up of the first crack. Figure 2-9 illustrates the case for 5 MSD cracks ahead of the lead crack. It can be seen that the residual strength for any lead crack half-length beyond point B will be reduced to point E.

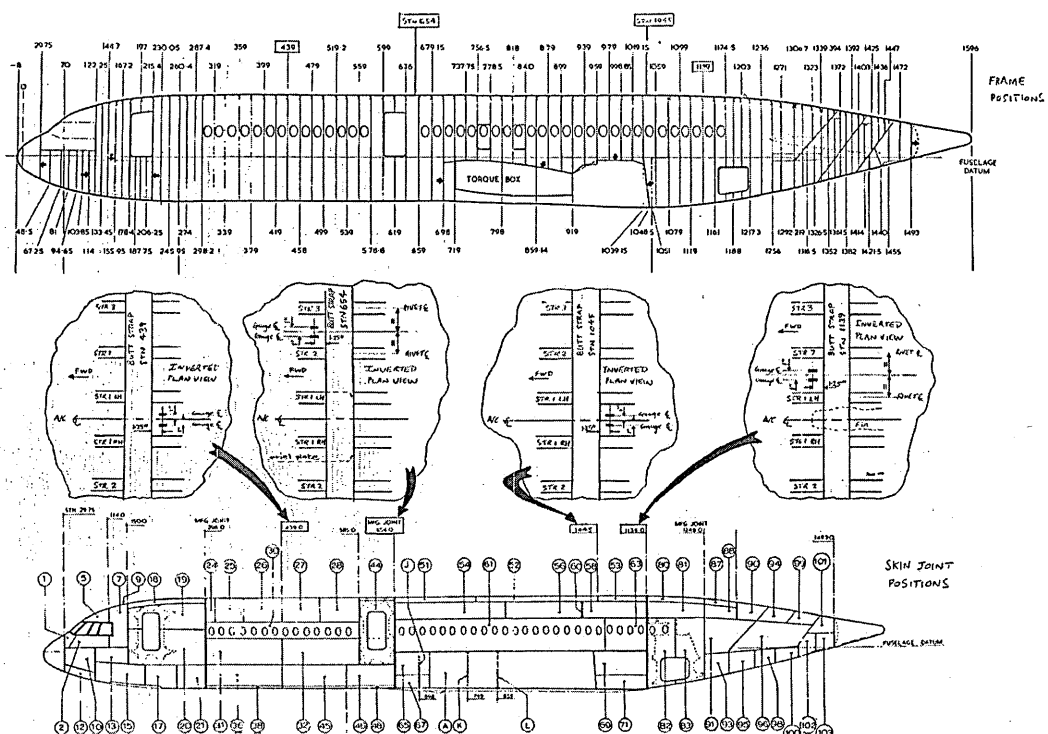
Figure 3-5: Location of Strain Gauge Bridges for Fuselage Butt Strap OLM Programme

To validate the DT analysis described above, various Operational Load Measurement (OLM) Programmes have been conducted on RAF VC10 since 1986. The Programmes essentially involve fixing strain gauges to the areas of the airframe under evaluation and recording the loads experienced by the structure for numerous flight cycles. One such OLM Programme included the instrumentation of the fuselage crown of a RAF VC10 K Mk2 as detailed at Figure 3-5.

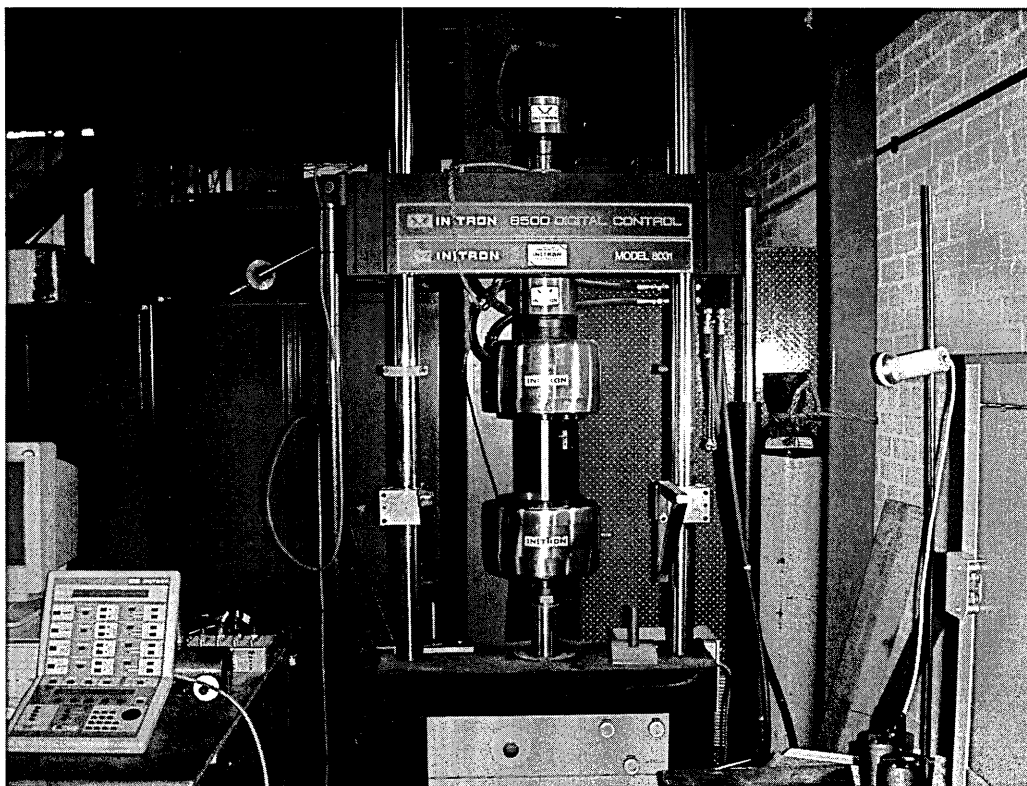
Figure 4-8: 50KN Uniaxial Instron Test Facility

The specimens were fatigue tested using a uniaxial digitally controlled 50KN Instron Test Facility as shown in Figure 4-6. The minimum applied load to the specimens was established as being 2.64KN and the average test load was 2.96KN, which are both below the recommended 10% of the maximum capability of the test machine. Ideally a lower capacity machine should have been used to test the specimens however, no other test machines were available and any induced errors would be minimised by the machine's digital control unit. No major problems were encountered during the tests but the machine did stop during some of the initial 2.64KN tests. The problem was resolved by recalibrating the test machine each time a new specimen was placed in the machine. All constant amplitude fatigue tests were conducted at 10Hz but planned variable amplitude tests could only be conducted at 6Hz due to the testing being at the lower capacity of the machine.

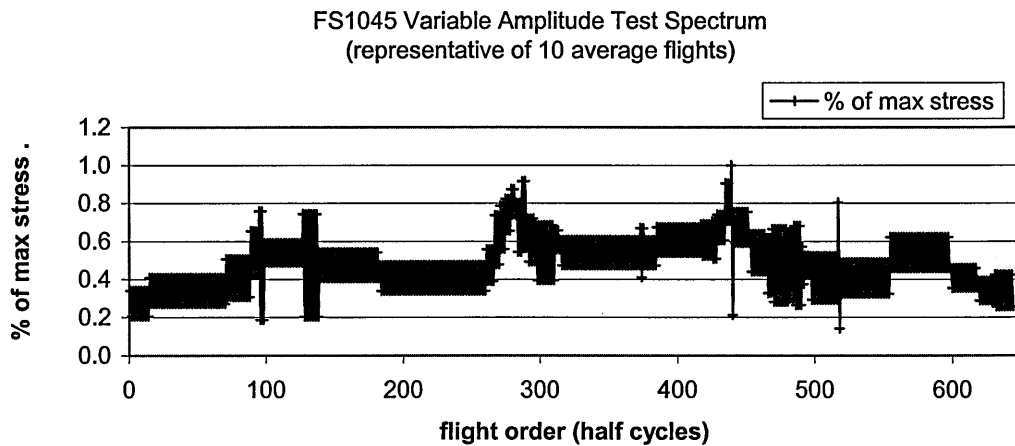
Figure 4-9: Variable Amplitude Test Spectrum

Operational longitudinal stresses at the FS1045 circumferential butt joint were obtained from an Operational Loads Measurements (OLM) Programme, detailed at Chapter 3, on a RAF VC10 KMk2. The fuselage stresses were obtained for various different Sortie Profile Codes (SPCs) including taxiing, take-off and landing and were then subjected to rainflow cycle counting analysis. Each sortie was then weighted accordingly to produce a spectrum that was representative of a typical RAF VC10 KMK2 flight. The spectrum was provided in order of magnitude only and was therefore rearranged, as detailed at Appendix A, to produce a typical flight spectrum with a more representative stress distribution. To simplify the analysis and to produce as realistic a spectrum as possible the final spectrum used amalgamated the average fatigue damage encountered for 10 flights into one spectrum as illustrated at Figure 4-9.

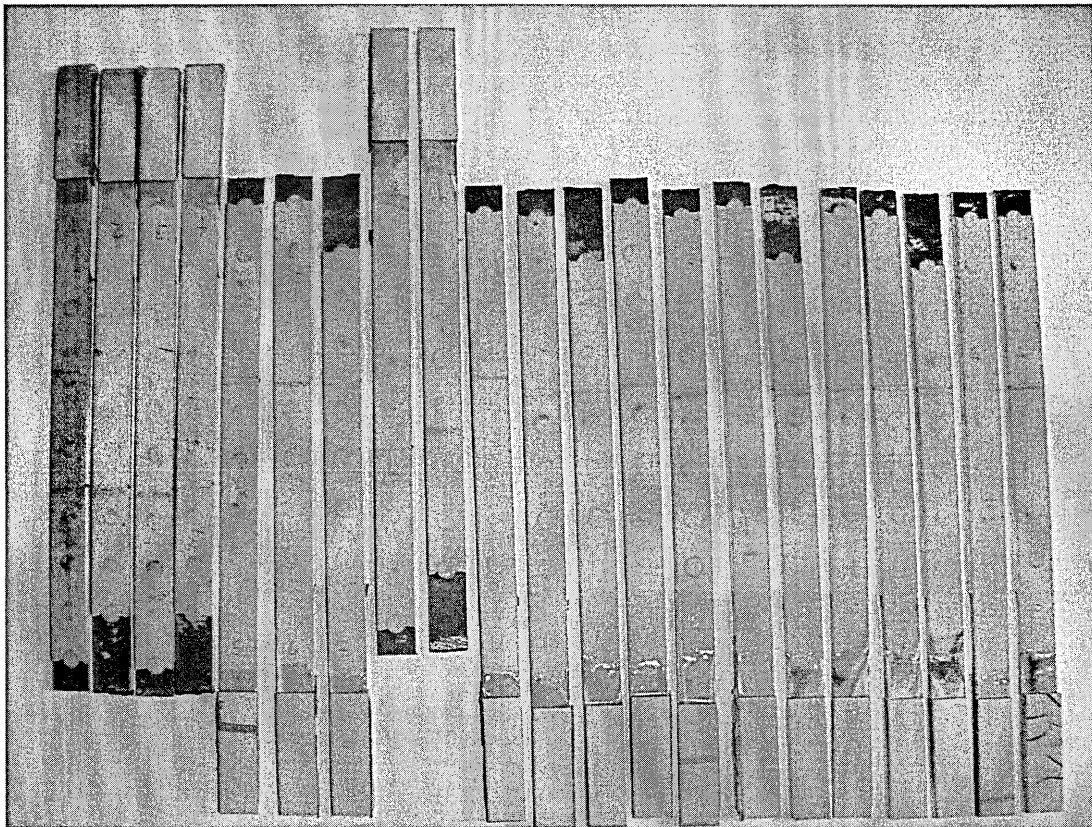
Figure 4-10: Tested Specimens (Forward Orientation at Top)

A total of 25 specimens were prepared for extended uniaxial fatigue testing of which 23 were tested using various constant amplitude loads. The remaining 2 specimens were due to be tested using the variable amplitude load spectrum, identified above, but there was insufficient time in which to complete these tests.

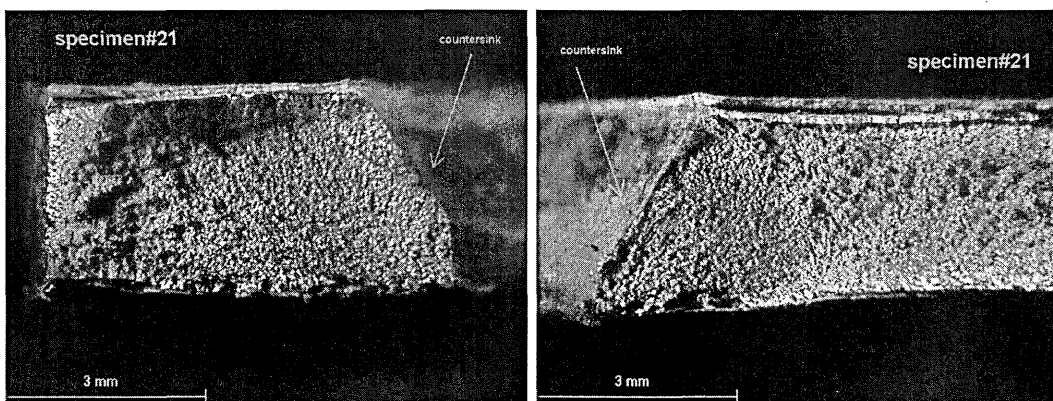
**Figure 4-13: Fracture Surfaces - Specimen#21
(both sides of countersink hole)**

All of the failed specimen fracture surfaces were examined using a microscope paying particular attention to the region of crack initiation. It was observed that, for all of the specimens that failed along the outer most rivet of the butt joint, a fatigue crack had initiated from the high stress concentration region at the tip of the countersink, as shown at Figure 4-13 & 4-14. The fatigue crack length varied but the average was approximately 3.5mm before the onset of fracture. Full details and images, at various magnifications, of the fracture surfaces of each specimen are provided at Appendix B.

Specimen#21 took 103485 constant amplitude test cycles to fail at a maximum load of 2.96KN. Fatigue cracks initiated at the tip of the countersink and propagated to approximately 3.5mm before the specimen fractured.

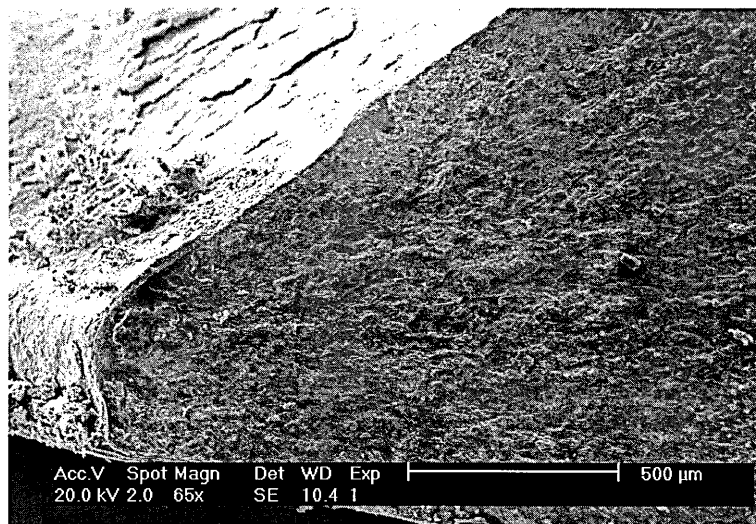
Figure 4-17: SEM Image of Specimen#9 Fracture Surface

From the observations made using the microscope, 6 specimens, that showed the most evidence of possible corrosion pitting, were selected for examination using the Scanning Electron Microscope (SEM). The SEM analysis identified the presence of predominantly 3 different mechanisms of fracture; ductile fracture, fatigue and a mixture of ductile and fatigue fracture. All 6 specimens showed signs of pre-existing defects and all of them also had small (50 microns) amorphous regions characteristic of the presence of corrosion as detailed at Figures 4-17 & 4-18 below.

Evidence of pre-existing fatigue and amorphous regions along the edge of the countersink

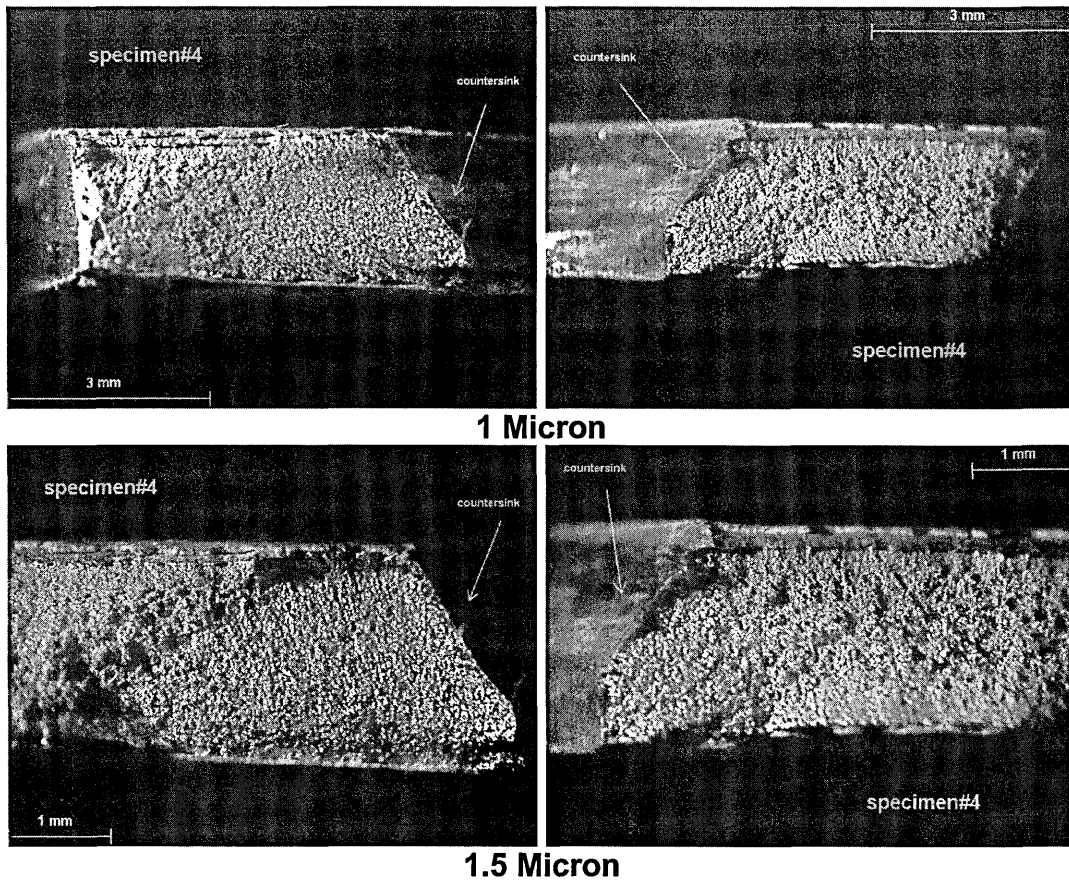
Specimen#4 (6-Rivets) took 36945 constant amplitude test cycles to fail at a maximum load of 3.7KN (R=0.2). The fatigue crack initiated at the tip of the countersink and propagated to approximately 3mm before the specimen fractured. There is evidence of a pre-existing fault at the extreme tip of the countersink.

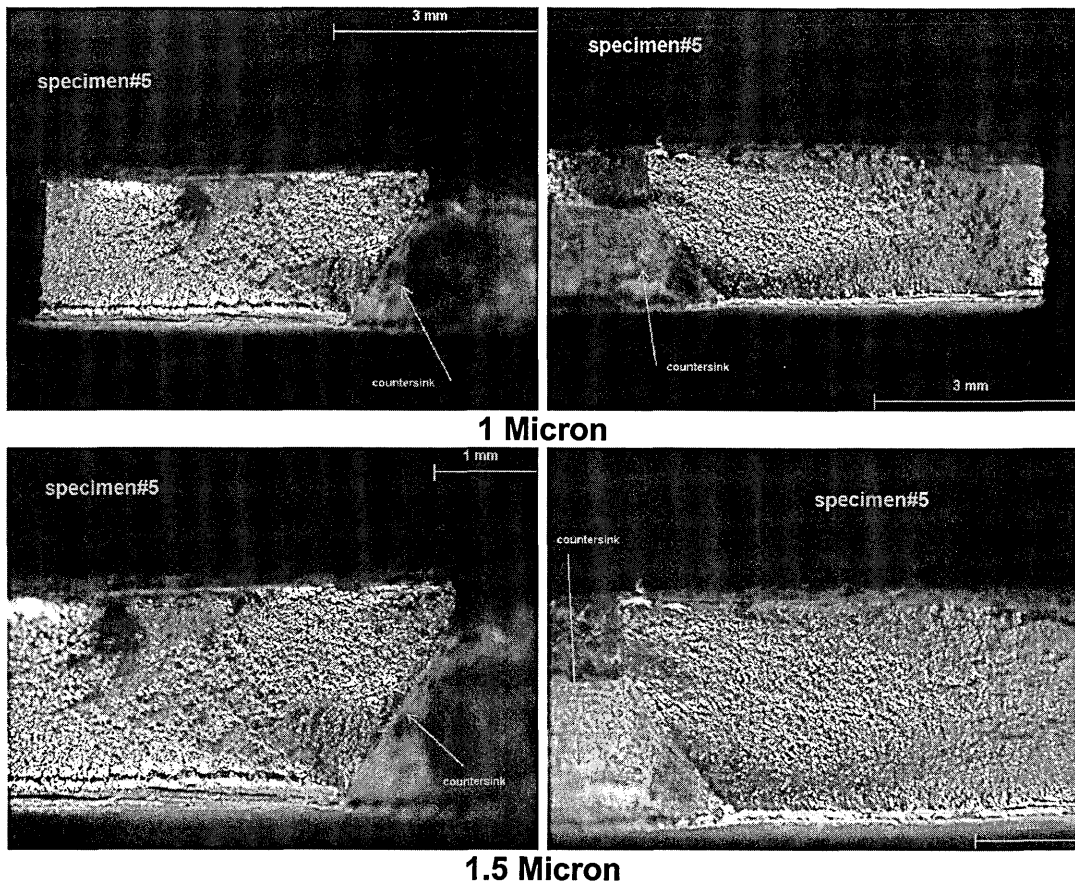
Specimen#5 (8-Rivets) took 83067 constant amplitude test cycles to fail at a maximum load of 3.0KN (R=0.2). The fatigue crack initiated at the tip of the countersink and propagated to approximately 3mm before the specimen fractured. There is evidence of small defects at the extreme tip of the countersink.

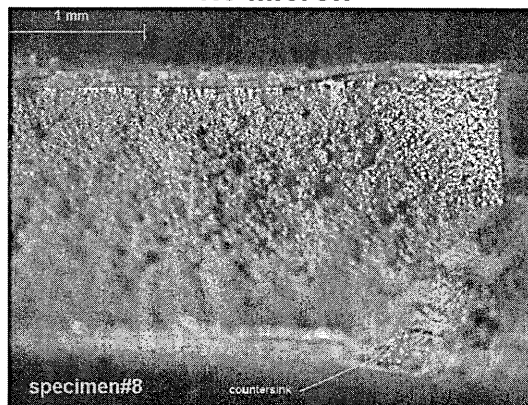
2 Micron

Specimen#8 (8-Rivets) took 147549 constant amplitude test cycles to fail at a maximum load of 2.6kN (R=0.2). The fatigue crack initiated at the tip of the countersink and propagated to approximately 4.5mm before the specimen fractured.

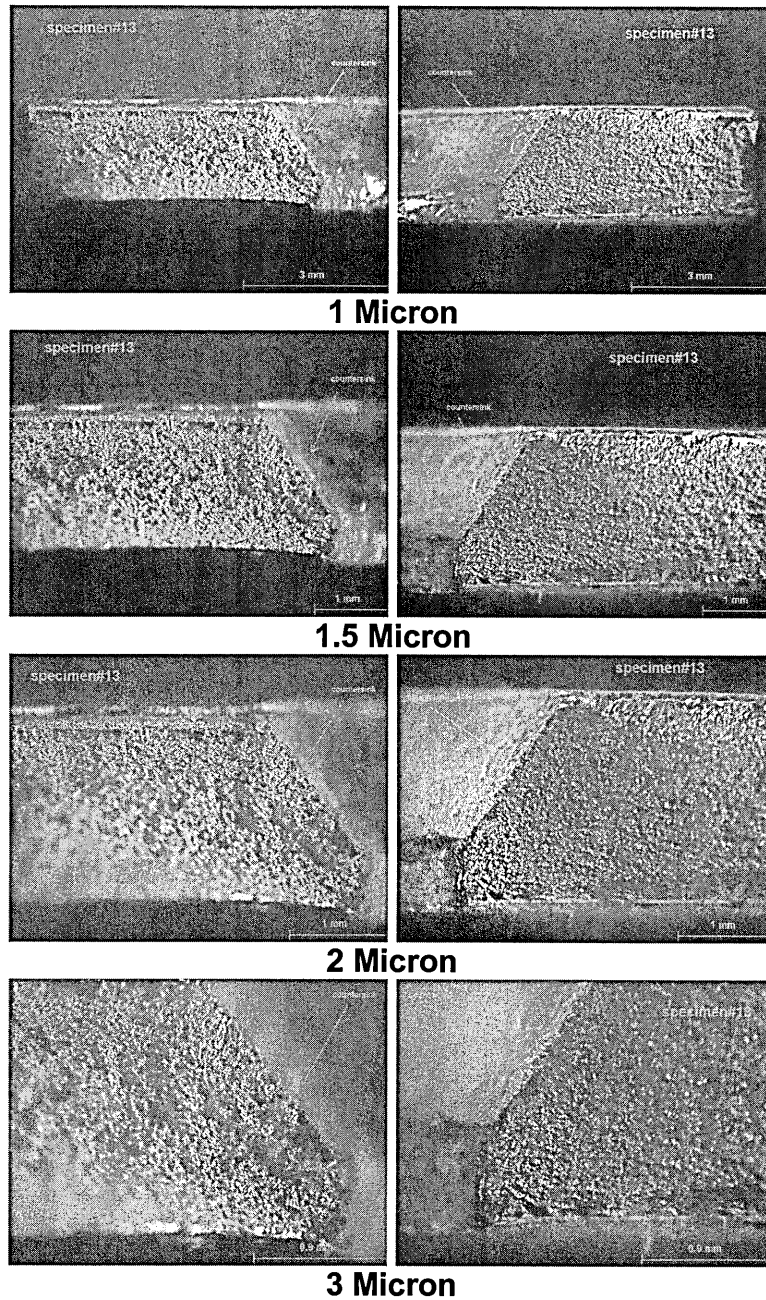
Specimen#13 (8-Rivets) took 47653 constant amplitude test cycles to fail at a maximum load of 3.0KN (R=0.2). The fatigue crack initiated at the tip of the countersink and propagated to approximately 3mm before the specimen fractured. At high magnification there is evidence of small defects at the extreme tip of the countersink.

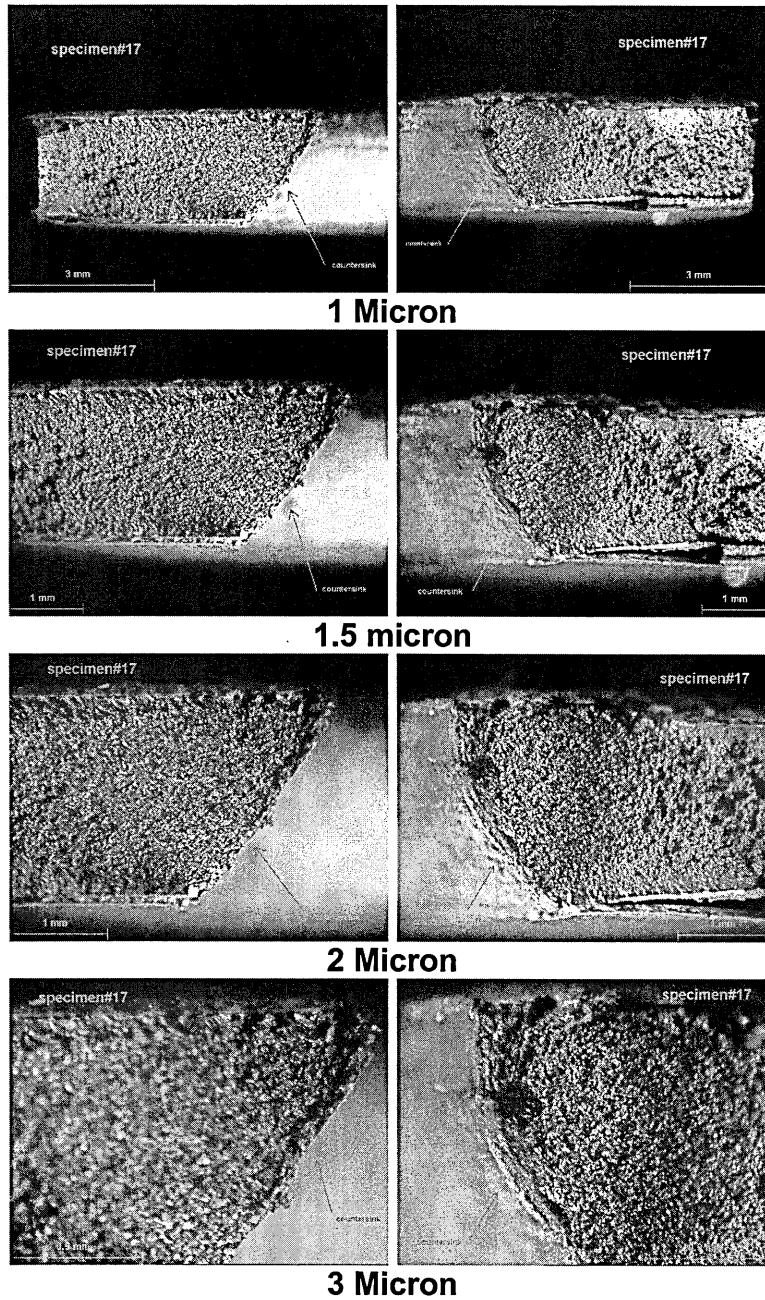
Specimen#17 (6-Rivets) took 223780 constant amplitude test cycles to fail at a maximum load of 3.0KN (R=0.2). The fatigue crack initiated at the tip of the countersink and propagated to approximately 3.5mm before the specimen fractured. At high magnification there is evidence of small defects at the extreme tip and edge of the countersink.

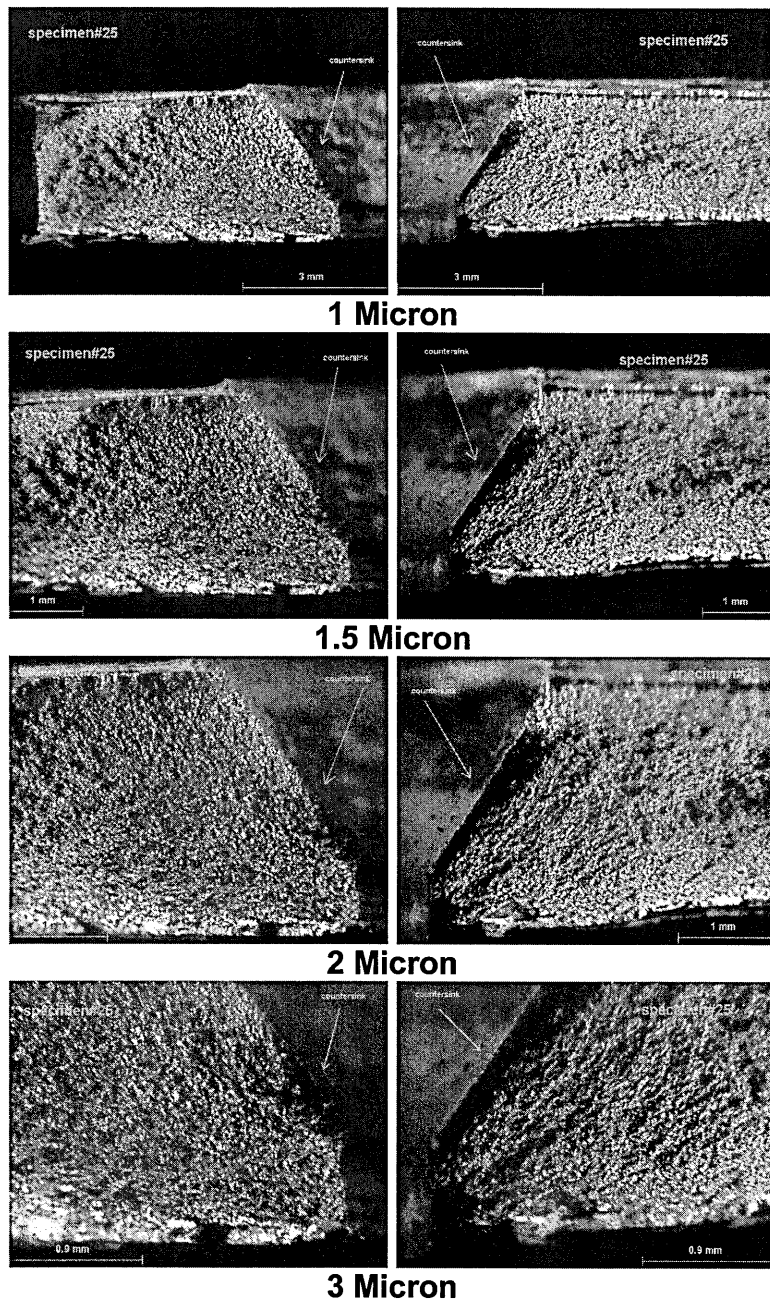
Specimen#25 (8-Rivets) took 50168 constant amplitude test cycles to fail at a maximum load of 3.0KN (R=0.2). The fatigue crack initiated at the tip of the countersink and propagated to approximately 4mm before the specimen fractured. At high magnification there is evidence of small defects at the extreme tip and edge of the countersink

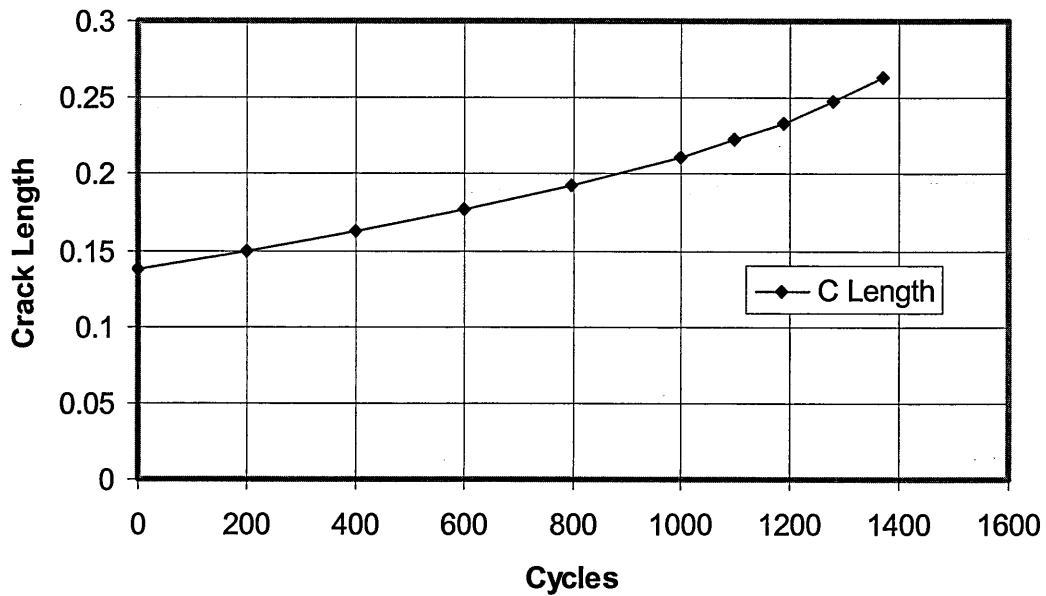
double corner crack at hole (Crack C Length vs. Cycles)
