CRANFIELD UNIVERSITY

*Investigating dependencies between laser drilling process parameters,  
recast layer thickness and corrosion-fatigue life for turbine vane cooling  
film holes*

Doctor of Philosophy (PhD)

July 2017

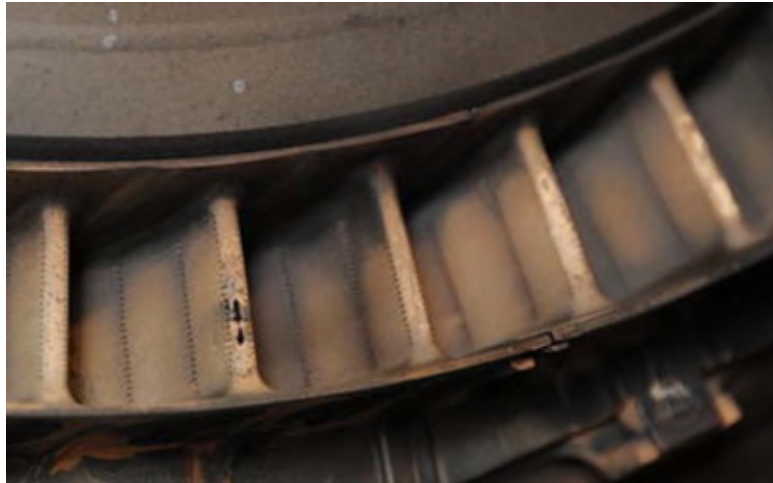
**Figure 2-3. Photograph of thermal cracking and overheating in nozzle guide vanes (Mishra, Johney, *et al.*, 2014).**

Damages arising during service in aeroengines may result from operating engine conditions and/or service environment (Carter, 2005), such as aerodynamic excitations, combustion instabilities, mechanical vibrations, rotor imbalance (Cowles, 1996), hot corrosion (Eliaz, Shemesh and Latanision, 2002a), and foreign object damage (Chen, 2005). The root cause of failure of an LP turbine blade by thermal-mechanical fatigue in a low bypass turbofan engine was analysed (Mishra, Johney, *et al.*, 2014). Forensic and metallurgical investigations results revealed that the blade surface experienced heavy oxidation, making it weak, more brittle, and prone to crack initiation. High thermal cyclic loading and high mechanical stresses due to high throttle excursion contributed to blade failure. Furthermore, affected overheating, burns and erosion in HP nozzle guide vanes (see Figure 2-3).

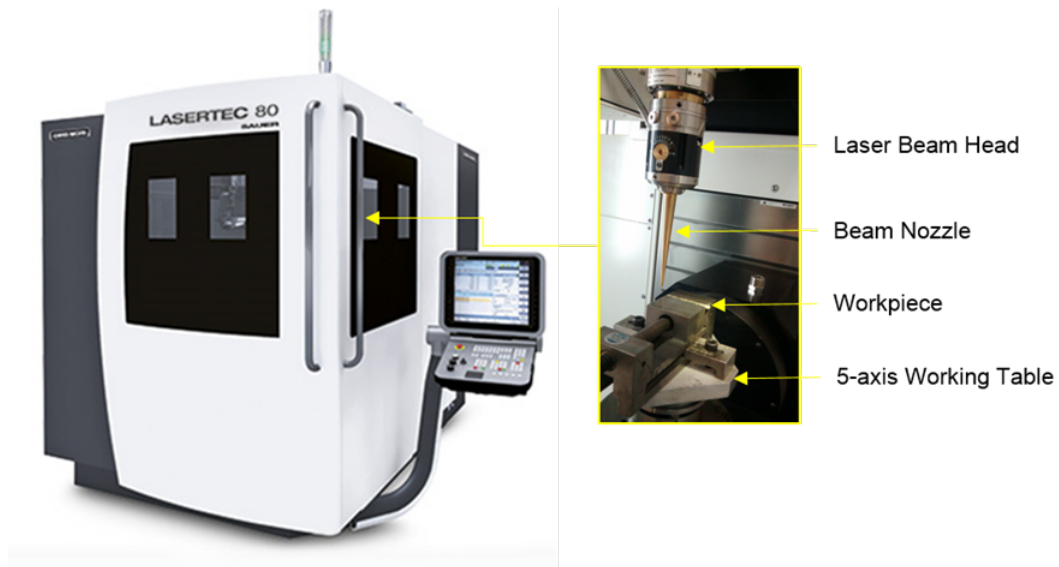
A 5-axis LASERTEC 80 PowerDrill machine (see Figure 3-3), fitted with a 300 Watts millisecond pulsed Nd: YAG laser source at a wavelength of  $1.064 \mu\text{m}$  was used for the experiments. All experiments performed on a laser beam angled at  $30^\circ$  to the workpiece surface. Typical beam profile characteristics in DMG machine is shown in Figure 3-4. A beam profiler measures the beam spatial energy density distribution. It provides an understanding of the beam spatial characteristics such as beam focus spot size, peak

Figure 3-3. Laser machine used for the drilling of the samples.

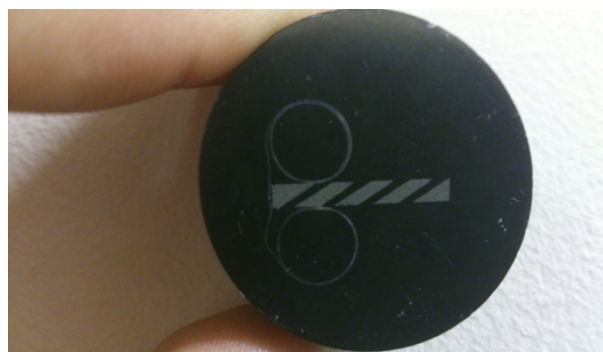
**Figure 3-7. Resin mounted laser drilled sample for metallography examination.**
