CRANFIELD UNIVERSITY

PhD THESIS

**Investigation into the Propagation and Inspection of
Stress Corrosion Cracks under Compressive Loading.**

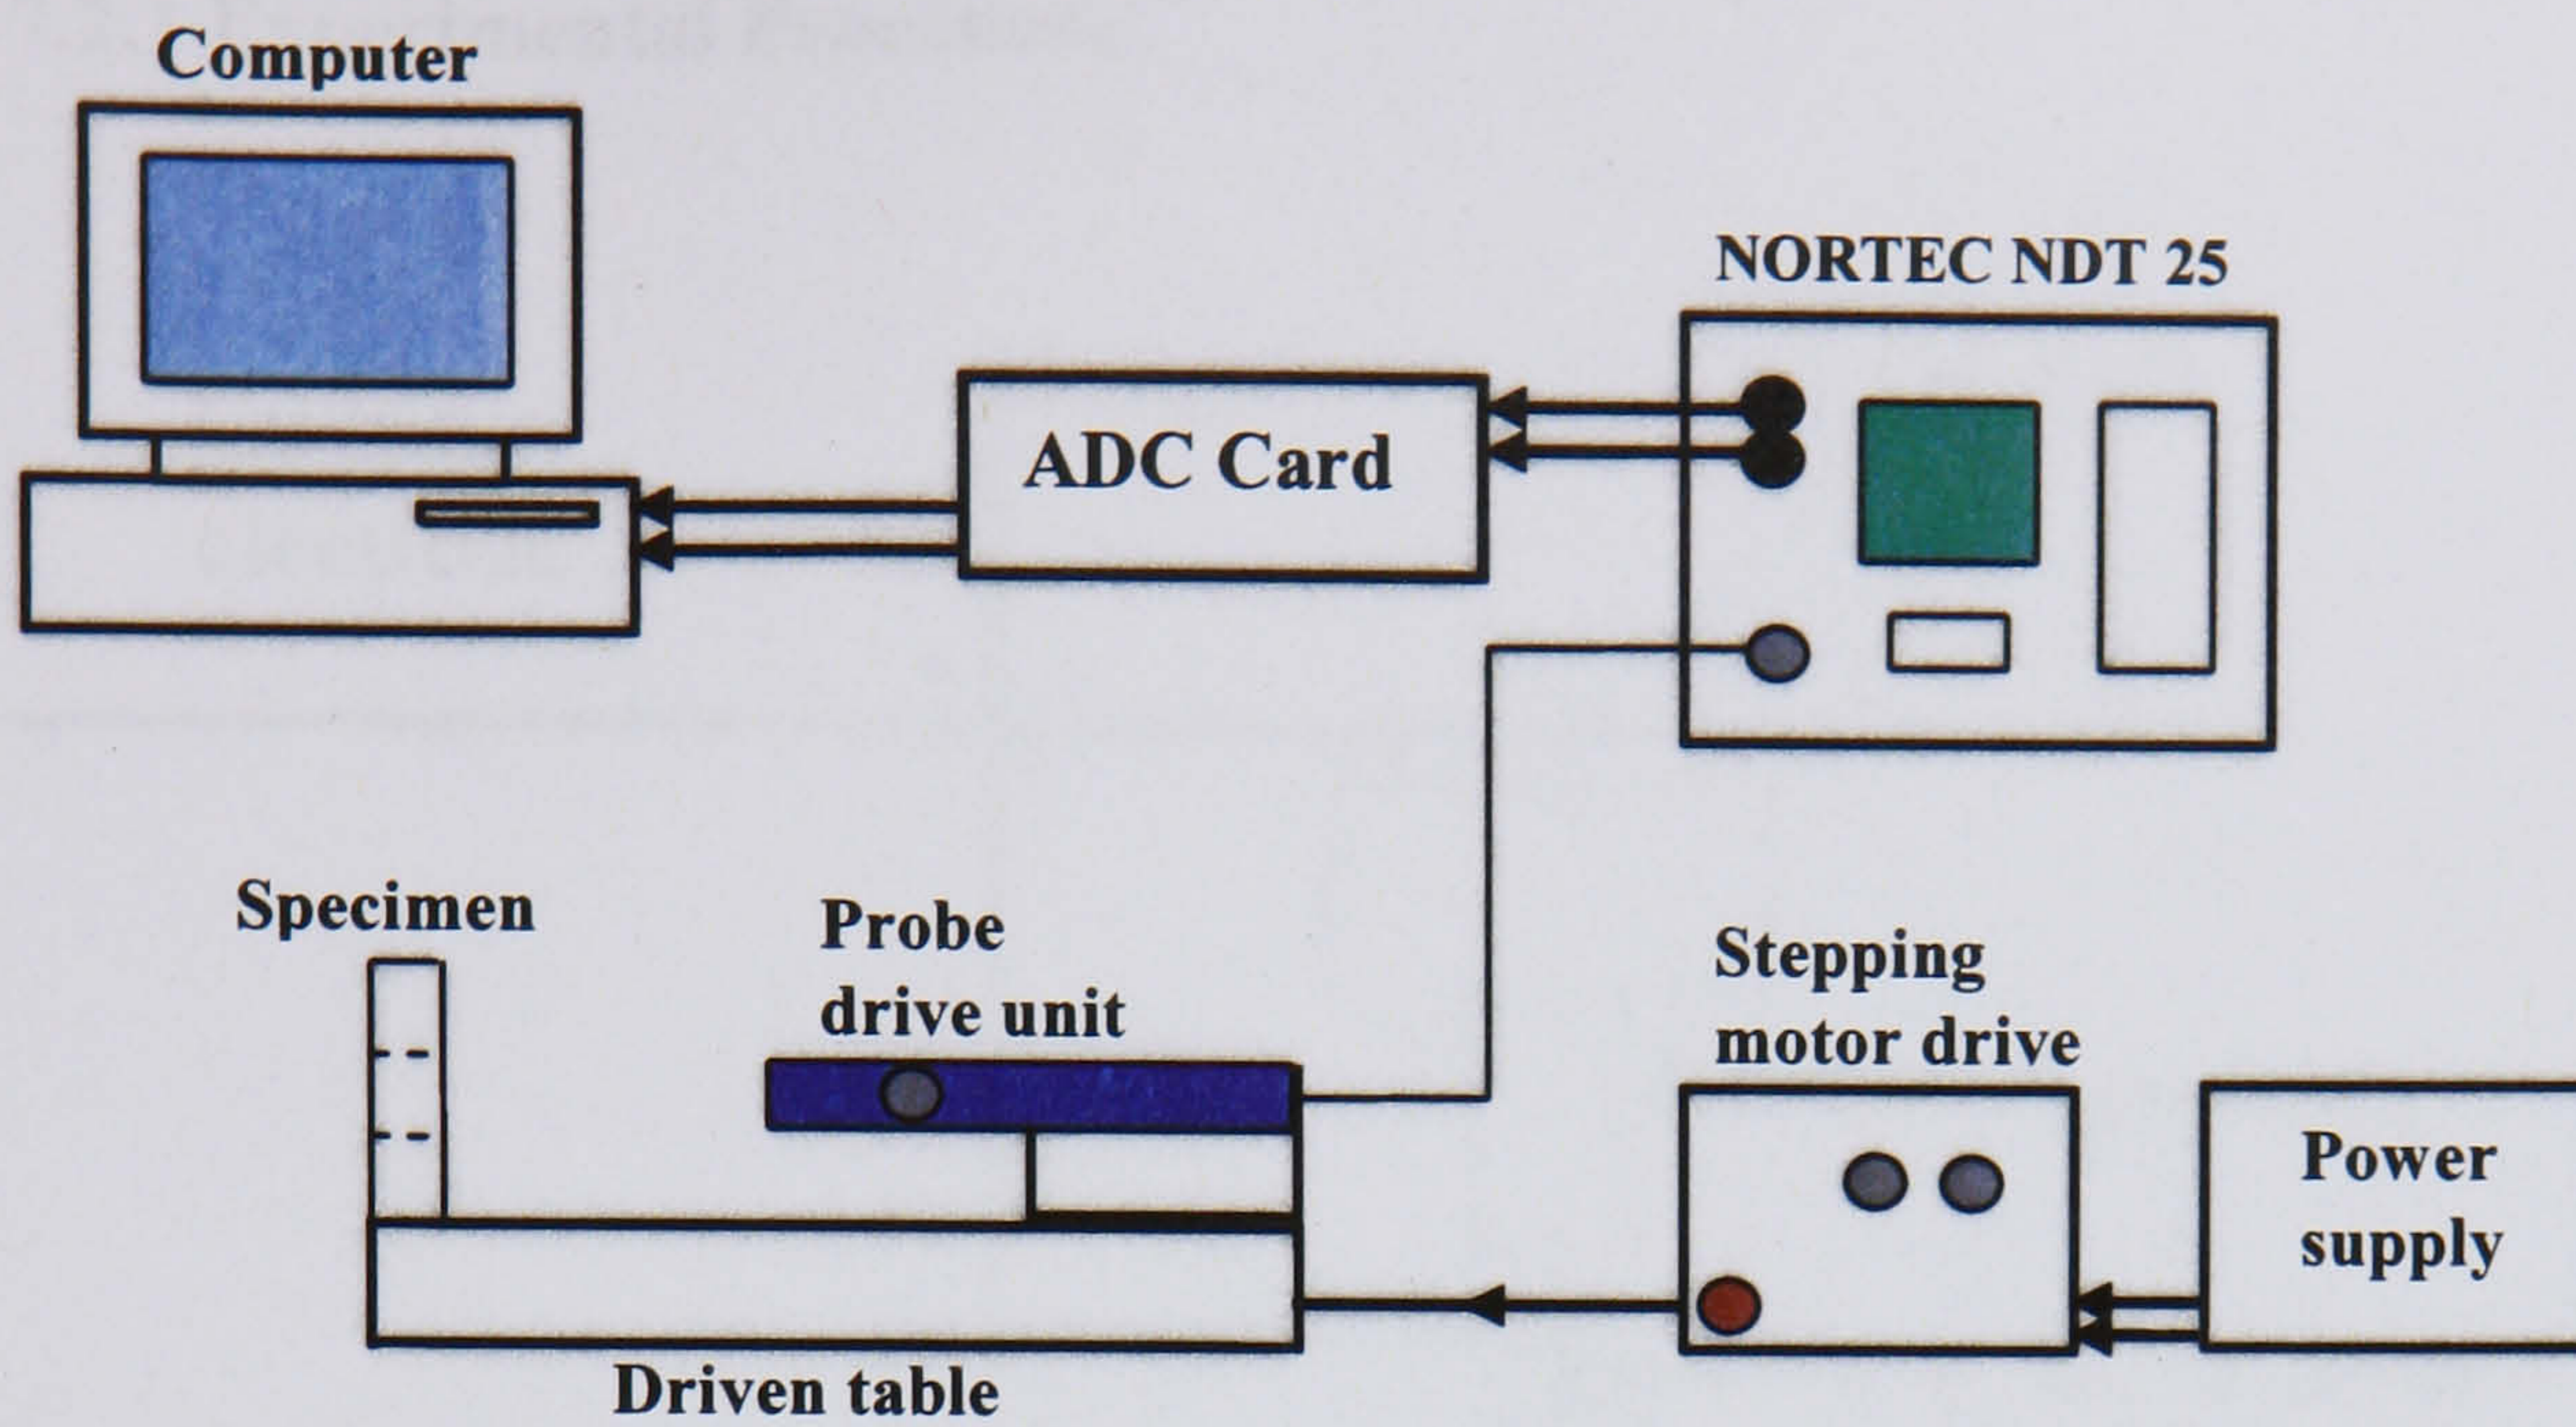
Figure 41 shows a schematic of the experiment set-up for eddy current testing.

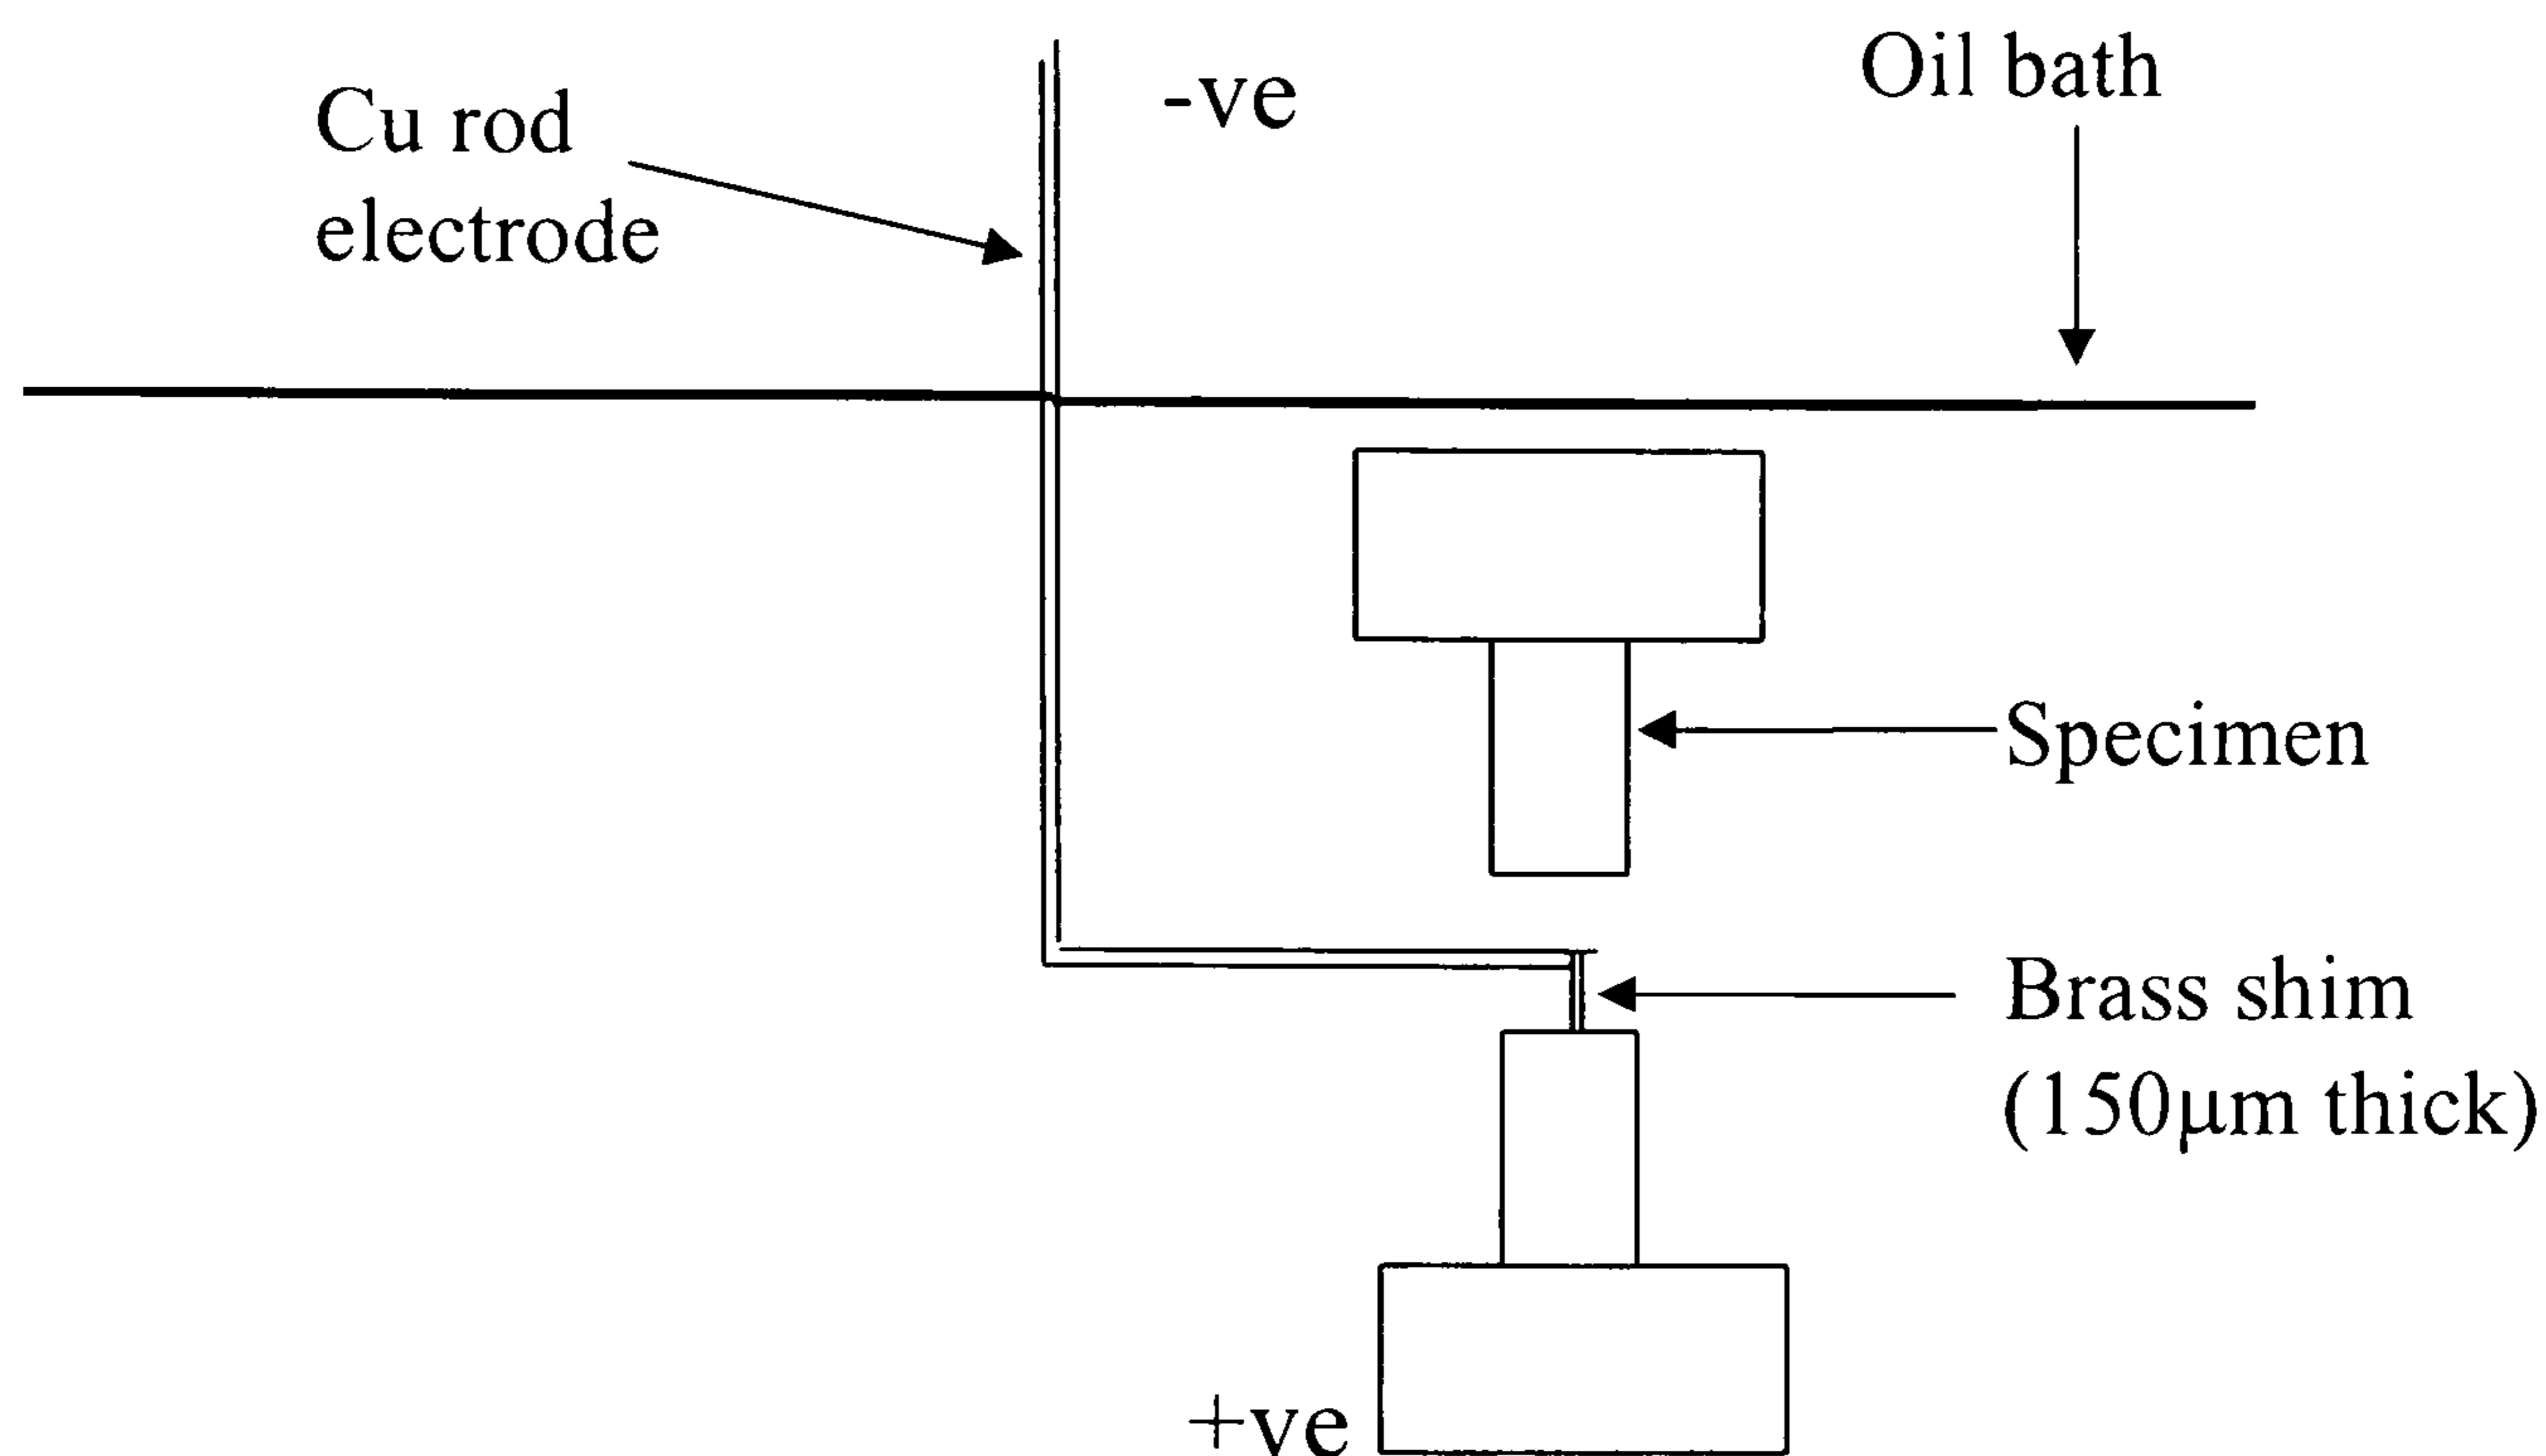
Figure 42 Diagram showing arrangement to produce spark machined defects inside 5mm diameter hole in the calibration specimen.

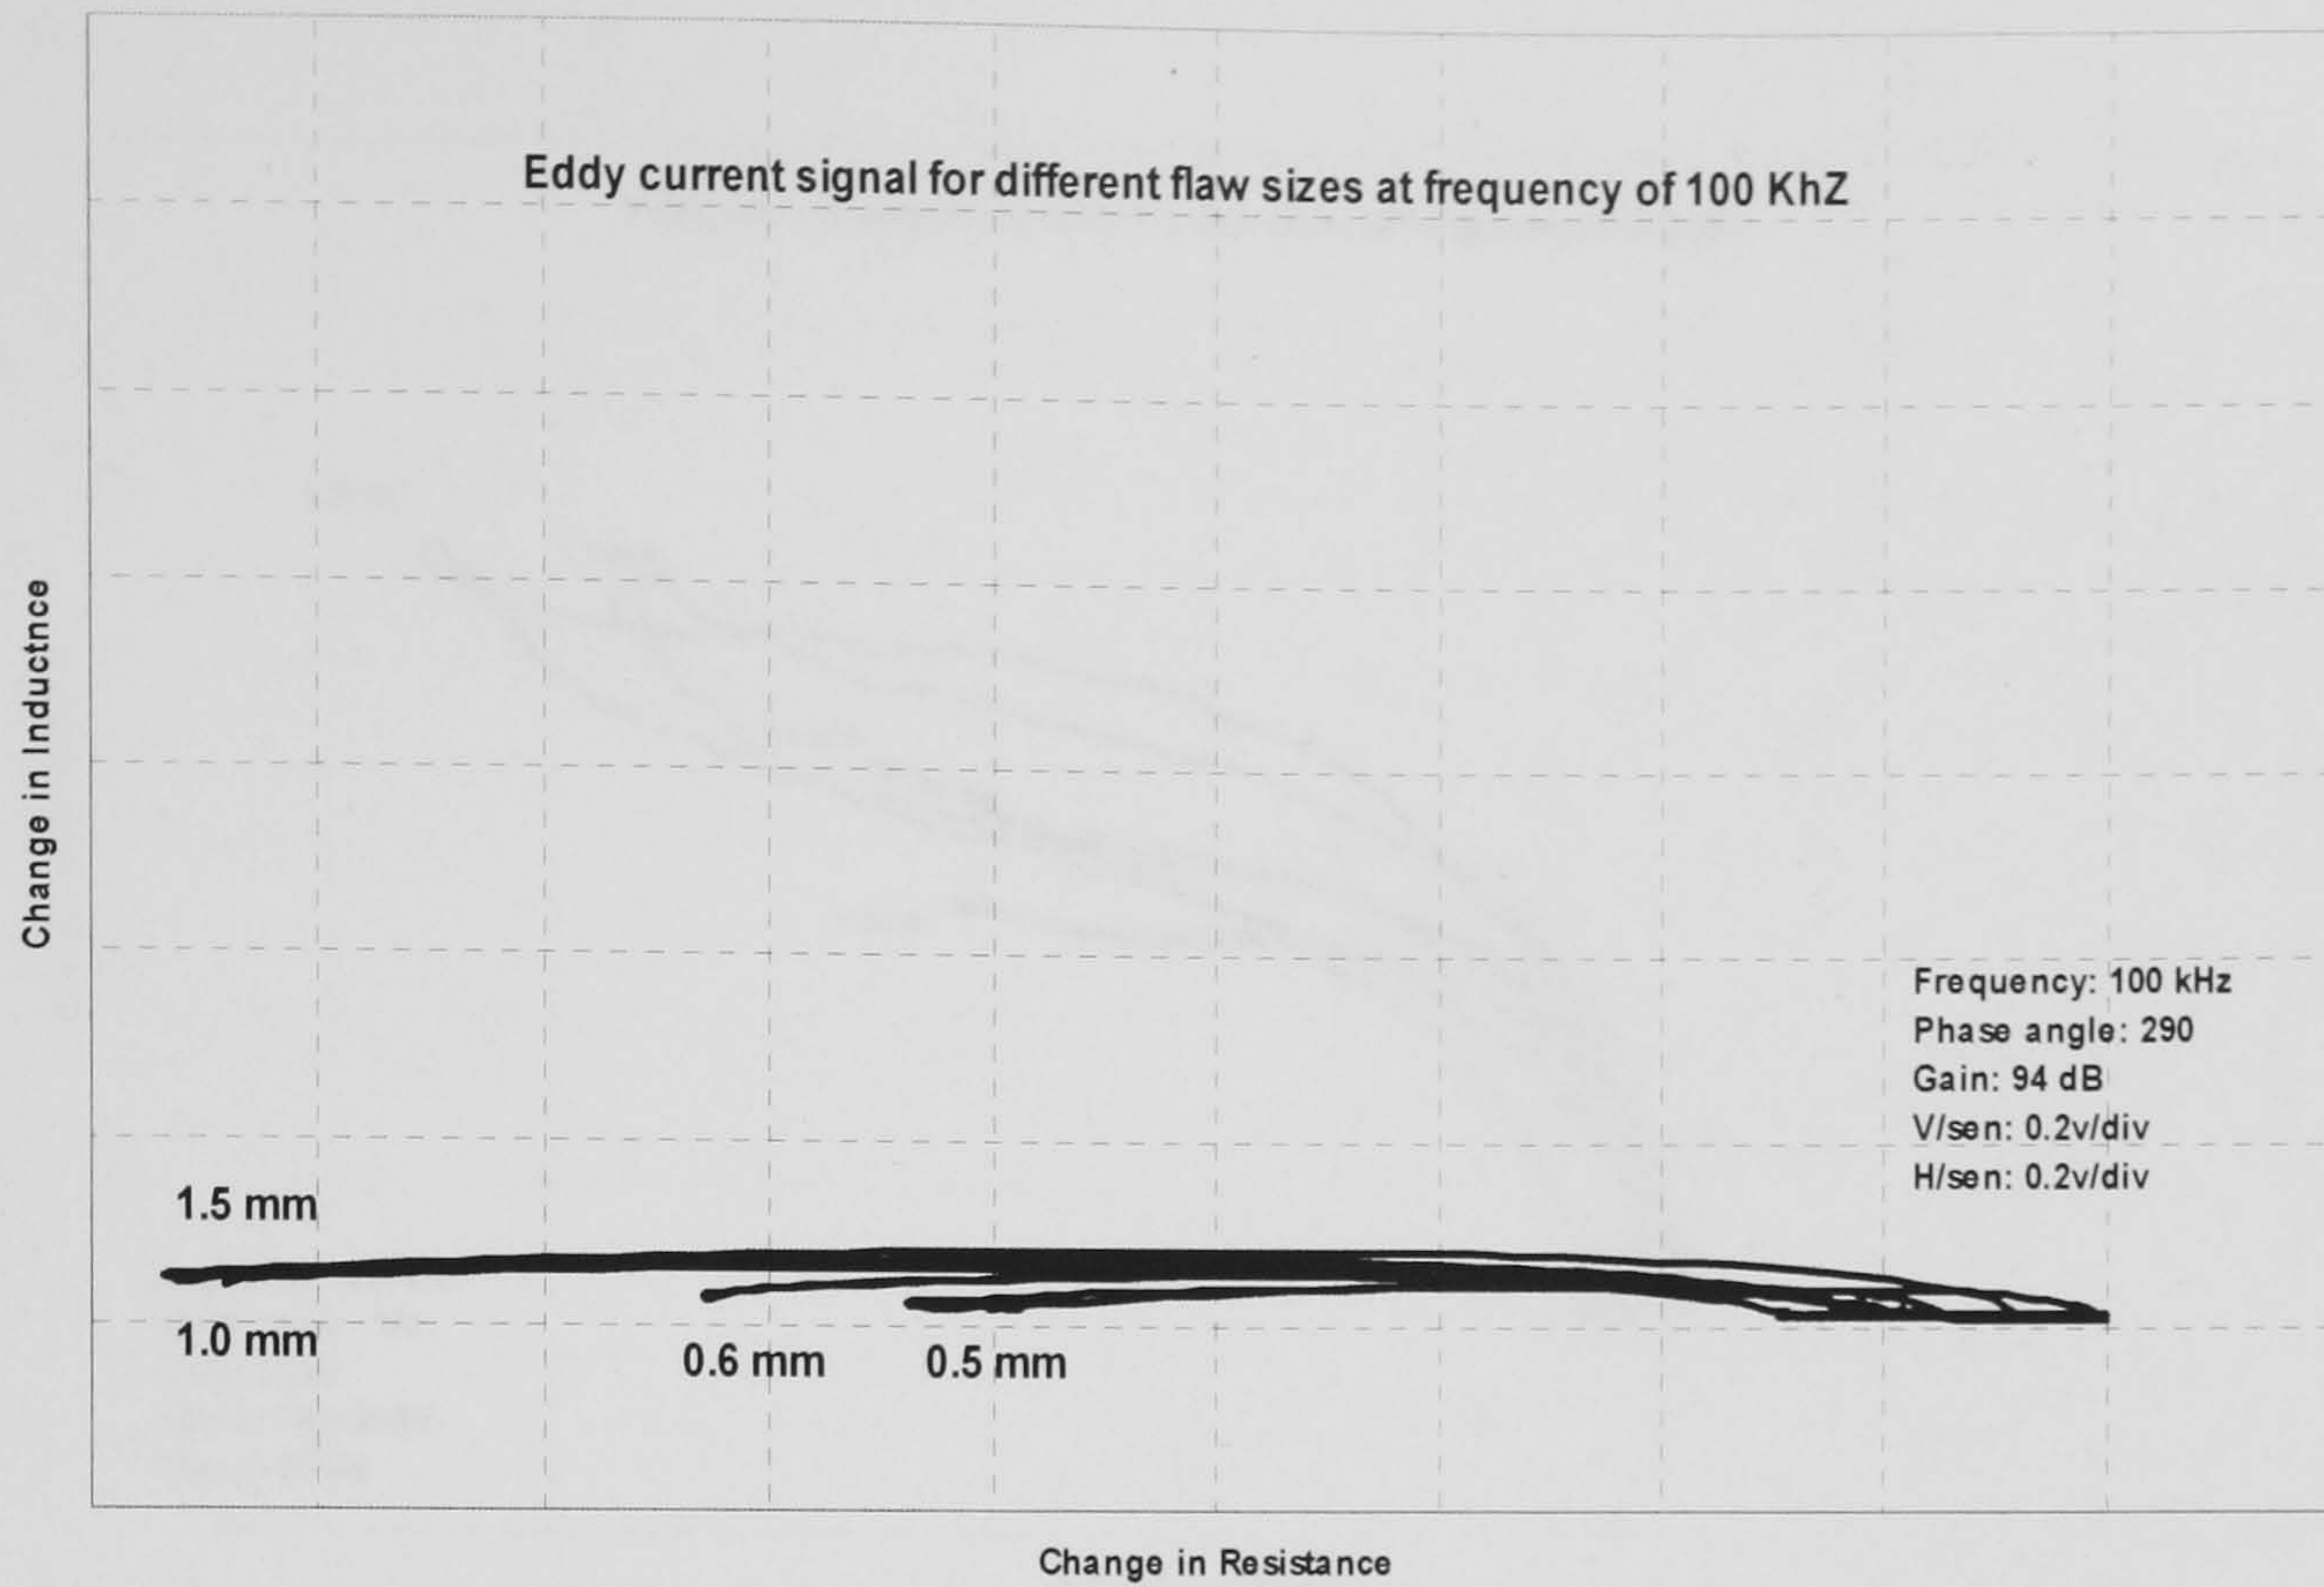
Figure 61 Eddy current signals for different flaw sizes at frequency of 100 kHz.

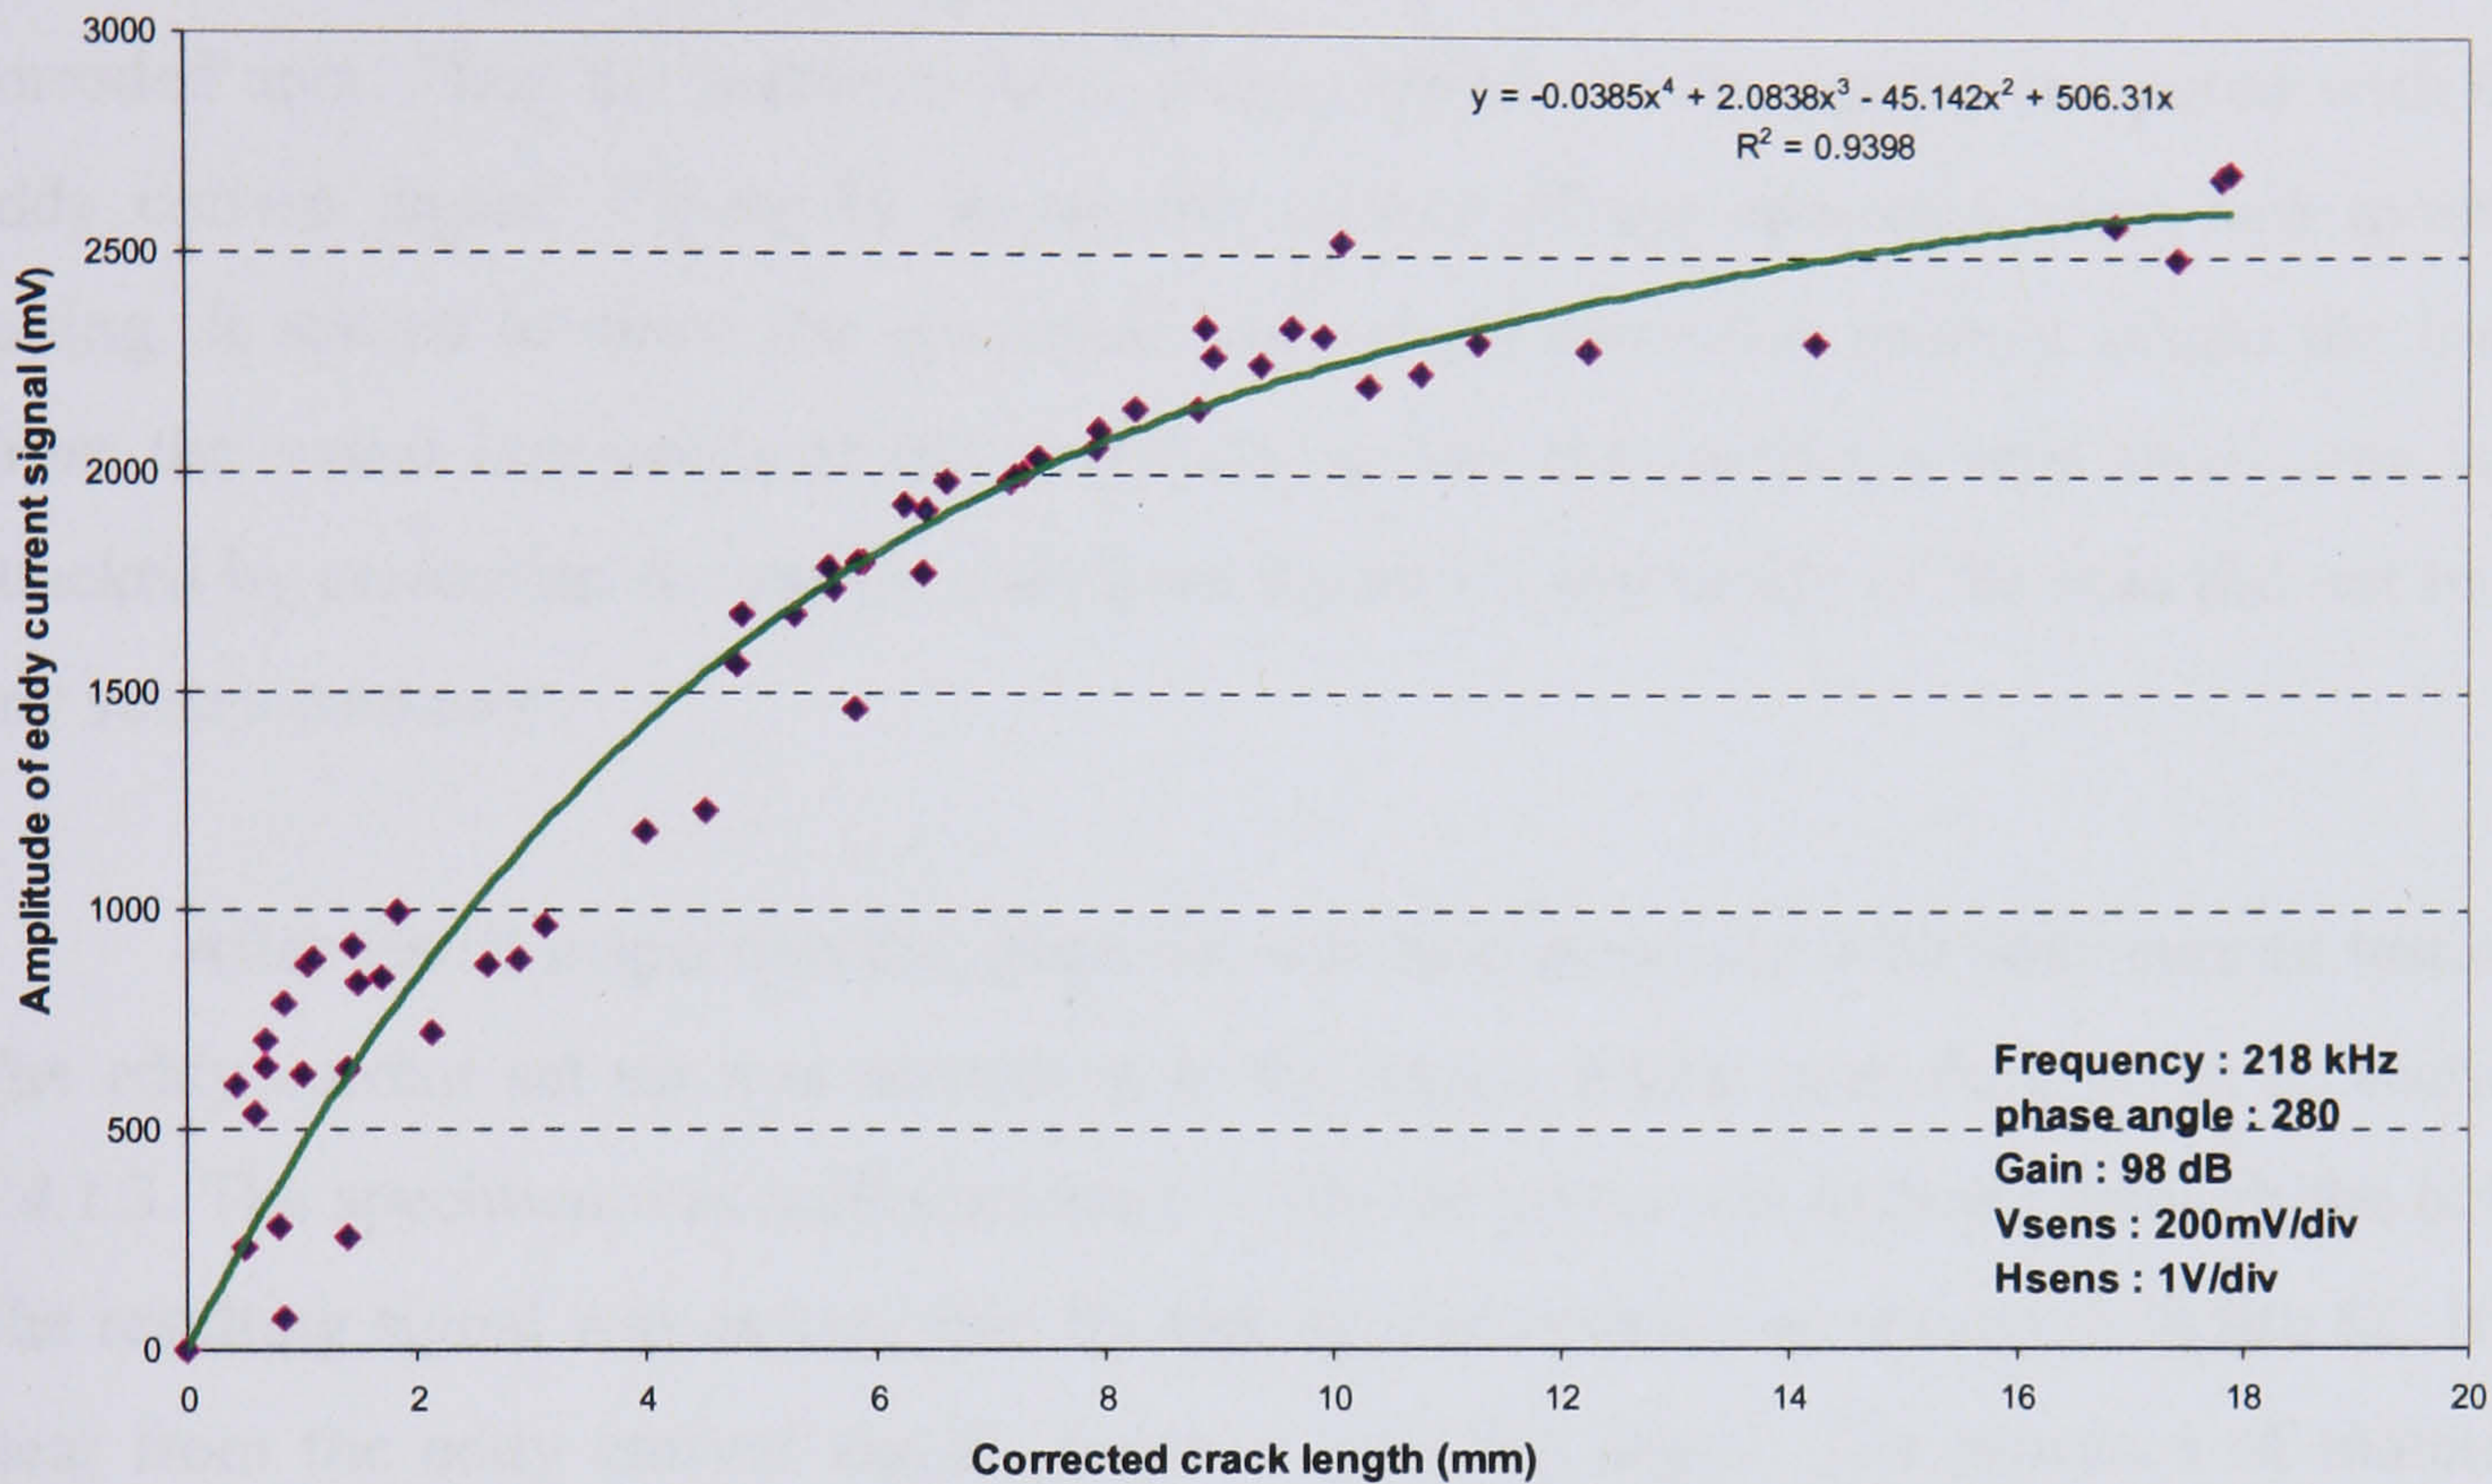
Figure 80 Calibration of eddy current amplitude as a function of crack length.

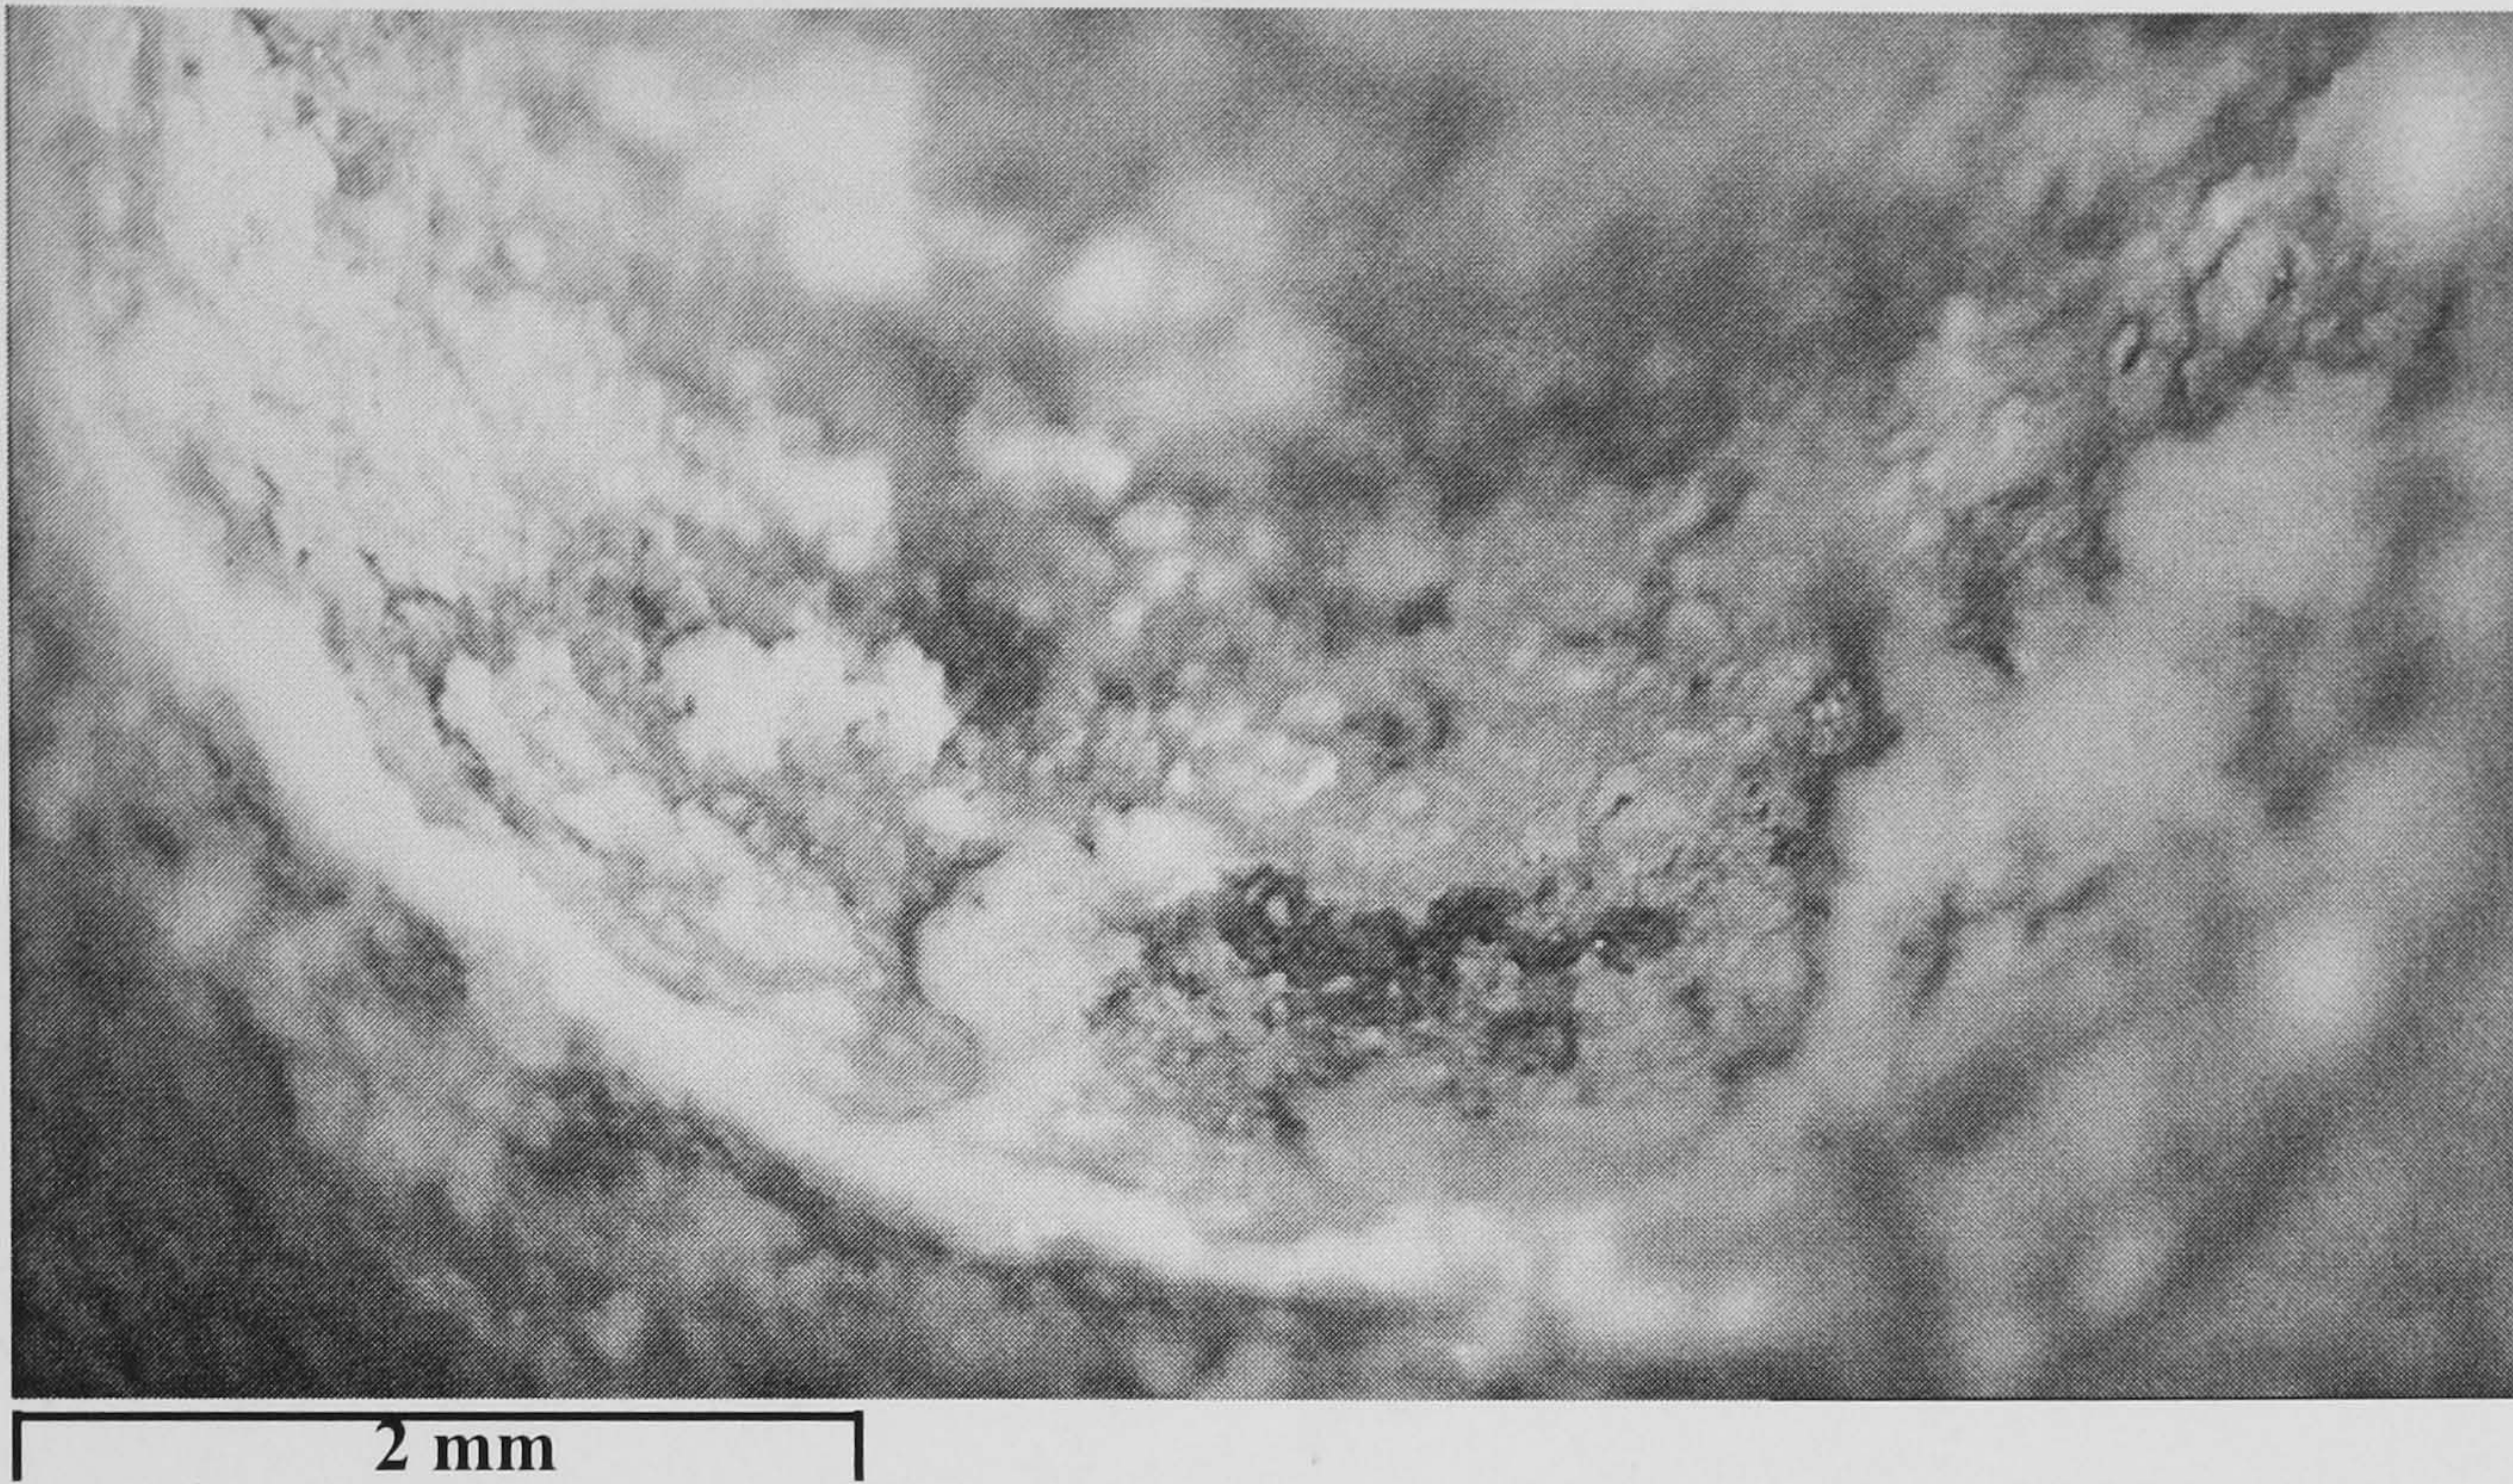
Figure 98 Optical micrograph showing the corrosion product inside the hole surface after 8 weeks.
