Damage Resistance of Aircraft Wing Structure Using Low Cost Carbon Fibre
Composite Materials

School of Applied Science
MSc thesis

MSc by Research
Academic Year: 2010 - 2011

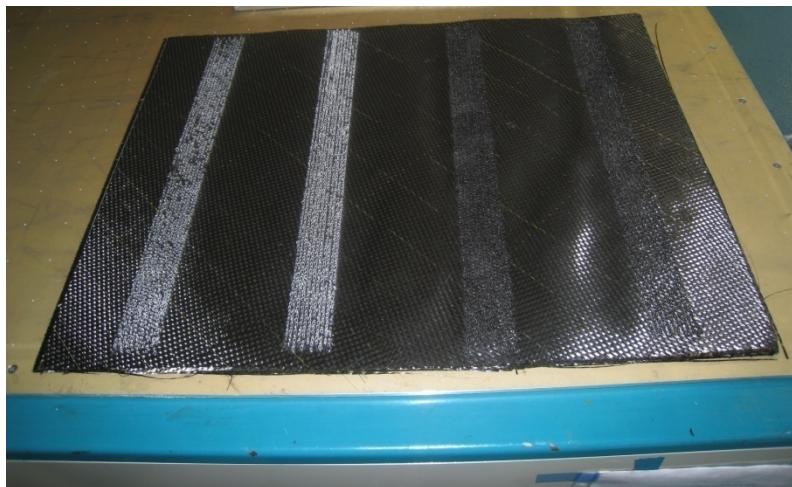
Because the glass thread is very smooth and relatively tough, it could be easily tufted even though the preform was very tight because of the presence of hard binder particles in the fibre tows. The carbon thread is stiffer and the flexibility is lower than for glass thread; as a result the carbon thread was broken during several trials, even though two supplementary methods were used, i.e. preheating and lower tufting speed. A more effective technique used sprayed water as a lubricant. The water was sprayed on the top of the preform beforehand and sprinkled on the ongoing area during the tufting process. Disadvantageously however, the preform needed to be dried at 50°C for two days.

Figure 33 Picture of tufted preform (loop side), the white is glass and the black is carbon

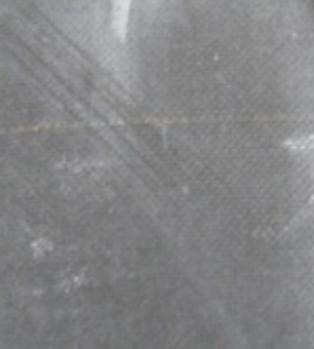
Crack	Not visible	Obvious delamination along 45°direction 41.6 mm

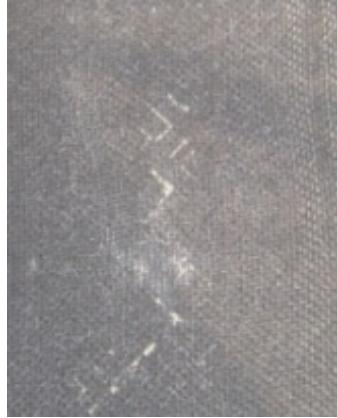
0.1 mm deep dent Rectangle shape	Obvious Fracture Longitudinal extension 34.5×15.1 mm	Not visible
	Opposite

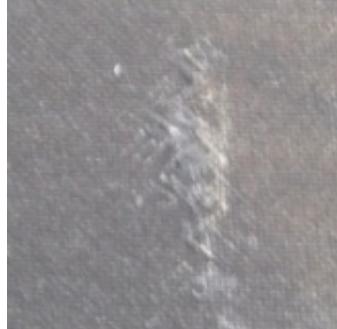
Long Shatter	Obvious Fracture 22.1×10.3 mm	Not visible
