CRANFIELD INSTITUTE OF TECHNOLOGY

Ph.D THESIS

J.M.F. MOTA

CHEVRON CRACKING IN STEEL WELD METALS

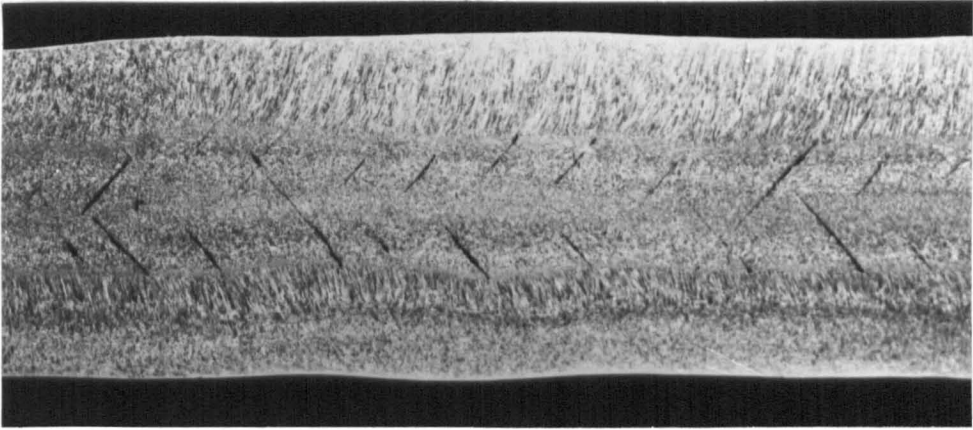
Figure 1 - Typical example of chevron cracking in a longitudinal section of an industrial sample. 1x.

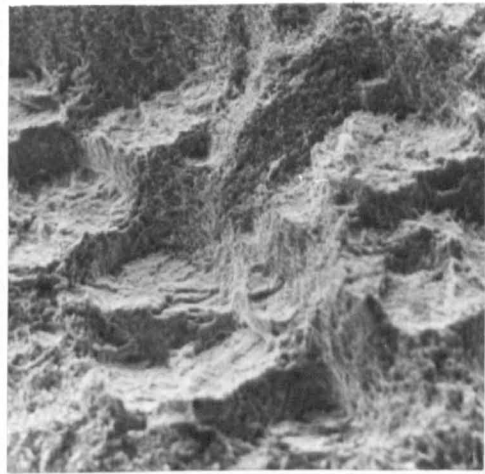
Figure 2 - Details of a chevron crack.

- (a) Longitudinal section observed in the light microscope. 200x.
- (b) Fracture surface observed in the scanning electron microscope (from a direction perpendicular to the horizontal components). 80x.

These cracks, which can occur in medium strength weld metals of the carbon manganese and low alloy type, are characterized by their orientation, which is approximately transverse to the welding direction and at 45° with the plane of the plates in a butt welded joint. The cracks are more easily identified in longitudinal sections of the weld metal cut perpendicularly to the plane of the plates; in these sections some cracks intersect at 90° producing typical chevrons, observable at low magnifications, Figure 1. In the optical or scanning electron microscopes, the stepped characteristic is readily apparent with two sets of components observed with the outline of a staircase, Figure 2.

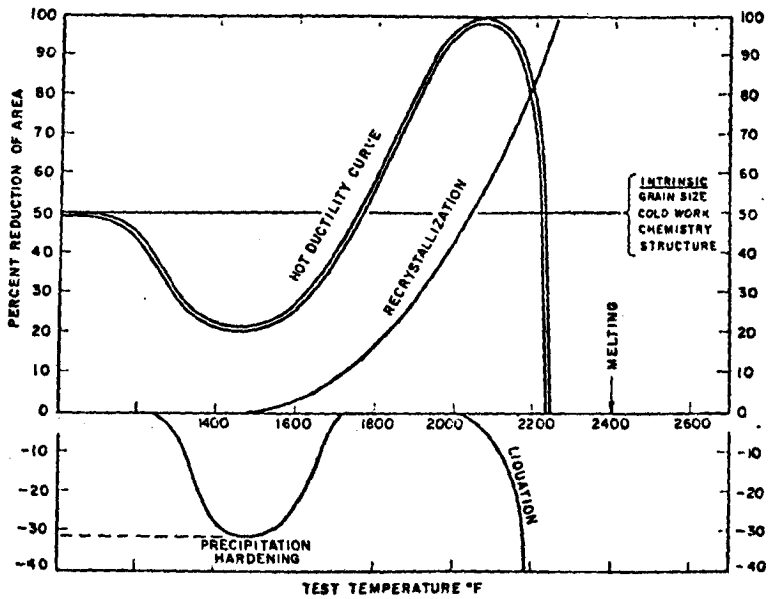
Figure 3 - Hypothetical hot ductility curve along with individual contributions which combine to make the curve.
(After Yeniscavich).

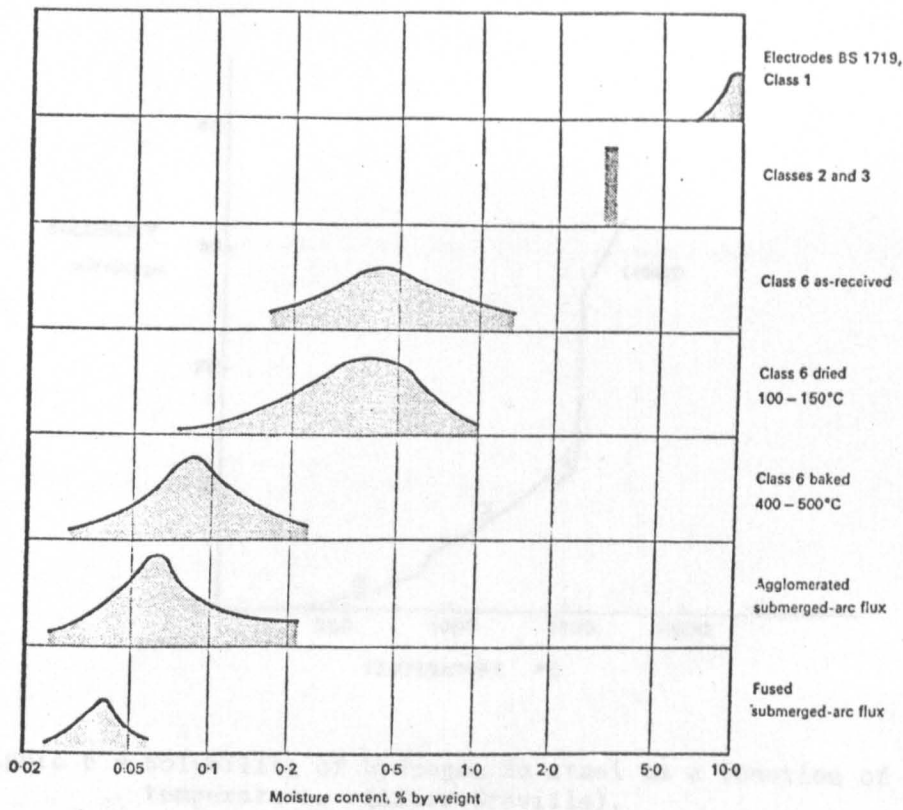
Note : Heights of curves indicate relative frequency of test results for each type of consumable.

Figure 4 - Typical potential hydrogen levels (moisture levels in coatings and fluxes). (After Coe).

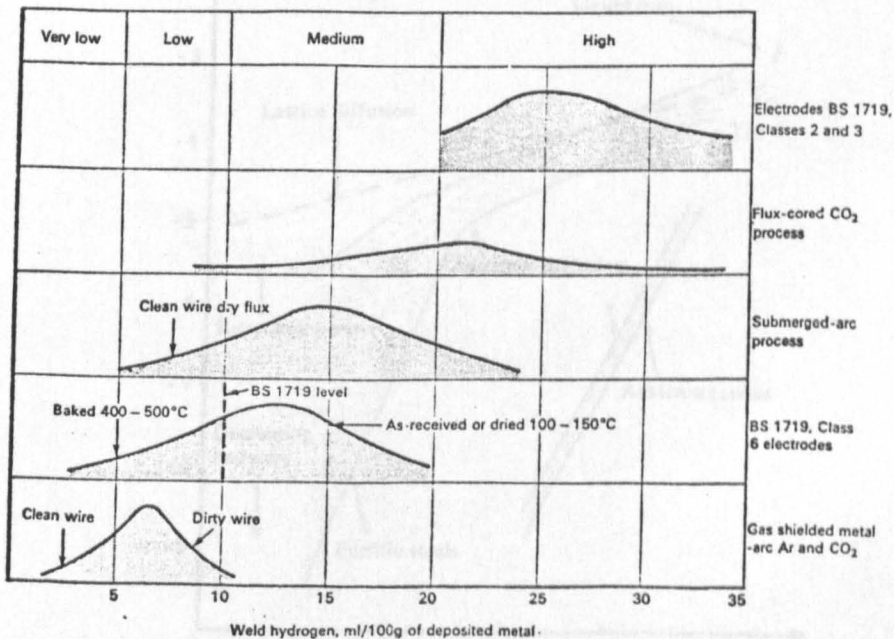
Note: BS 1719, Class 1 electrodes cannot be shown on this diagram as they normally give weld hydrogen levels of between 70 and 100ml/100g. (Heights of curves indicate relative frequency of test results for each type of consumable)

Figure 5 - Typical hydrogen levels in weld metals deposited with different types of consumables. (After Coe).

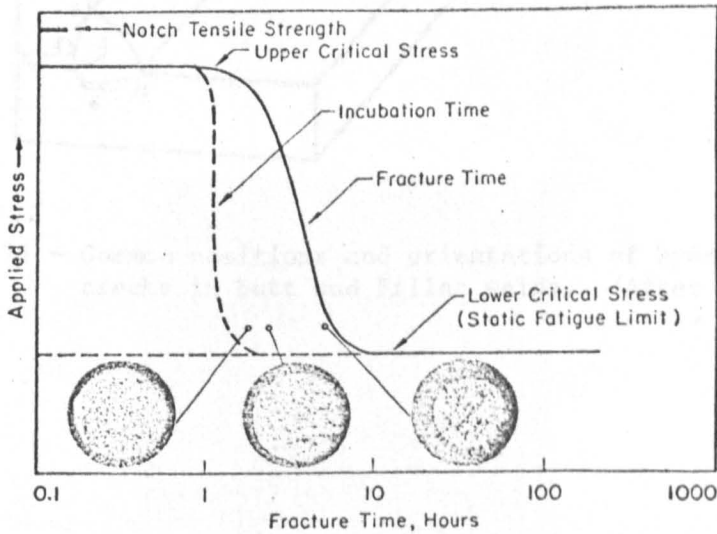
Figure 10 - Schematic representation of failure characteristics of a hydrogenated high strength steel. (After Troiano).

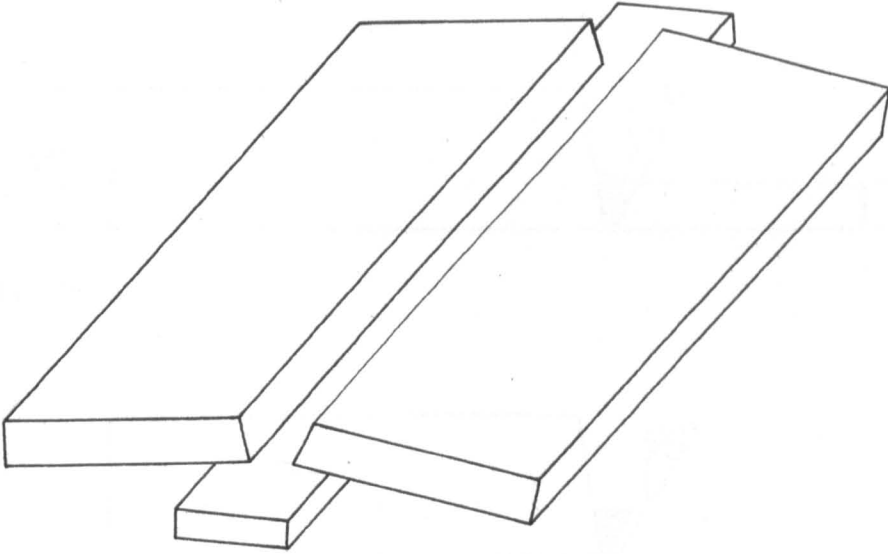
Note : All dimensions are in millimetres. The plates were 380mm long.
Figure 12 - Weld preparation for the Tuliani test.

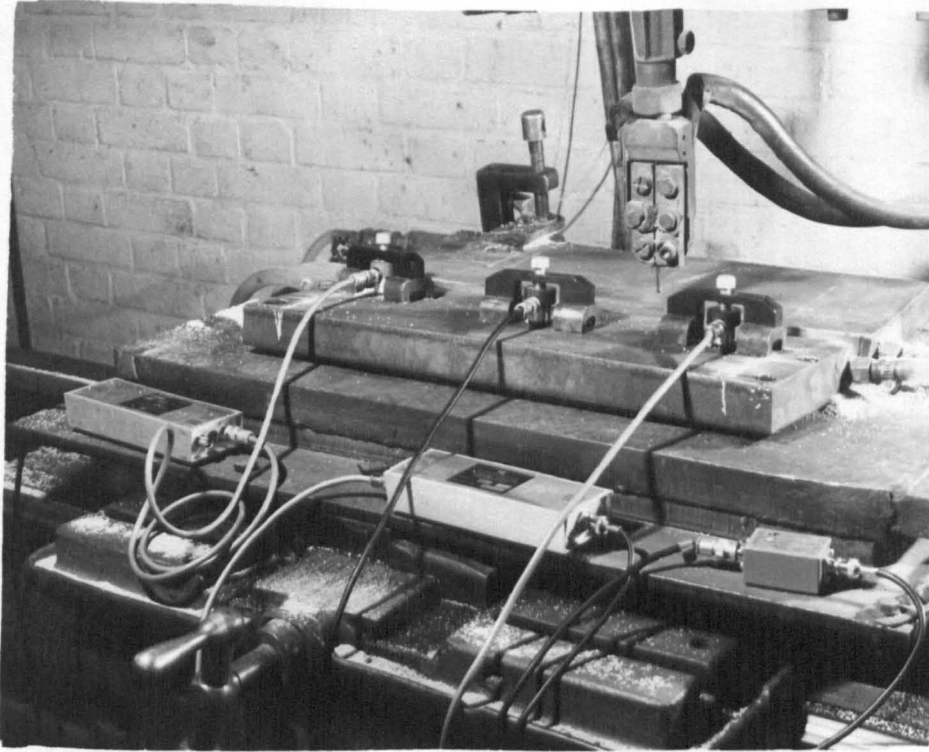
Figure 19 - Test plates with acoustic emission transducers to detect the occurrence of cracks in the deposited weld metal.

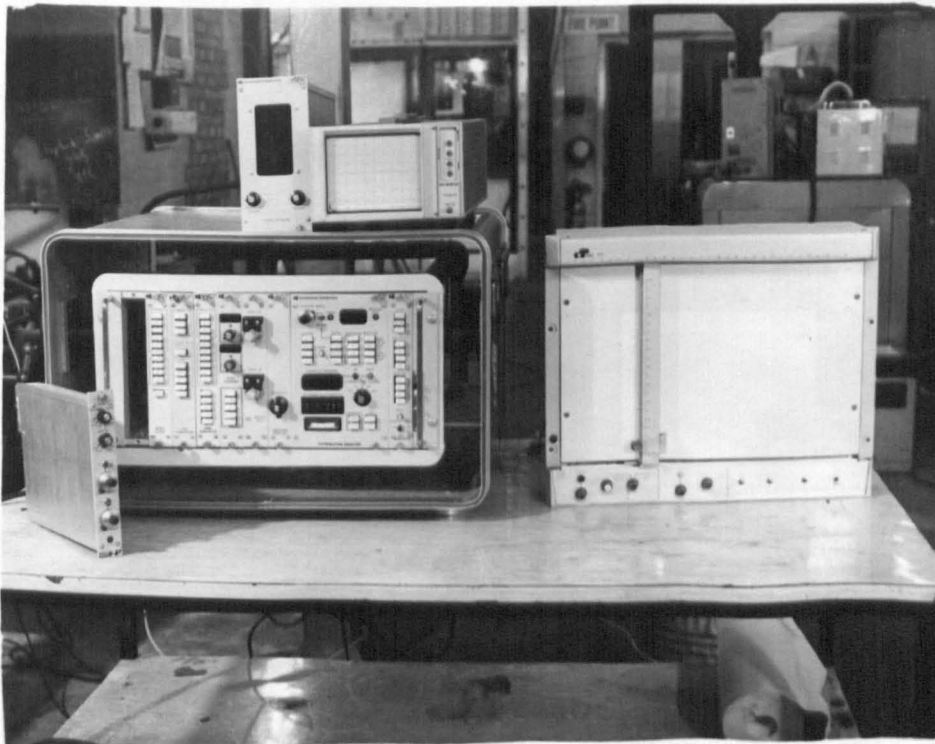
Figure 20 - Equipment used for the acoustic emission monitoring.

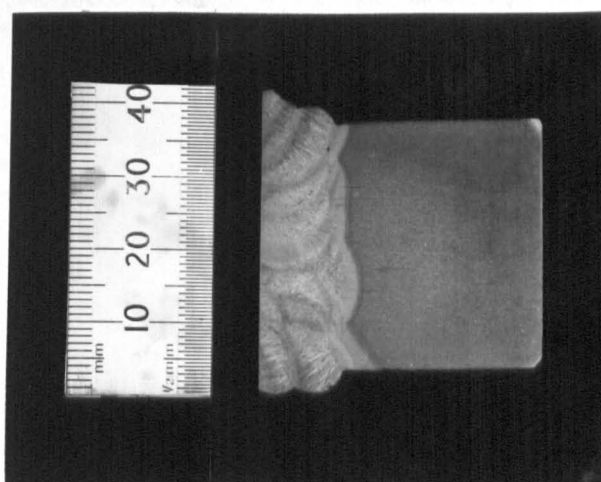
Figure 23 - Sectioning of weld metal specimens to prepare fracture surfaces to be examined in the scanning electron microscope.

(a) Chevron crack.

(b) Vertical crack.

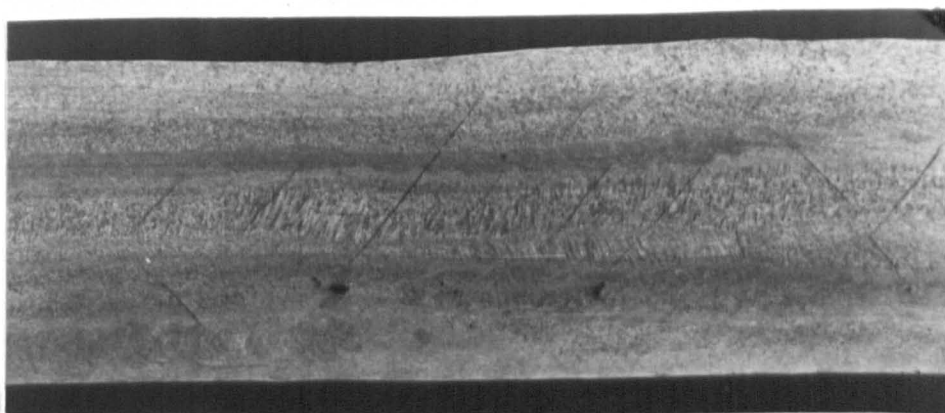
Figure 24 - Chevron cracks in the industrial sample A.

(c) Longitudinal section showing the longest cracks found. 1x.

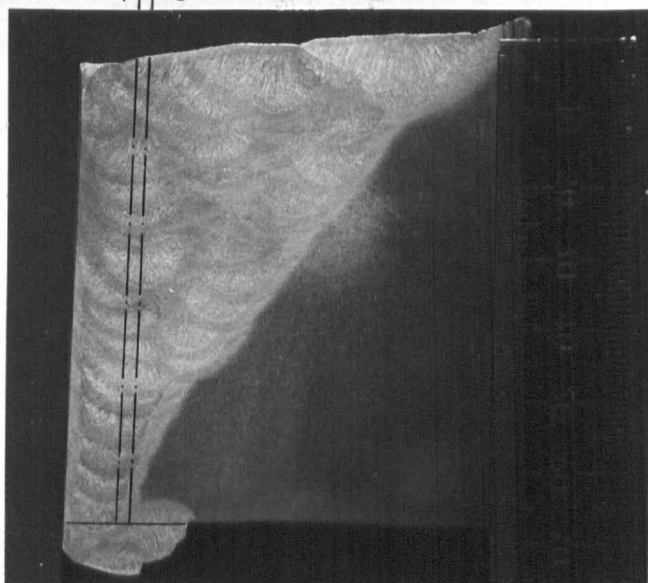
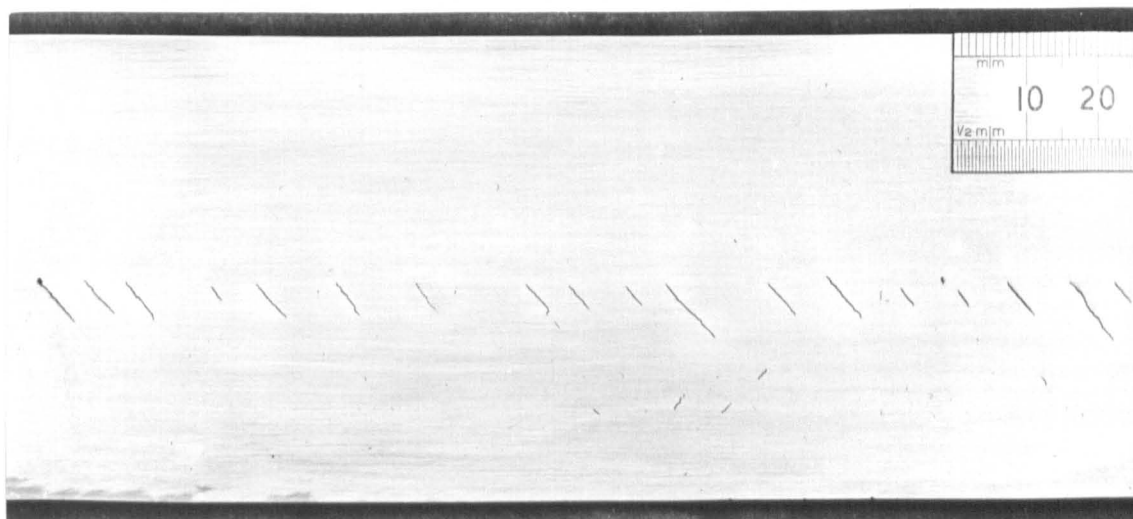
Figure 25 - Chevron cracks in the industrial sample B.

(b) Longitudinal section corresponding to the plane π_1 . 1x.

(c) Longitudinal section corresponding to the plane π_2 . 1x.

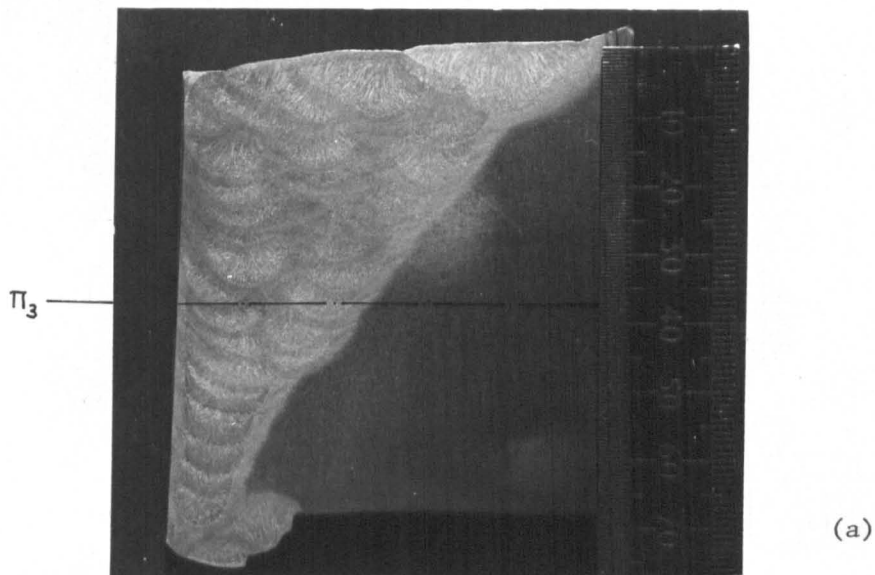
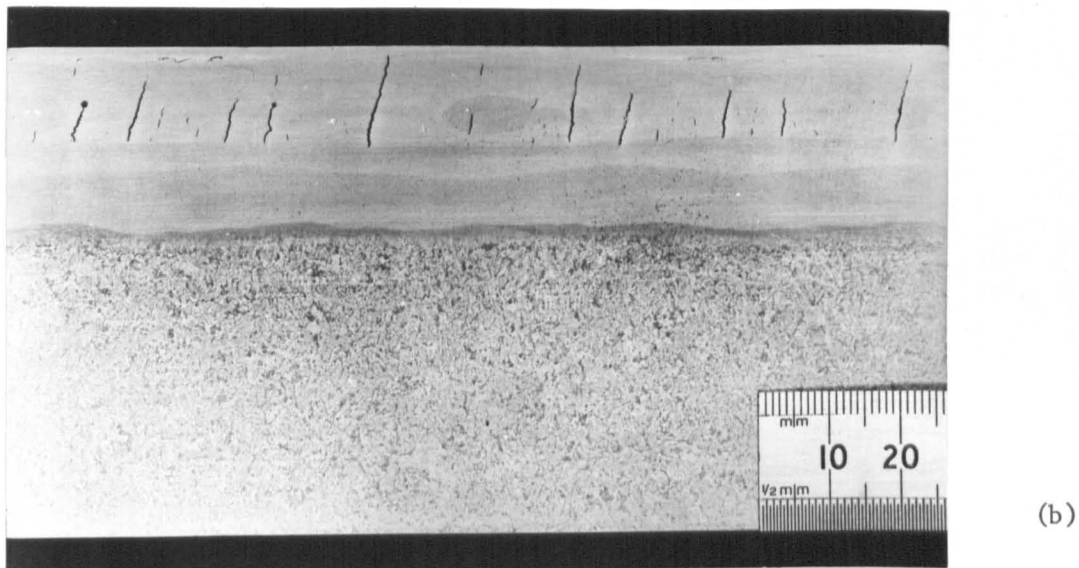
Figure 26 - Chevron cracks in the industrial sample B

- (a) Cross section of the joint where the cracks were found. 1x.
- (b) Longitudinal-horizontal section (corresponding to the plane Π_3). 1x.

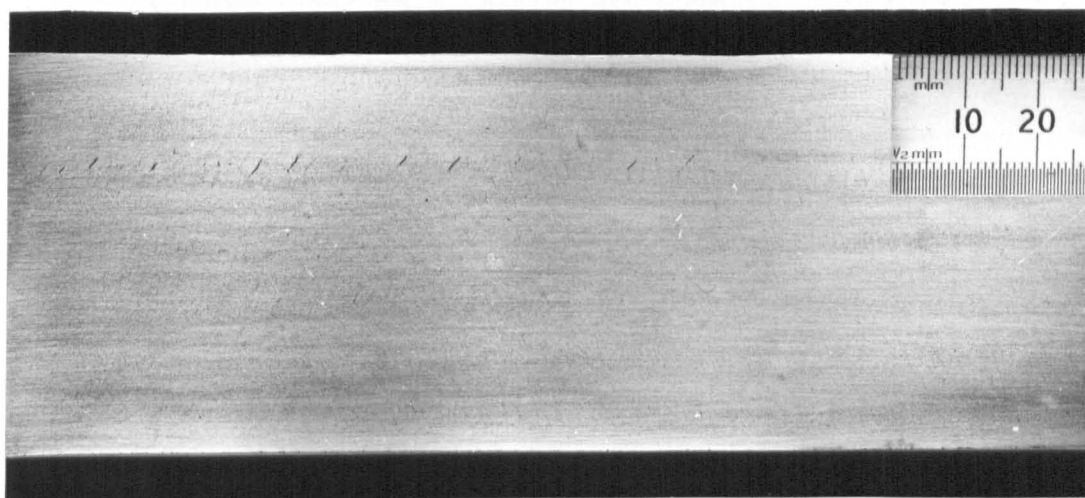
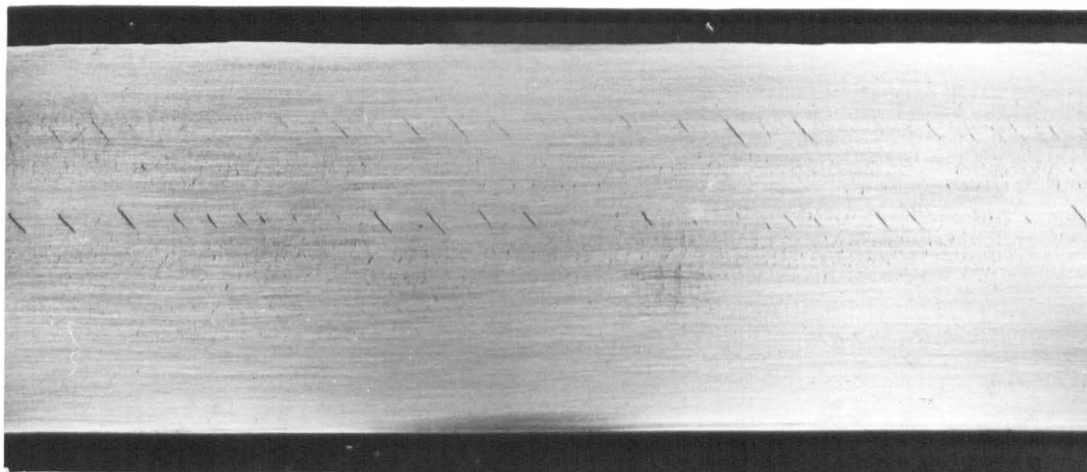
Figure 28 - Chevron cracks in submerged arc welds

(a) Deposited with the wire-flux combination S4 + OP41TT. TP9. 1x.

(b) Deposited with the wire-flux combination SD3/Mo + OP41TT. TP21. 1x.

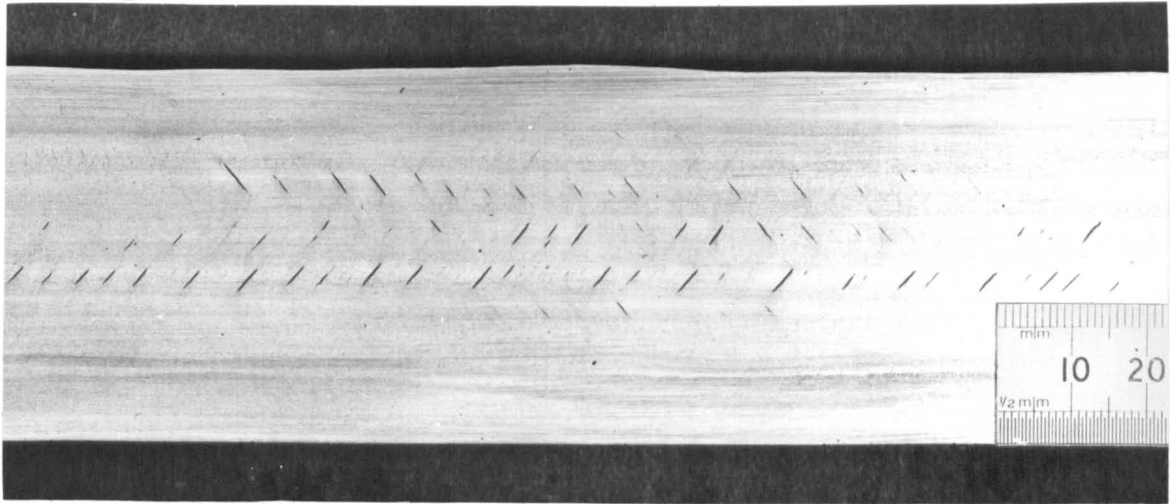
Figure 29 - Chevron cracks in a submerged arc weld deposited with the wire-flux combination SD2/3Ni + OP41TT. TP17. 1x.

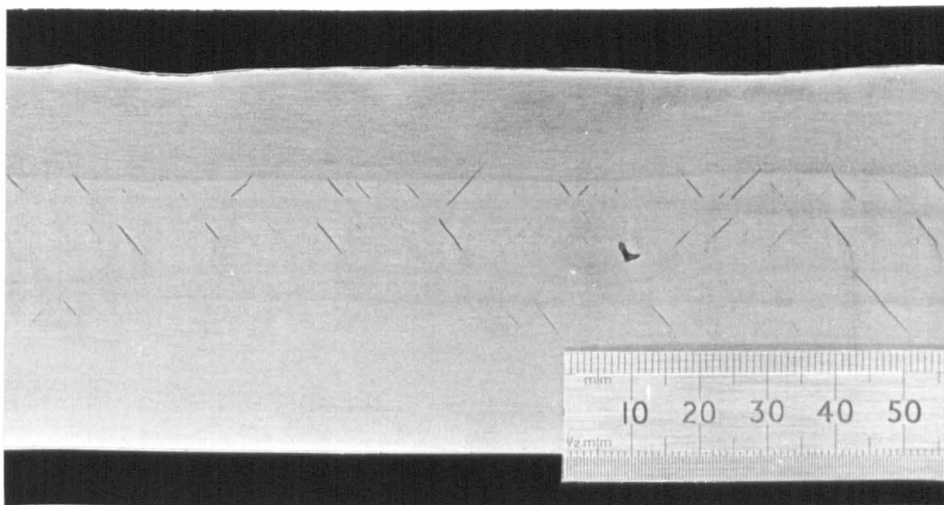
Figure 30 (a) Chevron cracks in a submerged arc weld deposited with the wire flux combination SD2/3Ni + OP41TT. High heat input weld made by Crouch (7). (b) Cross section of the weld metal and backing bar.

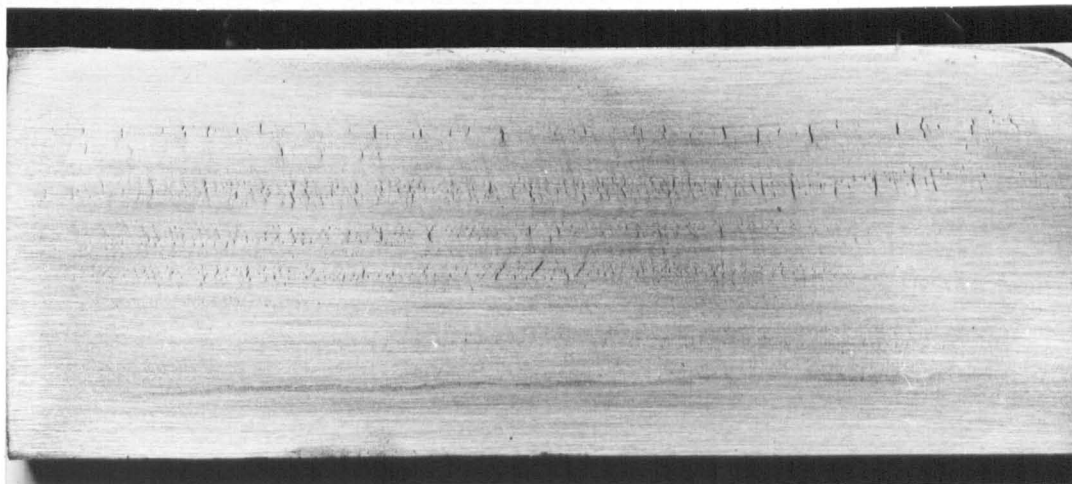
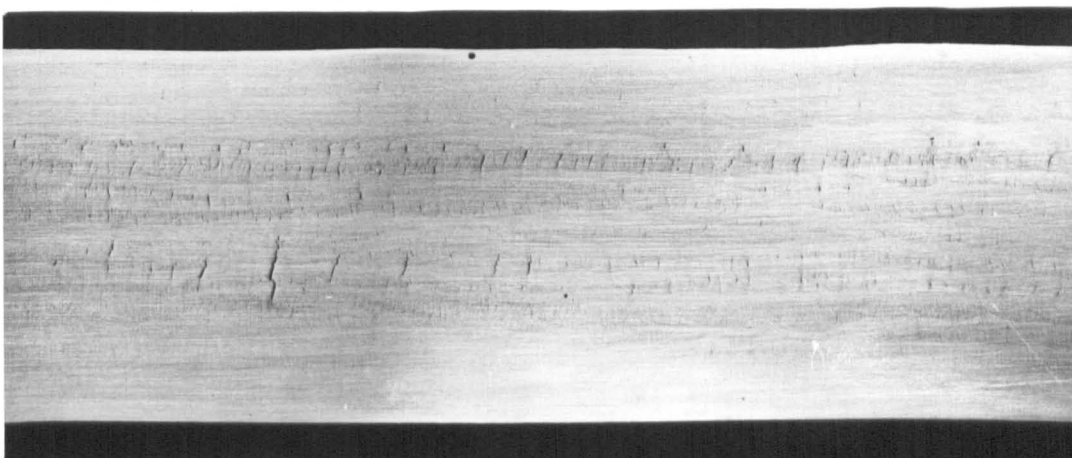
Figure 31 - Vertical cracks in high strength submerged arc welds

- (a) Deposited with the wire-flux combination $\text{SD3/1Ni}\frac{1}{2}\text{Mo} + \text{OP41TT}$ (damp). TP24. 1x.
- (b) Deposited with the wire-flux combination $\text{SD2/1Cr1Ni}\frac{1}{2}\text{Mo} + \text{OP41TT}$ (as received). TP26. 1x.
- (c) Deposited with the wire-flux combination $\text{SD2/1Cr1Ni}\frac{1}{2}\text{Mo} + \text{OP41TT}$ (damp). TP27. 1x.

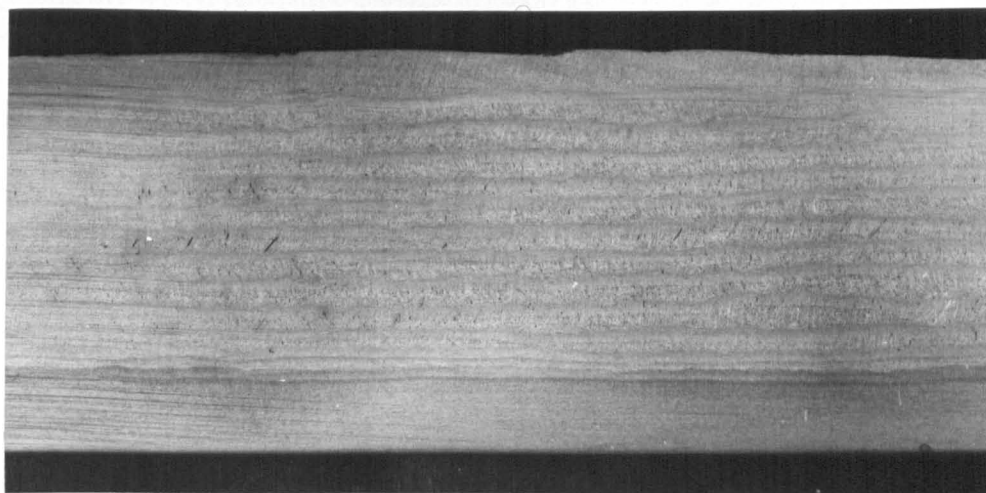
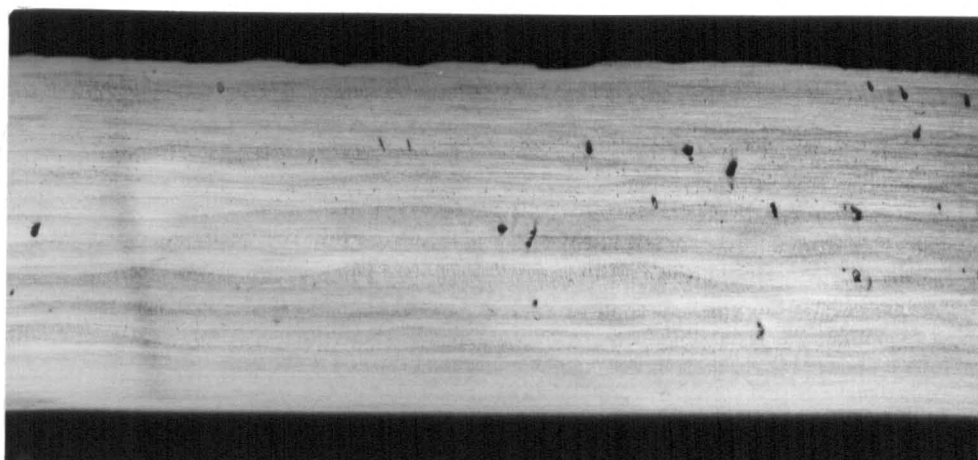
Figure 32 - Chevron cracks, fissures and porosity in manual metal arc welds deposited with E8018C1 electrodes.

- (a) Weld with electrodes from manufacturer A. TP32. 1x.
- (b) Weld with electrodes from manufacturer B. (batch 1). TP35. 1x.
- (c) Weld with electrodes from manufacturer B. (batch 2). TP38. 1x.

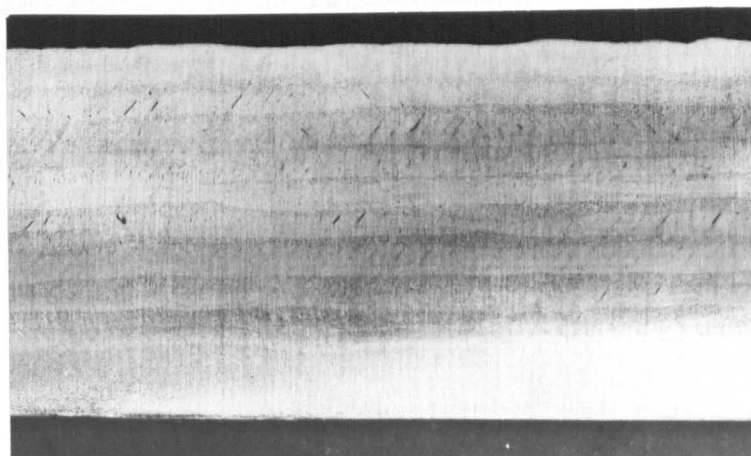
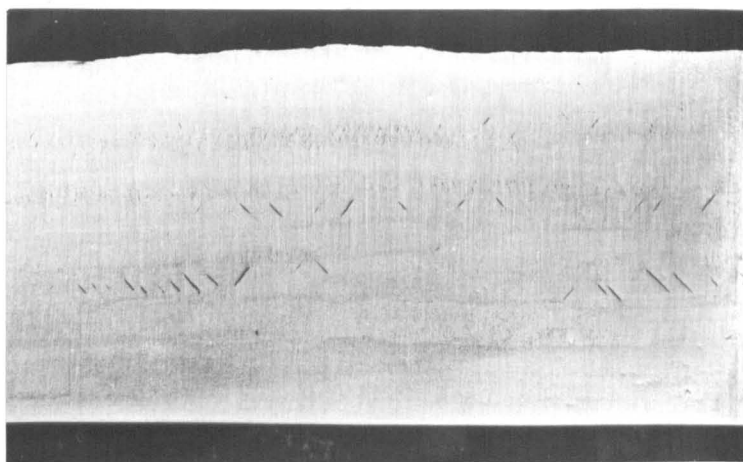
Figure 33 - Chevron cracks in manual metal arc welds

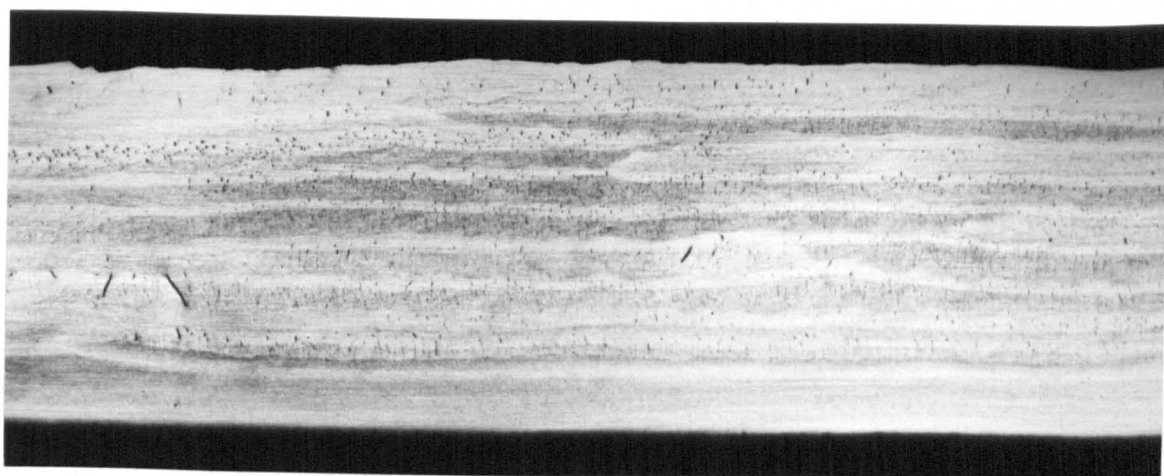
Figure 34 - Chevron cracks in manual metal arc welds.

(b) Deposited with electrodes C2. TP48. 1x.

(c) Deposited with electrodes C3. TP49. 1x.

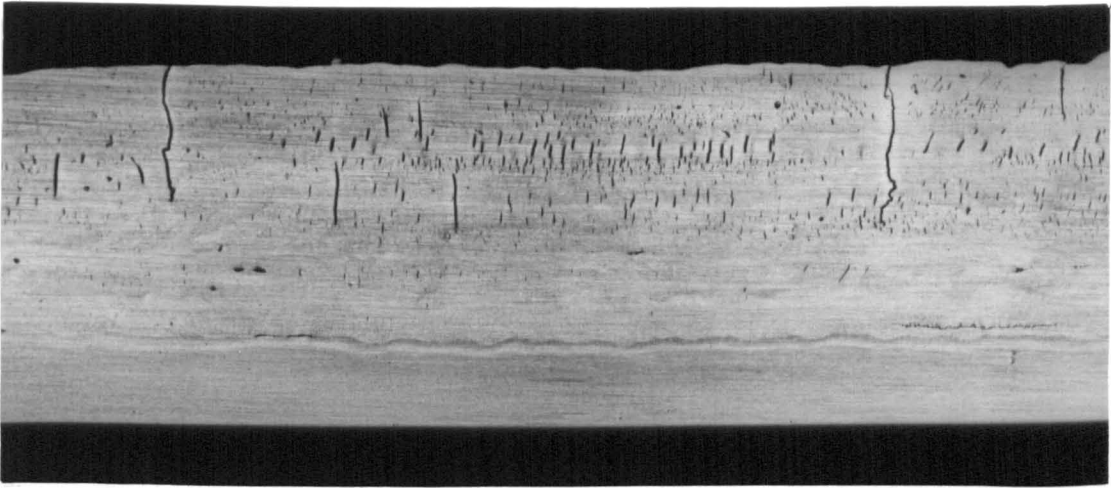
Figure 35 - Vertical cracks in a manual metal arc weld with electrodes C5. TP51. 1x.

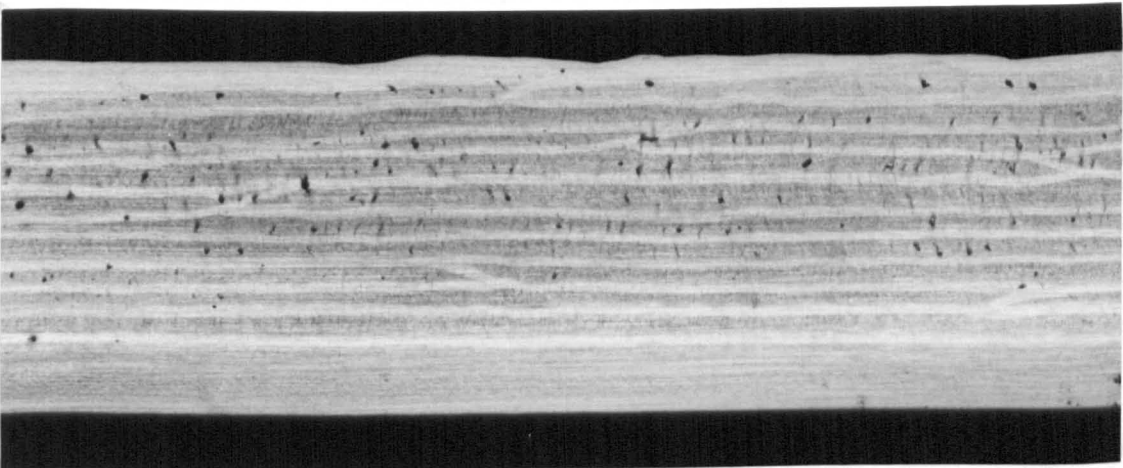
Figure 36 - Porosity in a manual metal arc weld with rutile electrodes R1. TP52. 1x.

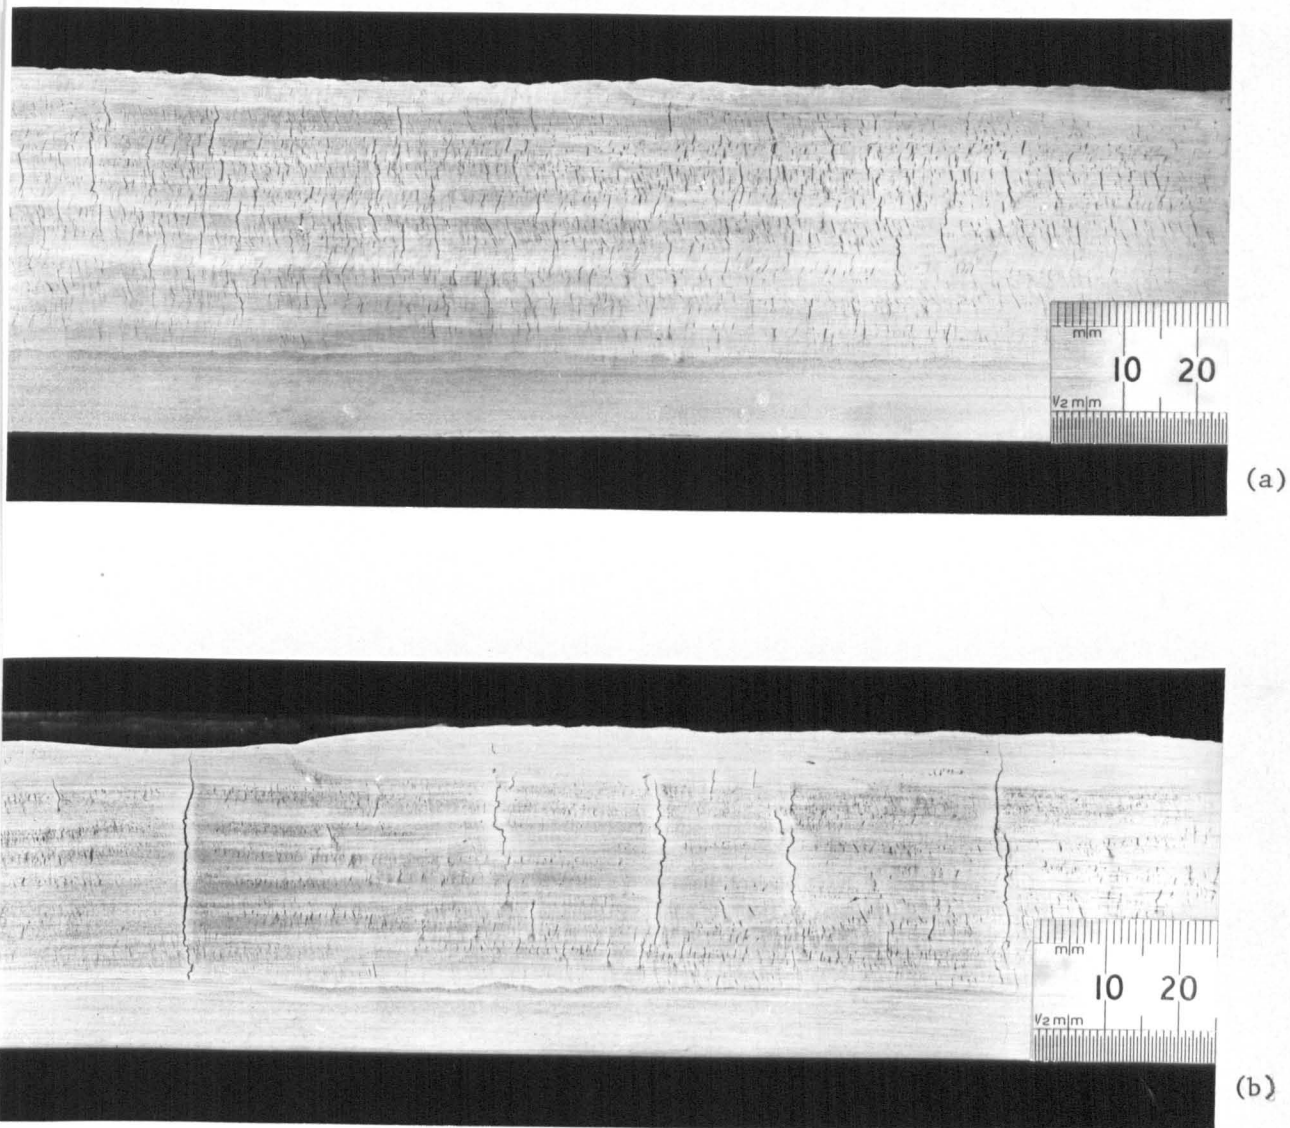
Figure 37 - Vertical cracks in manual metal arc welds with electrodes B5Ni.

(a) Weld with electrodes in the as received condition. TP62. 1x.

(b) Weld with electrodes baked at 400°C. TP63. 1x.

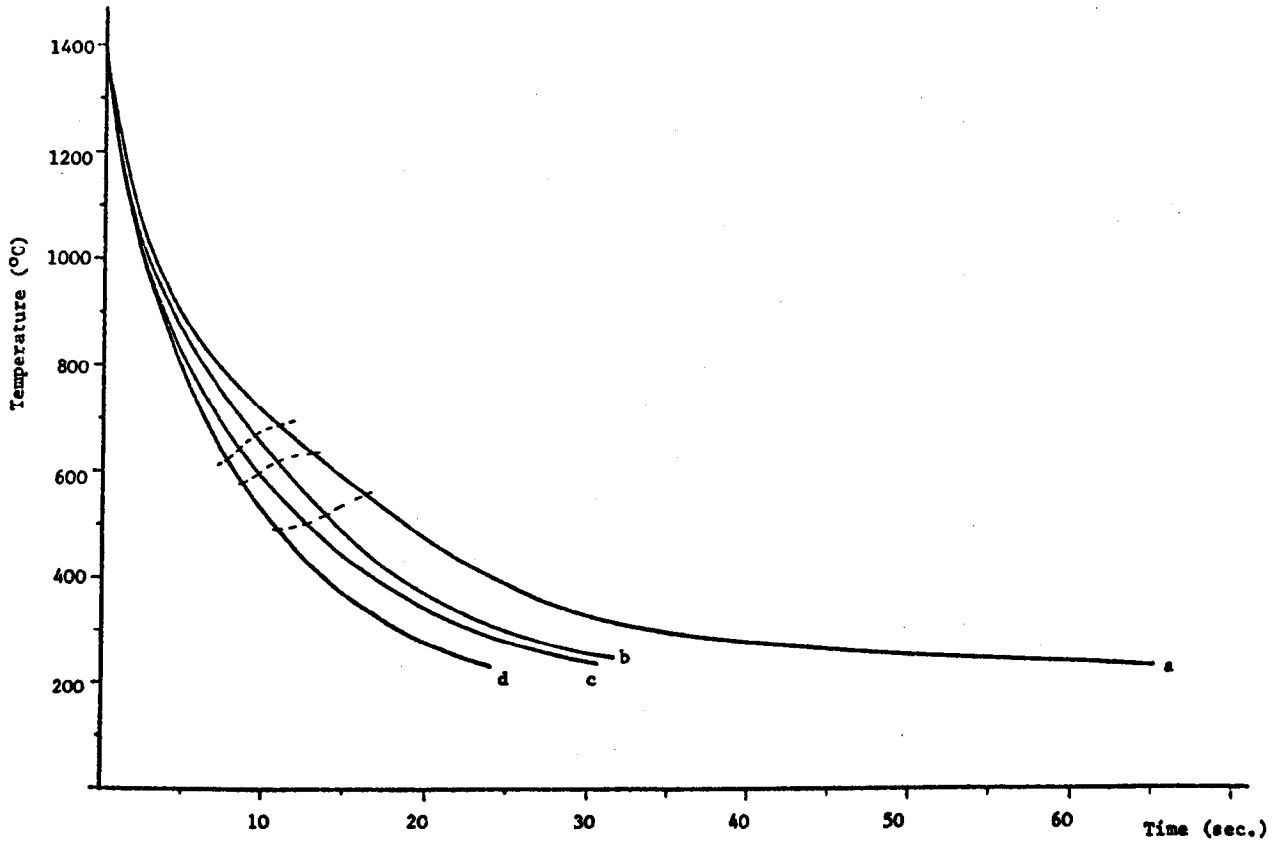
a. 90°C pre-heat, no water cooling.

b. No pre-heat, no water cooling.

c and d. No pre-heat, cooling water flow rate 15ℓ/min.

Figure 38 - Weld metal cooling curves between 1400° and 300°C observed during the continuous water cooling test. (Heat input 2.4 kJ/mm, except for d which was 1.6 kJ/mm).

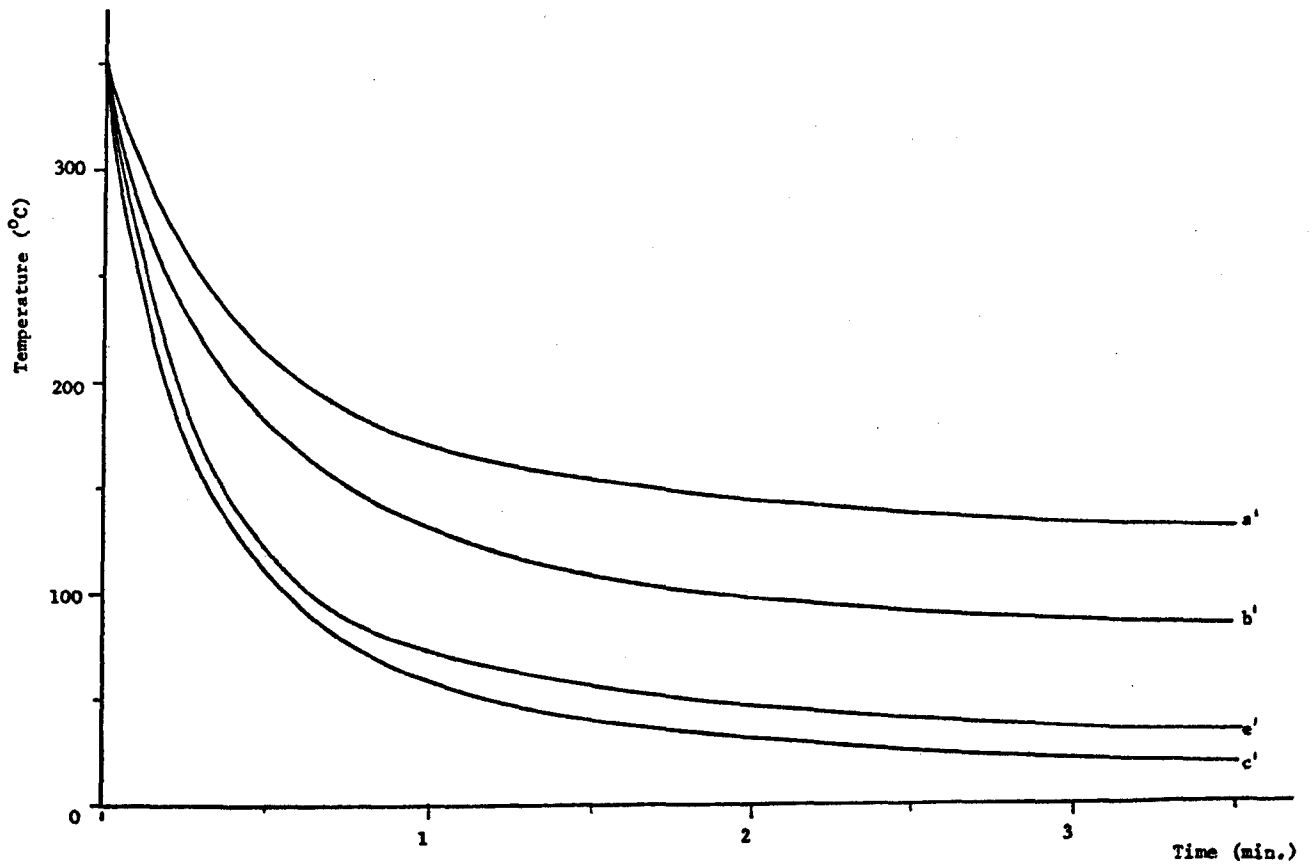
- a' 90°C pre-heat, no water cooling.
- b' No pre-heat, no water cooling.
- c' No pre-heat, cooling water flow rate 15ℓ/min.
- e' No pre-heat, cooling water flow rate 1ℓ/min.

Figure 39 - Weld metal cooling curves below 350°C observed during the continuous water cooling test. (Heat input 2.4 kJ/mm).

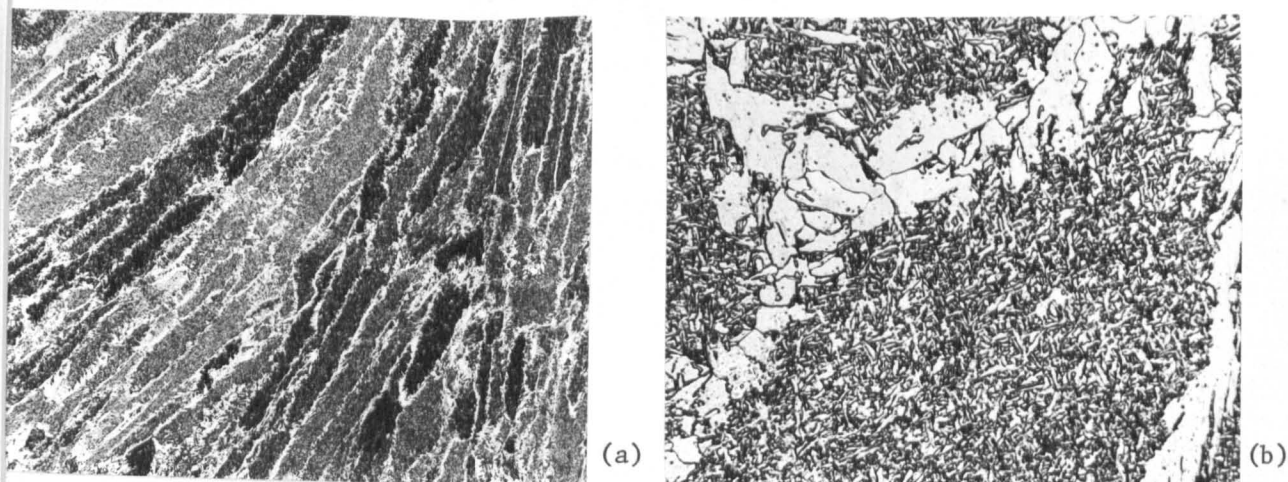
Figure 42 - Microstructure of a submerged arc weld deposited with the wire-flux combination. SD3 + OP41TT. TP6.

(a) 50x. (b) 500x (reduced 30% on reproduction).

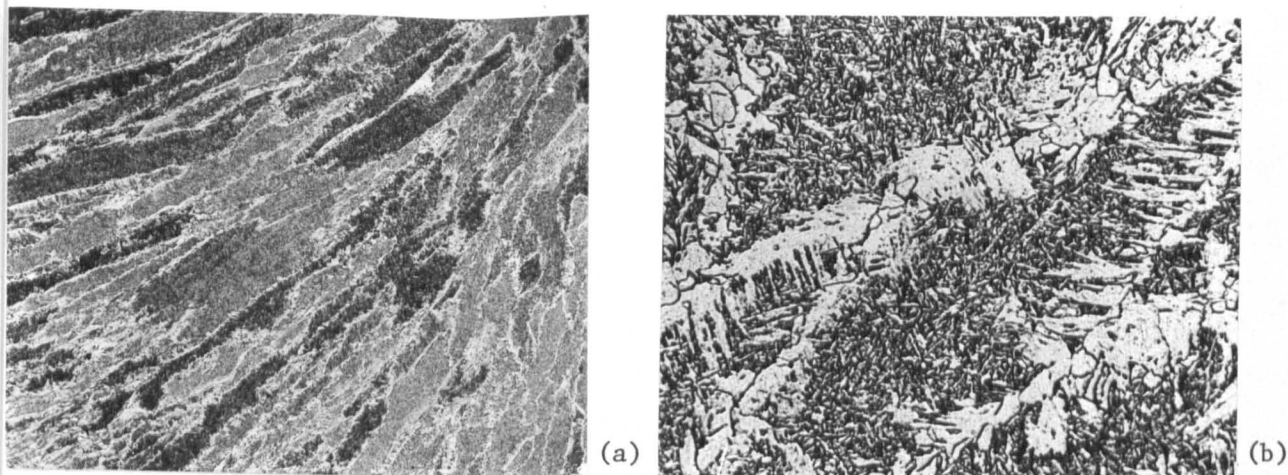
Figure 43 - Microstructure of a submerged arc weld deposited with the wire-flux combination S4 + OP41TT. TP9.

(a) 50x. (b) 500x (reduced 30% on reproduction).

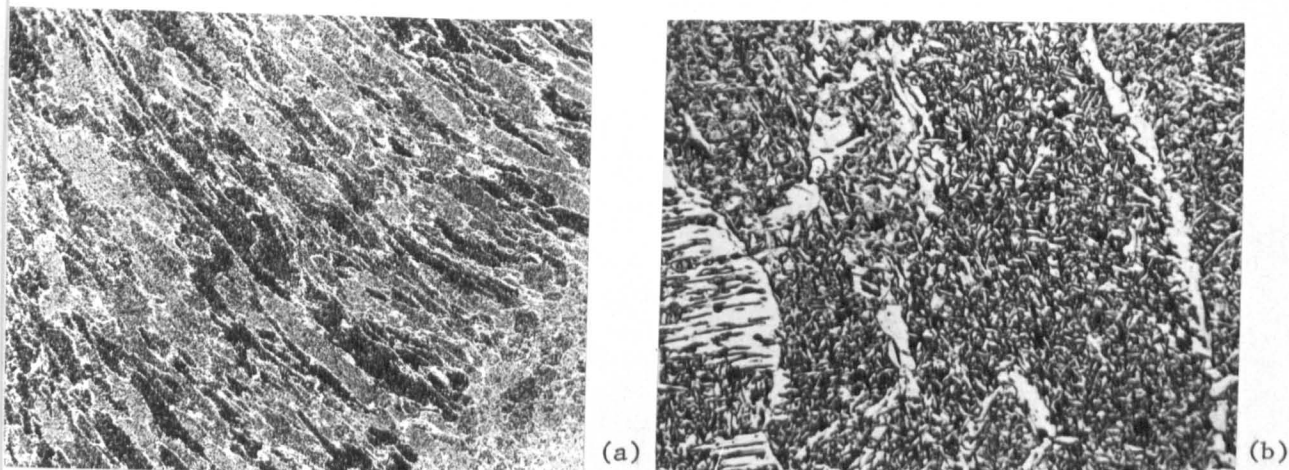
Figure 44 - Microstructure of a submerged arc weld deposited with the wire-flux combination SD3/1Ni + OP41TT. TP11.

(a) 50x. (b) 500x (reduced 30% on reproduction).

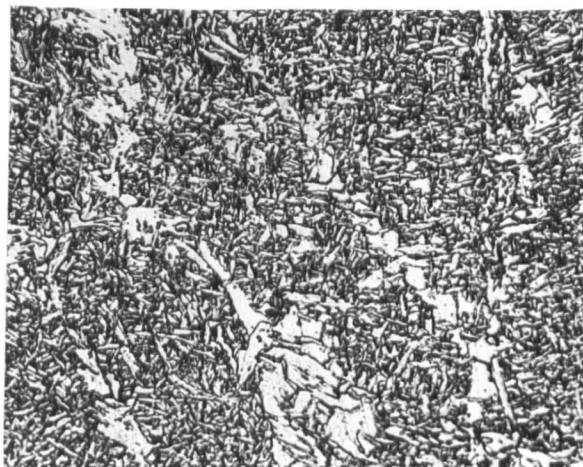
Figure 46 - Microstructure of a submerged arc weld deposited with the wire-flux combination SD2/3Ni + OP41TT. High heat input weld by Crouch (7).

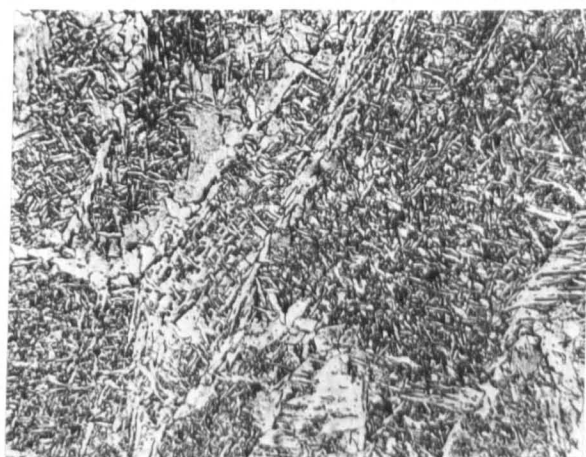
Figure 52 - Microstructure of a manual metal arc weld deposited with E8018C1 electrodes (from manufacturer B, batch 2). TP37.

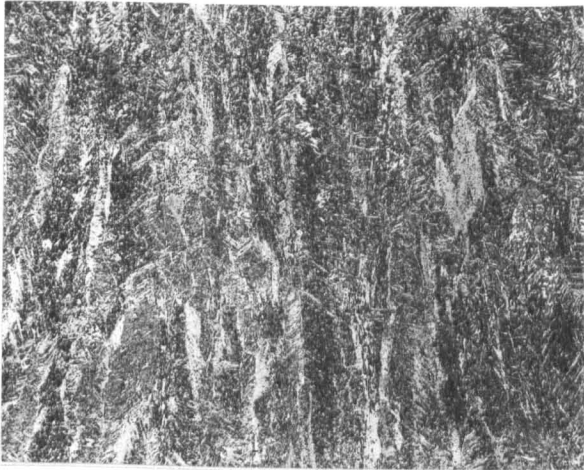
Figure 56 - Microstructure of a manual metal arc weld deposited with electrodes B4. TP44.

(a) 50x. (b) 500x (reduced 30% on reproduction).

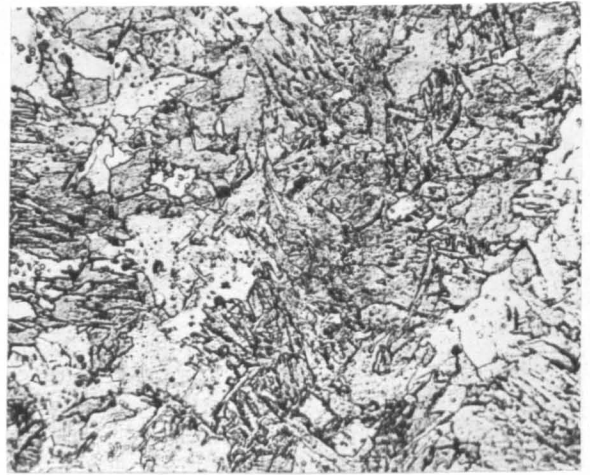
Figure 68 - Microstructure of a manual metal arc weld deposited with commercially available E6013 electrodes. TP39.

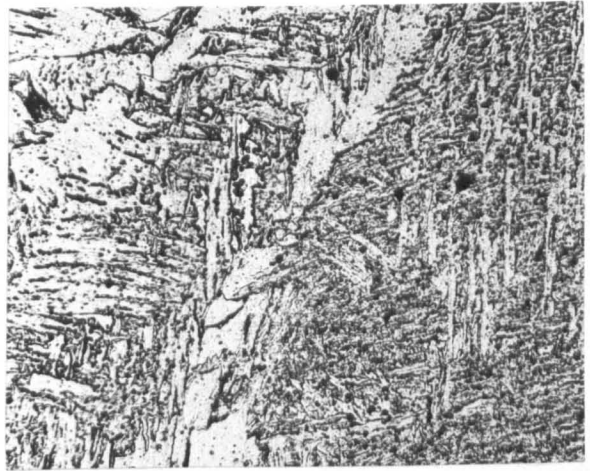
Figure 69 - Microstructure of a manual metal arc weld deposited with electrodes R1. TP52.

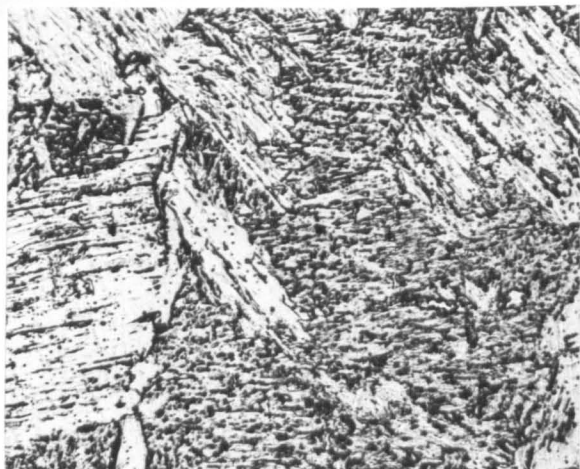
Figure 71 - Microstructure of a manual metal arc weld deposited with electrodes R3. TP54.

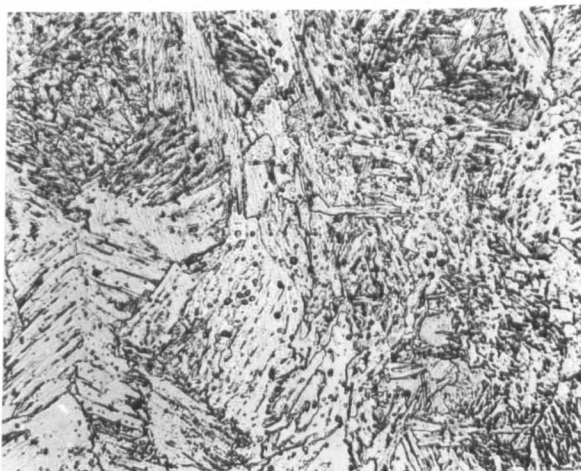
Figure 72 - Microstructure of a manual metal arc weld deposited with electrodes R4. TP55.
