CRANFIELD INSTITUTE OF TECHNOLOGY

Ph.D THESIS

J.M.F. MOTA

CHEVRON CRACKING IN STEEL WELD METALS

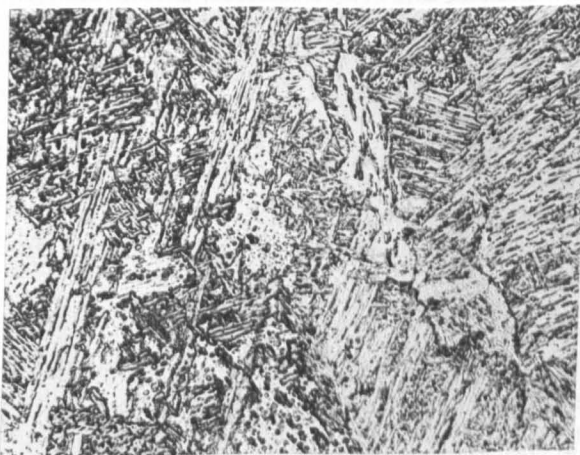
Figure 73 - Microstructure of a manual metal arc weld deposited with electrodes R5. TP56.

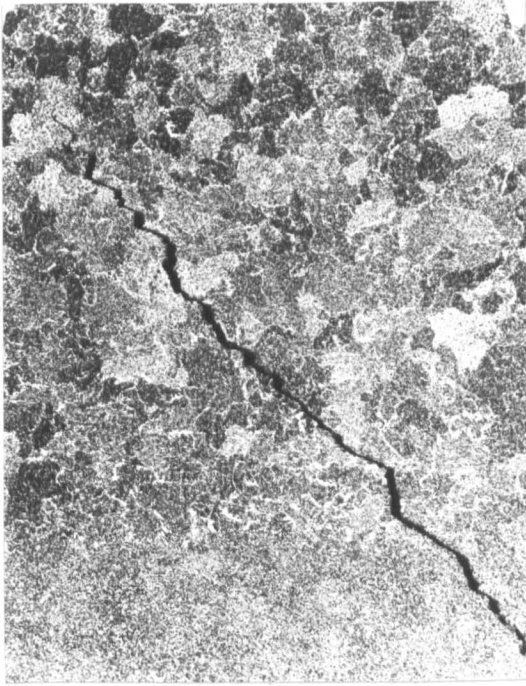
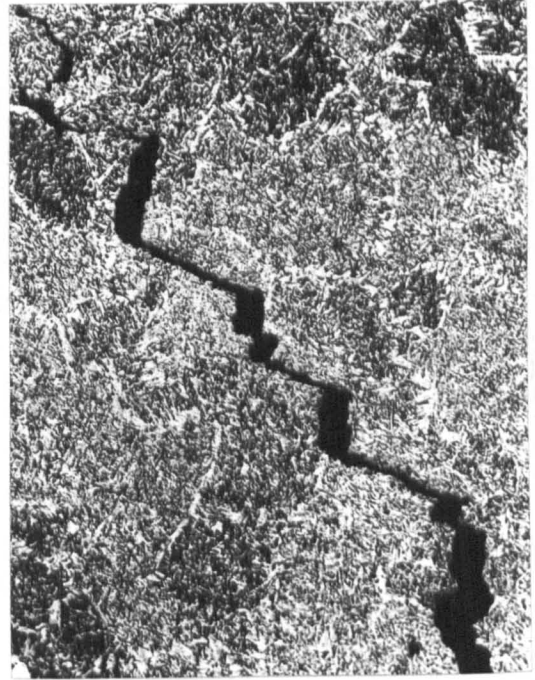
Figure 74 - Chevron crack in the industrial sample A.

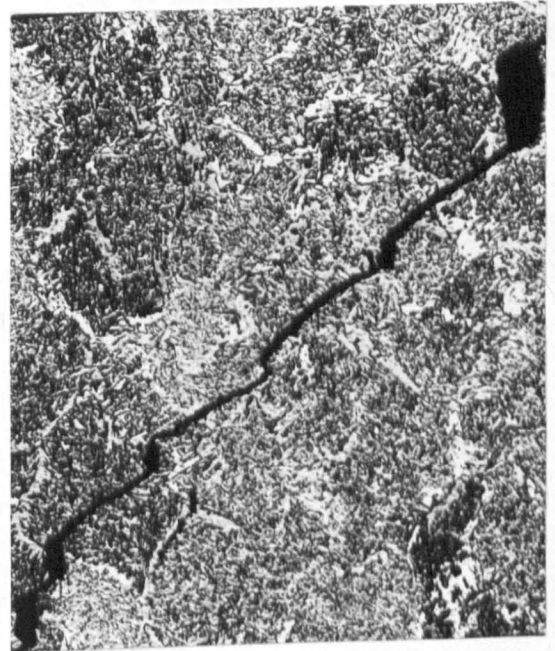
Figure 75 - Chevron crack associated with a pore. Industrial Sample A.

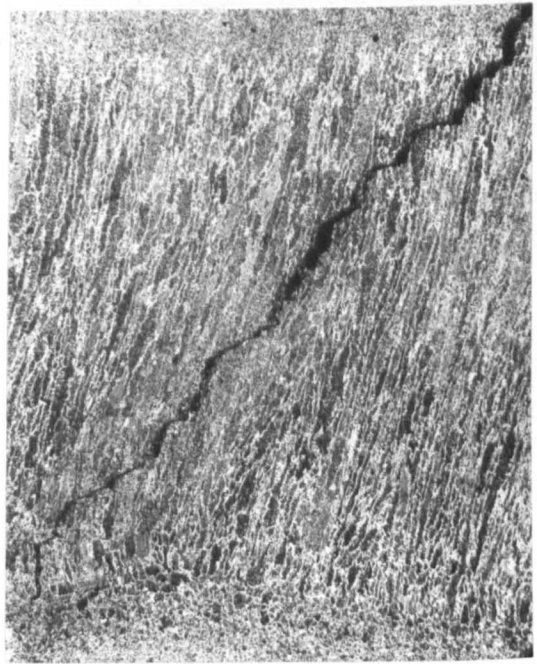
Figure 76 - Chevron cracks in the industrial sample B.
(a) and (b) 20x.

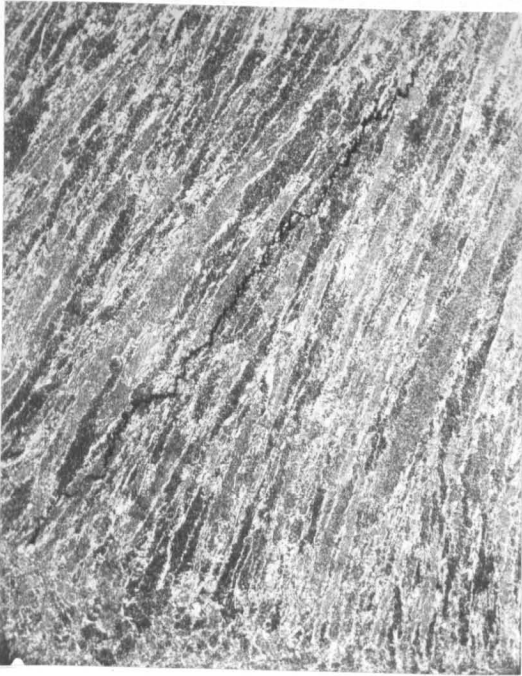
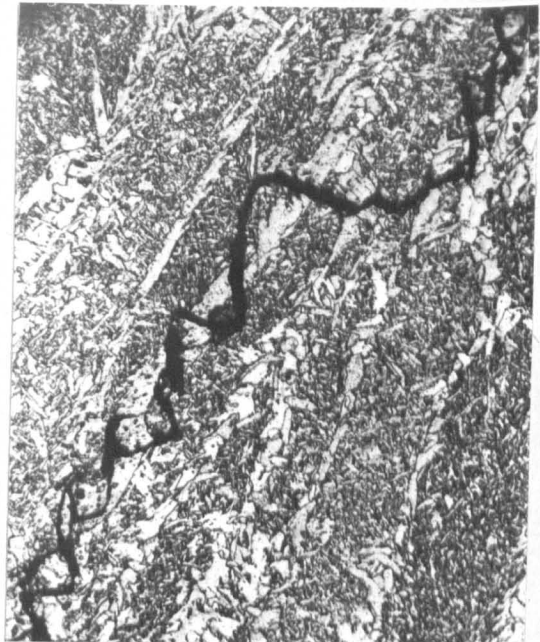
Figure 77 - Chevron crack in a submerged arc weld with the wire-flux combination SD3/1Ni + OP41TT. TP12.

(a) 40x.

(b), (c) and (d) details from (a). 400x.

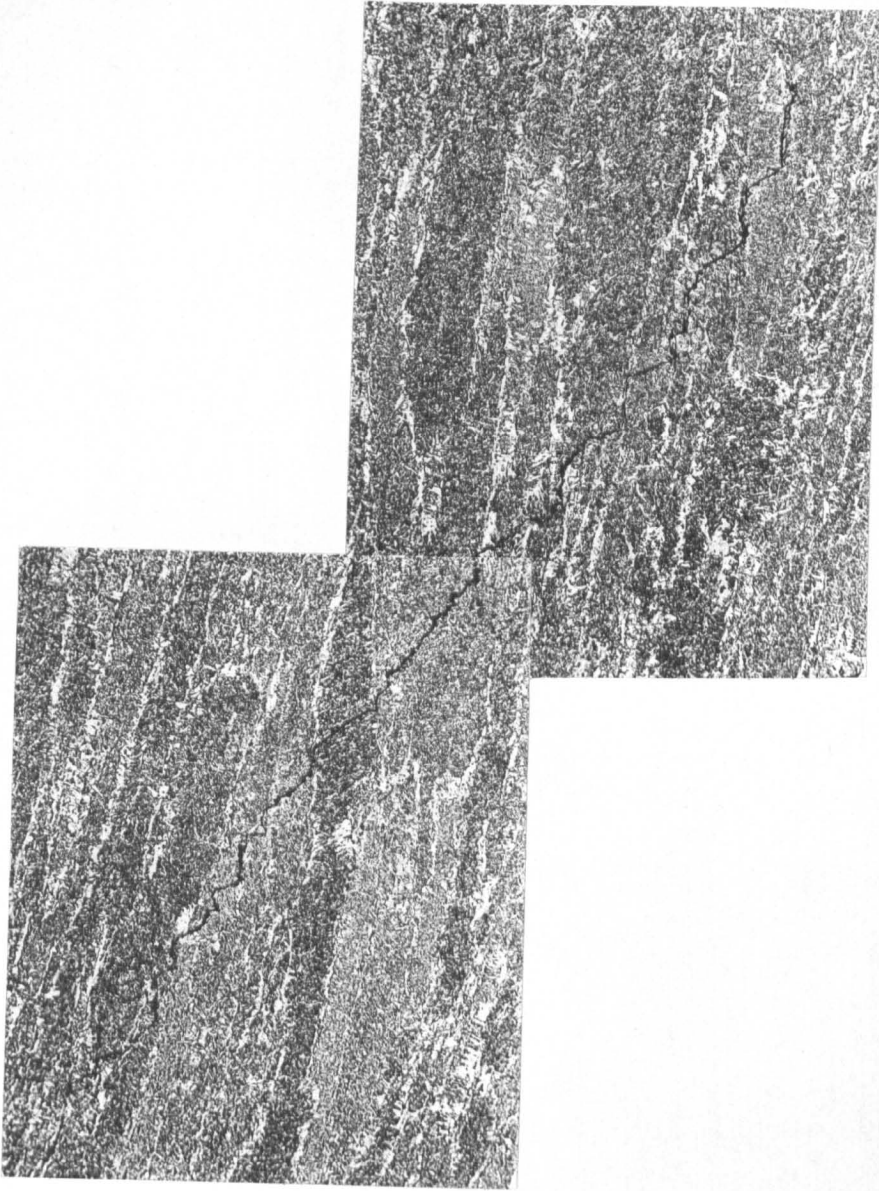
Figure 78 - Chevron crack in a submerged arc weld with the wire-flux combination SD2/3Ni + OP41TT. TP17. 120x.

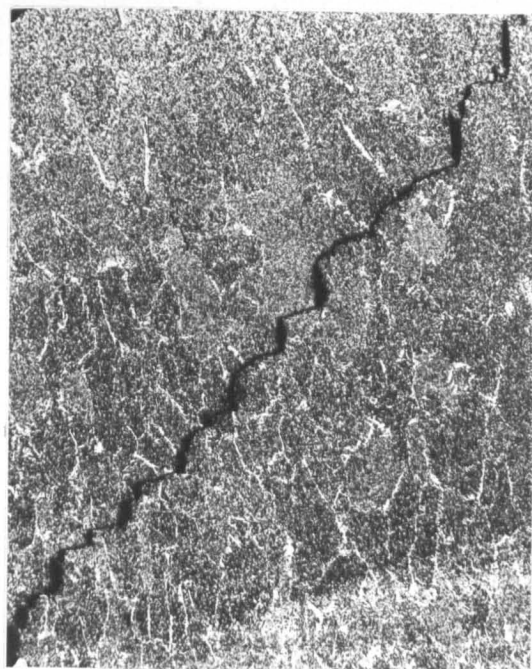
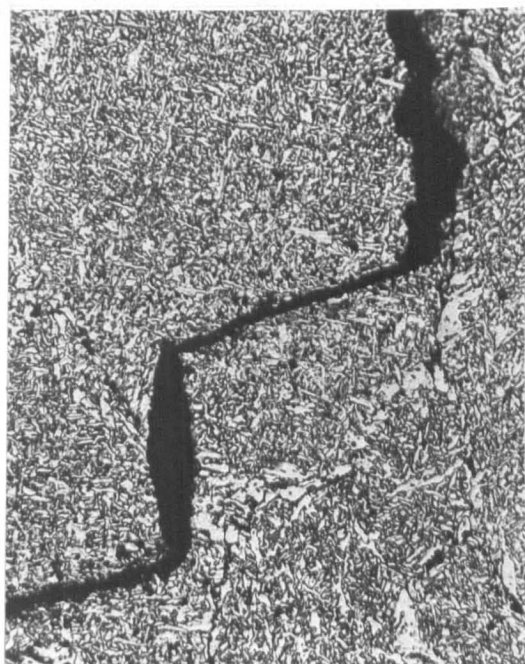
Figure 79 - Chevron crack in a submerged arc weld with the wire-flux combination SD3/Mo + OP41TT. TP21.

(a) 60x, (b) Detail, 400x.

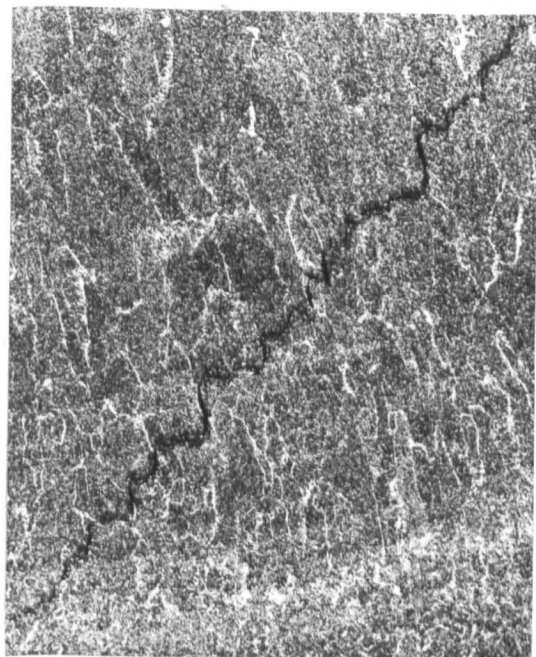
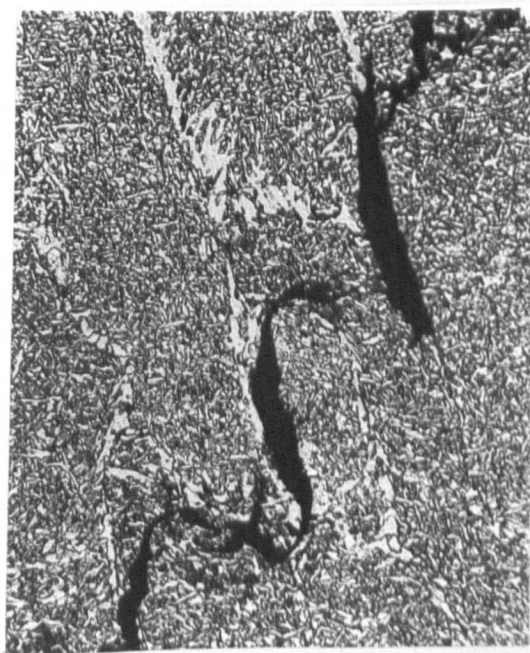
Figure 80 - Chevron crack in a submerged arc weld with the wire-flux combination SD3/Mo + OP41TT showing incomplete linking between vertical components. TP21.

(a) 60x. (b) Detail, 400x.

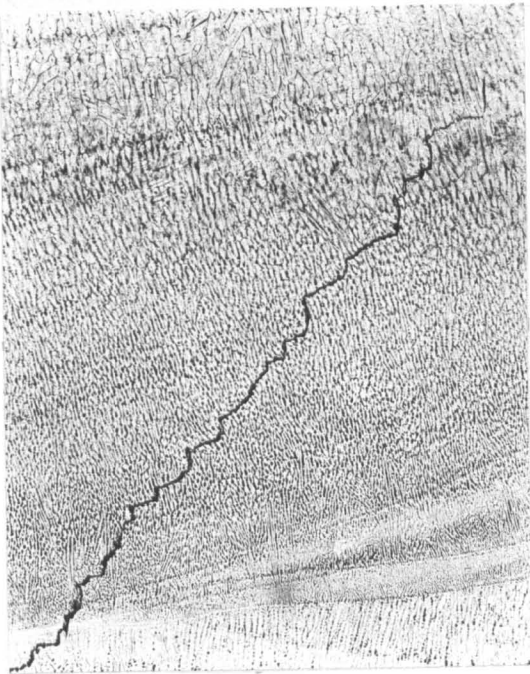
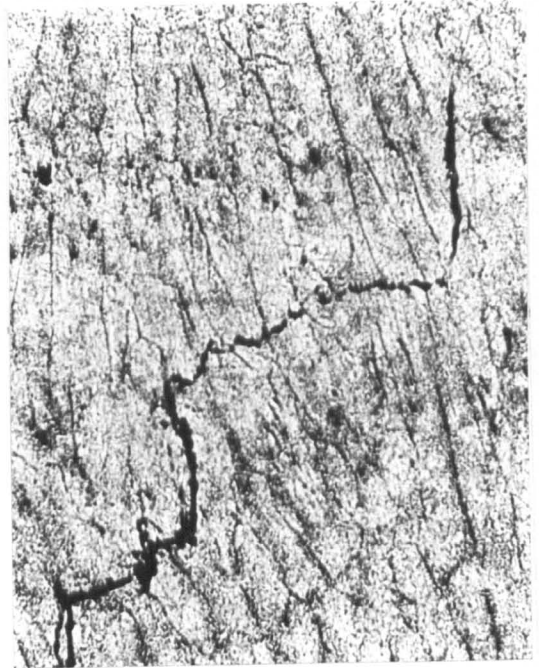
Figure 81 - Chevron crack in a submerged arc weld with the wire-flux combination SD3/Mo + OP41TT. TP21. (same crack as in Figure 79). Saspanansa etch.

(a) 40x. (b) Detail, 200x.

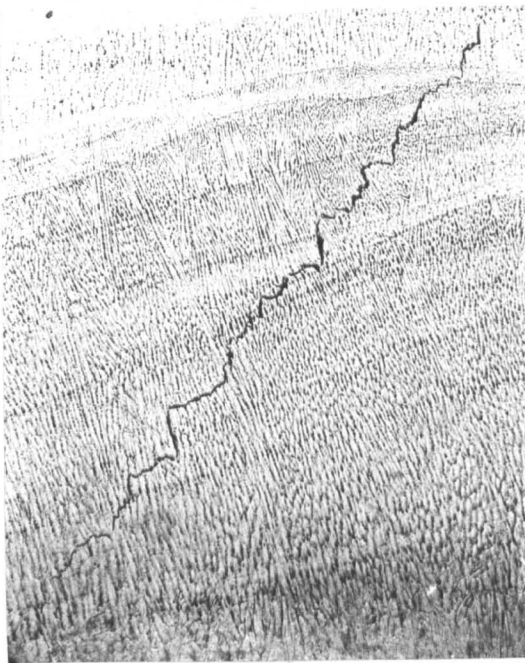
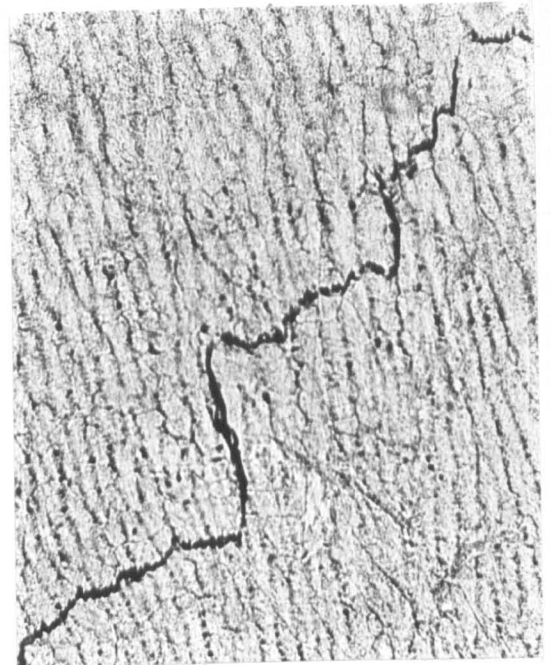
Figure 82 - Chevron crack in a submerged arc weld with the wire-flux combination SD3/Mo + OP41TT. TP21. (Same crack as in Figure 80). Saspanansa etch.

(a) 40x. (b) Detail, 200x.

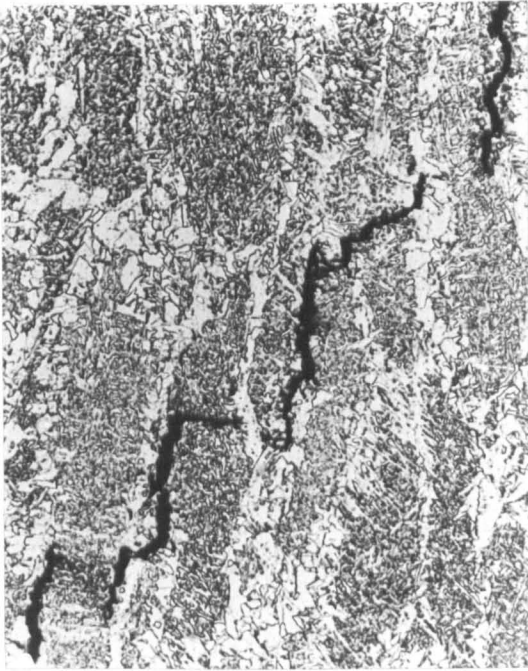
Figure 83 - Detail of a chevron crack in a manual metal arc weld with electrodes E8018C1. TP29. 200x.

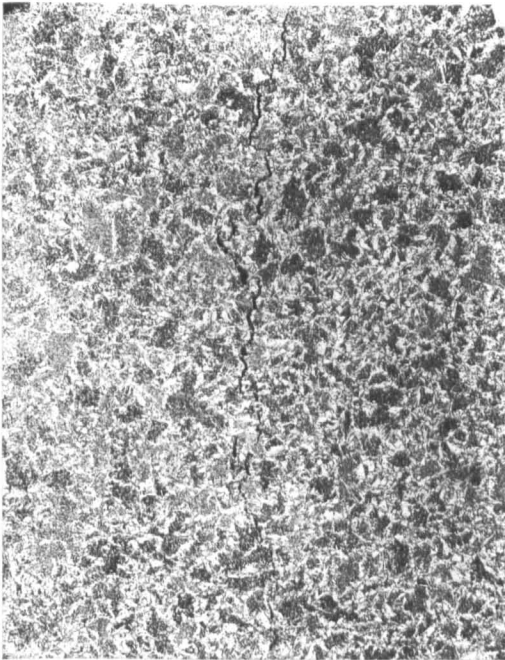
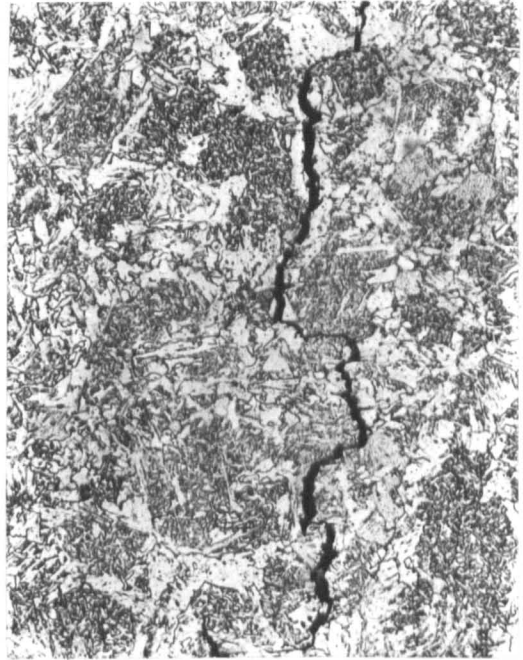
Figure 84 - Chevron crack in a manual metal arc weld with electrodes E8018C1 as observed in the longitudinal horizontal plane (parallel to the plane of the plates). TP29.

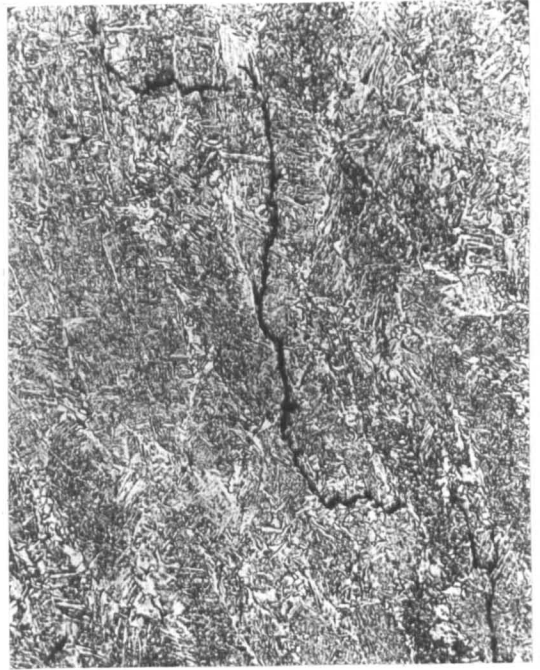
Figure 85 - Chevron crack in a manual metal arc weld with electrodes B1. TP40.

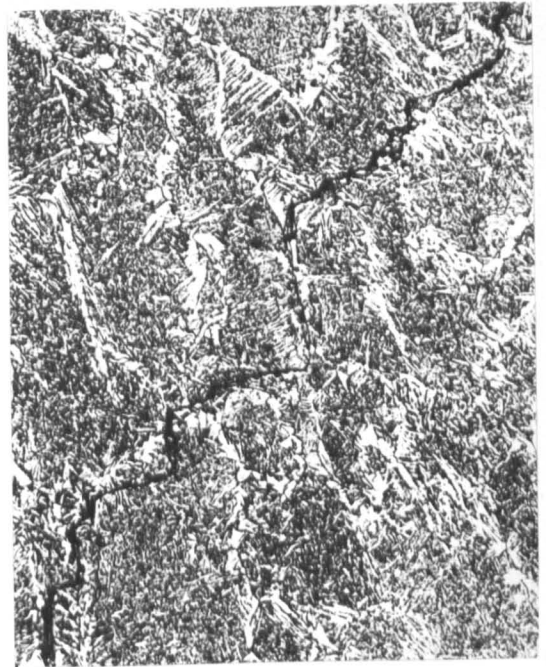
Figure 86 - Chevron crack in a manual metal arc weld with electrodes C1. TP47.

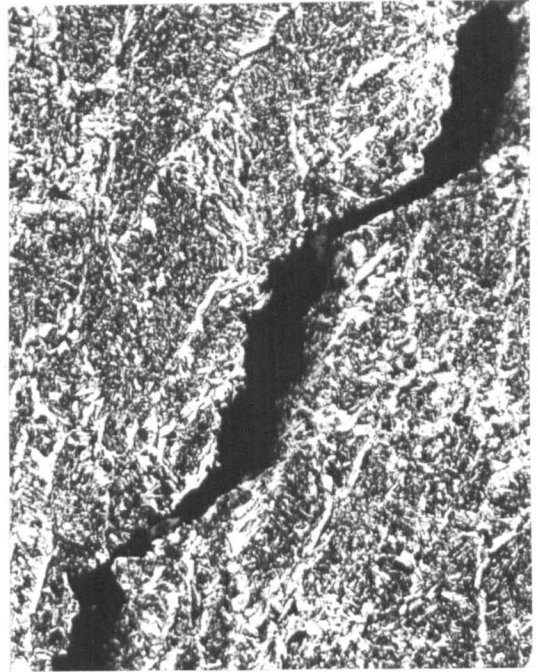
Figure 87 - Wide open chevron crack in a manual metal arc weld with electrodes C1. TP47.

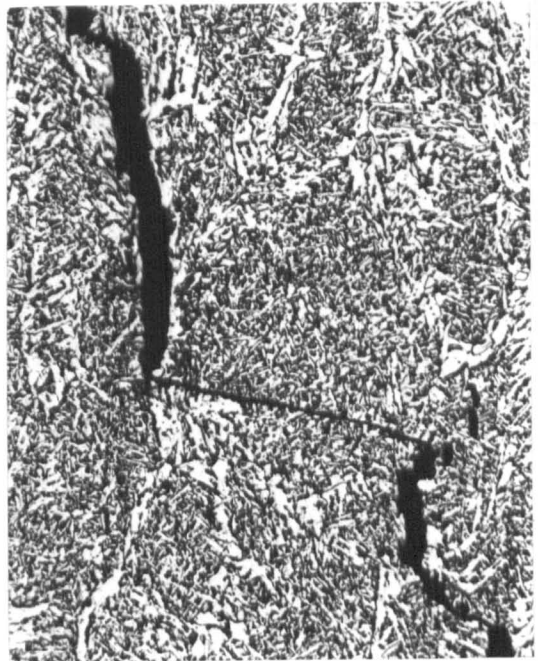
Figure 88 - Chevron crack in a manual metal arc weld with electrodes C4. TP50.

(a) 60x.

(b) Detail 400x.

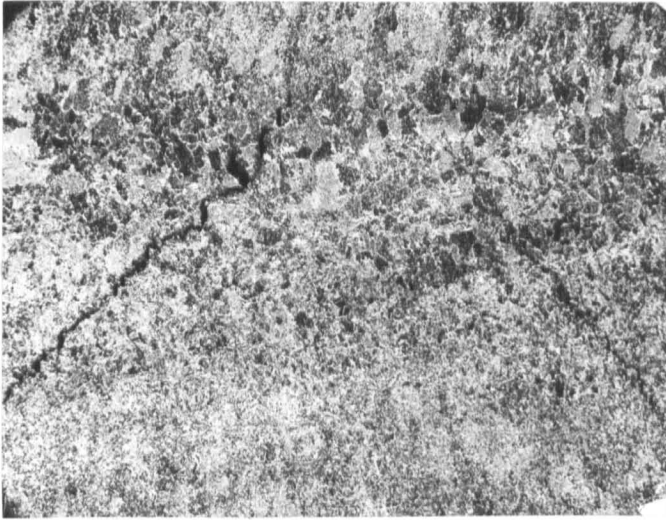
Figure 89 - Chevron cracks with different orientations in the same run. Manual metal arc weld with electrodes E8018C1. TP35. 20x.

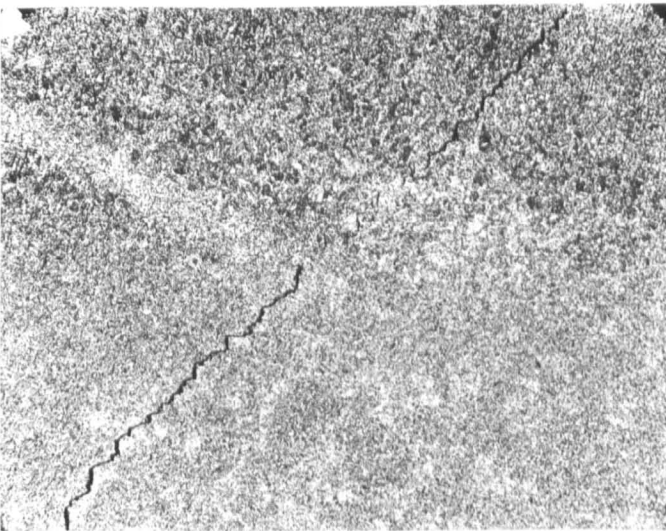
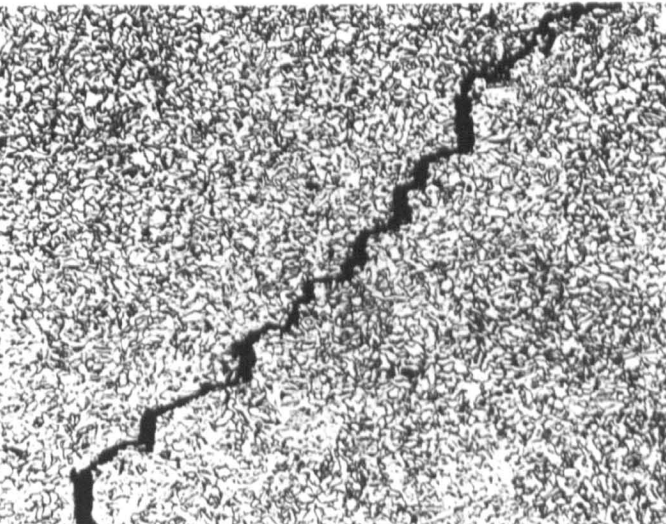
Figure 90 - Chevron crack in the refined region of a manual metal arc weld with electrodes B2. TP42.
(a) 40x. (b) Detail 200x

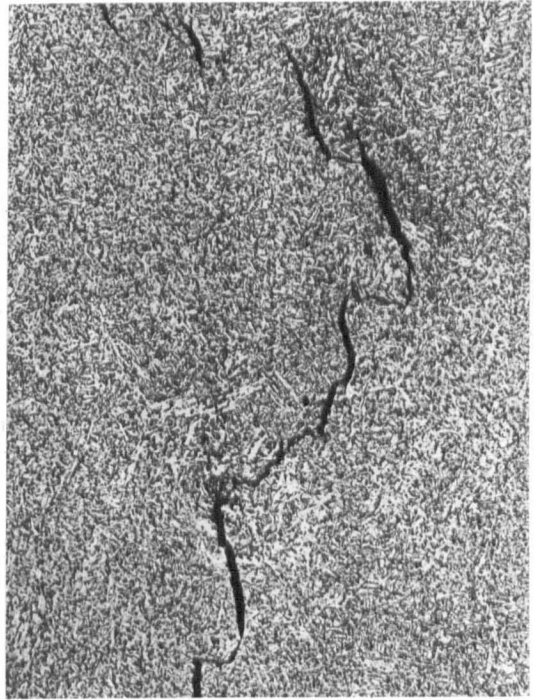
Figure 93 - Vertical crack with a morphology reminiscent of a chevron crack. Submerged arc weld deposited with the wire-flux combination SD3/1Ni $\frac{1}{2}$ Mo + OP41TT. TP24.

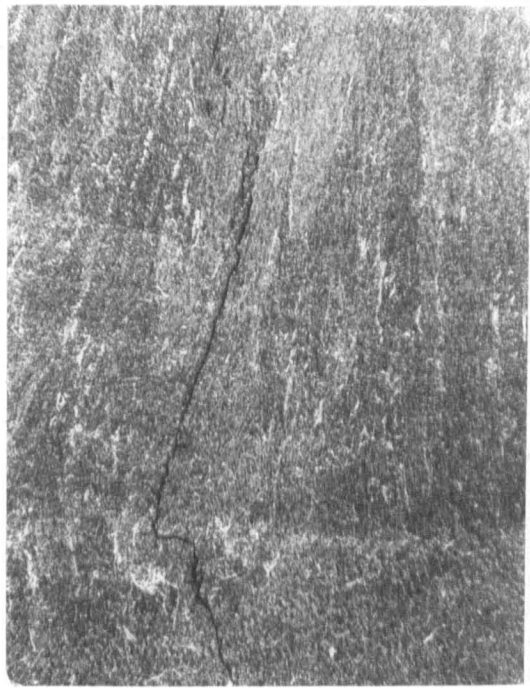
Figure 94 - Vertical cracks without typical cracking path. Submerged arc weld deposited with the wire-flux combination SD3/1Ni $\frac{1}{2}$ Mo + OP41TT. TP24.

(a) and (b) 80x.

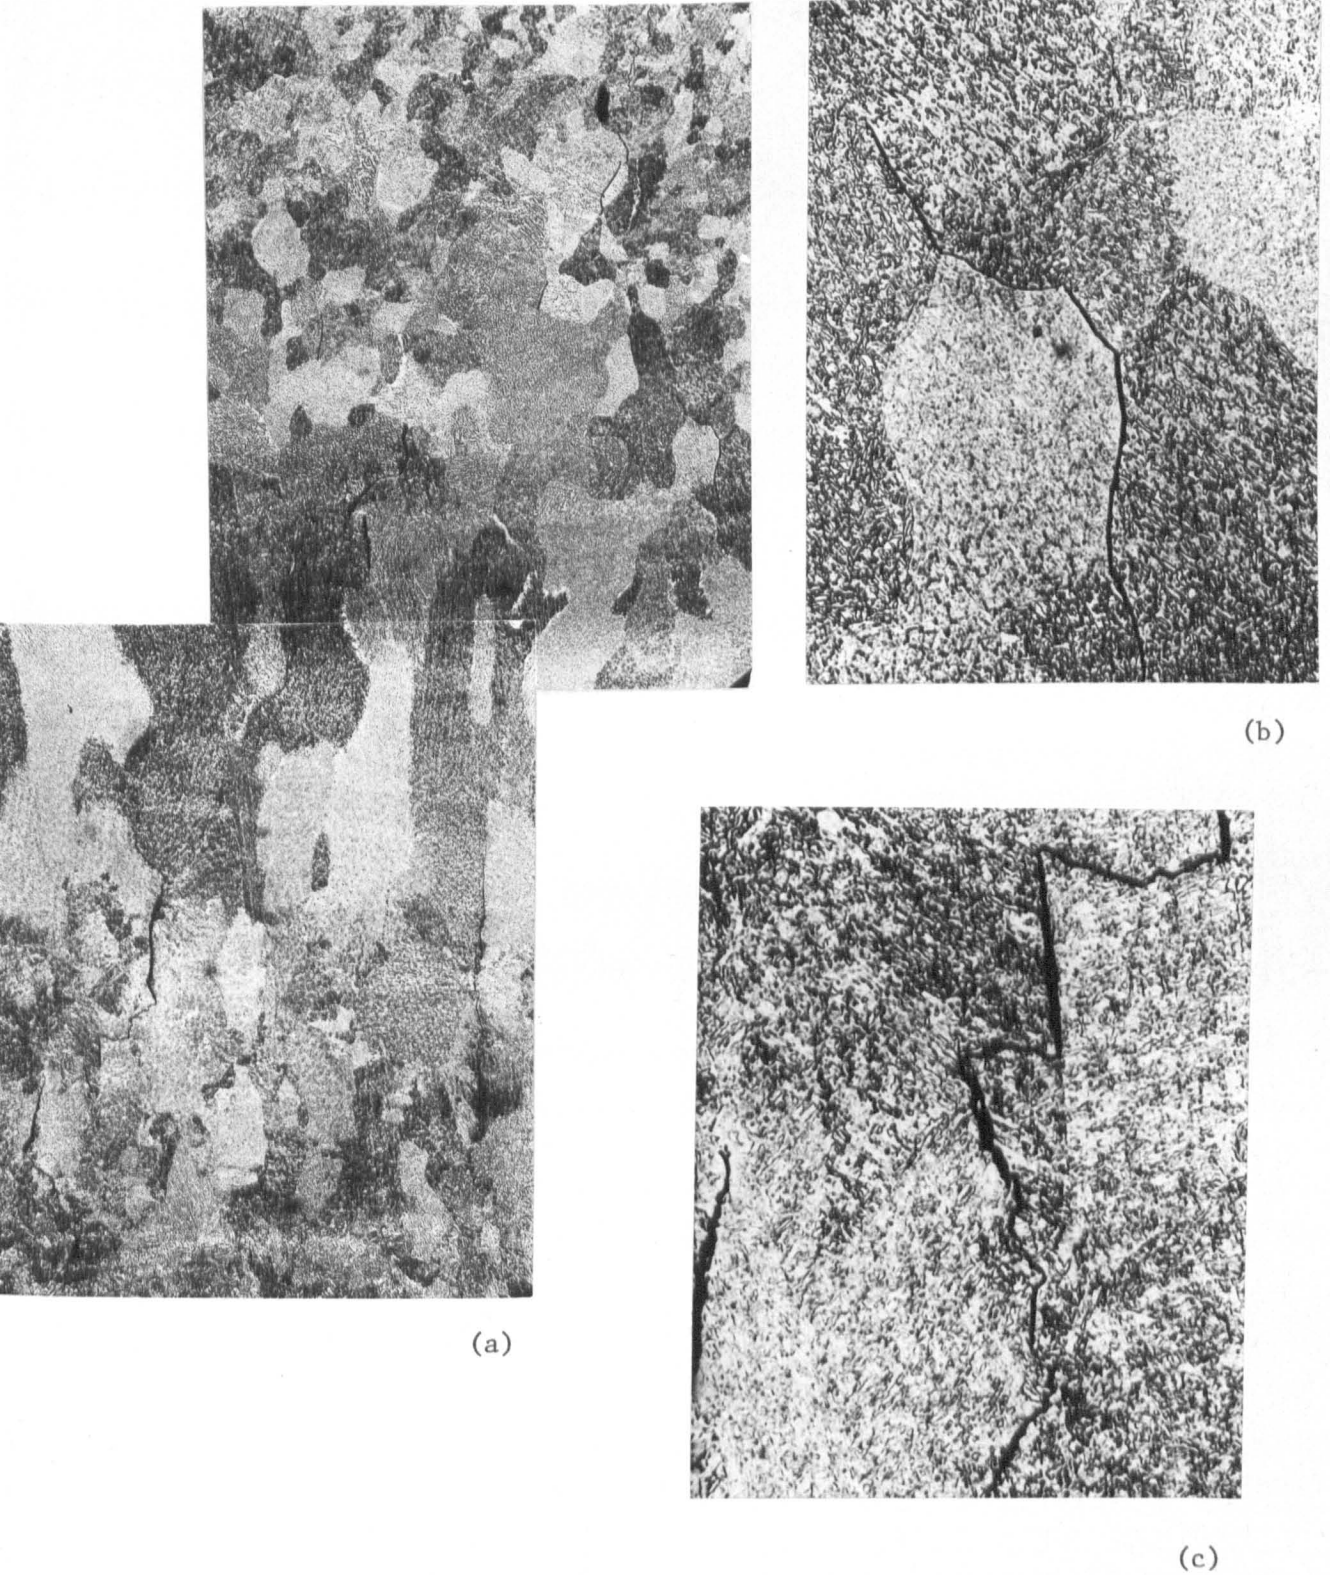
Figure 95 - Vertical cracks in a manual metal arc weld deposited with electrodes B5Ni. TP62.

(a) 40x.

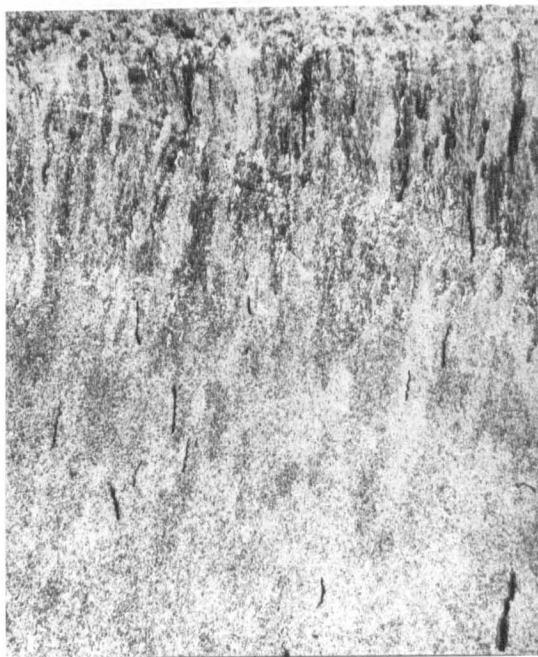
Figure 96 - Microfissures in manual metal arc welds.

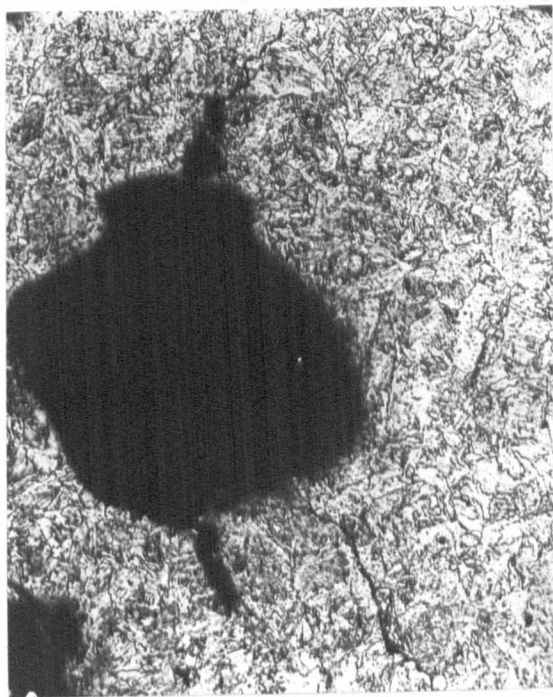
Figure 97 - Microfissures in manual metal arc welds.

(a) Deposited with electrodes E6013. TP39. 80x.

(b) Deposited with electrodes R4. TP55. 80x.

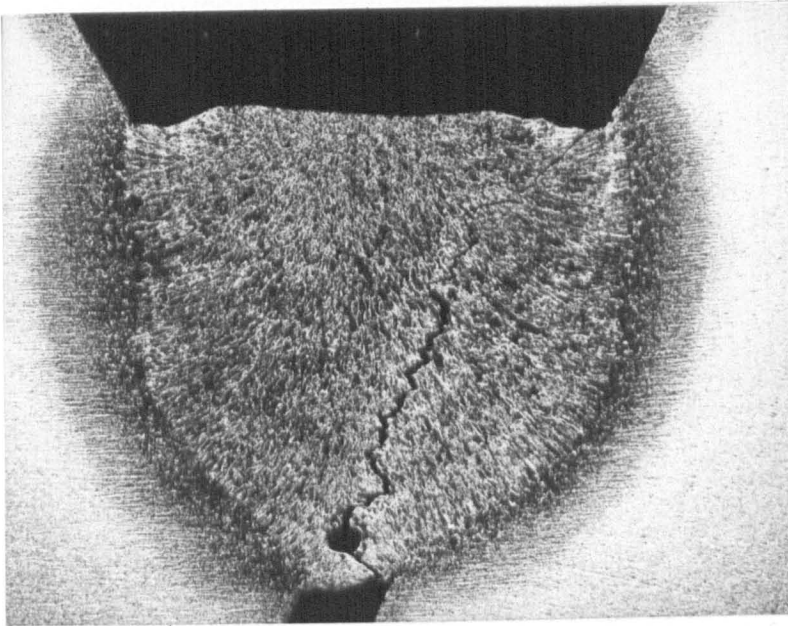
Figure 98 - Longitudinal crack with a staircase morphology produced in a Y groove Tekken test. Weld metal deposited with electrodes Cl. Cross section of the joint. 5x.

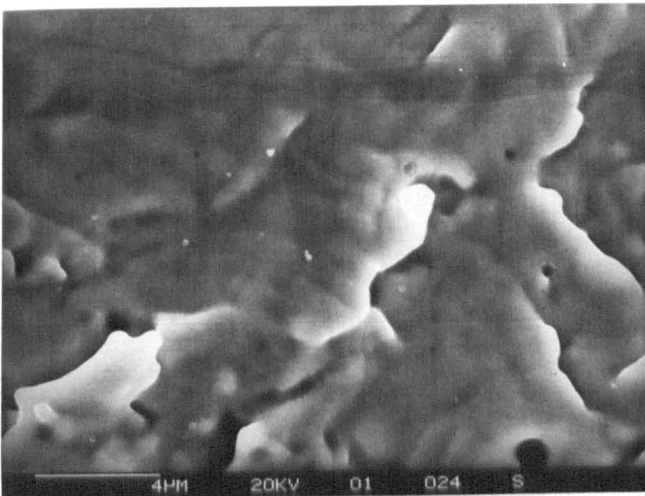
Figure 102 - Vertical component of a chevron crack which was exposed to high temperatures. Industrial sample B.

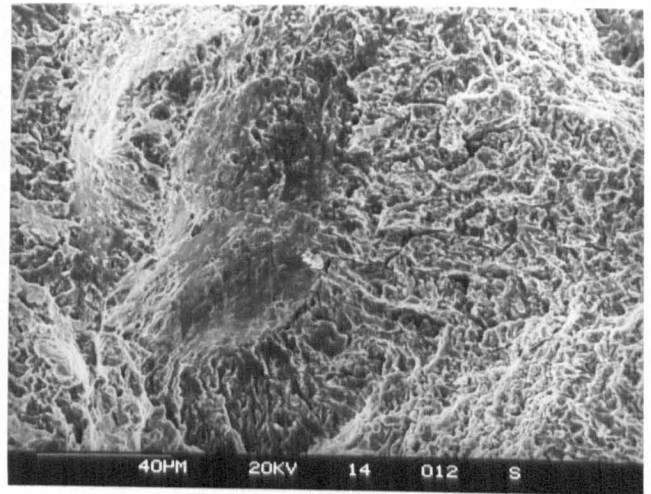
Figure 105 - Vertical component of a chevron crack in a submerged arc weld. TP21.

- (a) General aspect.
- (b) Detail from (a).
- (c) Another detail from (a).

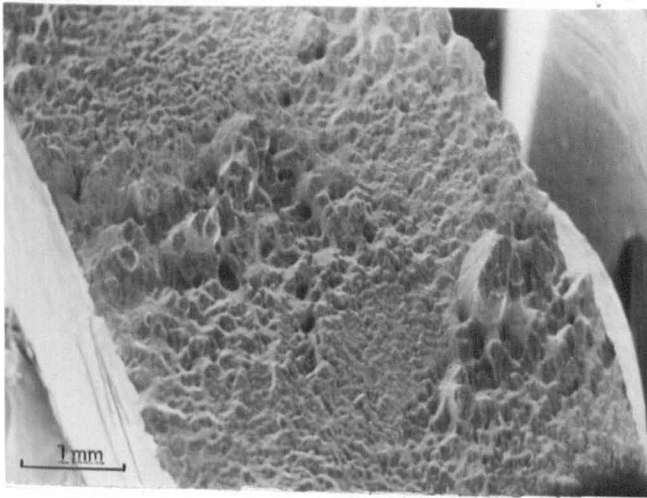
Figure 107 - Vertical components of a chevron crack in a manual metal arc weld. TP42.

- (a) General aspect. (b) Detail from (a). (c) Detail from (b).
- (d) Detail of a component nucleated at an inclusion.
- (e) Detail of a component showing inter and transgranular failure.
- (f) Detail of the centre of a component without clear origin.

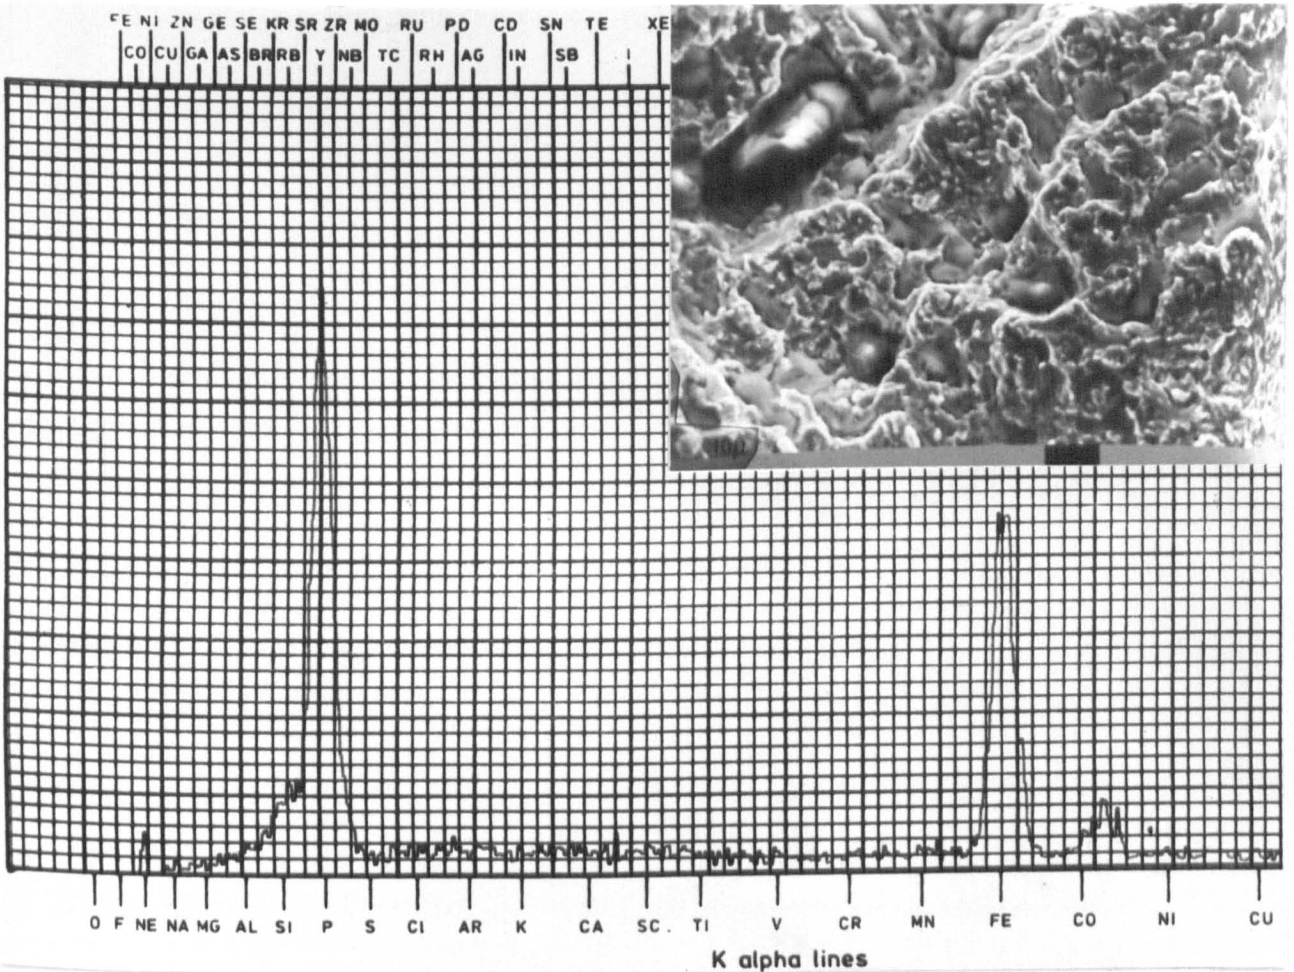
Figure 113 - Vertical crack in a submerged arc weld associated with phosphorous segregation. TP27.

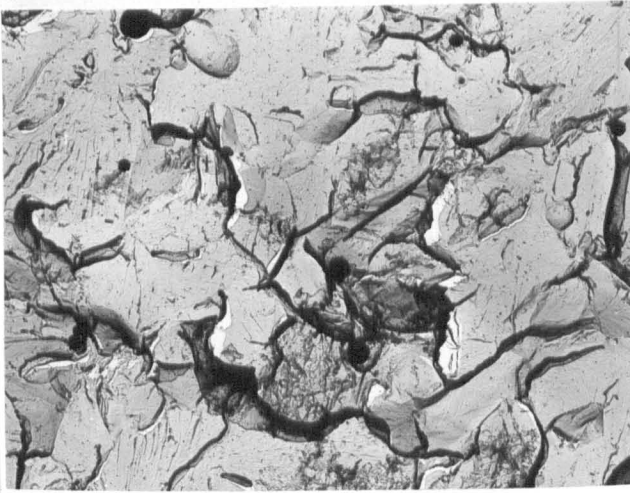
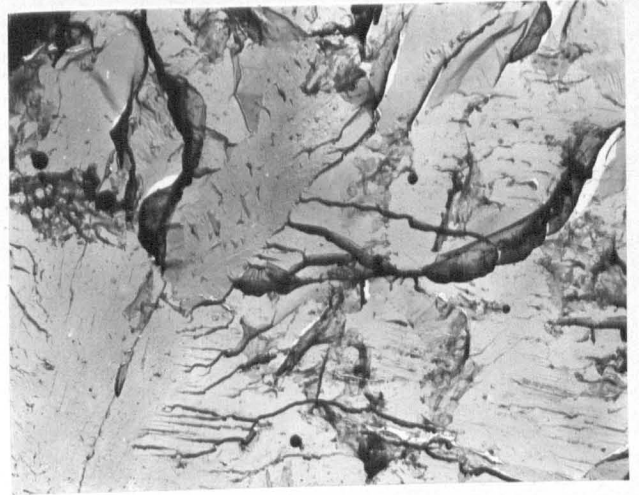
Figure 125 - (a) and (b) Thermal facets on the fracture surface of a chevron crack (same crack as in Figure 108). TP47. 15000x.

(a) General aspect, 5000x. (b) Detail, 18000x.
125. (a) and (b) Thermal facets on the fracture surface of a chevron crack (same crack as in Figure 108). TP47. 15000x. 207

Carbon extraction replicas from the fracture surface of chevron cracks were observed in the transmission electron microscope after having examined the corresponding surfaces on the scanning electron microscope. This work was intended to investigate the existence of very small features, such as thermal facets and thermal grooving, associated with a free surface exposed to high temperatures, which in general cannot be resolved by the scanning microscope. These features could be easily observed on replicas from the reheated chevron cracks mentioned in the previous section, Figure 124, or on replicas from fracture surfaces containing similar smooth areas, Figure 125. In other cases, for which the scanning microscope revealed only quasi-cleavage failure in the vertical components of the chevron cracks, no thermal facets or thermal grooving could be identified on the carbon replicas in spite of extensive search. Essentially it was confirmed that areas of dimples alternated with areas of quasi-cleavage, Figure 126. In a few cases thermal facets and grooving were found in very small, circular shaped areas, which were identified as voids (micropores or inclusion holes).

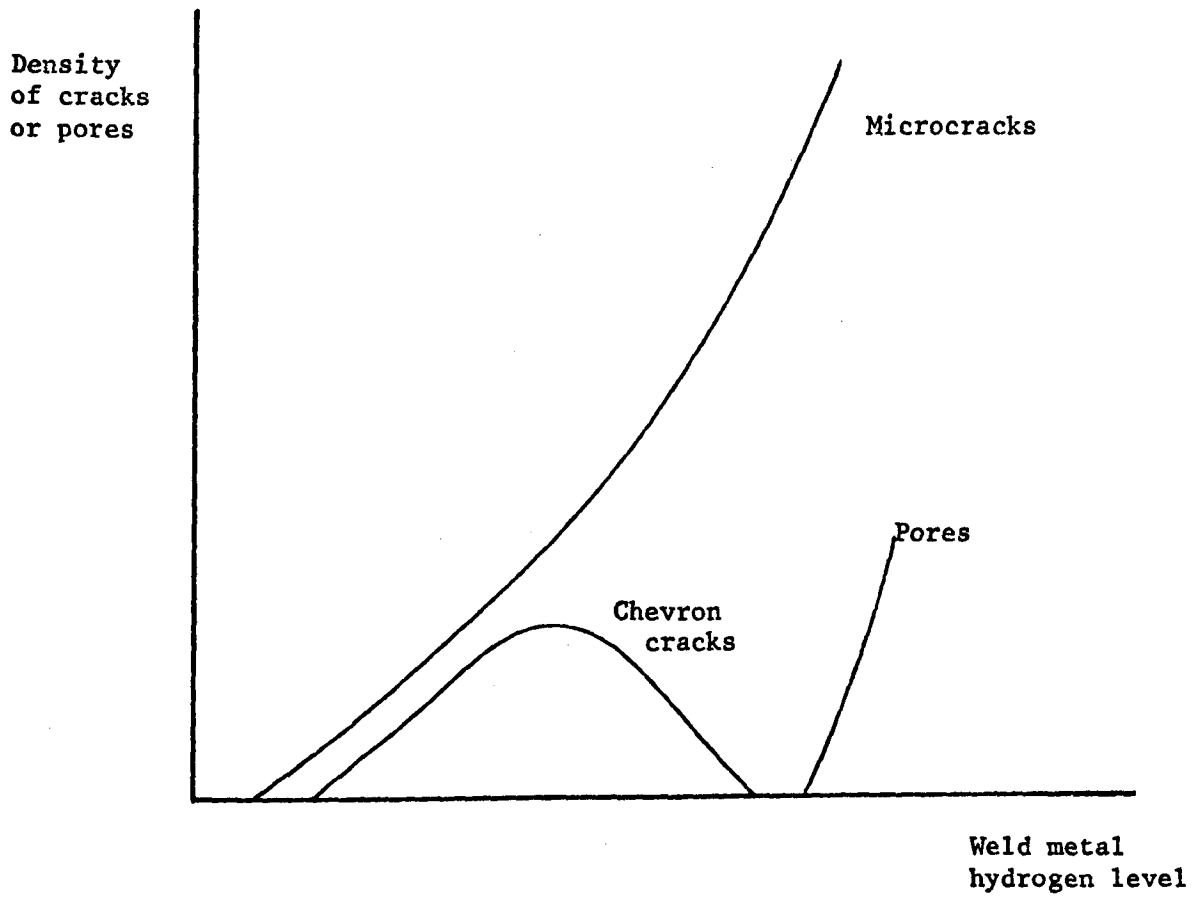
Figure 127 - Variation in the type and incidence of cracking with the hydrogen level in medium strength weld metals deposited with basic electrodes.
