CRANFIELD UNIVERSITY

INFLUENCE OF CORROSION DAMAGE ON THE INITIATION OF FATIGUE CRACKS IN HIGH STRENGTH STAINLESS STEELS

M.Phil Thesis

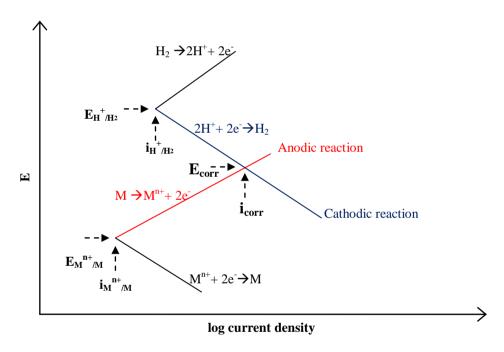
Figure 2-2: Evans diagram for a metal corroding in acid solution

Curves, called polarisation curves, representing the behaviour of the potential as a function of the logarithm of the current density can be used to predict the corrosion rate. For a given corrosion cell, the polarisation curves for the anodic and cathodic reactions are schematically plotted in the same diagram, called an Evans diagram, to assess the corrosion rate and the influence of a change in the corrosion potential or the corrosion current on the corrosion rate, as illustrated in Figure 2-2.

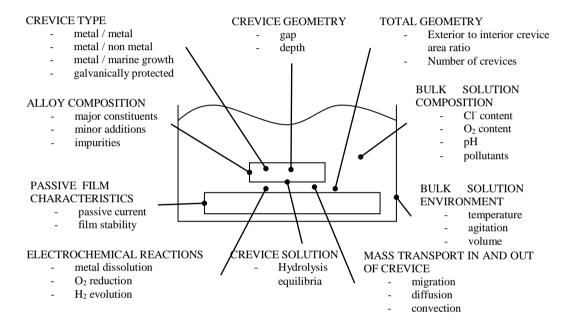
Figure 2-6: Factors affecting crevice corrosion [12]

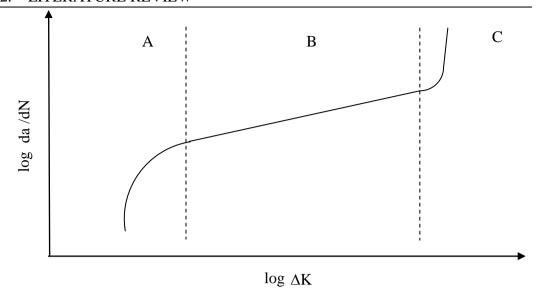
Figure 2-9: Schematic plot of the fatigue crack growth rate as a function of the stress intensity factor range

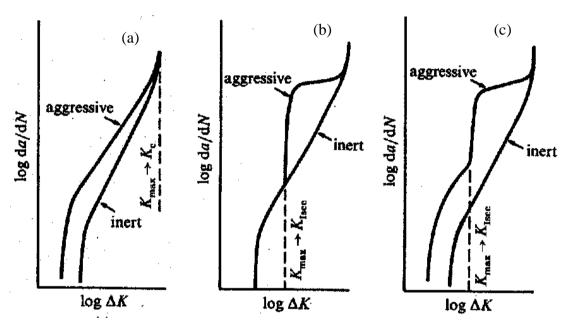
Figure 2-10: Crack growth behaviour for true corrosion fatigue (a), stress corrosion fatigue (b) and mixed corrosion fatigue (c) $^{[19]}$

In the mixed corrosion plot (c), the two previous behaviours are combined. For stress intensity factor ranges below $K_{\rm ISCC}$, the true corrosion crack growth rate behaviour prevails, whereas above $K_{\rm ISCC}$ the crack growth rate followed the stress corrosion fatigue trend.

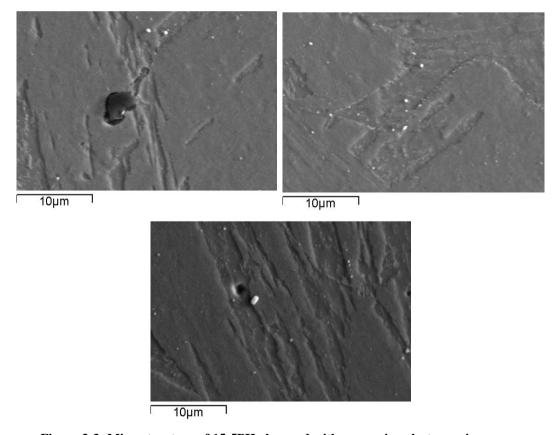
Figure 3-3: Microstructure of 15-5PH observed with a scanning electron microscope

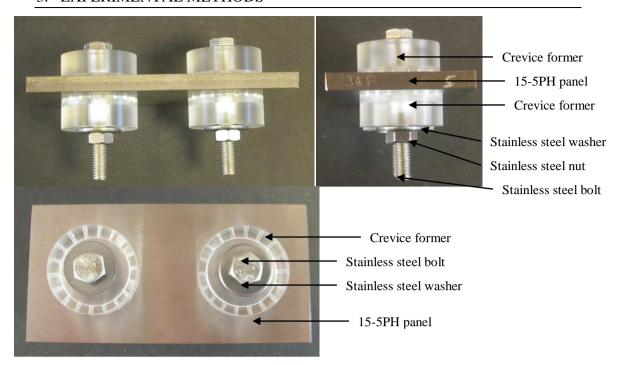
Figure 3-7: Crevice formers assembled on 15-5PH stainless steel panels

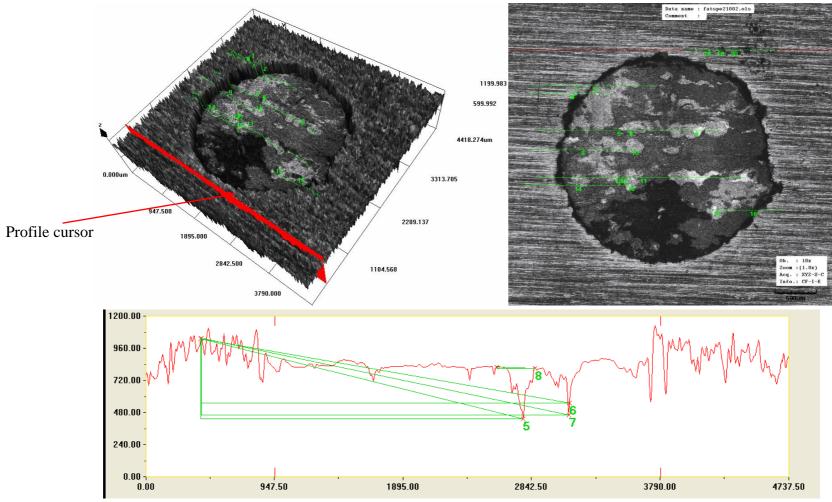
Figure 3-10: 2D and 3D images of a corrosion damage and profile

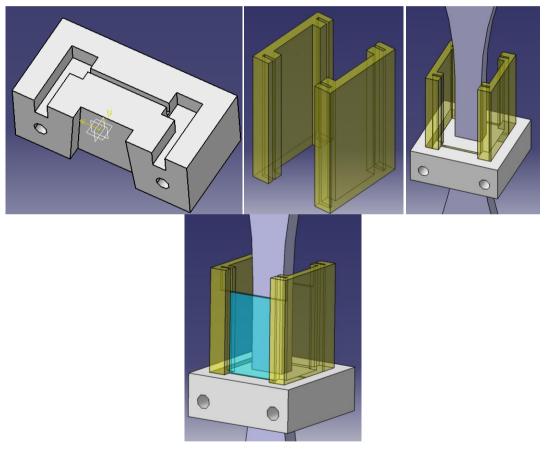
Figure 3-13: Sketch of the second cell

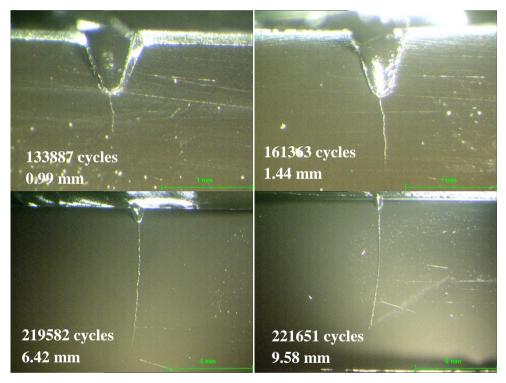
Figure 3-14: Replicas of fatigue crack initiated at a notch (Specimen 7)

The replica technique was an easy and reliable method to use but was disruptive and time consuming which therefore prevented to take a lot of measurement during the tests. Indeed, the tests had to be stopped for at least 10 minutes to take replicas. Hence, another quicker, automated and non-disruptive method was envisaged to monitor the fatigue crack during the tests using a digital camera.

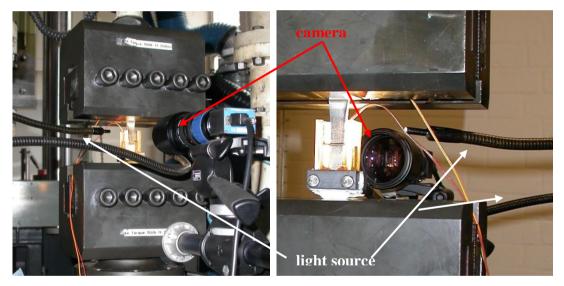
Figure 3-15: Digital camera set up

The crack length measurements were made by tracking back the crack from just before failure, where the crack was clearly visible, to the earliest stage at which the crack could be distinguished. Measurements were taken only if the beginning and the tip of the crack were visible.

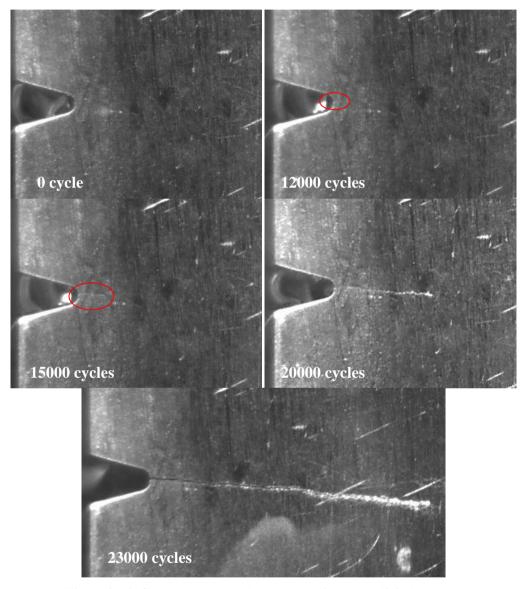
Figure 3-16: Crack growth development monitored by digital camera

The crack length measured from the pictures taken with the camera was then plotted against the normalised potential to extract the equation linking the potential to the crack length.

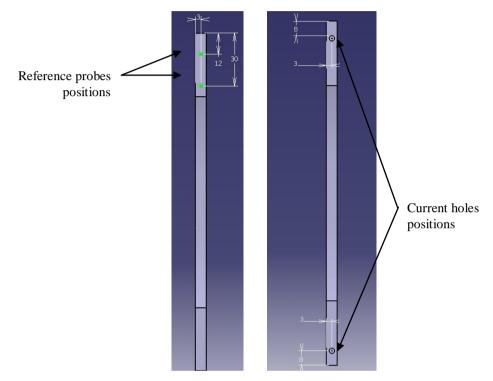
Figure 3-17: Location of the reference probes and the current holes on one lateral sides of the tension test specimen

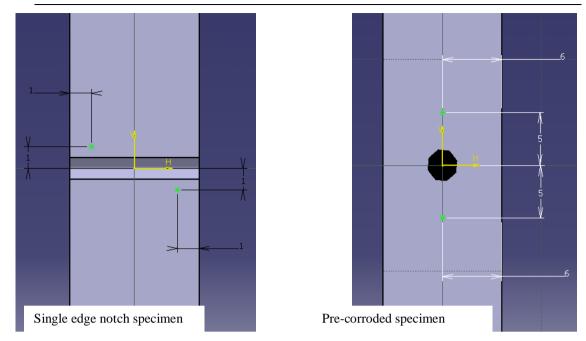
Figure 3-18: Location of the active probes on SEN and pre-corroded tension test specimens

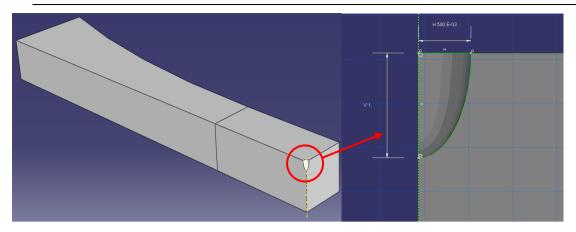
Figure 4-1: Corrosion flaw geometry and location

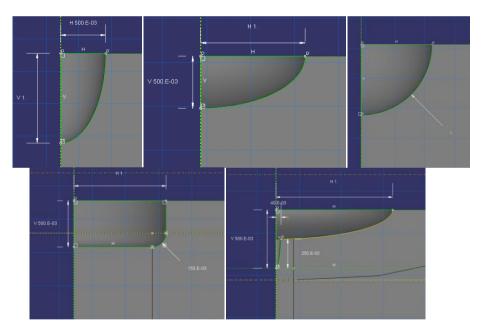
Figure 4-3: Profile of the arbitrary geometry corrosion flaws

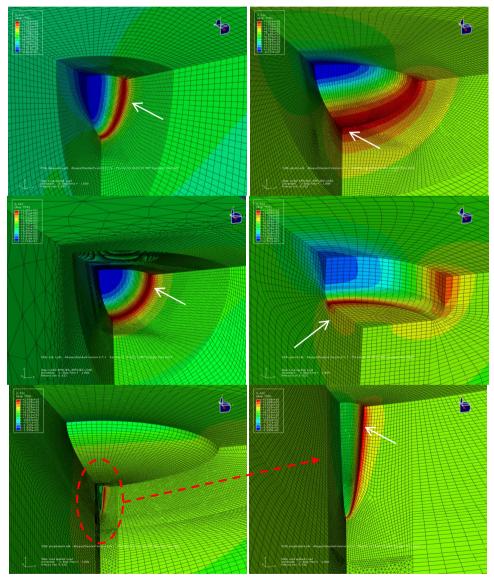
Figure 4-4: Longitudinal stress contours for each flaw geometry

For each geometry, the contours of the longitudinal stress are displayed in Figure 4-4. The location of the maximum longitudinal stress was indicated by a white arrow on the picture, and its value as well as the corresponding stress concentration factor, were detailed in Table 4-1. From these results, it appears that for 15-5PH stainless steel, deep and narrow flaws are more damaging than shallow flaws. In addition, shallow flaw with a deeper part at the bottom represents the most severe damage from these five cases.

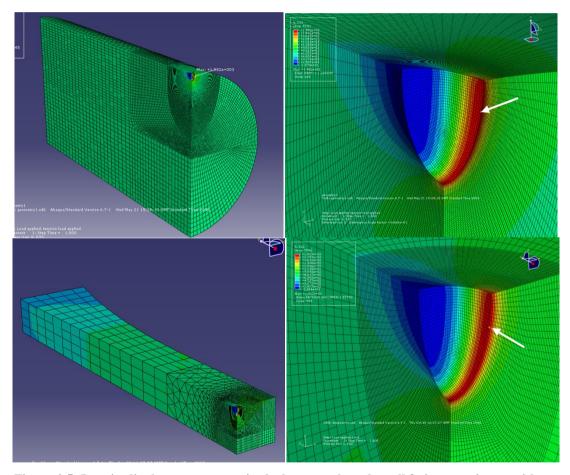
Figure 4-5: Longitudinal stress contours in the larger scale and small fatigue specimens with an identical corrosion damage

Despite the slight difference (0.8%) between the stress concentration factors due to the slight difference of mesh between the two specimens, it was concluded that the specimen geometry did not have a significant effect on the stress concentration factor value. Therefore, the finite element analyses to assess the stress concentration factor of the corrosion flaws found in the larger scale fatigue specimens were carried out with the small fatigue specimen geometry to keep to the minimum the number of elements used, hence the computational time.

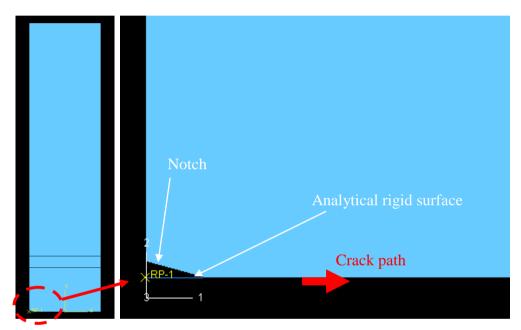
Figure 4-7: SEN specimen and analytical rigid surface

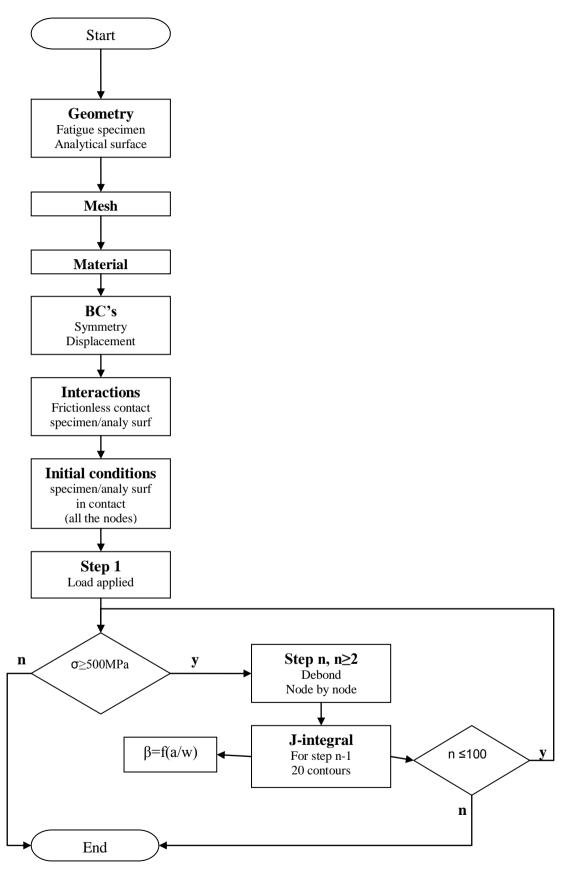
Figure 4-8: Flow chart for the crack propagation and J integral calculation program by FEA

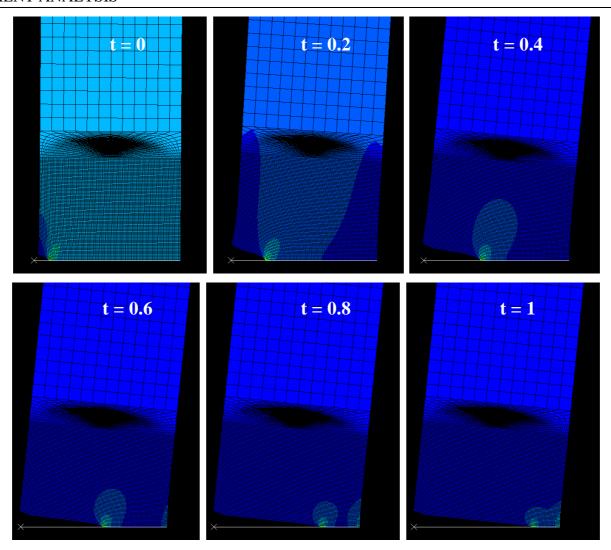
Figure 4-9: Crack propagation at different steps of the analysis

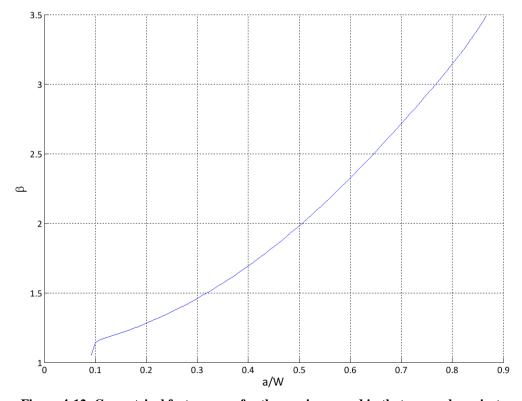
Figure 4-12: Geometrical factor curve for the specimen used in that research project

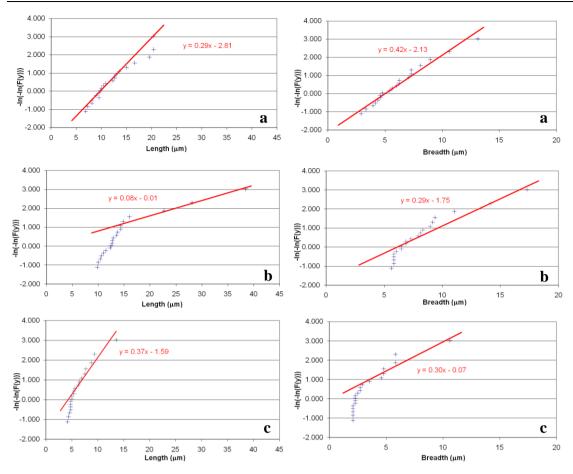
Figure 5-6: Extreme value graphs for 18 days (a), 3weeks (b) and 4 weeks (c) exposure

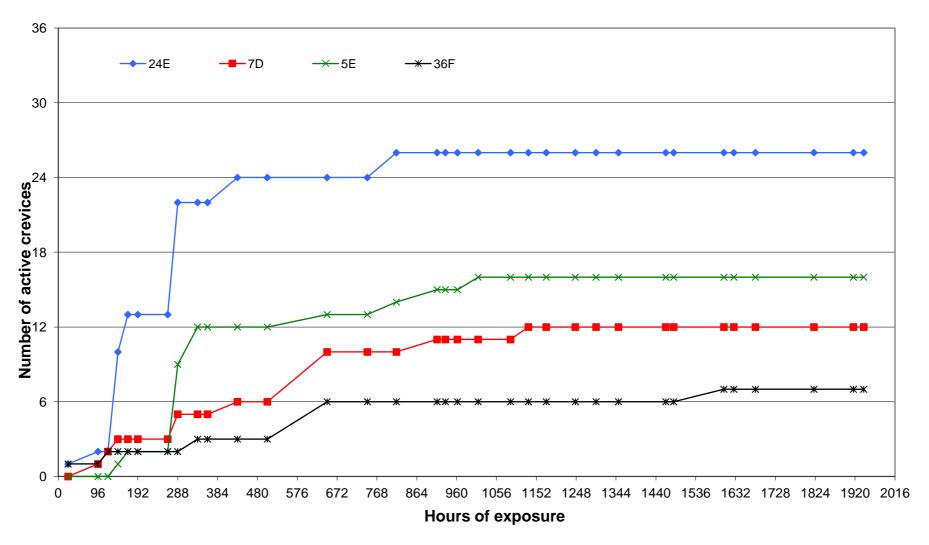
Figure 5-7: Number of active crevices as a function of the exposure time on the upper, more exposed face

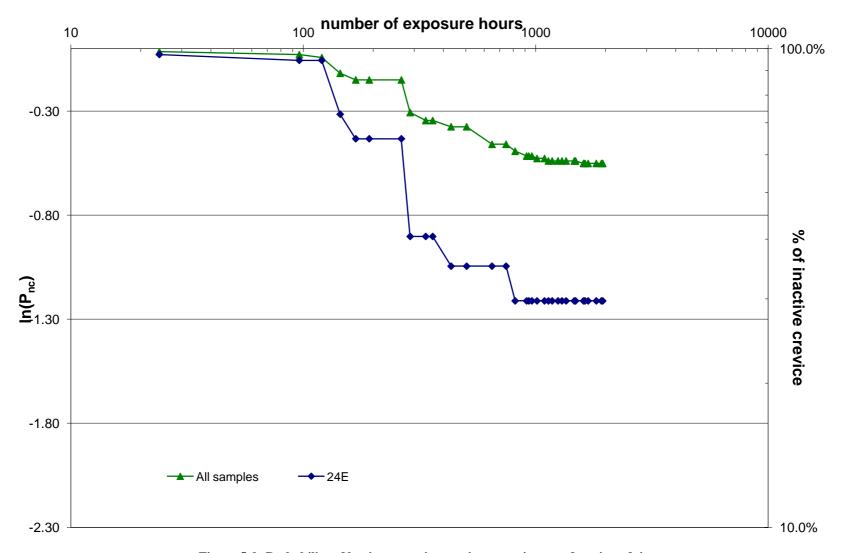
Figure 5-9: Probability of having no active crevice corrosion as a function of time

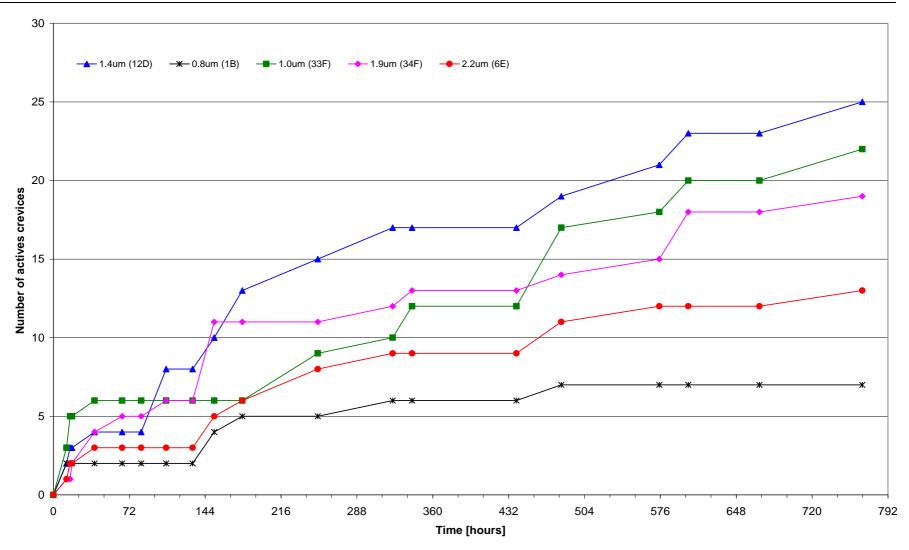
Figure 5-10: Number of active crevices as a function of the exposure time on the upper, more exposed face

For both the upper and lower surfaces, although no clear patter had been observed, it seems that the rougher panels develop more active crevices, which is the reverse of what was expected. It appears that in these experiments, the onset of crevice corrosion had been controlled not by the volume of electrolyte contained in the crevice but by the access of that electrolyte contained into the crevice gap; access being easier in the case of the rougher surface with the wider gap.

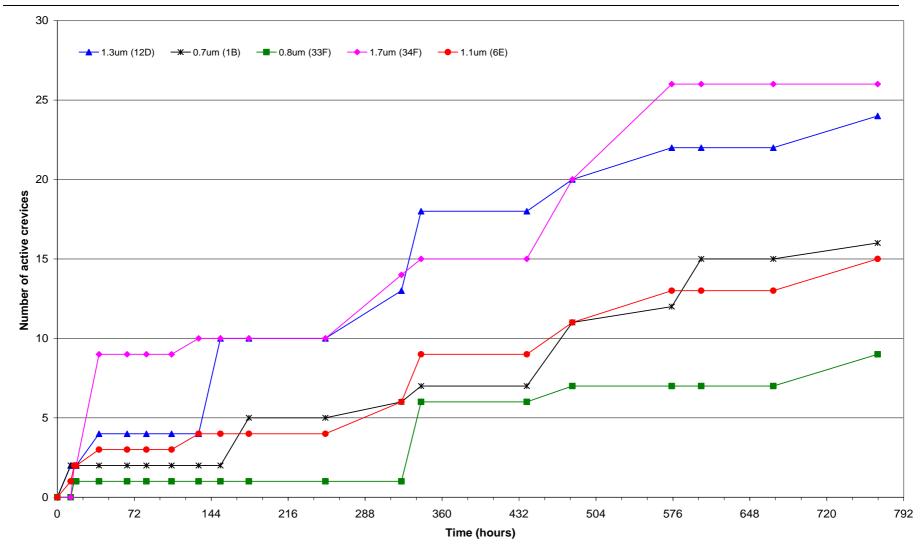
Figure 5-11: Number of active crevices as a function of the exposure time on the lower, less exposed face

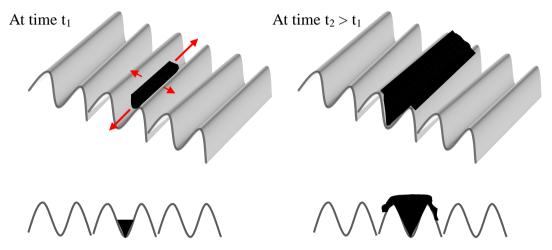
Figure 5-14: Sketch of the propagation of the acidic solution in the crevice

The active corrosion spreading along the grinding marks can be explained by the fact that it would be easier for acidic solution accumulating in the crevice to run along the grooves, formed by the grinding marks, rather that crossing from a groove to another, as sketched in Figure 5-14. The level of acid in a particular groove would need to be high enough to go over the ridge of that groove to the next one.

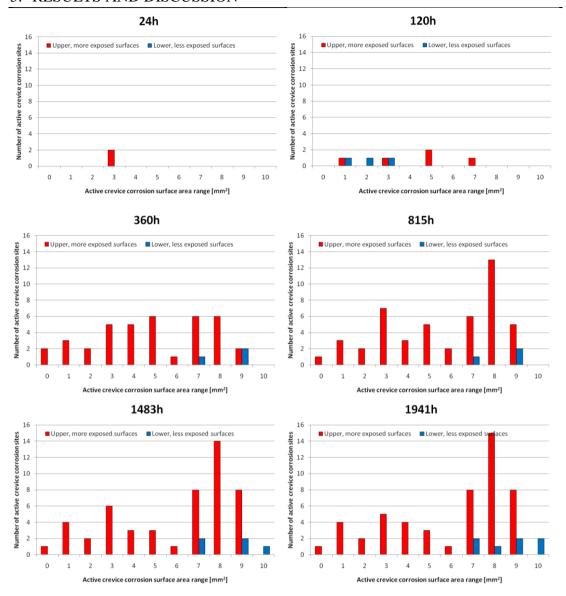
Figure 5-15: First set of experiment - Active crevice corrosion surface area distributions at different exposure times

Each crevice corrosion site of each panel had been measured using the methodology described in section 3.3.4.1 for different exposure times. The distributions of the active crevice corrosion surface area for the two sets of experiments are displayed in Figure 5-15 and Figure 5-16. Although measurements were made for ten and twelve different exposure times respectively for the first and second set of experiments, only six distributions per set were displayed.

Considering the upper, more exposed surfaces in both set of experiments, illustrated in red in Figure 5-15 and Figure 5-16, it was observed that the distributions are first restrained to few ranges and then spread over more and more ranges with time. For instance, for the second set of experiments, the distribution for the upper, more exposed surfaces first lay between 0-3mm² at 12.5h and then spread over more ranges with time, to finally lie between 0-11mm² at the end of the experiment.

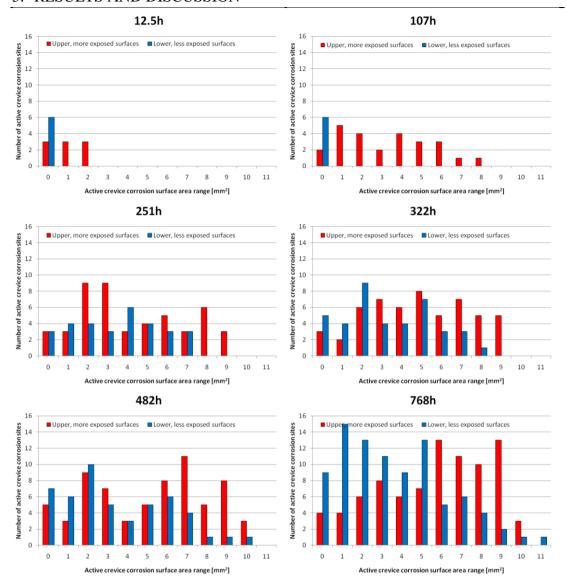
Figure 5-16: Second set of experiment - Active crevice corrosion surface area distributions at different exposure times

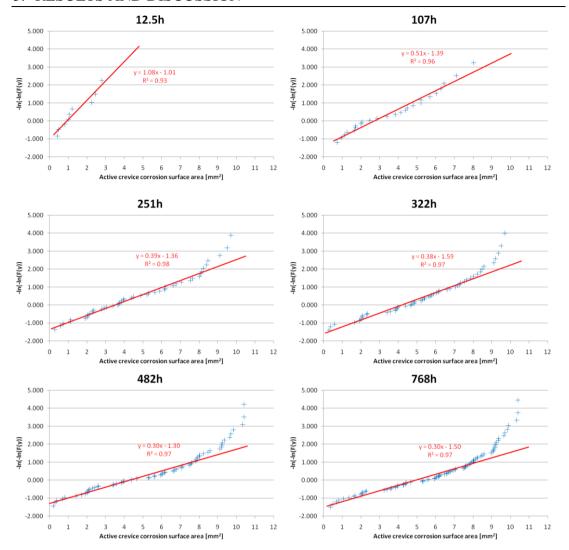
Figure 5-17: Extreme value graph of active crevice corrosion surface area

Extreme value statistics was applied to these distributions in order to get the most probable maximum area of active crevice corrosion site at different exposure time for both set of experiments and both surfaces and thus assess the crevice corrosion growth rate across the surface. Figure 5-17 displayed the extreme value graph corresponding to the distributions shown in Figure 5-16. At short exposure times (e.g. 107h), the graphs had a reasonable straight line fit for data smaller that 9mm², from which the most probable maximum area of active crevice corrosion can be calculated. At longer exposure times (e.g. 322h), the graphs deviated from a straight line and levelled off as the area of active crevice corrosion approached 9mm². These observations were made for both set of experiments and both surfaces. As the aim of these measurements was to examine the crevice corrosion growth rate across the surface, the most probable maximum areas of active crevice corrosion were calculated by applying extremes value statistics to the data less than 9mm² since from that point the growth significantly slow down. Indeed, each castellated crevice sites on the crevice former had an area of 11.3mm² and the maximum possible area of active crevice corrosion was defined by the size of the crevice former. According to the extreme value graphs, 9mm² seemed to be the point where the growth rate of the active crevice corrosion area was influenced by the restricted size of the crevice former.

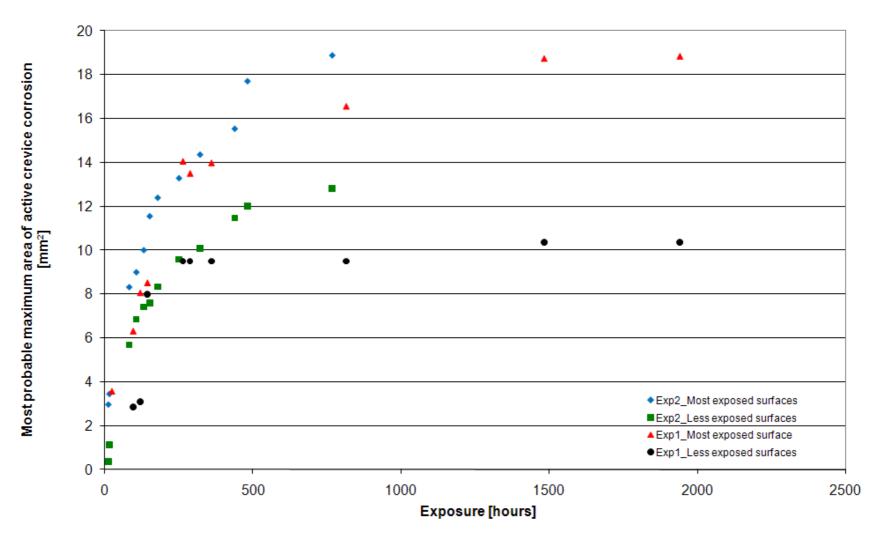
Figure 5-18: Most probable maximum area of active crevice corrosion as a function of the exposure time

Regarding the lower, less exposed surface curves, the area growth rate curve for the second experiment followed a pattern closed to the one followed by the upper, more exposed surface curves but with lower amplitude. However, the curve for the first experiment had a high initial rate until 300 hours and then seemed to flatten around 10mm².

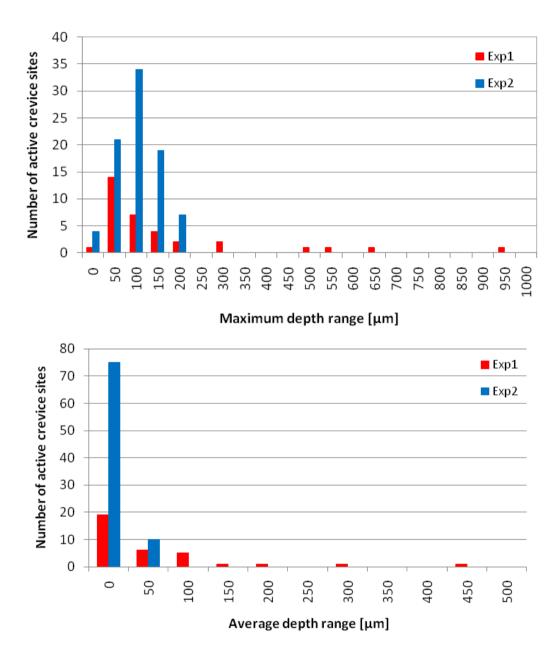
Figure 5-19: Maximum depth distribution

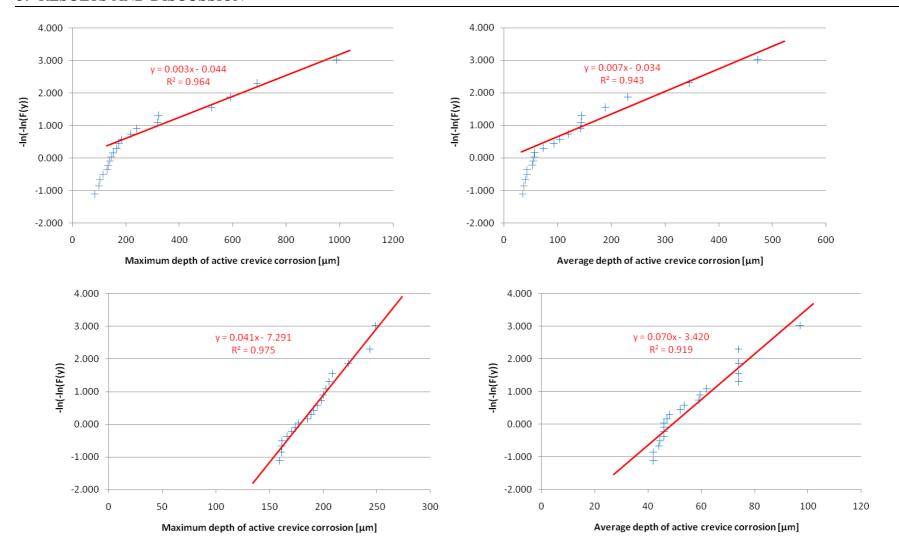
Figure 5-20: Extreme value graph of active crevice corrosion depth for the first and second set of experiments (respectively top and bottom graph)

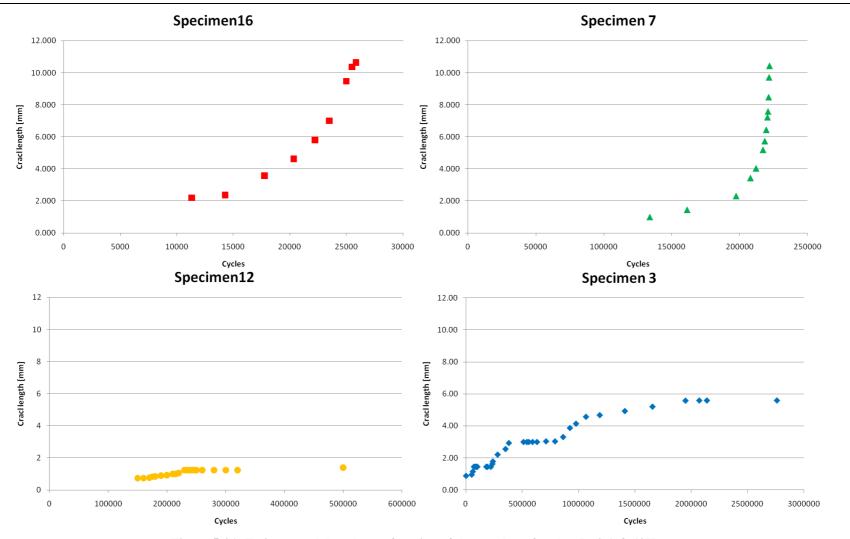
Figure 5-21: Fatigue crack length as a function of the number of cycles, R=0.1, f=10Hz

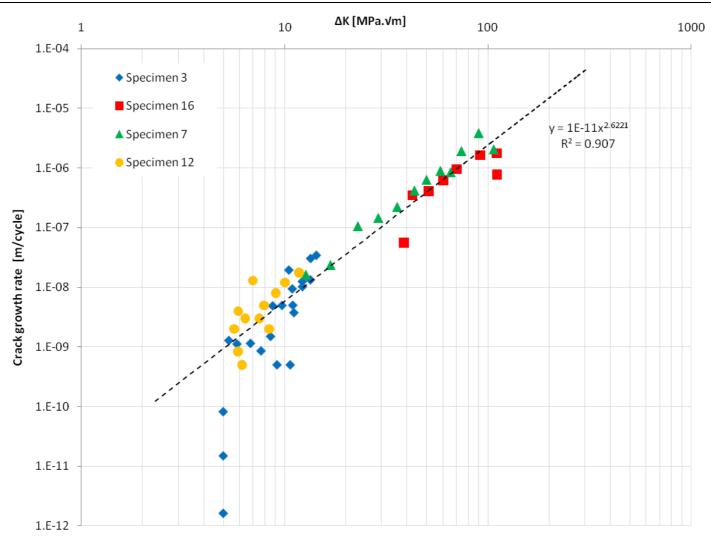
Figure 5-22: 15-5PH fatigue crack growth rate in air, R=0.1, f=10Hz

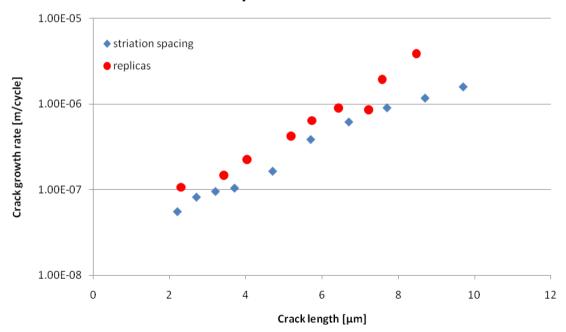
Figure 5-23: Crack growth rate comparison: replica and striation spacing measurements

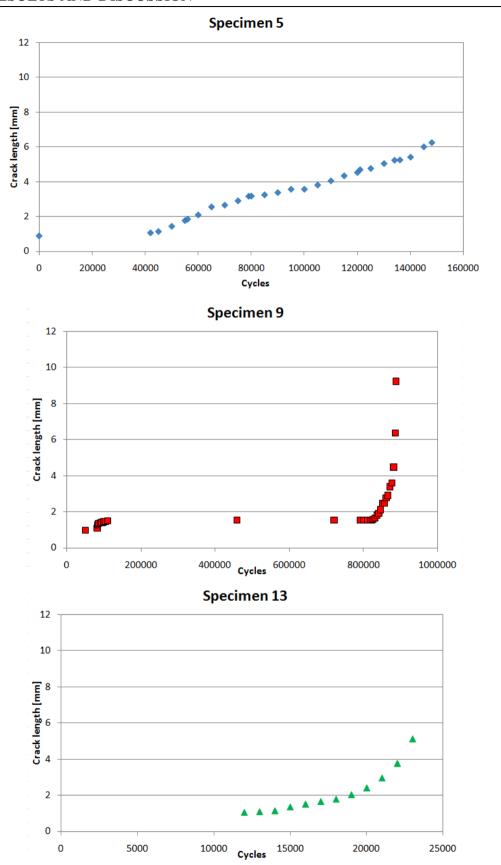
Figure 5-24: Fatigue crack length as a function of the number of cycle in a 3.5% NaCl solution, $R{=}0.1,\,f{=}3Hz$

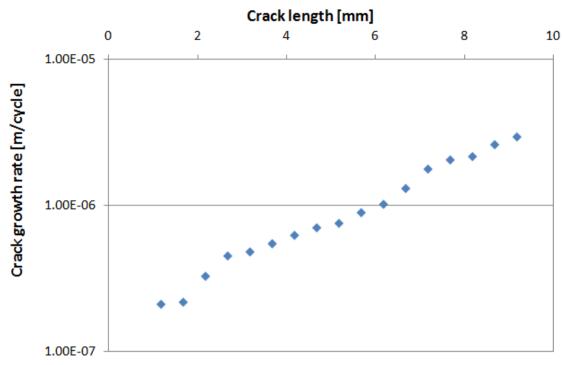
Figure 5-25: Specimen 18 – Crack growth rate as a function of the crack length in 3.5% NaCl solution, R=0.1, f=3Hz

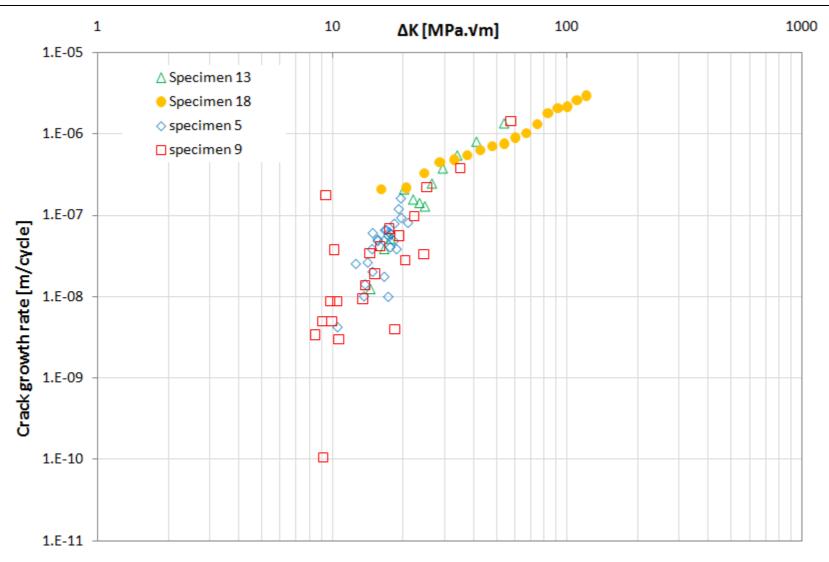
Figure 5-26: Fatigue crack growth rate in 3.5% NaCl solution, R=0.1, f=3 Hz

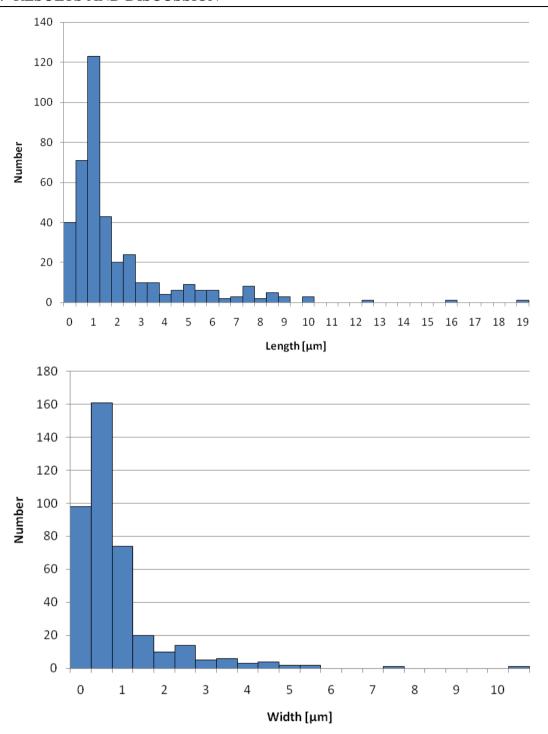
Figure 5-27: Pit size distribution in specimen 10

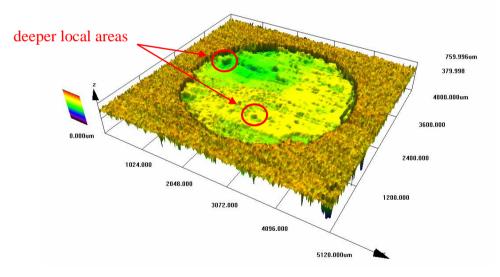
Figure 5-30: Specimen 2 - 3D image of the crevice corrosion damage

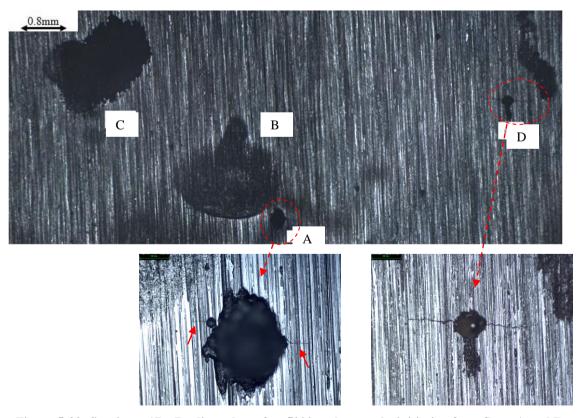
Figure 5-32: Specimen 17 – Replica taken after 5000 cycles, cracks initiating from flaws A and D

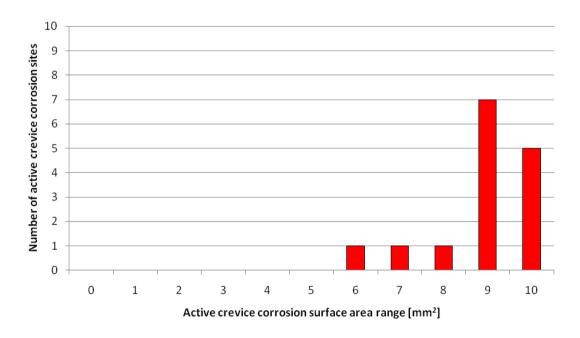
Figure 6-2: Active crevice corrosion surface area distribution after 1393h

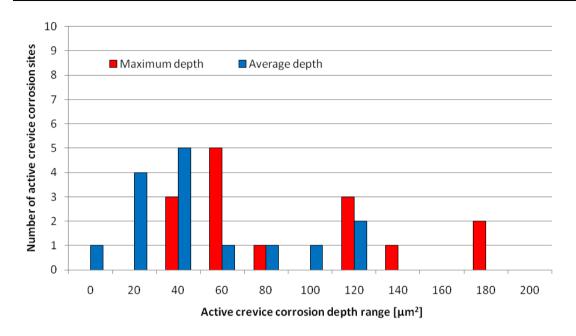
Figure 6-3: Active crevice corrosion depth distribution after 1393h

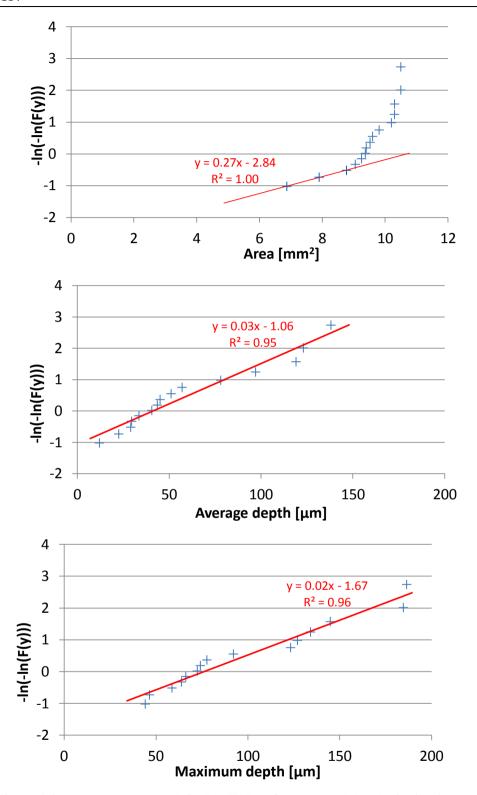
Figure 6-4: Extreme value graph for MLX17 surface area and depth distributions

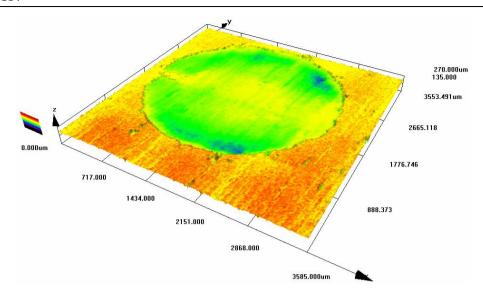
Figure 6-5: 3D image of the corrosion damage in MLX7 specimen

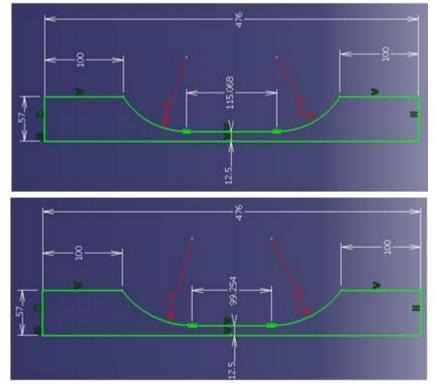
Figure 7-3: Larger scale tension test specimen profiles

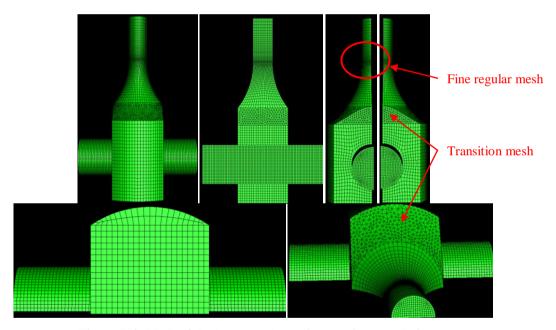
Figure 7-4: Mesh of the larger scale tension specimen and pin

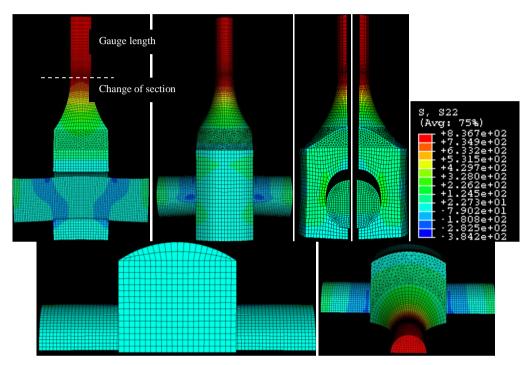
Figure 7-5: R=95mm - Longitudinal stress contours

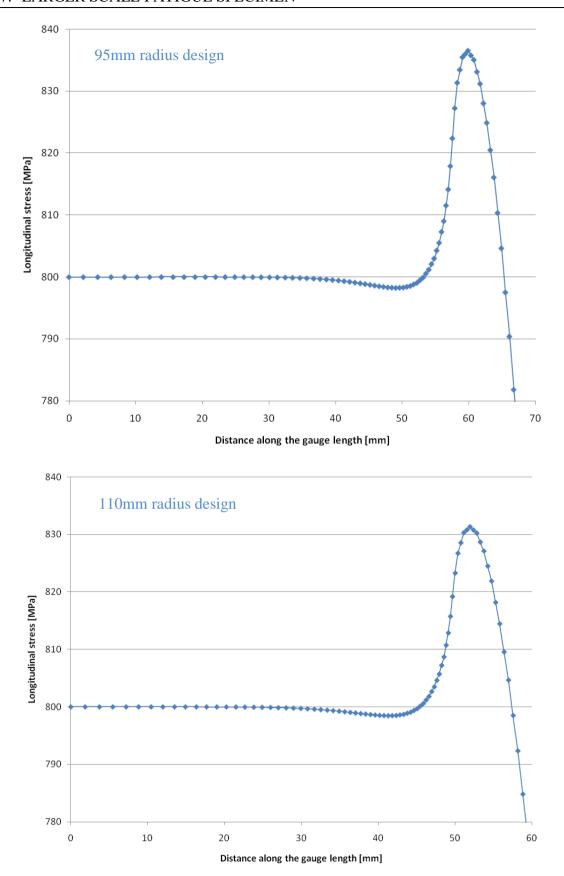
Figure 7-6: Longitudinal stress along the gauge length and the change of section

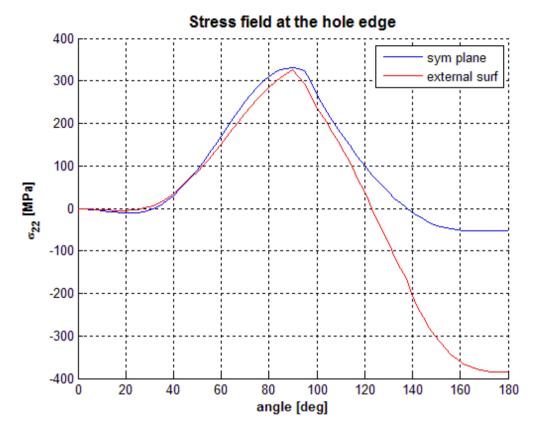
Figure 7-7: R=110mm - Longitudinal stress around the pinhole

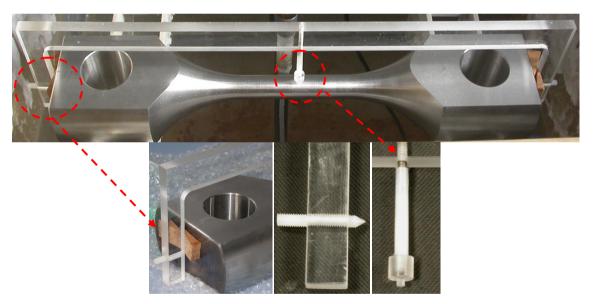
Figure 7-11: Crevice former for the larger scale fatigue specimen

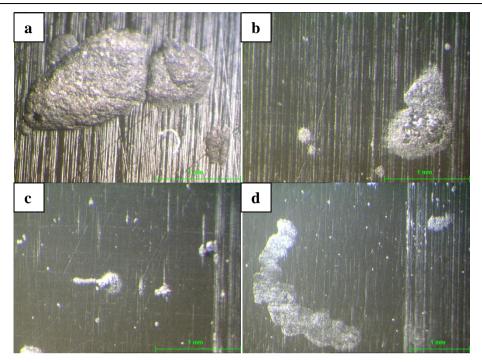
Figure 7-14: Replicas of the corrosion under the crevice former (a) and dry salt patches (b, c and d) on larger scale fatigue specimen 1

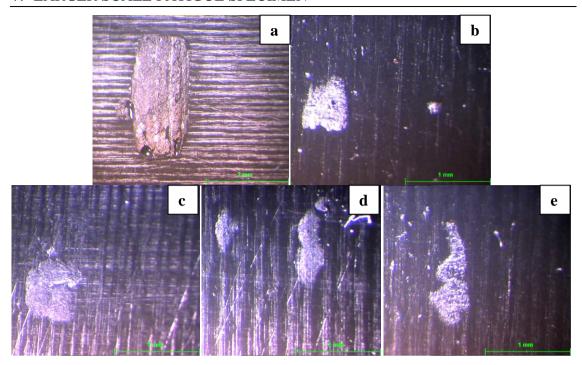
Figure 7-15: Replicas of the corrosion under the crevice former (a) and dry salt patches (b, c, d, and e) on larger scale fatigue specimen 2

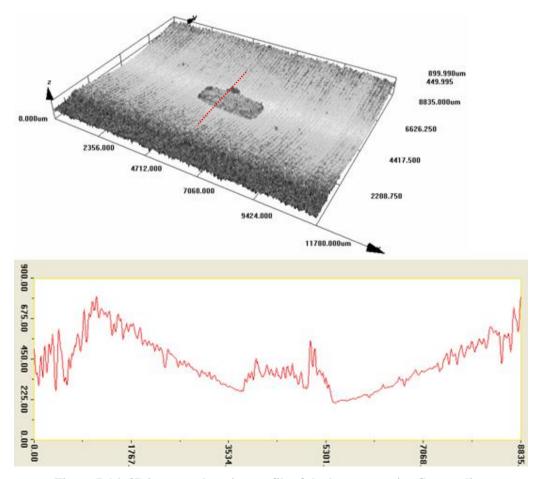
Figure 7-16: 3D image and section profile of the large corrosion flaw replica

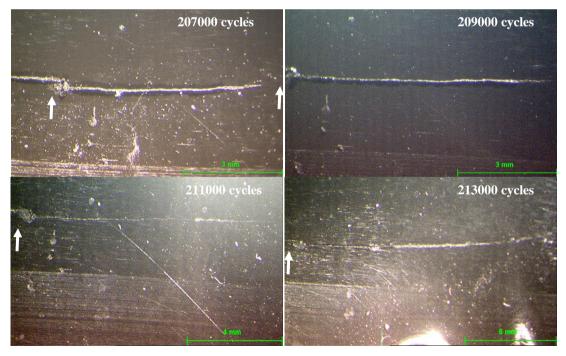
Figure 7-18: Larger scale fatigue specimen 1 - Fatigue crack propagation

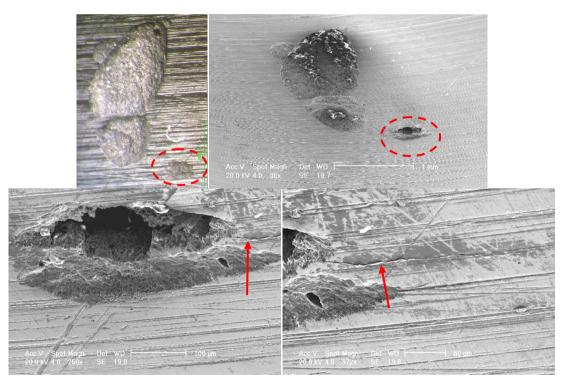
Figure 7-21: Larger scale fatigue specimen 1 - Replica of the damage produced by the crevice former before testing (a) and fatigue crack initiating from the damage observed after failure (b)

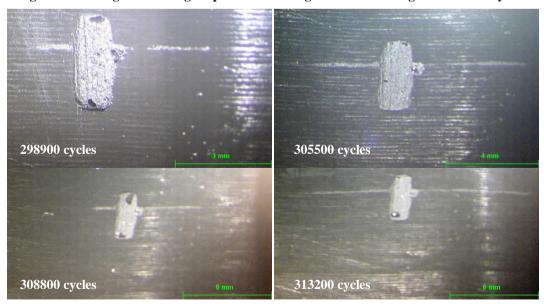
Figure 7-23: Larger scale fatigue specimen 2 - Fatigue crack propagation

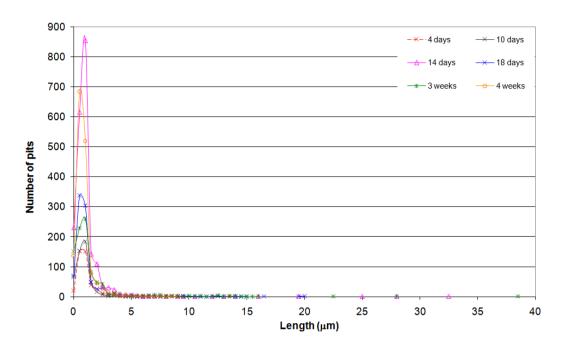
Figure 8-1: Pit length distribution gathering MSc and MPhil testing results

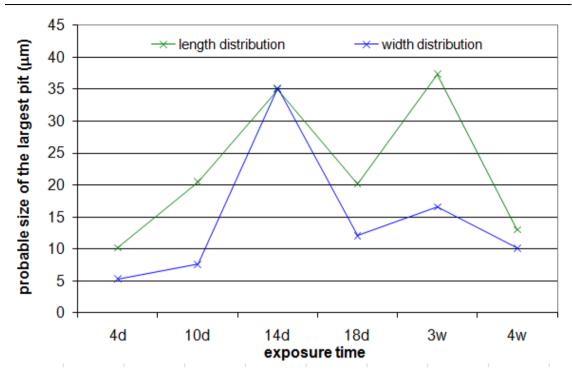
Figure 8-5: Most probable size of the largest pit as a function of the exposure time

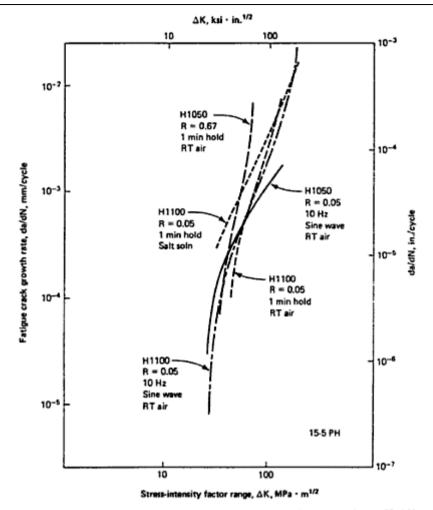
Fatigue crack growth rates in WOL specimens of 15-5 PH stainless steel in the H1050 and H1100 conditions in room temperature air and in a 3.5% NaCl solution.

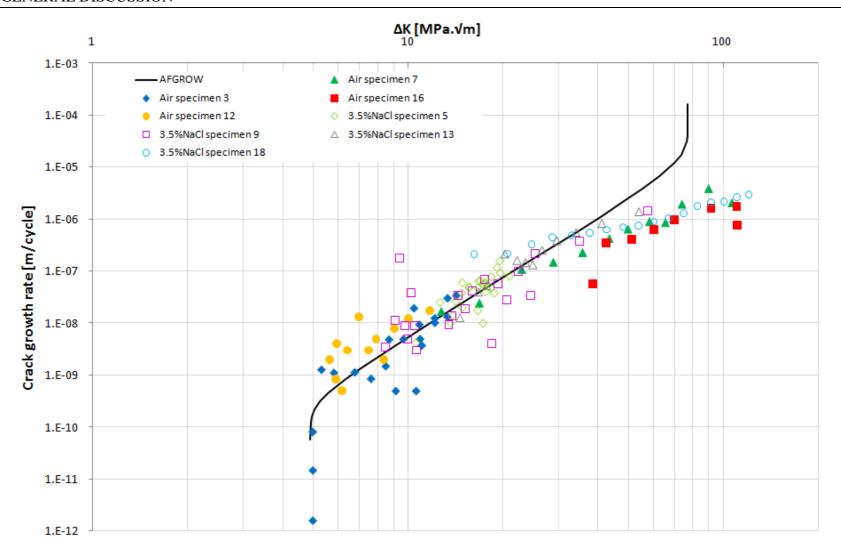
Figure 8-8: Comparison between the AFGROW and the experimental crack growth rate

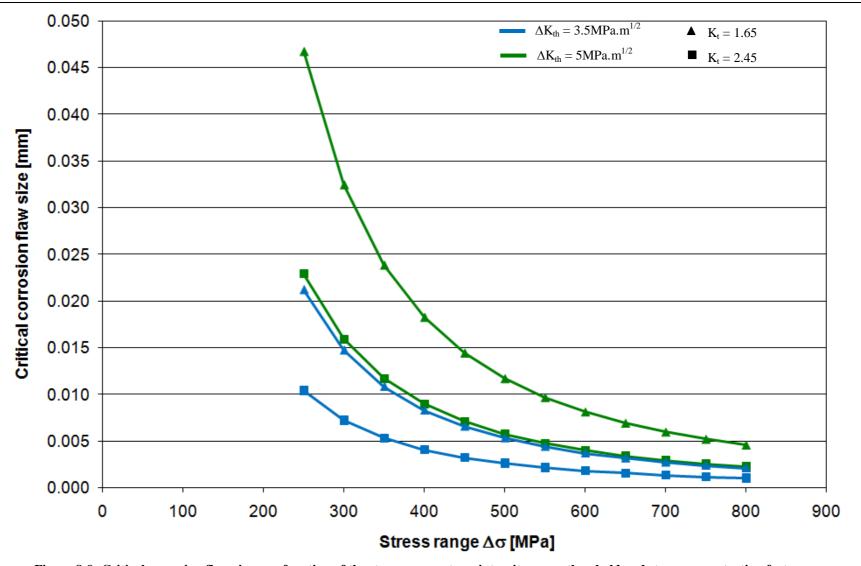
Figure 8-9: Critical corrosion flaw size as a function of the stress range, stress intensity range threshold and stress concentration factor

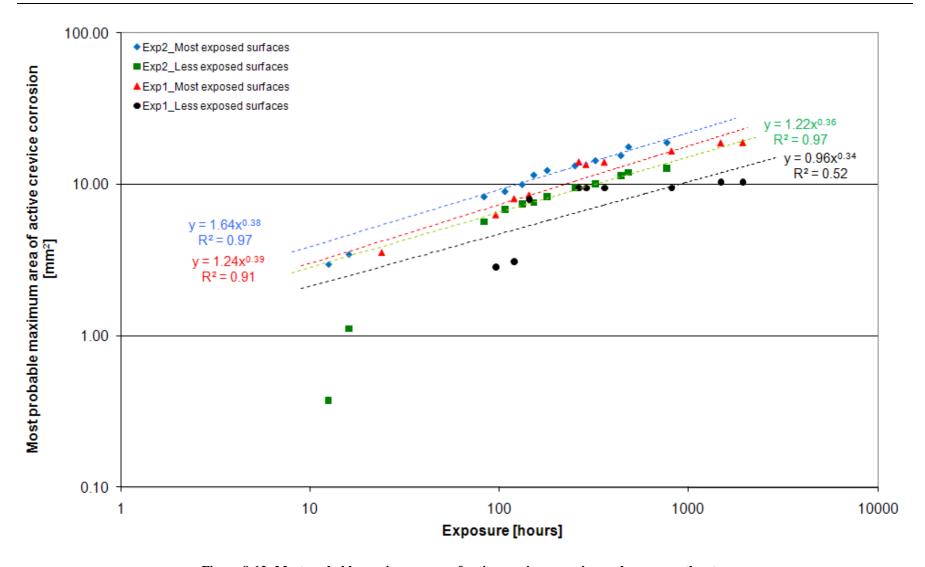
Figure 8-12: Most probable maximum area of active crevice corrosion and area growth rate

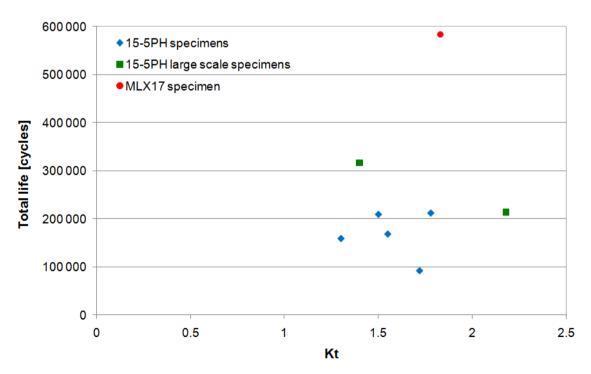
Figure 8-13: Total fatigue life as a function of the stress concentration factor of the corrosion flaw

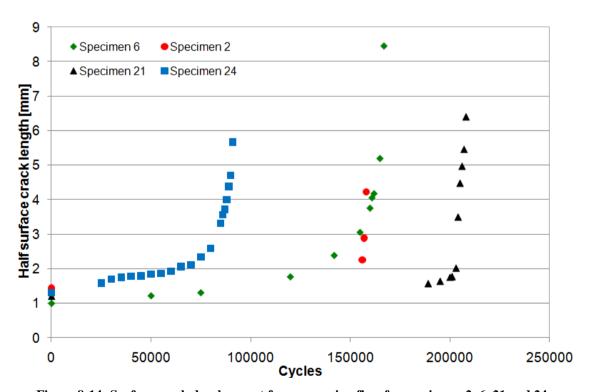
Figure 8-14: Surface crack development from corrosion flaw for specimens 2, 6, 21 and 24

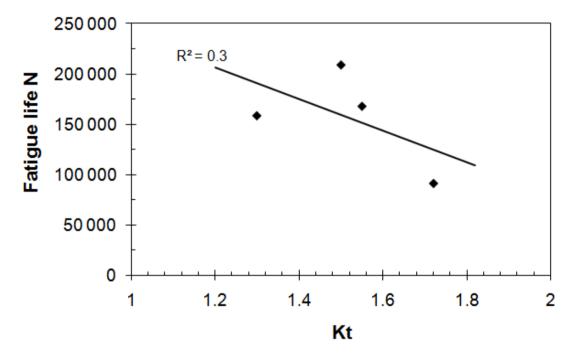
Figure 8-15: Total fatigue life as a function of the stress concentration factor values for specimens 2, 6, 21 and 24

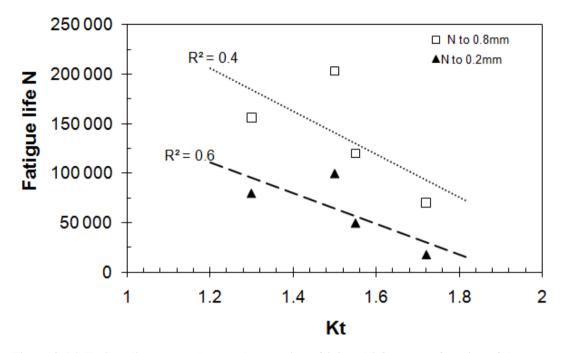
Figure 8-16: Fatigue lives to reach a crack extension of 0.2 and 0.8mm as a function of the stress concentration factor values for specimens 2, 6, 21 and 24

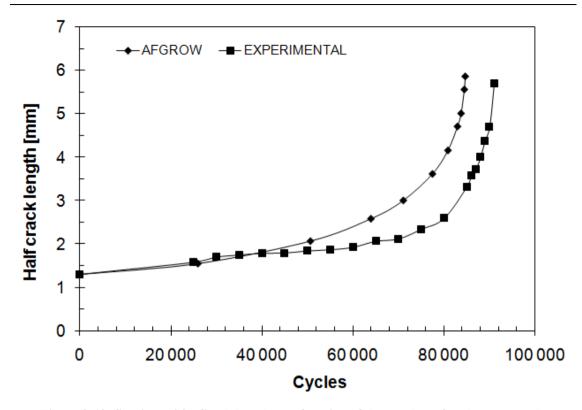
Figure 8-18: Specimen 24 - Crack length as a function of the number of cycles measured experimentally and using AFGROW
