CRANFIELD UNIVERSITY

INFLUENCE OF CORROSION DAMAGE ON THE INITIATION OF FATIGUE CRACKS IN HIGH STRENGTH STAINLESS STEELS

M.Phil Thesis

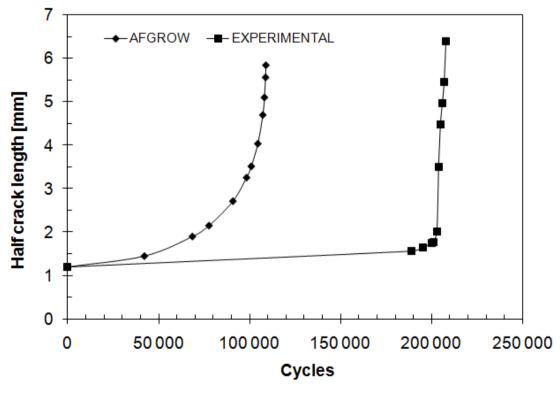
Figure 8-19: Specimen 21- Crack length as a function of the number of cycles measured experimentally and using AFGROW
