A scanning electron microscopy study of projectile entry fractures in cortical bone; genesis and microarchitectural features

Abstract

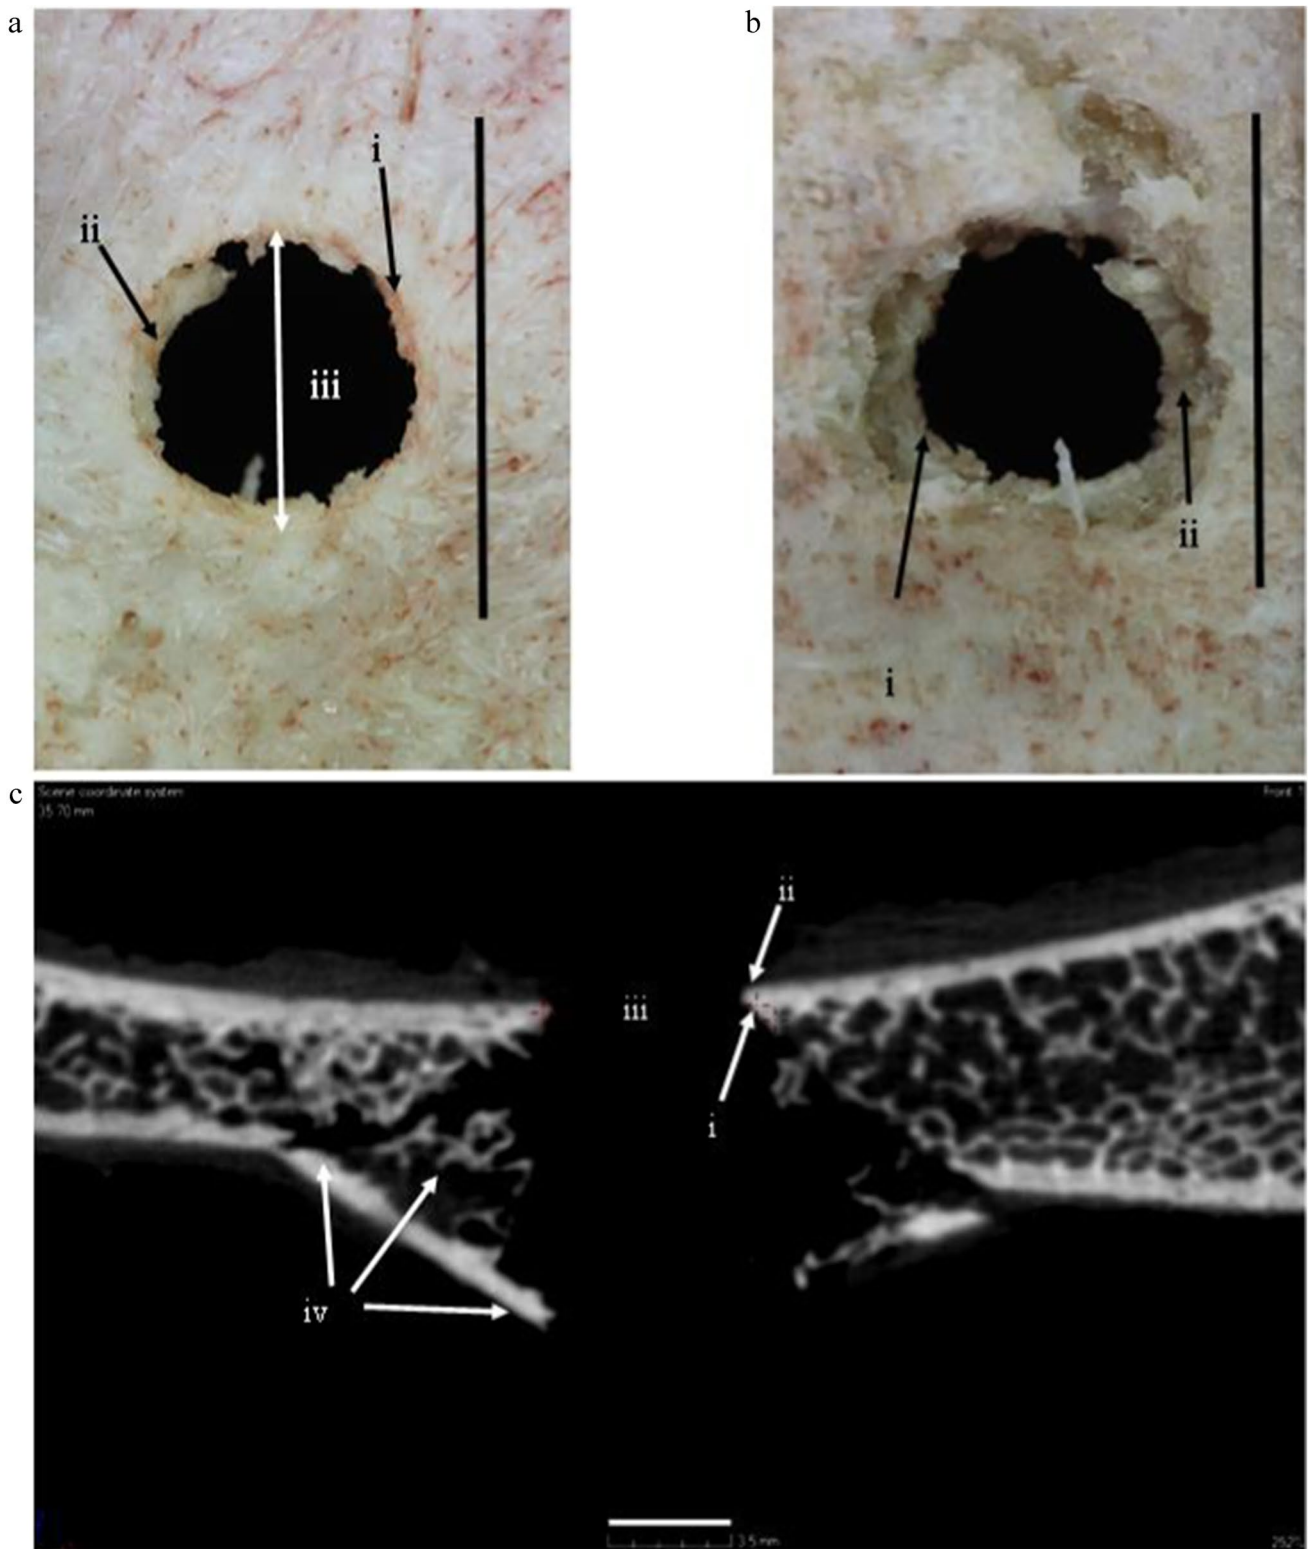
Fig. 1 Key nomenclature for the components of a bevelled fracture in sandwich bones; **a–b**, 163 m/s perforating impact (E_i 11.78 J, E' 0.42 J/mm²; scales bars 10 mm); **a**, **i**, apex of the entry cortical fracture edge (EnCF); the top edge of EnCF where the cortical fracture edge and cortical surface meet; the EnCF itself runs under the apex and is not visible from above; **ii**, cortical roof fragment; fragmentary component of the conoid roof remaining in situ after fragmentation and ejection of the bulk of the conoidal volume; the distal edge faces the cortical entry and the medial edge the cortical surface; **iii**, cortical entry; delineated in cross section by the EnCF and in surface view by the apex of the EnCF; **b**, same cortical entry as in seen in **a** but from the bevel side; **i**, EnCF angling away from the apex; **ii**, underside of the cortical roof fragment seen in **a**; **c**, 158 m/s perforating impact (E_i 11.05 J, E' 0.39), μ CT cross-sectional view showing internal structure; (scale bar 3.5 mm) **i**, EnCF, **ii**, apex of the EnCF, **iii**, cortical entry; **iv**, fragment of conoid

To accurately convey the orientation of structural features in the SEM images, the nomenclature presented in Fig. 1 is utilised for analysis. The *entry cortical fracture edge* (EnCF) meets the cortical surface at the *apex* (Fig. 1a, c), which defines the cortical entry when viewed from above. When viewed from below (Fig. 1b) and in cross section (Fig. 1c), the cortical entry is circumscribed by the EnCF. The tri-layered conoid formed by impact consists of a *cortical roof* and *cortical floor* with the trabeculae in between [4]. This conoid typically undergoes comminution but can leave behind traces in the form of cortical roof and floor fragments. When present, the *medial edge* of cortical roof fragment faces the EnCF, whilst the *distal edge* faces into the cortical entry.

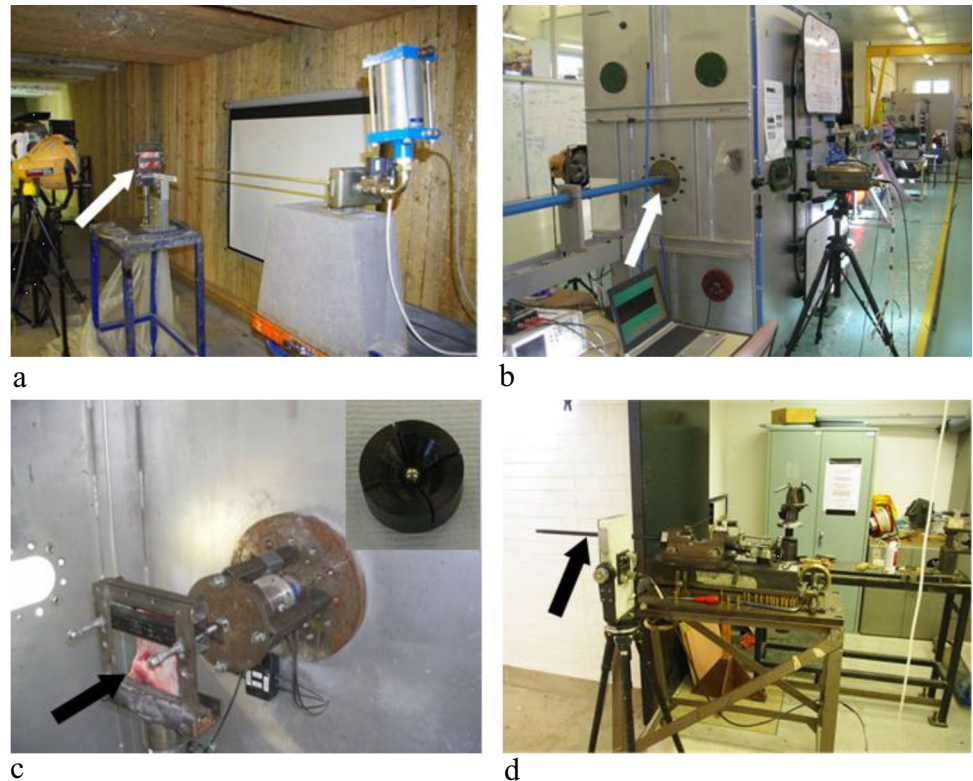
Fig. 2 Projectile delivery systems; **a**, compressed air gun with 6 mm barrel situated in front of a clamped specimen (arrow); **b**, 21.3 mm calibre gas gun chamber with high-speed camera located on a tripod at the viewing window; the 21.3 mm barrel enters the chamber at left (arrow); **c**, view inside the 21.3 mm gas gun chamber showing specimen clamped in front of the barrel (arrow); part of the viewing window is illuminated at left; inset shows a 6 mm projectile housed in a plastic sabot; **d**, image of Enfield number three proof housing with barrel located at left (arrow)

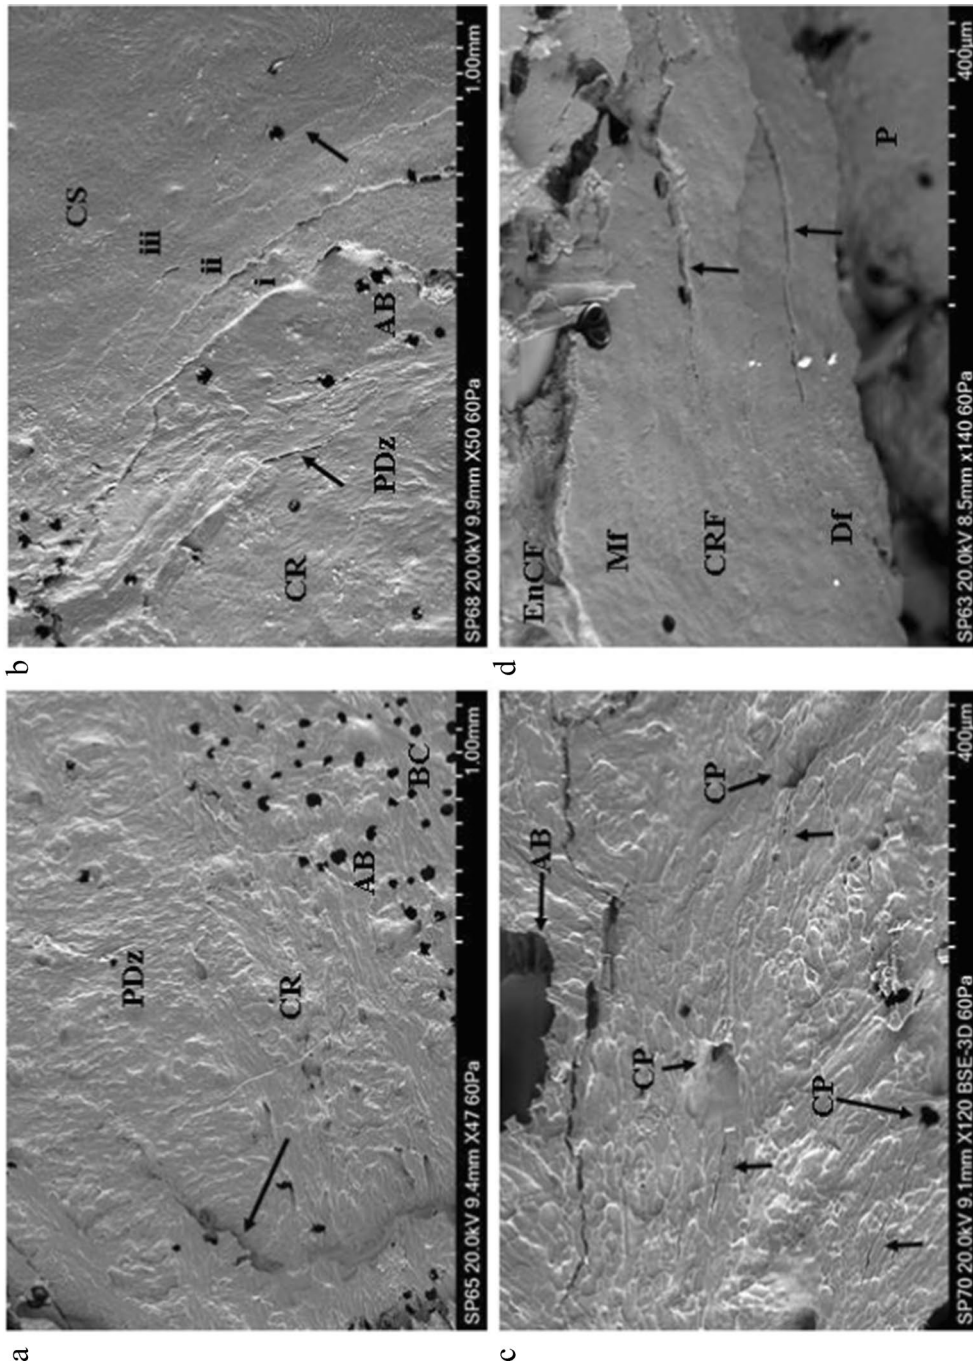
Fig.3 Genesis of the cortical entry in sandwich bones; plastic deformation and ring cracks (BC, base of compressed region; CS, cortical surface; CR, cortical roof; CRF, cortical roof fragment; MF, medial fracture edge of cortical roof fragment; DF, distal fracture edge of cortical roof fragment; P, putty used to seal the floor of the entry; AB, air bubble artefact); **a** 54 m/s rebound impact, fleshed specimen (*Ei* 1.30 J; *E'* 0.05 J/mm²), CS located just out of view top left and across the top of the micrograph; micrograph indicates extensive plastic deformation is involved in formation of the concavity (PDz); a ring crack is visible at left (arrow) with the base of the concavity located at the bottom right (BC); **b** 57 m/s rebound impact, fleshed specimen (*Ei* 1.44 J, *E'* 0.05 J/mm²); micrograph of the right edge of a depressed fracture showing three generations of larger ring cracks (annotated i–iii) and two smaller cracks (arrowed); deformation forming the cavity occurs both along the ring crack fracture margins and in plastically deformed zones without visible fracture; **c** ~57 m/s impact (defleshed specimen) showing cortical surface adjacent to impact site (located along top of micrograph); concentrically orientated nascent ring cracks (white arrows) can be seen arising from cortical pores (CP); **d**, 96 m/s perforating impact (*Ei* 4.08 J, *E'* 0.14 J/mm²); cortical roof fragment with the distal edge displaced downwards into the cortical entry and displaying concentric fractures consistent with ring cracking during the initial stages of impact (arrows)

Fracture in the compressed region in 3 of the 4 rebound impacts took the form of distinct circumferentially orientated *ring cracks* which occupied parts of the circumference, rather than completely encircling it (Fig. 3, a–b). Impact resulted in multiple generations of ring cracks extending from inside to outside of the cortical discs (Fig. 3b), with each ring crack formed successively at the widening contact radius of the projectile as it penetrated deeper into the cortex. In the fourth specimen, nascent concentric ring cracks less than 400 microns in length were observed emanating from cortical pores near the edge of the compressed region, indicating these had acted as stress concentrating flaws during impact (Fig. 3c). Separation of cortex at the ring cracks contributed to the observed compression of the cortical roof. Apparent ring cracks were also preserved on a section of cortical roof fragment resulting from a 96 m/s perforating impact (Fig. 3d, black arrows at right). Radial cracks arising normal to the apex of the EnCF were observed in one fleshed 54 m/s rebound impact (5 cracks) and one defleshed \sim 57 m/s impact (2 cracks). All were less than 500 μ m in length apart from one large, approximately 1 mm crack in the cortex peripheral to the EnCF in the defleshed impact.

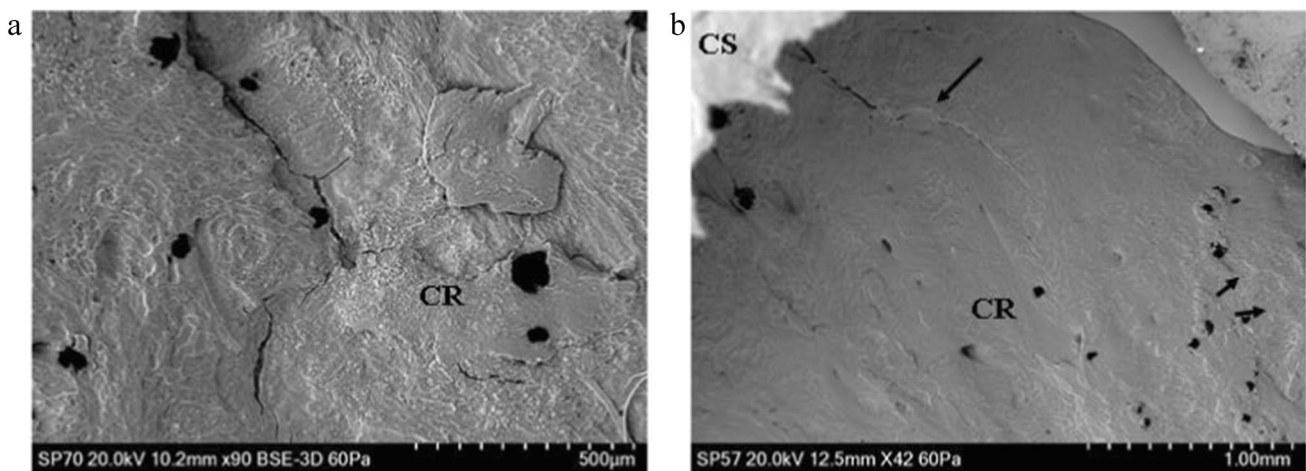
Fig. 4 Genesis of the cortical entry in sandwich bones; failure of the cortical roof (CS, cortical surface; CR, cortical roof); **a** \sim 57 m/s rebound impact (defleshed specimen); surface of cortical roof showing vertically orientated fracture dividing the roof into two halves; fracture resulted from tensile failure of the inner surface of the cortical plate under compressive loading; **b** 75 m/s perforating impact

($Ei=2.47$ J, $E'=0.09$ J/mm²), view of the cortical roof of a nearly intact conoid displaced downwards so it is beneath the cortical surface and protruding from the inner cortical plate; the surface has not been modified by impact but bears a fracture ending before the mid-section (arrow)

Initial failure of the cortical roof in both rebound and perforating impacts occurred via a fracture arising normal to the free fracture margin of the roof; this process was observed in both a rebound impact (Fig. 4a) and in the cortex of a relatively intact tri-layered conoid. In the latter case, the conoid had been displaced downwards and tilted so that the cortical

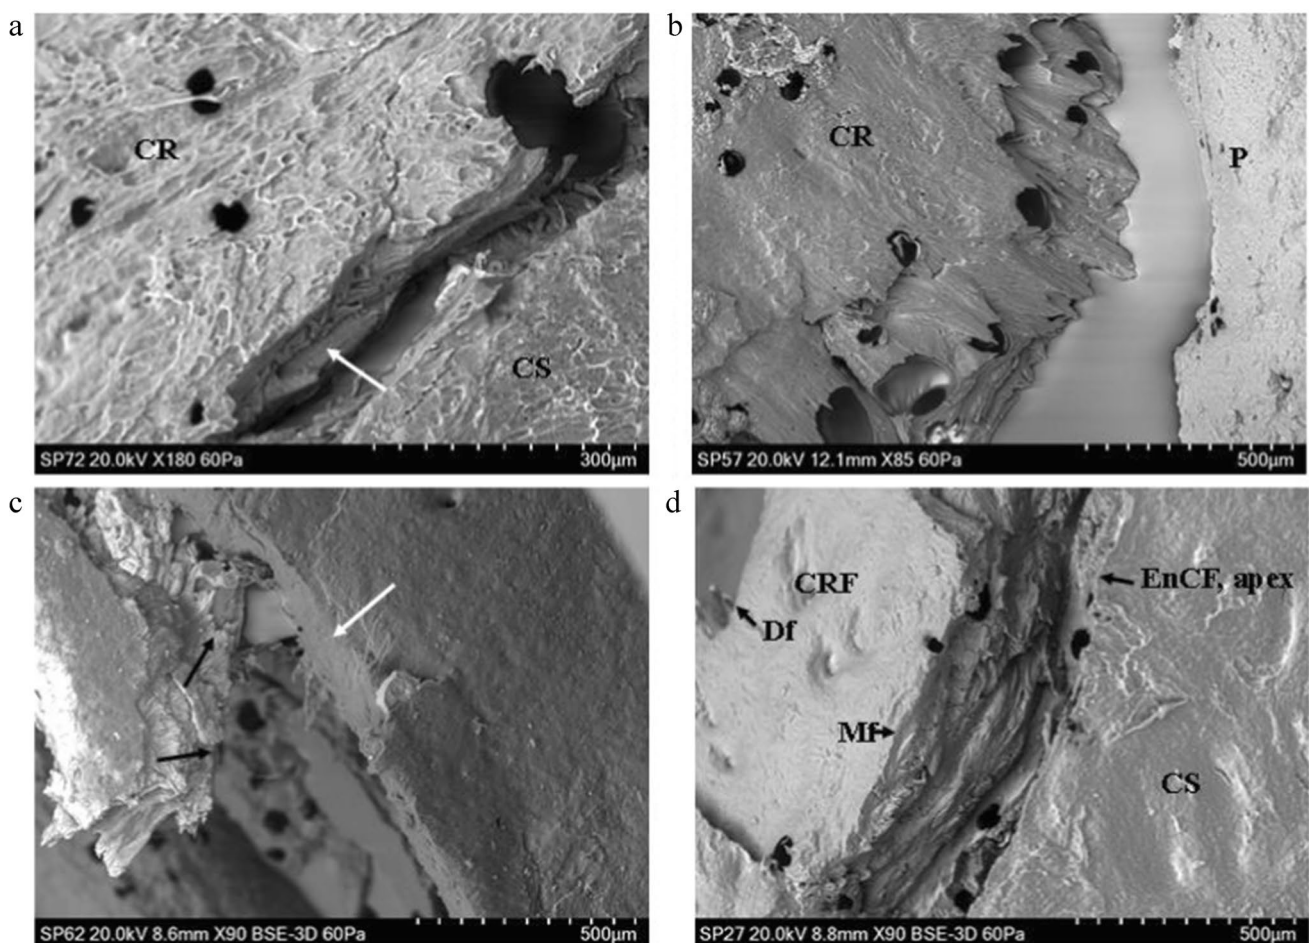
Fig. 5 Genesis of the cortical entry in sandwich bones; stepping of the cortical roof (CS, cortical surface; CR, cortical roof; CRF, cortical roof fragment; MF, medial fracture edge of cortical roof fragment; Df, distal fracture edge of cortical roof fragment; P, putty used to seal the cortical entry for negative moulding; EnCF, entry cortical fracture edge); **a** ~57 m/s rebound impact (defleshed specimen), mode I (tensile, crack opening) fracture mode indicated by stepping of the fracture edge across lamellar planes inside the cortical roof (arrow); **b** 75 m/s perforating impact ($E_i=2.47$ J, $E' = 0.09$ J/mm²) showing right fracture edge of the cortical roof of the nearly intact conoid

seen in Fig. 4b, complex stepped morphology resulting from mode I fracture across lamellae; fracture edge is angulated to match the corresponding angulation of the EnCF; **c** 94 m/s perforating impact (E_i 3.94 J, $E' 0.14$ J/mm²), cortical roof fragment with the distal surface facing upwards and displaying internal lamellae on the medial side orientated in different planes (highlighted by the small arrows); large arrow indicates an area of smooth bone consistent with being surface-modified plastic deformation; **d** 161 m/s perforating impact (E_i 11.44 J, $E' 0.40$ J/mm²) showing cortical roof fragment with pronounced stepping across the lamellae of the medial fracture margin

components (Fig. 5, b–c) or presented a more uniform stepped morphology (Fig. 5d). The pointed lamellar morphology is illustrated in Fig. 5b, which shows the lower right margin of the cortical roof of the intact conoid seen in Fig. 4b. In this part of the conoid, the stepped region was angled to match the corresponding angulation of the EnCF, and the overlapping pointed lamellar fracture edges produced a complex fracture surface. This morphology may have resulted from the plane of the crack in relation to the lamellar structure in that region or from a pull-out process as the conoid was compressed downwards. Stepped fracture margins with pointed fracture edges were also observed on a smaller scale in a fragment of cortical roof resulting from a 94 m/s impact; in this specimen, the pointed ends of the

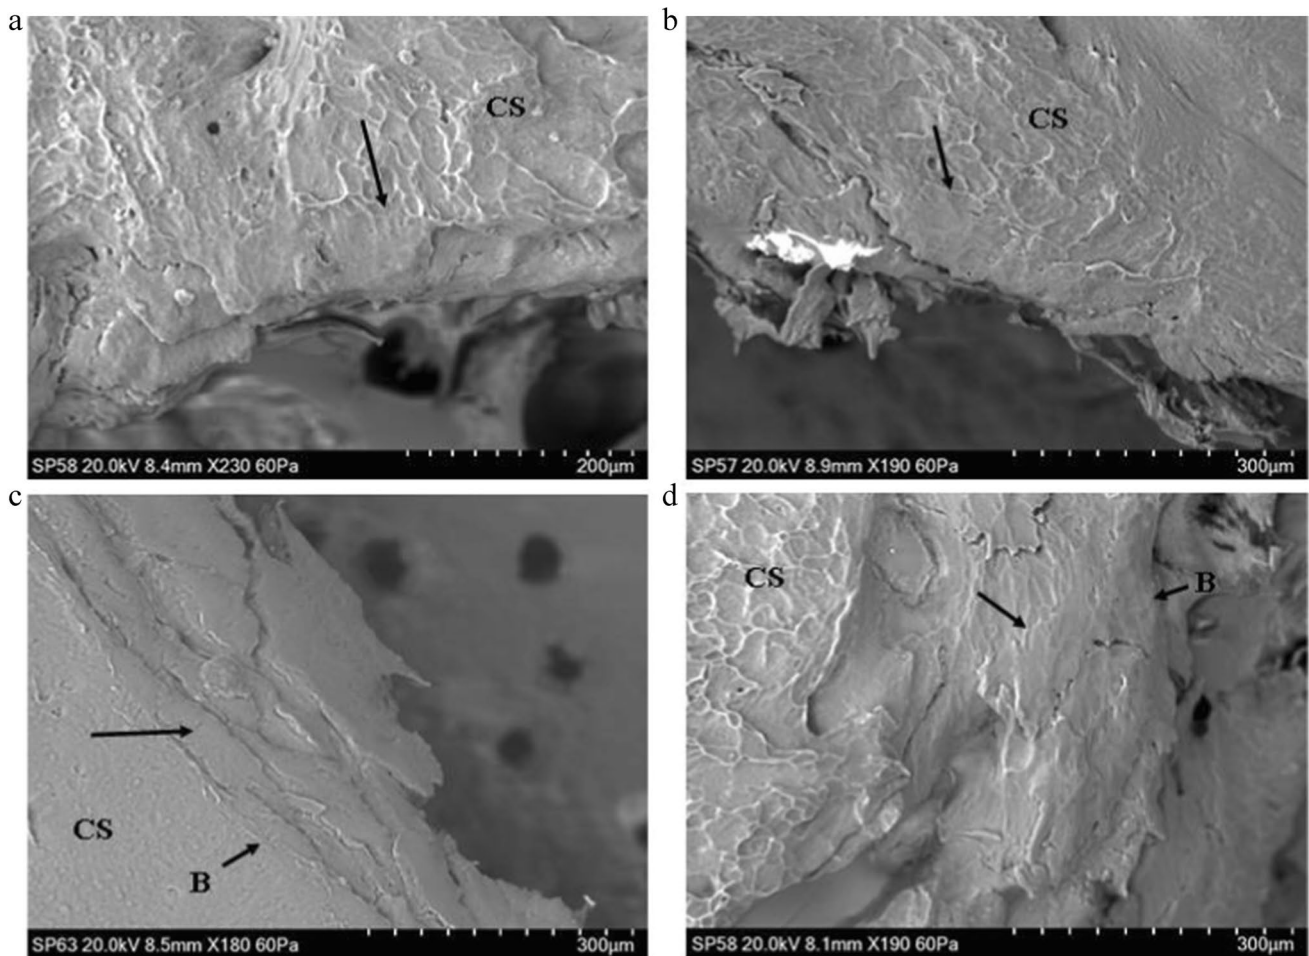
Fig. 6 Surface-modified plastic deformation (SPD), 74–96 m/s perforating impacts (CS, cortical surface); **a** 74 m/s impact ($E_i=2.45$ J, $E' = 0.09$ J/mm²) showing SPD with transition of cortical sculpturing to smooth zone (black arrow); **b** 75 m/s impact ($E_i=2.47$ J, $E' = 0.09$ J/mm²) showing area of SPD with cortical sculpturing fading out at the point indicated by the arrow; bending results in a ductile morphology at the apex of the EnCF; **c** 96 m/s impact (E_i 4.08 J,

$E' 0.14$ J/mm²) with SPD showing compressed, deformed cortex (top black arrow) and bending without fracture (B) leading to a ductile morphology; **d** same specimen as in **a** showing SPD on a descending fragment of cortical roof, arrow indicates the point at which cortical sculpturing fades; bending at **B** is extensive enough to allow the fragment to descend into the cortical entry without fracture

This transition zone is illustrated in specimens impacted at 74–75 m/s Fig. 6, a–b and in specimens impacted at 149–333 m/s in Fig. 7, a–b. Additional features of SPD, present to varying extents in each affected region, were a compressed, deformed cortex and down-bending in the absence of visible fracture. These features are illustrated in a 96 m/s impact in Fig. 6c and in a 591 m/s and 609 m/s impact in Fig. 7 c–d, respectively. The down-bending associated with SPD resulted in a ductile morphology at the apex of the EnCF. Figure 6d shows a cortical roof fragment where bending was extensive enough to allow it to descend into the cortical entry without visible fracture at the top edge (B in the image). Areas of SPD sometimes showed circumferential fractures running along the modified cortical surface (Fig. 7c); these were indistinguishable from ring cracks when they were of large size. The contrast between the cortical surface in the immediate cortical landscape and SPD

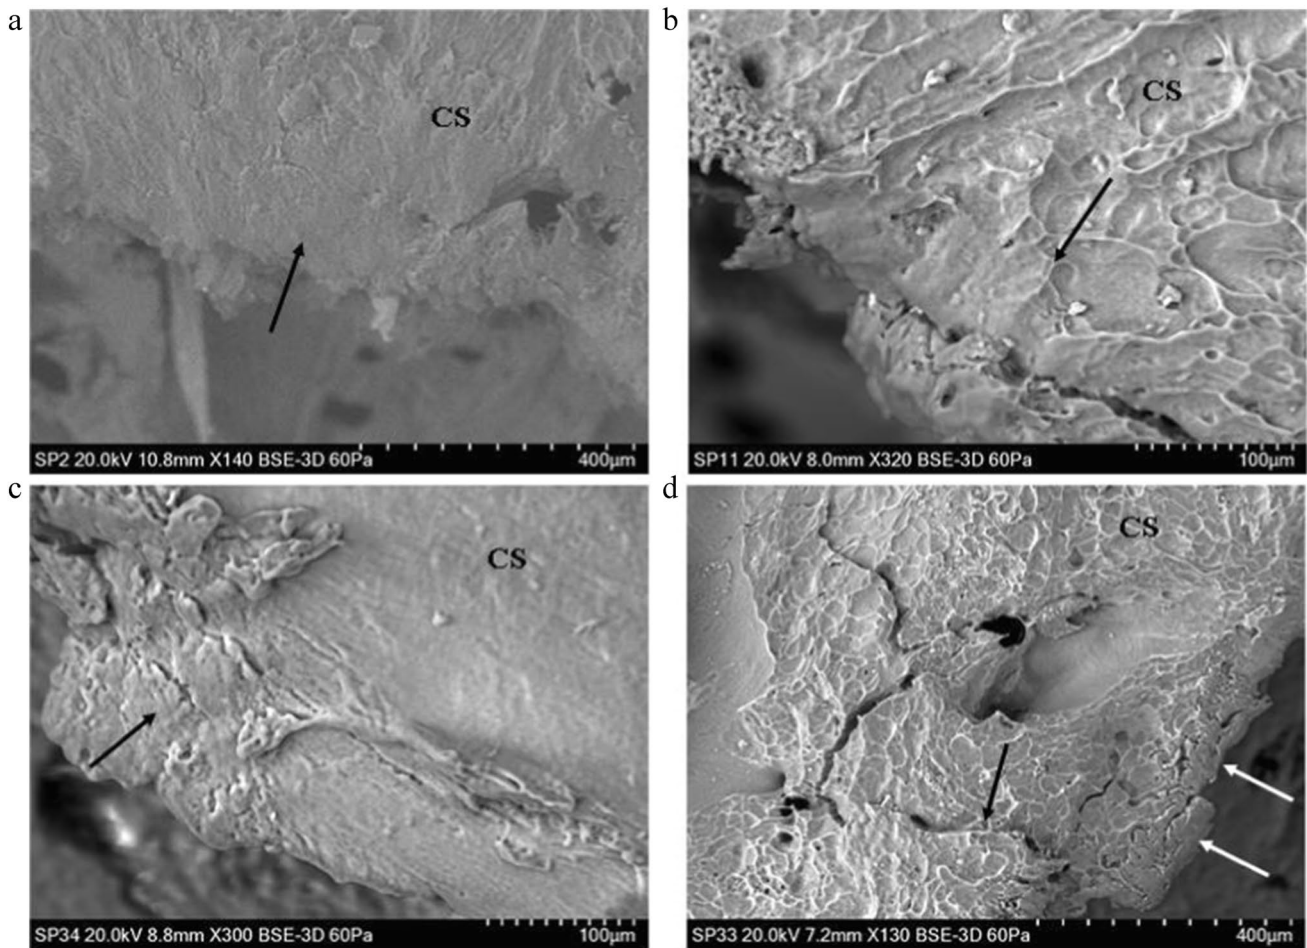
Fig. 7 Surface modified plastic deformation (SPD), 149–609 m/s perforating impacts (CS, cortical surface); **a** 149 m/s impact ($E_i=9.78$ J, $E' = 0.35$ J/mm²) showing loss of surface detail (arrow); **b** 333 m/s impact ($E_i=49.07$ J, $E' = 1.74$ J/mm²) showing SPD with transition of cortical sculpturing (arrow), **c** 591 m/s impact ($E_i=154.37$ J,

$E' = 5.46$ J/mm²) showing SPD (black arrow) with small transverse fractures; **d** 609 m/s impact ($E_i=163.89$ J, $E' = 5.80$ J/mm²) showing SPD along the apex of the EnCF (lower white arrows) in relation to the immediate cortical landscape; note the radial crack emanating from the EnCF (black arrow)

along the apex is illustrated in Fig. 7d. In this example, the cortical surface adjacent to the apex was markedly sculpted; this morphology contrasted greatly with the region of SPD which showed complete loss of sculpturing, bending without visible fracture and a compressed, smoothed appearance.

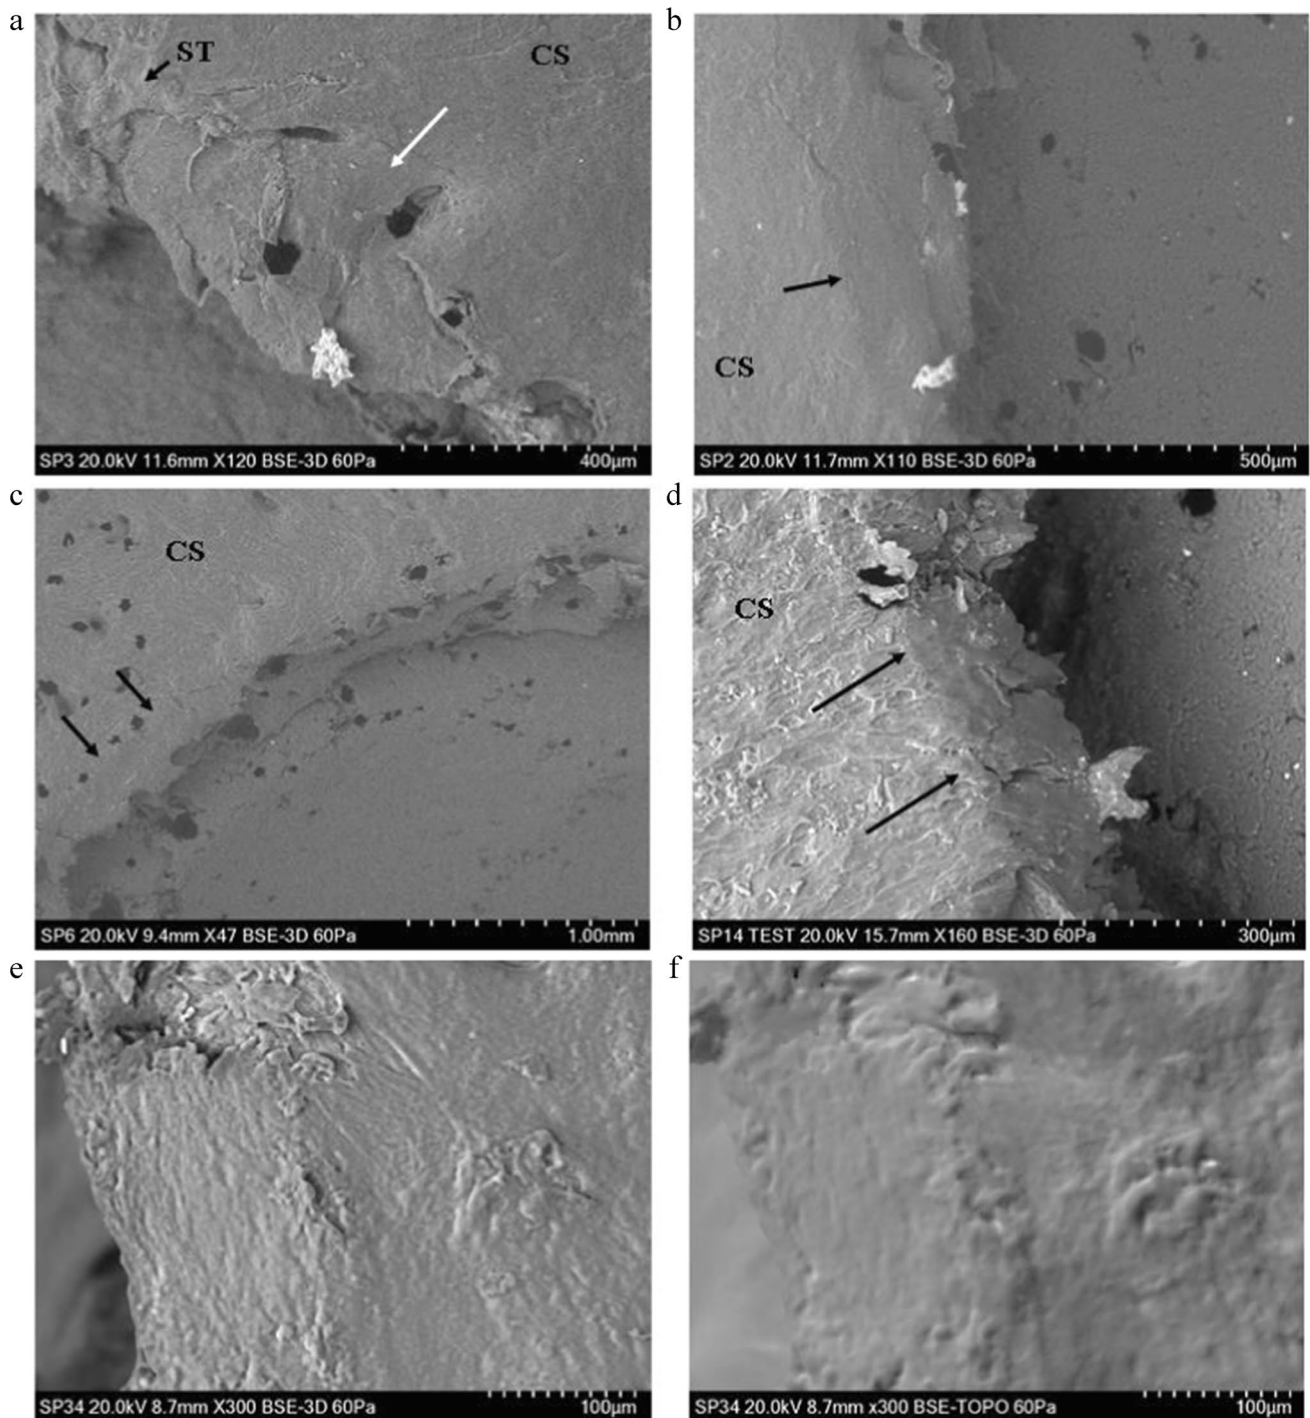
Fig. 8 Peripheral plastic deformation and associated ductile morphology (perforating impacts), (CS cortical surface; ST, soft tissue); **a** 163 m/s impact ($Ei=11.72$ J, $E'=0.41$ J/mm²), showing small area of plastic deformation with intact surface sculpturing; note that the CS is continuous with the bent section of bone (white arrow); **b** 149 m/s impact ($Ei=9.78$ J, $E'=0.35$ J/mm²), area of plastically deformed bone with intact surface sculpturing and fold identified by arrow; this area is at the lower edge of a section of cortical roof fragment; **c** 165 m/s impact ($Ei=12.05$ J, $E'=0.43$ J/mm²) showing margin of cortical

entry with cortical bending due to plastic deformation, particularly at the area identified by black arrows; **d** 570 m/s impact ($Ei=143.96$ J, $E'=5.09$ J/mm²); area of plastic deformation with the fold identified by arrows; note that this region combines pronounced cortical sloping with some surface modification; **e** 591 m/s impact ($Ei=154.37$ J, $E'=5.46$ J/mm²) showing figure continuity of the cortical surface with the plastically deformed region; **f** topographic view of **e** confirming bending of the cortex

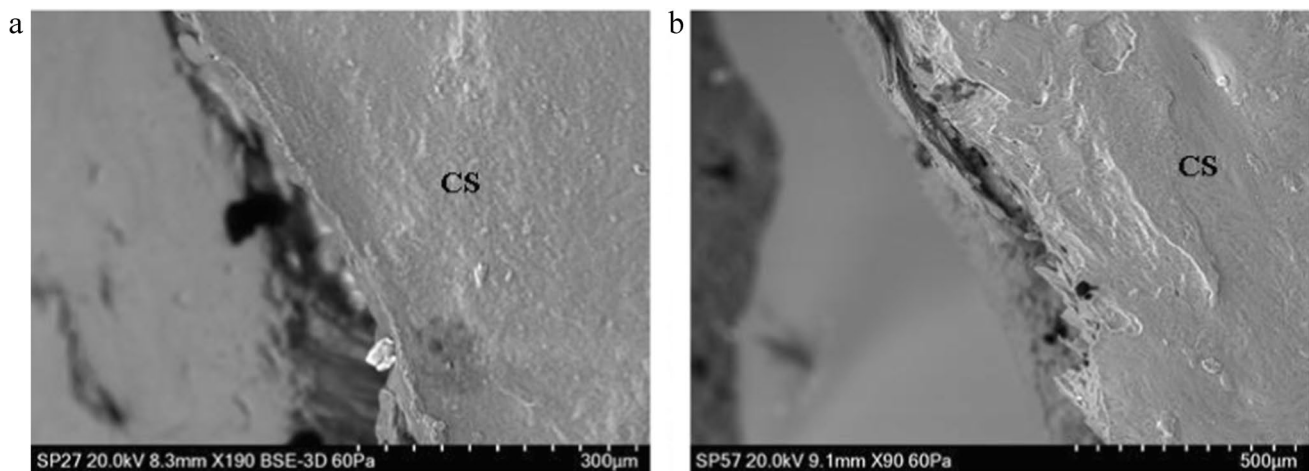
Fig. 9 Apex of the EnCF in non-plastically deformed zones, perforating impacts (CS, cortical surface); **a**, 161 m/s impact (E_i 11.44 J, E' 0.40 J/mm²), abrupt and straight-edged apex; **b**, 75 m/s impact

($E_i=2.47$ J, $E'=0.09$ J/mm²), showing more complex fracture morphology with re-entrant geometries; both fracture edges seen here differ markedly from zones of SPD and PPD

Neither SPD nor PPD were distributed uniformly around the whole circumference of the cortical entries and when absent the EnCF presented with abrupt edges (Fig. 9a) or complex edges with re-entrant geometries between fragmented cortical components (Fig. 9b).

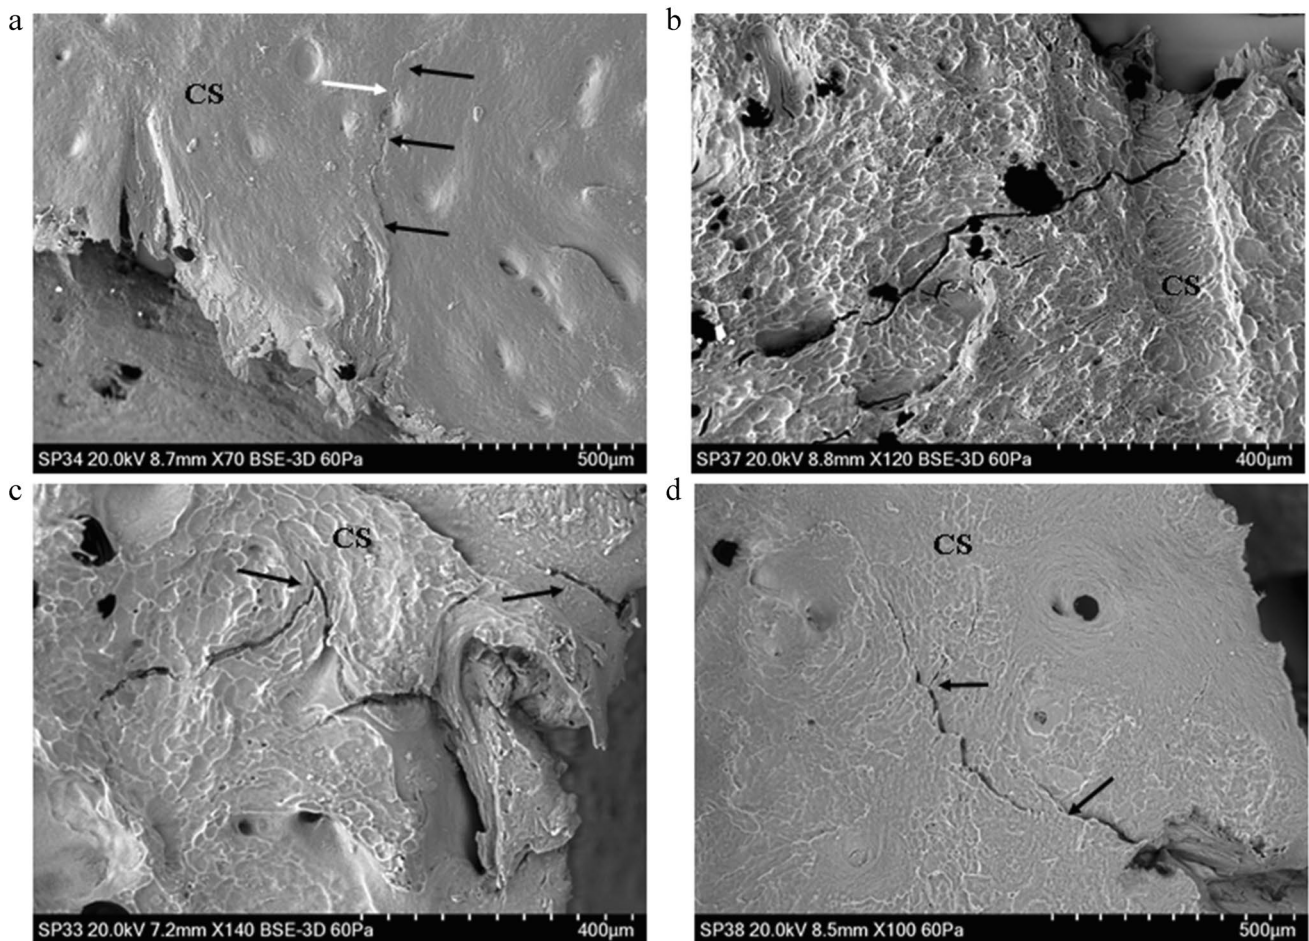
Fig. 10 Radial cracks originating from the entry cortical fracture edge, perforating impacts (CS, cortical surface); **a** 591 m/s impact ($Ei=154.37$ J, $E'=5.46$ J/mm²), narrow crack crossing cortical pit and showing a small ligament bridge (white arrow); **b** 850 m/s impact ($Ei=319.60$ J, $E'=11.31$ J/mm²) showing large, wide radial crack

crossing cortical furrow; **c** 609 m/s impact ($Ei=163.89$ J, $E'=5.80$ J/mm²), showing crack with a bifurcation (left arrow) and a separate straight radial crack inside a cortical furrow (right arrow); **d** 871 m/s impact ($Ei=335.71$ J, $E'=11.88$ J/mm²), long radial crack with two points of bifurcation (arrows)

Radial cracks were observed in 19 of the 21 perforated specimens across the velocity series (illustrated for impacts from 591 to 871 m/s in Fig. 10, a–d). Radial cracks were identified in 12 of the 14 impacts between 58 and 168 m/s and in all 7 impacts between 333 and 897 m/s. Radial cracks followed both relatively straight (Fig. 10, a–b) and tortuous (Fig. 10c) paths. Tortuosity is not clearly associated with velocity; for example, the tortuous crack in Fig. 10c is associated with a 609 m/s impact, whilst the straight crack in Fig. 10b is created by an 850 m/s impact. Some of the radial cracks exhibited uncracked ligament bridging despite high impact velocity (e.g., white arrow in Fig. 10a). Radial cracks ranged from being narrow (Fig. 10a) to open (Fig. 10, b–d) and occasionally exhibited bifurcations along their path (Fig. 10, c–d, arrows). Estimates of crack length using the scale in the images indicated that radial cracks > 1 mm in length were more common in high-velocity impacts. Of the 14 perforated specimens impacted between 58 and 168 m/s, only three possessed radial cracks longer than 1 mm (impacted at 58 m/s, 165 m/s and 167 m/s, respectively). In contrast, a total of 4 out of 6 specimens impacted between 333 and 897 m/s had radial cracks greater than 1 mm in length (impacted at 591 m/s, 850 m/s, 885 m/s and 897 m/s).

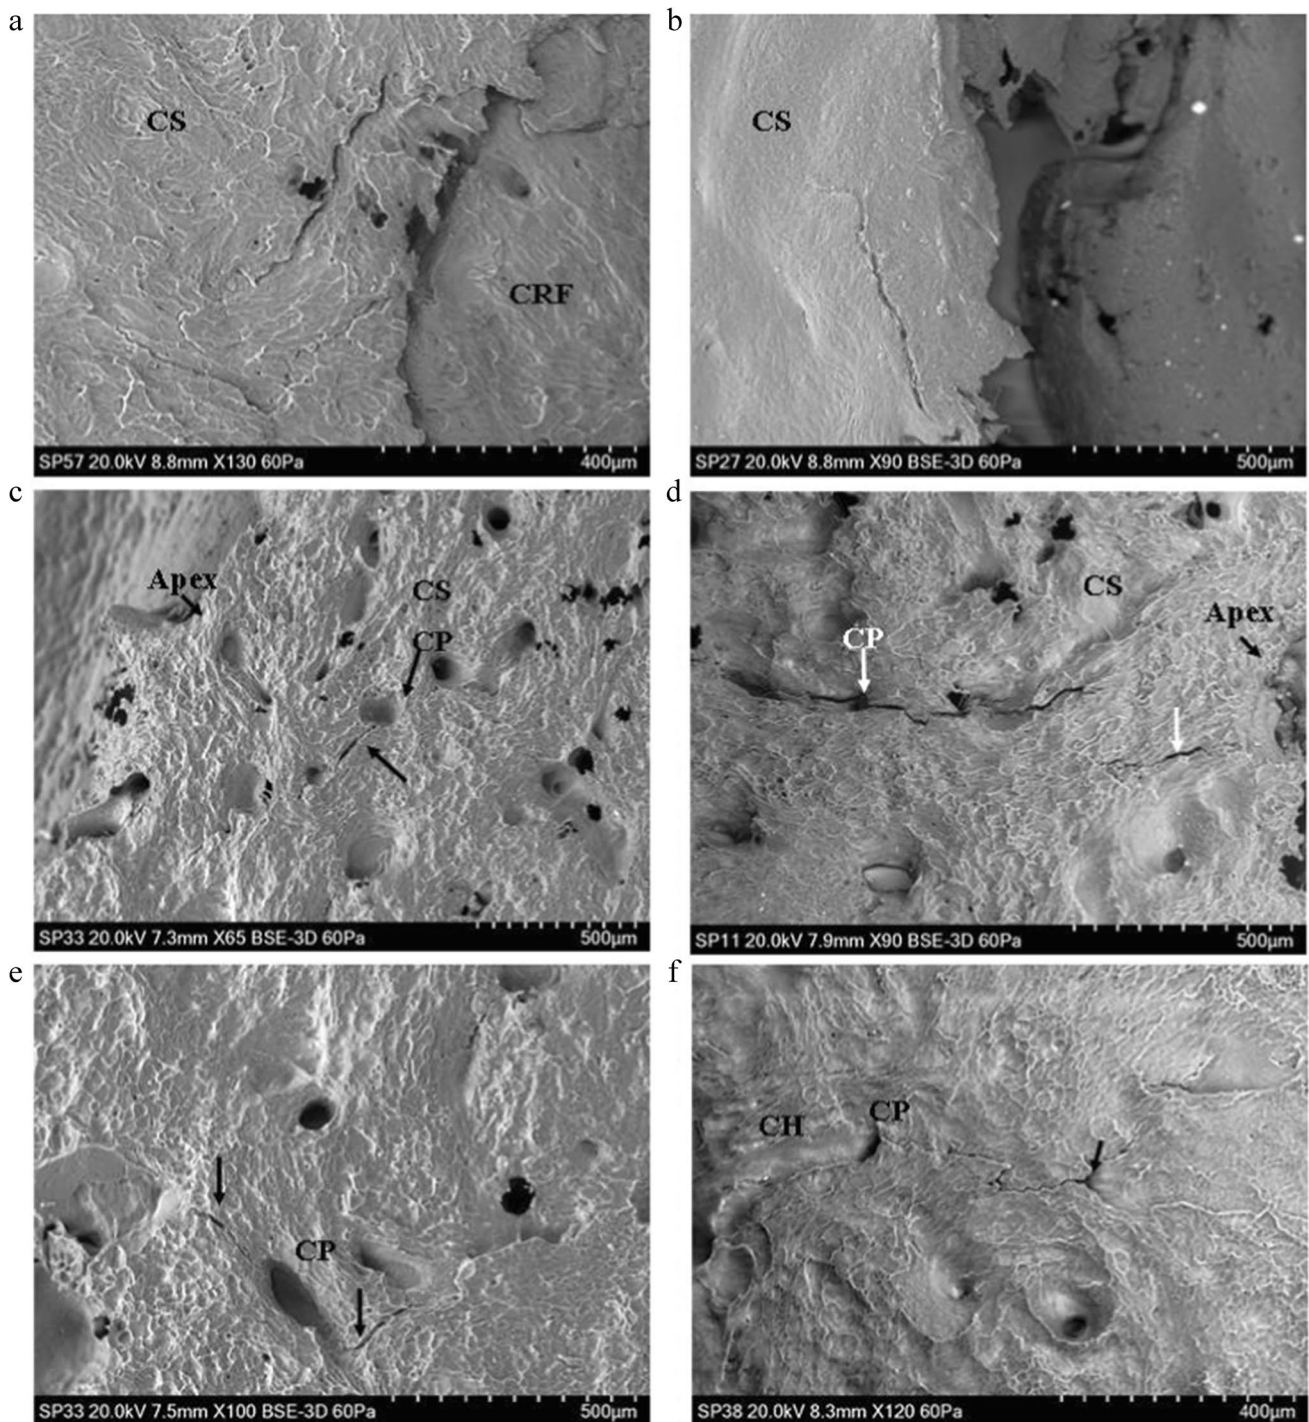
Fig. 11 Concentric cracking and cracks arising from cortical stress concentrators, perforating impacts (CS, cortical surface, CR, cortical roof; CRF, cortical roof fragment, CP, cortical pore; CH, channel); **a** 75 m/s impact ($E_i=2.47$ J, $E'=0.09$ J/mm²), showing concentric crack adjacent to a fragment of cortical roof; **b** 161 m/s impact ($E_i=11.44$ J, $E'=0.40$ J/mm²) with concentric crack near the EnCF; **c** 609 m/s impact ($E_i=154.37$ J, $E'=5.46$ J/mm²) showing concentric crack arising from cortical pit adjacent to the apex of the EnCF; **d** 333 m/s perforating impact ($E_i=49.07$ J, $E'=1.74$ J/mm²), large radially orientated crack adjacent to the apex and associ-

ated with a cortical pore; note the smaller radially orientated crack (lower arrow) that arises within the cortex not a pore; **e** same specimen as in **c**, showing elliptical cortical pore with the major axis running upwards from right to left; stresses acting normal to this axis resulted in stress concentrating at the tips of the elliptical cavity and resulted in cracking at both ends [34]; **f**, 871 m/s perforating impact ($E_i=335.71$ J, $E'=11.88$ J/mm²) showing figure crack associated with a cortical pore/channel complex and extending to a smaller pore-type structure at right (arrow)

Circumferential cracks were identified in a total of 9/14 impacts between 58 and 168 m/s and 4/7 impacts between 333 and 897 m/s. These cracks were found both near the apex of the EnCF (Fig. 11, a–b) and further away in the

cortical landscape; in one case, a concentric crack was found approximately 1.5 mm from the cortical entry. Unlike the rebound impacts, circumferential cracks in the perforating impacts did not appear to form concentric generations but were dispersed diffusely around the cortical entry. Cortical pits and pores acted as stress concentrators during impact and were detected as the origin for some circumferential (Fig. 11c) and radial (Fig. 11d) cracks. In elliptical pores, stresses acting normal to the major axis resulted in cracking at each end due to concentration of stresses there (Fig. 11e) [34]. Pore and pit cracks did not always occur in isolation, with an example of a linked pore-crack complex occurring in an 871 m/s impact (Fig. 11f). Cortical pore cracking occurs both near the apex of the EnCF (Fig. 11, a–b) and more distant, with the pore in Fig. 11e being over 1 mm away from it.
