MICROSTRUCTURAL DAMAGE OF THERMAL BARRIER COATINGS DUE TO CMAS  
ATTACK

SCHOOL OF APPLIED SCIENCES  
SURFACE ENGINEERING AND NANOTECHNOLOGY INSTITUTE (SENTI)

Full Time Ph.D Student  
Academic Year: 2010 - 2013

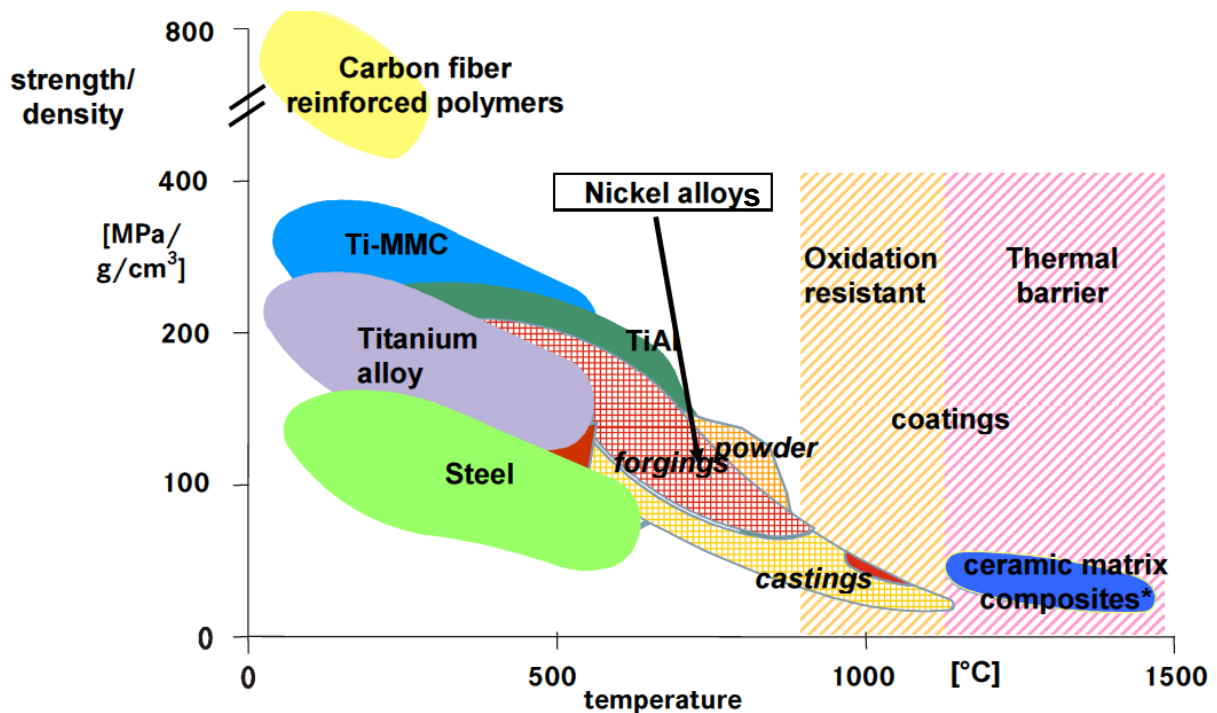
Figure 5: Temperature capabilities of classes of materials [14].

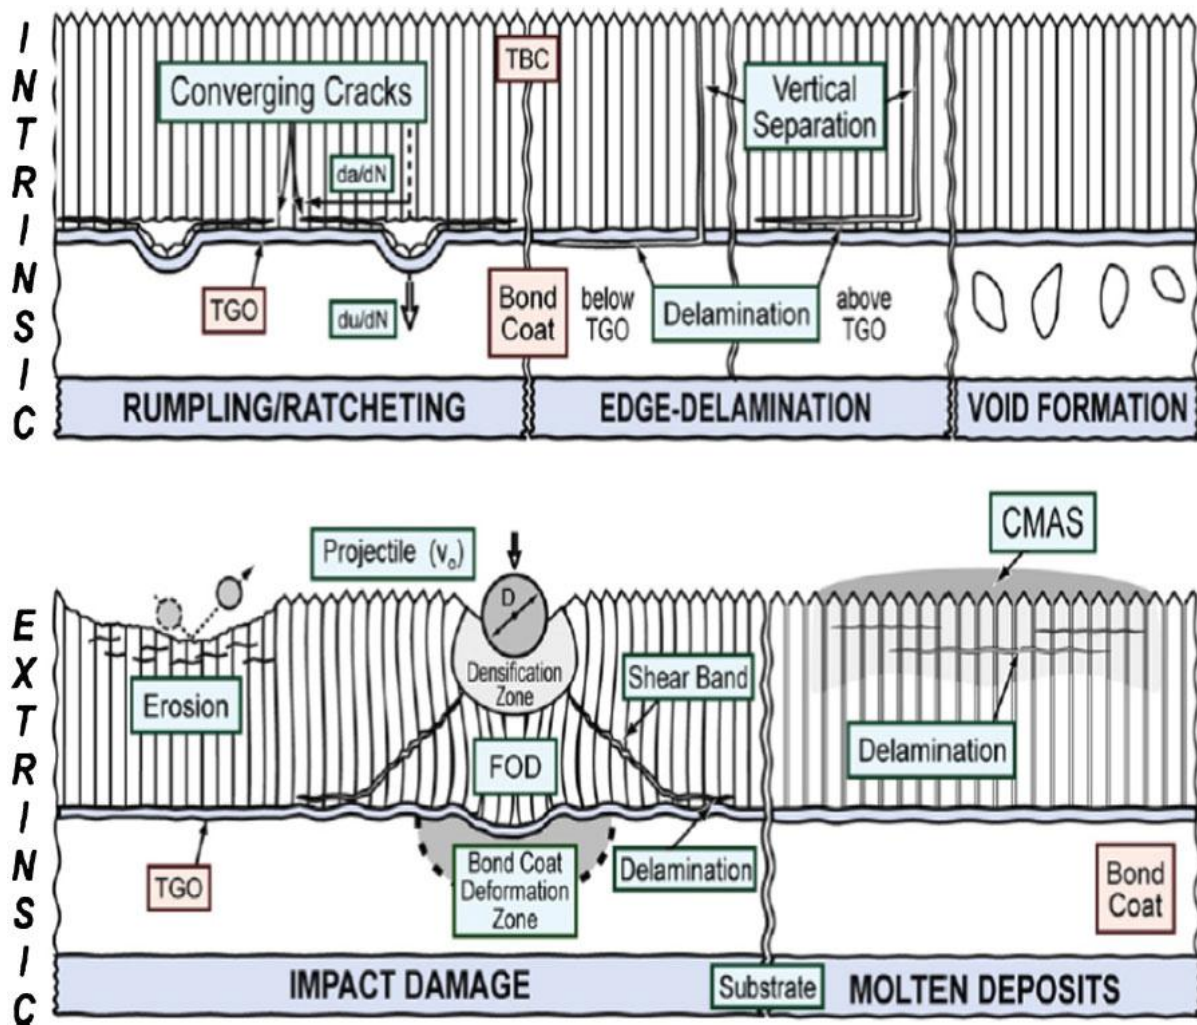
Figure 23: A schematic of the degradation model proposed by Evans et al. [52]

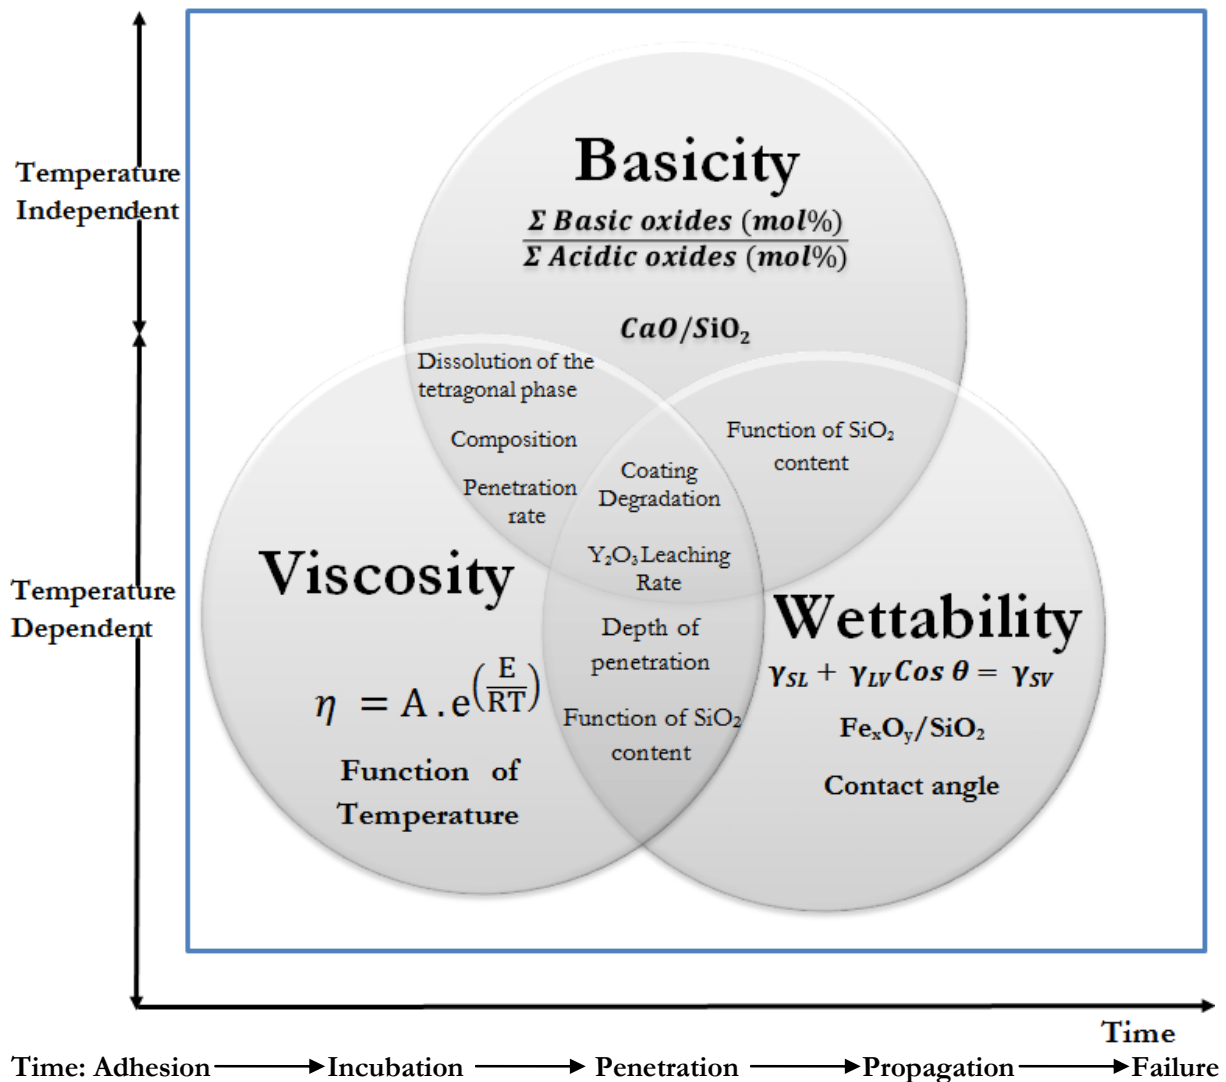
Figure 47: Five interacting parameters that determines the severity of damage to TBCs caused by molten oxides

Viscosity, Time and Temperature. However, the individual effects of these parameters as well as their collective effect on damage mechanism is part of the ongoing study and their interactive behaviour and severity shall be investigated as part of future studies. Based on these parameters, the model in Figure 47 is proposed, which is a schematic of the expected inter-relationship of Basicity, Wettability, Viscosity, Time and Temperature.

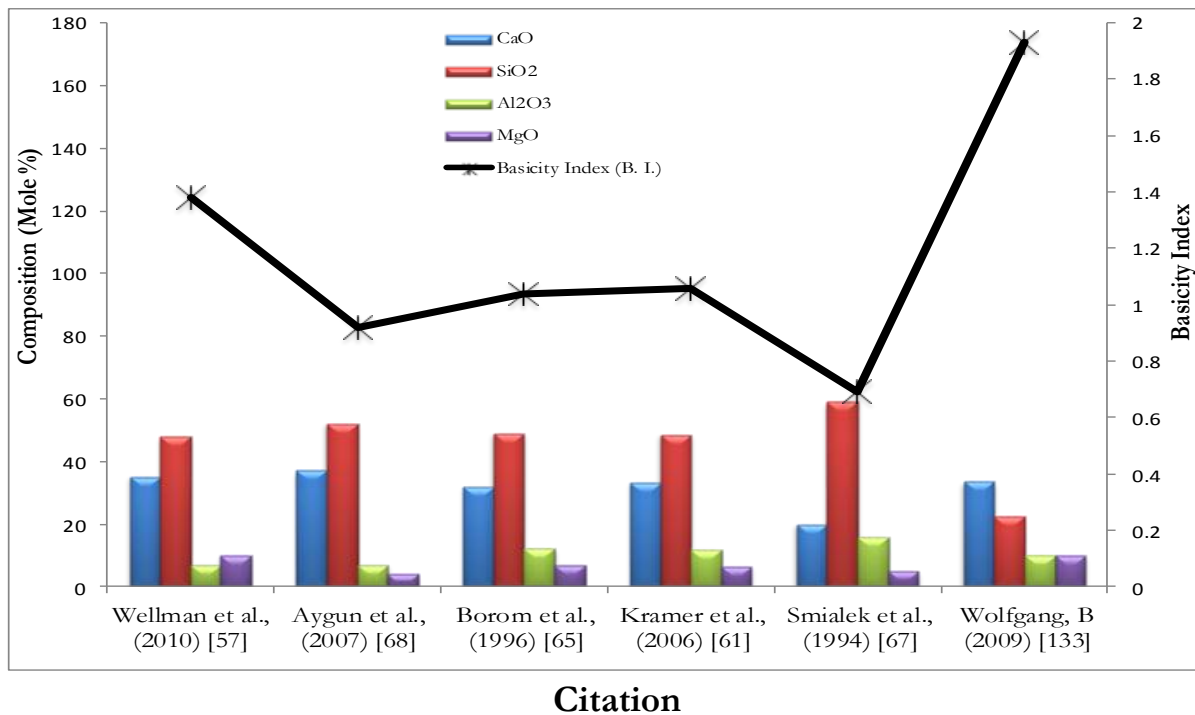
Figure 49: Comparison of CMAS compositions with Basicity [150]

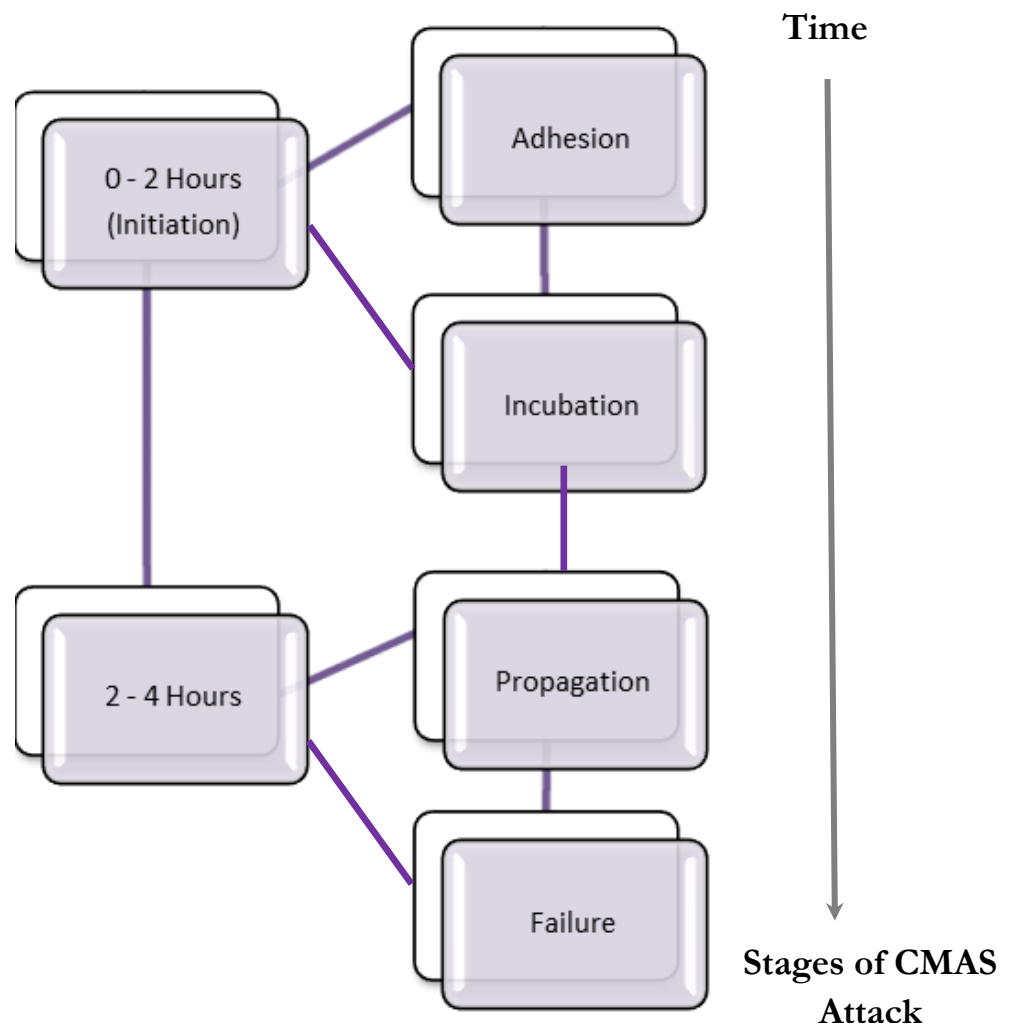
Figure 85: Reaction path of TBC attack with minimum amount of CMAS, to demonstrate exposure time effect on molten deposits attack.

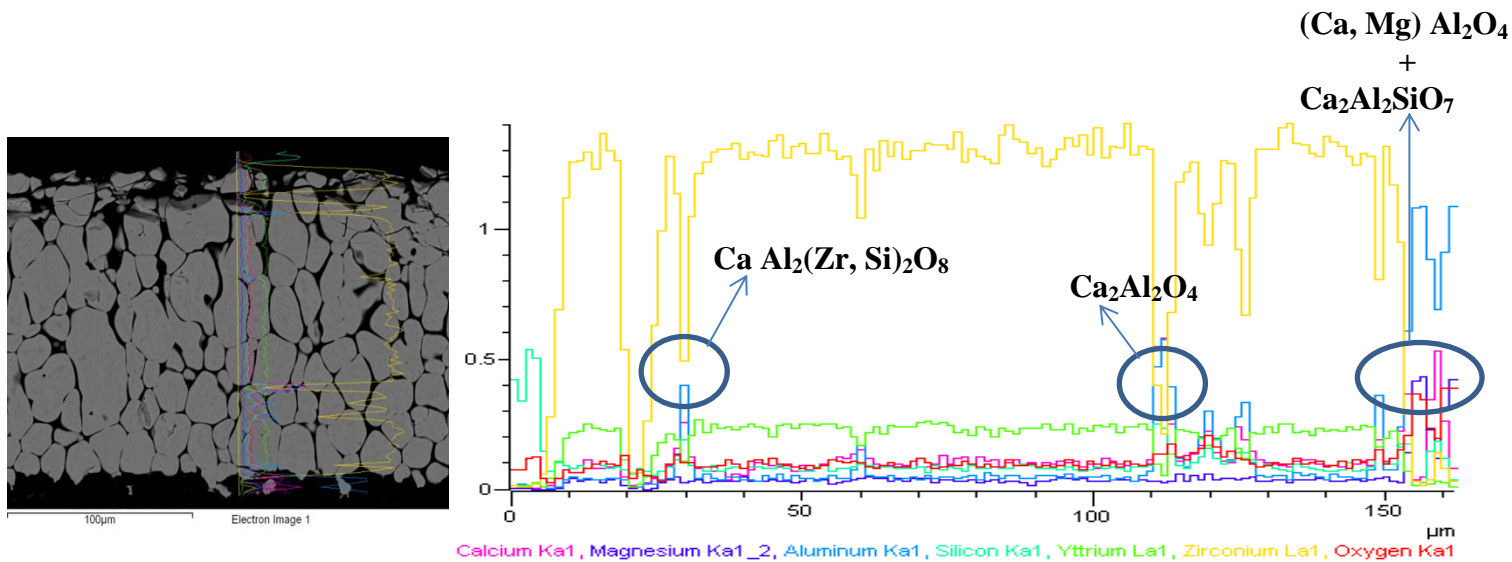
Figure 134: EDAX line scan results for C73M10A7S11 (B. I. = 4.68).
