# Mechanical Stress Effects on 550 °C Hot Corrosion Propagation Rates in Precipitation Hardened Ni-Base Superalloys: CMSX-4, CM247LC DS and IN6203DS

Neil Chapman<sup>1,2</sup> · Simon Gray<sup>2</sup> · Joy Sumner<sup>2</sup> · John Nicholls<sup>2</sup>

Received: 26 May 2021 / Revised: 16 November 2021 / Accepted: 18 November 2021 /  
Published online: 10 December 2021  
© The Author(s) 2021

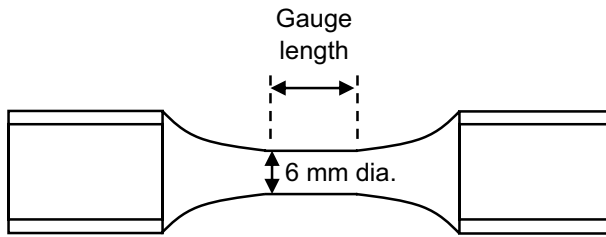
**Fig. 1** Schematic of fatigue specimen

The materials were single-point turned into plain fatigue specimens (Fig. 1) for the CF tests and 6 mm diameter cylindrical specimens (which represented the gauge diameter of the fatigue specimens) that were 10 mm long for hot corrosion exposures without the application of mechanical stress.

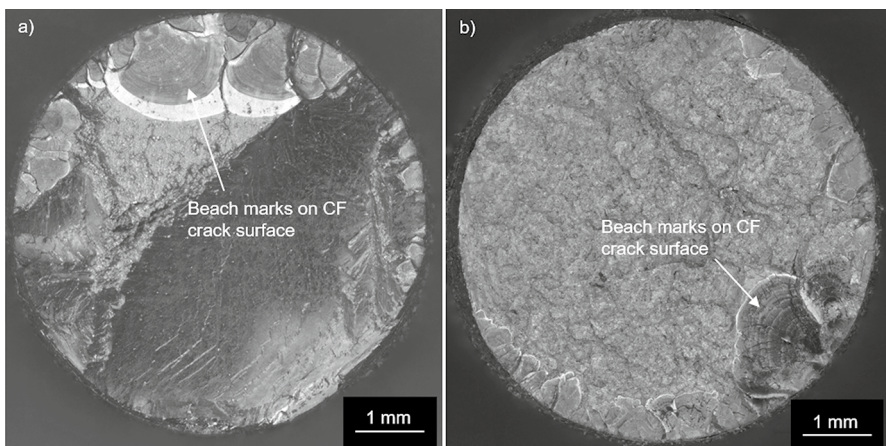
**Fig. 2** Optical microscopy images showing beach marks observed on the exposed CF crack faces after fracture occurred in **a** CMSX-4 (CF test completed 73 h with mean stress of 820 MPa) and **b** CM247LC DS (CF test completed 99 h with mean stress of 675 MPa)

Of the three materials subjected to the CF testing, only CMSX-4 and CM247LC DS experienced fractures. The respective fracture surfaces of these two materials indicated similar features in that multiple cracking had occurred which had propagated normal to the direction of mechanical stressing on the  $\langle 100 \rangle$  planes. The exposed crack surfaces revealed beach marks (Fig. 2) suggesting the cracking followed a start-stop-start process, but no evidence of fatigue striations could be found during the SEM examination. EDX mapping, on the unetched longitudinal sections, of the hot corrosion products within the CMSX-4 and CM247LC DS cracks that were remote from the final fracture, revealed an O [21] and S [20] embrittled phase (Fig. 3 shows an example from CMSX-4). Despite these similarities, a comparison of scatter plots showing the effect of mean stress against the duration of testing (Fig. 4) indicated that all three materials displayed different CF behaviours. All the CMSX-4 and CM247LC DS specimens had experienced cracking, which ultimately caused fractures in all but one of these superalloy specimens with significantly more scatter in the CM247LC DS results than in the CMSX-4 results. By contrast, the IN6203DS specimens successfully completed the 300 h of CF testing without showing any evidence of cracking. (For each material, the range of mechanical stress levels that were applied during the respective CF tests, included those which represented elastic stressing and others which represented plastic stressing. The identification of which CF test was performed with elastic or plastic stress though is not given in this paper to protect the sponsors' design data).

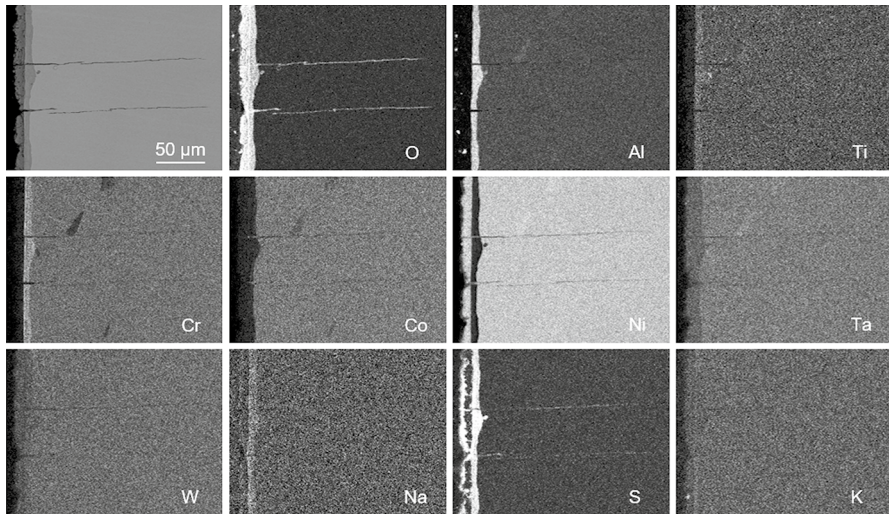
**Fig. 3** Example of EDX map from an unetched longitudinal section showing O and S penetration into CMSX-4 (CF test completed 73 h with mean stress of 820 MPa)

The longitudinal sections that contained cracks remote from the fracture were used to characterise the hot corrosion products within the cracks. This was achieved using Inca software to perform energy dispersive X-ray (EDX) mapping. Owing to overlapping Mo and S X-ray energy peaks though, this technique is unable to differentiate the two elements. However, due to the S content within the sprayed Na<sub>2</sub>SO<sub>4</sub>/K<sub>2</sub>SO<sub>4</sub> deposits and the relatively small Mo content in the chemistries of the materials, any Mo/S indication was assumed to be S.

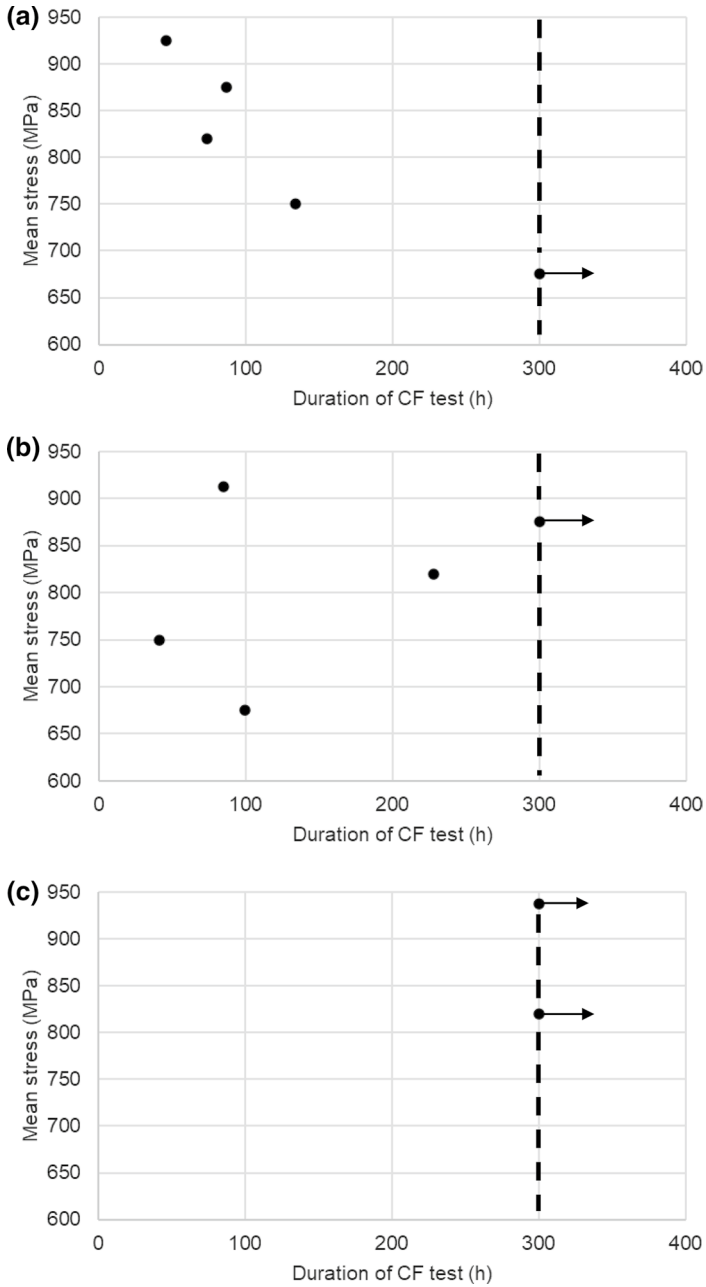
**Fig. 4** CF results of **a** CMSX-4, **b** CM247LC DS and **c** IN6203DS. Dashed lines represent end of test, arrows indicate runout specimens

surface-connected gamma-prime eutectic features were within the gauge length of the fatigue specimens. This randomness was therefore the most likely cause of the scatter observed within the CF results of CM247LC DS material (Fig. 4).

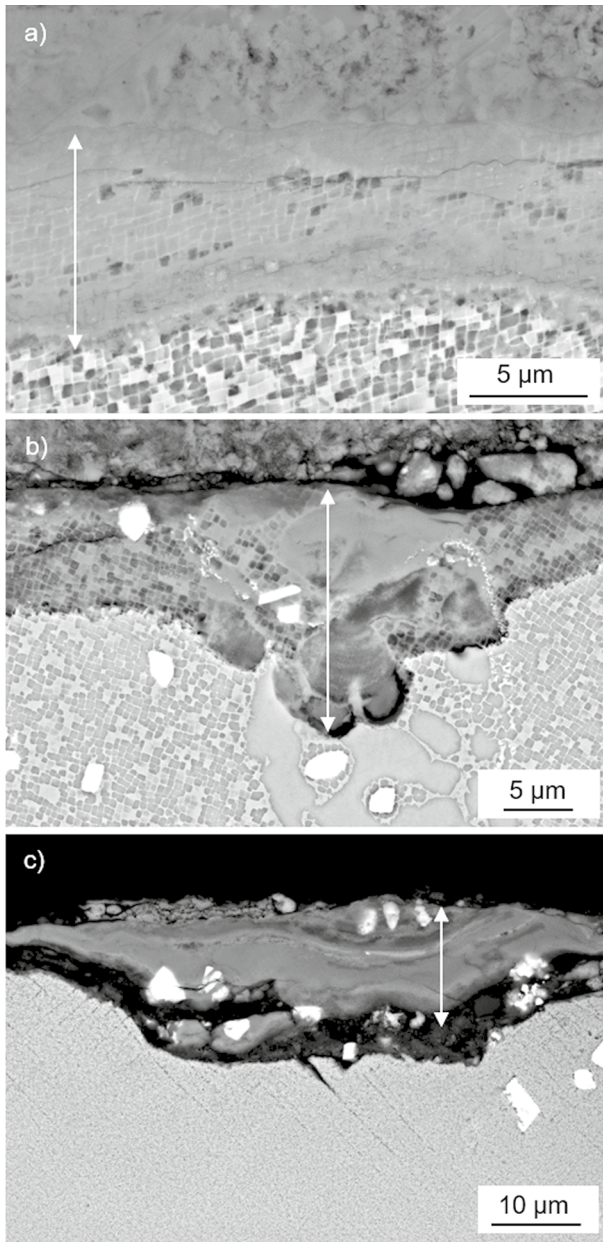
**Fig. 5** Back-scattered images of adherent intact scale on etched cross-sections of **a** CMSX-4 (CF test completed 86 h with mean stress of 875 MPa), **b** CM247LC DS (CF test completed 40 h with mean stress of 750 MPa) and **c** IN6203DS (CF test completed 300 h with mean stress of 938 MPa). Arrows indicate internal scale as defined by microstructural features (gamma prime and/or carbides)

To understand the different CF behaviours of the three materials, the polished and etched cross-sections of the specimens were used to investigate the effect of mechanical stress on the hot corrosion propagation rate. The back-scattered images obtained indicated the scale present consisted of an external and internal component (Fig. 5)

which were defined by the absence or presence of microstructural features such as the gamma-prime precipitates and/or carbides. Further to this, the images indicated the scale to be in various states of damage on each material, which was most likely caused by the high frequency of the CF tests. The damage observed included breakage/cracking of the internal scale in some areas suggesting spallation may have occurred, whilst other areas showed the internal scale to have minimal damage and were largely intact (as indicated in Fig. 5). The maximum observed depth of hot corrosion each fatigue specimen had experienced was therefore based on measuring the thickest intact internal scale from the respective back-scattered images. This allowed the mechanical stress influenced hot corrosion propagation rates, experienced during the CF testing, to be calculated as described in the Data analysis section.

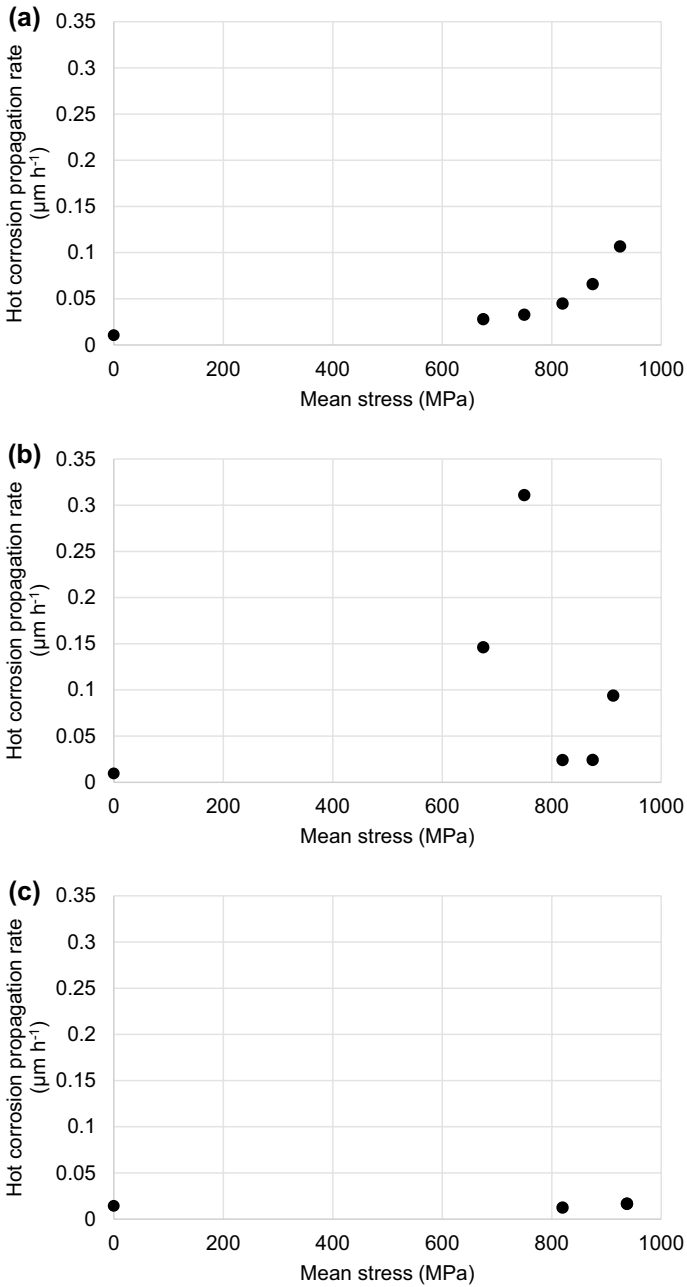
**Fig. 6** Mechanical stress effect on the maximum hot corrosion propagation rates of **a** CMSX-4, **b** CM247LC DS and **c** IN6203DS

Figure 6 shows a scatter plot for each material illustrating the effect that mechanical stress has on the calculated hot corrosion propagation rates. Also included in these plots is the respective hot corrosion propagation rate from the cylindrical specimens (obtained from the rate component in Eqs. 1–3) which were exposed without any mechanical stress being applied. No significant evidence of an increased hot corrosion propagation rate was found due to the mechanical stress applied during the CF testing of the IN6203DS material (rates of  $0.012$  and  $0.016 \mu\text{m h}^{-1}$  were calculated which were plausibly equal to the rate component of  $0.0142 (\mu\text{m h}^{-1})$  in Eq. 3). All fatigue specimens manufactured from CMSX-4 and CM247LC DS materials though did experience an increase in the hot corrosion propagation rate during the CF testing when compared with the respective rate components in Eqs. 1 and 2. In the case of CMSX-4, a predictable increasing trend in the calculated rate (rising from  $0.028$  to  $0.107 \mu\text{m h}^{-1}$ ) was associated with the mechanical stress which compared with the rate component of  $0.0105 (\mu\text{m h}^{-1})$  in Eq. 1. For CM247LC DS, the rates associated with the CF tests ranged between  $0.024$  to  $0.311 \mu\text{m h}^{-1}$  which were

all greater than the rate of  $0.000935 \text{ } (\mu\text{m h}^{-1})$  quoted in Eq. 2. However, no obvious trend was apparent for the mechanical stress-influenced CF hot corrosion propagation rates for CM247LC DS, and this appeared to be the cause of the greater degree of scatter in the CF results of this material.

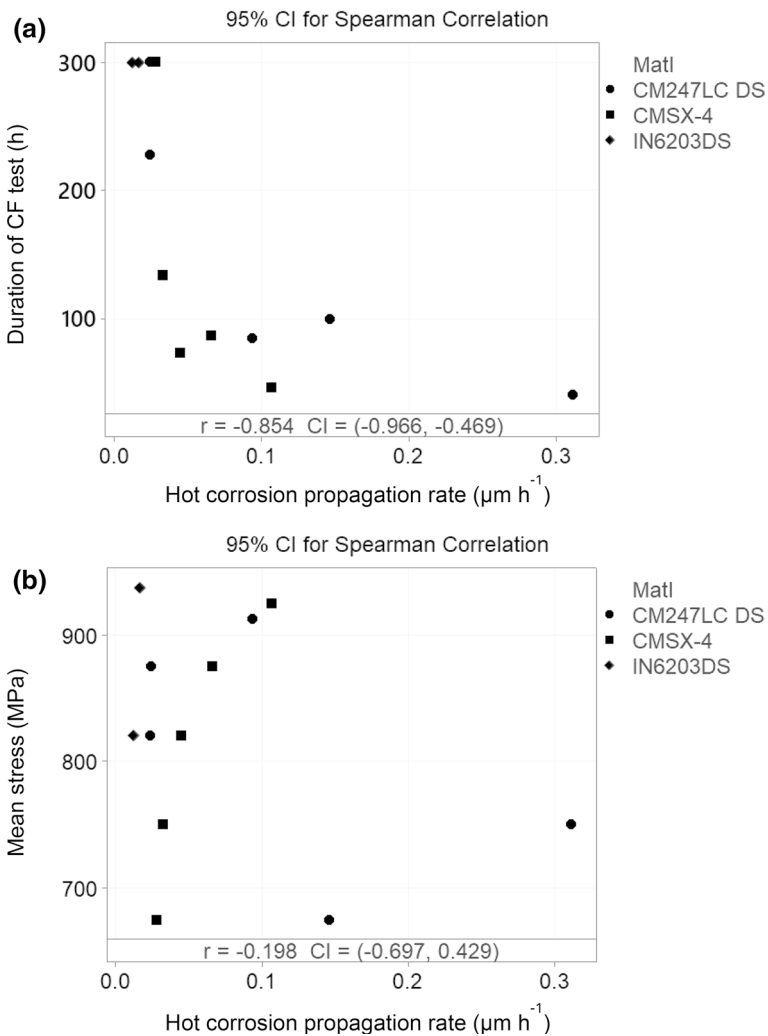
**Fig. 7** Spearman correlation analysis, performed with a 95% confidence interval, between **a** the hot corrosion propagation rate and the duration of the CF tests, and **b** the hot corrosion propagation rate and the mean stress the CF tests were performed at

After grouping the CF calculated hot corrosion propagation rates of all three materials into one group, a Spearman correlation test [22] was performed (using Minitab version 19 software) against the duration of the CF tests (Fig. 7a). This form of correlation test assesses monotonic relationships between two variables. An output is then provided which is used to determine if a non-linear relationship plausibly

exists between the two variables. The correlation coefficient obtained ( $-0.854$  with a 95% confidence interval of  $-0.966$  to  $-0.469$ ) indicated a strong relationship suggesting the hot corrosion propagation rate is an influential factor in the CF life of the three materials tested. However, it does not explain the cause of the increased rates.

Another Spearman correlation test was performed (Fig. 7b), but this time against the CF mean mechanical stress and the CF hot corrosion propagation rates. The correlation coefficient obtained ( $-0.198$  with a 95% confidence interval of  $-0.697$  to  $+0.429$ ) indicated little evidence for a relationship between these two variables. Although this may suggest that mechanical stress may not be an influential factor in the CF tests, it does not preclude it from interacting with another factor such as the microstructure.

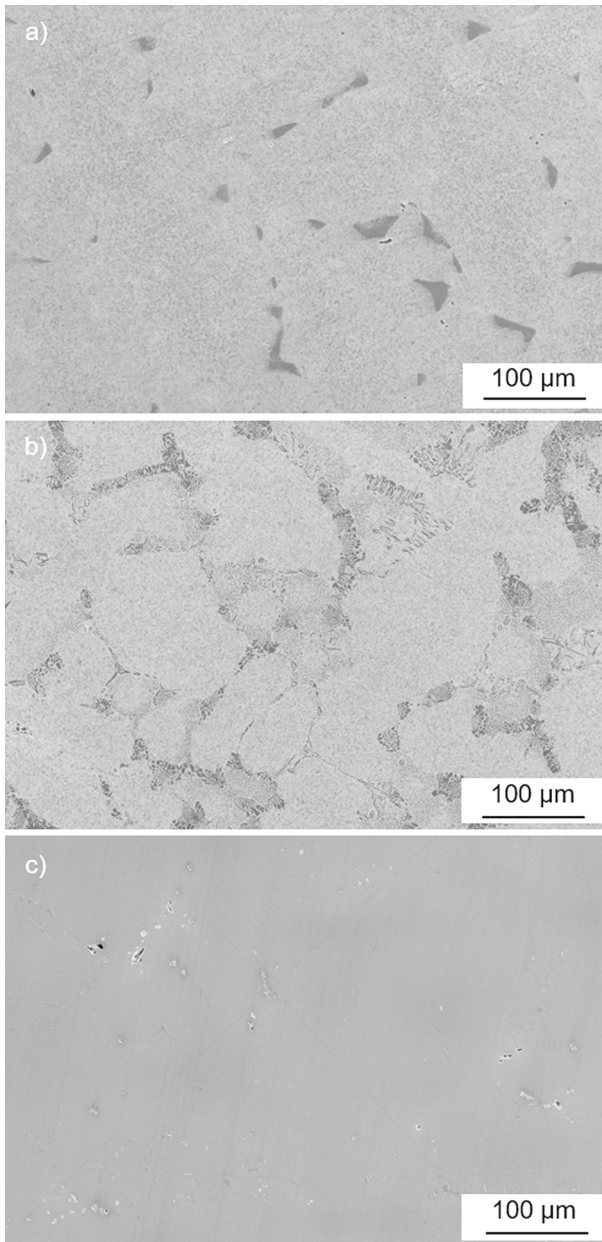
**Fig. 8** Secondary electron images of etched cross-sections showing the gamma prime eutectic in **(a)** CMSX-4 with a volume fraction, in image shown, of 3.0% (CF test completed 300 h with a mean stress of 675 MPa), **b** CM247LC DS with a volume fraction, in image shown, of 8.0% (CF test completed 300 h with a mean stress of 875 MPa) and **c** IN6203DS with a volume fraction, in image shown, of 0% (CF test completed 300 h with a mean stress of 820 MPa)

The interaction between the three factors (mechanical stress, gamma-prime precipitate volume fraction and gamma-prime eutectic volume fraction) may be more influential than the individual factors alone. Evidence of this possible interaction can be seen in Fig. 5b, which shows a localised region, associated with the gamma-prime of a surface connected eutectic region, that has experienced greater depths of hot corrosion attack than the adjacent areas.

To determine the gamma-prime eutectic volume fraction of the CMSX-4, CM247LC DS and IN6203DS materials, image analysis was performed (using Olympus Stream motion software) on three random areas of the etched cross-sections of two CF tested specimens per material. Table 3 shows the respective volume fraction for each area. For IN6203DS, no evidence of gamma-prime eutectic could be found in either specimen. In the case of CMSX-4, one specimen had gamma-prime eutectic volume fractions of 1.2, 0.9 and 1.5% (averaging out at a mean value of 1.2%) whilst the other specimen had values of 3.0, 2.1 and 3.3% (mean average of 2.8%). For CM247LC DS, values of 8.0, 6.3 and 6.1% (mean average of 6.8%) were recorded in one specimen and 7.7, 5.9 and 6.8% (mean average of 6.8%) were recorded in the other specimen. The overall mean average of the
