A preliminary study into injuries due to non-perforating ballistic impacts into soft body armour over the spine

Rosalind M. Jennings¹, Chris Malbon², Dr Fiona Brock¹, Lt. Col. Stuart Harrison³, Dr Debra J. Carr^{2,4}

Abstract

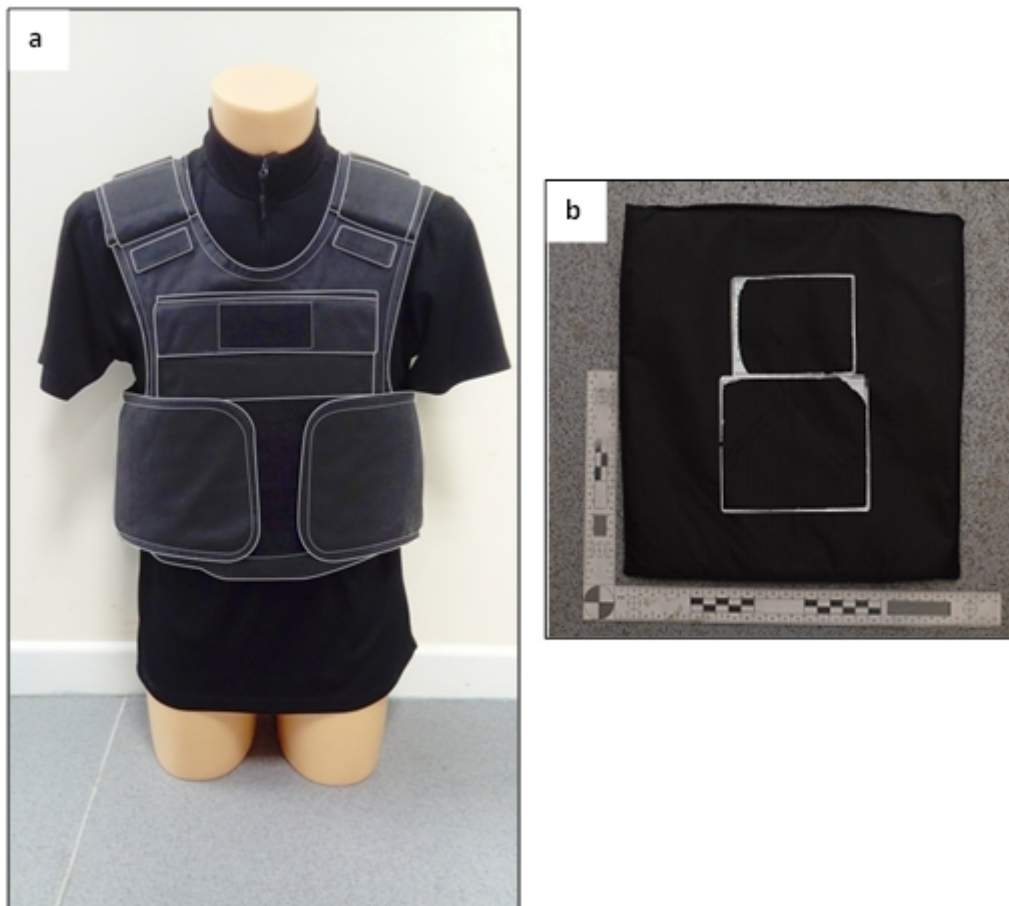
Figure 1: a) Typical police polo shirt with carrier vest over the top and b) standard UK ballistic test panel of HG1/A + KR1 body armour

A standard UK police polo shirt (50% polyester, 50% Nano Kool), and body armour carrier vest were used in combination with HG1/A + KR1 body armour test panels (fig 1).

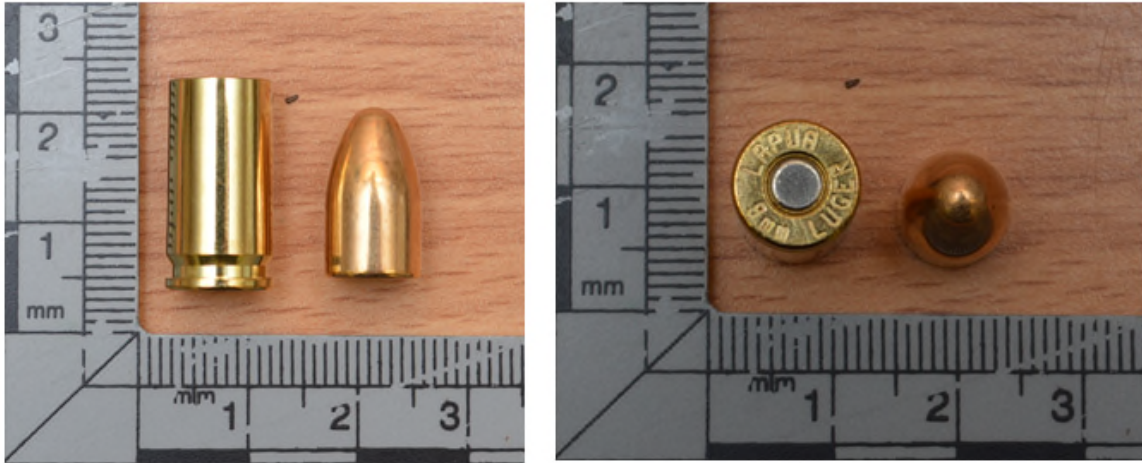
Figure 2: 9 mm Luger FMJ ammunition side and end on view

The ammunition used was 9 mm Luger (9 x 19 full metal jacket; made by - Nammo Lapur Oy, Finland), (fig 2).

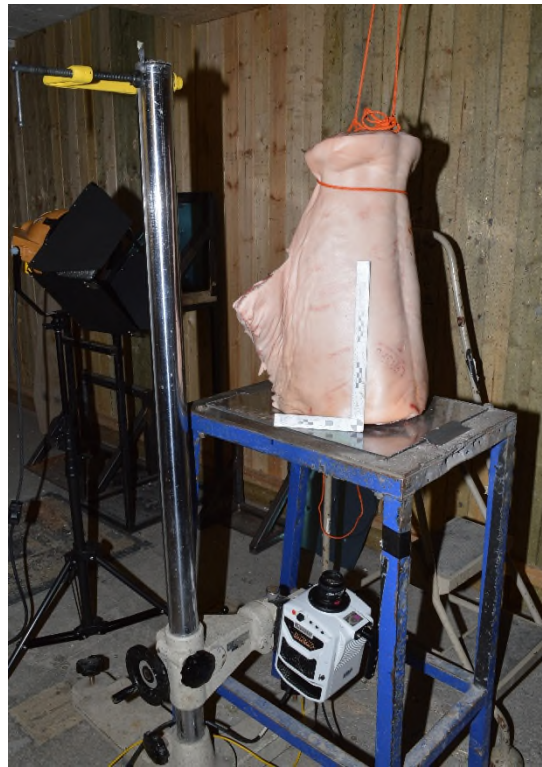
Figure 3: Testing set up before clothing and body armour put on

The pig barrel was photographed and soft tissue (skin and fat layers) thickness measured with forensic scale prior to testing. The barrel was placed on a clear topped table 10 m down range with the spine facing the end of the muzzle. The pig barrel was loosely tied to a beam to keep it upright during impact but allow natural movement (fig 3). An Enfield Number 3 Proof Housing with a 127 mm barrel fitted was used to fire the ammunition; this is a standard apparatus used in ballistic test ranges (fig 4). The pig barrel was covered in the polo shirt and then the body armour, in carrier vest, secured over the spine. Shots were aimed to hit the armour over a vertebra. All shots were aimed at least 50 mm from other shots resulting in five shots along the spine. The projectile impact velocities were recorded using a Weibel W-700 Doppler radar. A Phantom V1212 high-speed video camera recorded the impact events from underneath (20,000 frames per second, 5 μ s exposure time, 512 x 384 frame resolution).

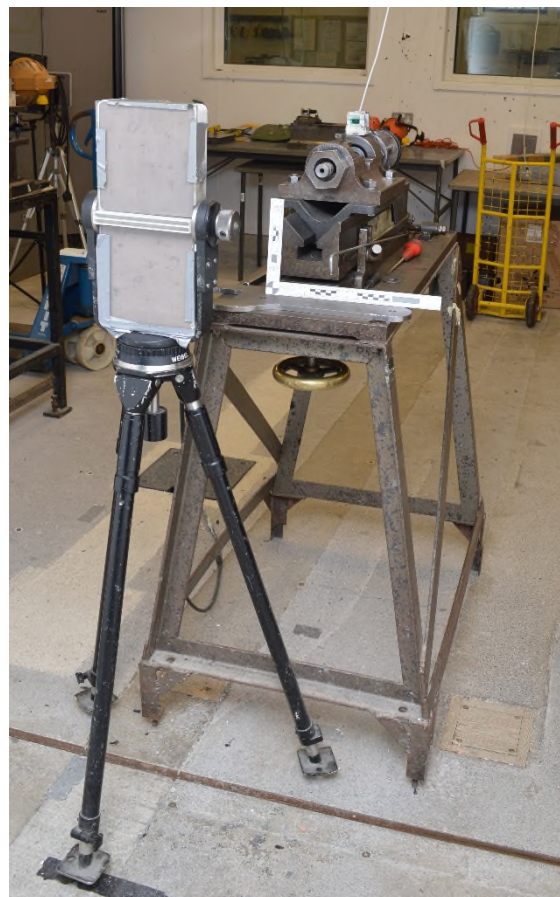
Figure 4: Proof housing with 127 mm barrel and Weibel Doppler radar to the left facing down the range

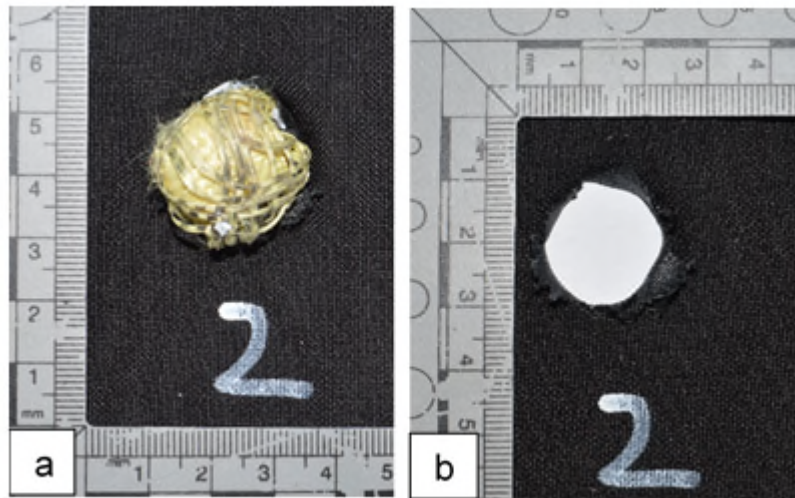
Figure 5: Rear of carrier vest used for shot 2 showing a) the armour still perforating through the fabric and b) damage to the vest after armour removed

For each spine shot the rear of the carrier vest was perforated by the rear face of the deformed armour (fig 5). Spine shots one, three and five penetrated 14 layers of the soft armour while spine shot two penetrated 20 layers.

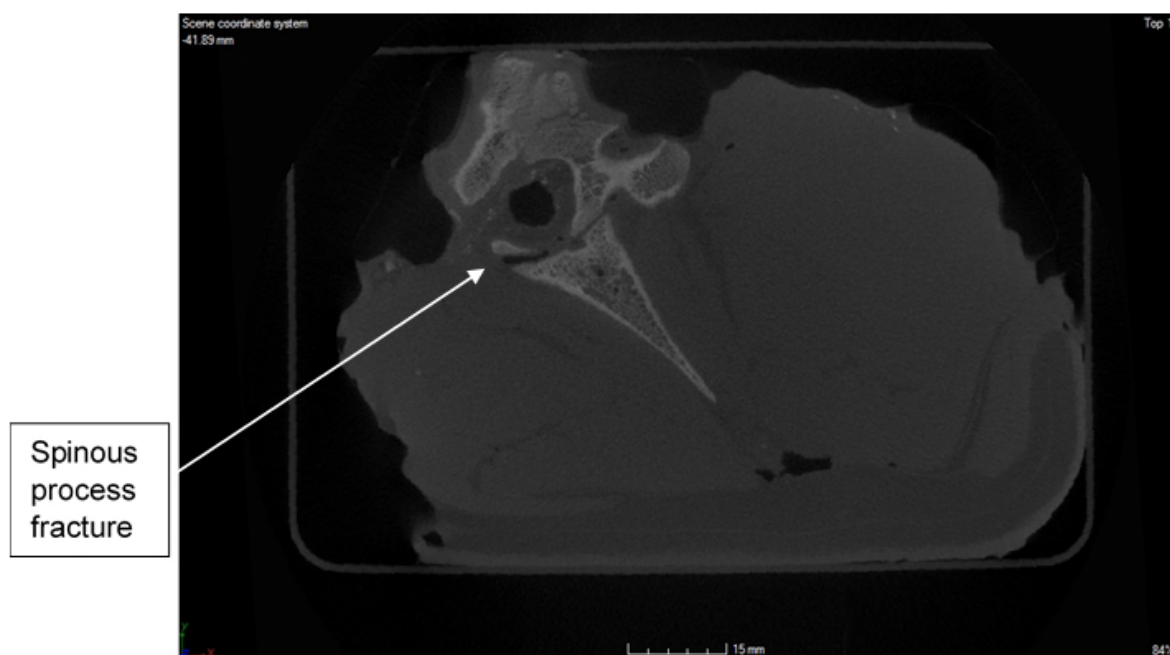
Figure 7: Micro-CT slice through spine shot 2 showing fracture at base of spinous process

From the x-radiographs and micro-CT scans there was no evidence of spinal canal or cord damage for any of the shots. Spine shot two resulted in a spinous process fracture (fig 7) and spine shot three shows evidence of a bony injury to the anterior side of the vertebral body without any accompanying fracture through the body (table 1) and is believed to be un-associated damage. An isolated stable fracture of the spinous process is considered of minimal impact and is normally treated conservatively without medical intervention. The injury may cause pain on mobilisation for the first few weeks but recovery time would be anticipated to be around six - eight weeks for full healing. For each of the shots a full recovery would be expected.

It is unknown if the spinous process fracture was a result of the initial impact or from the penetration of the armour into the soft tissue. It could be that the combination of these two mechanisms first weakened and then applied force to the spinous process causing the fracture. The bony fragment seen on shot three is on the anterior side of the vertebral body and although the exterior of that section showed no damage it is believed that this may be previous damage or a weakened area as there is no corresponding vertebrae process or body fracture and the fragment has come cleanly away.
