Title: The response of aluminium/GLARE hybrid materials to impact and to in-plane fatigue

Authors: F. Bagnoli, M. Bernabei, D. Figueroa-Gordon, P.E. Irving

To appear in: *Materials Science and Engineering A*

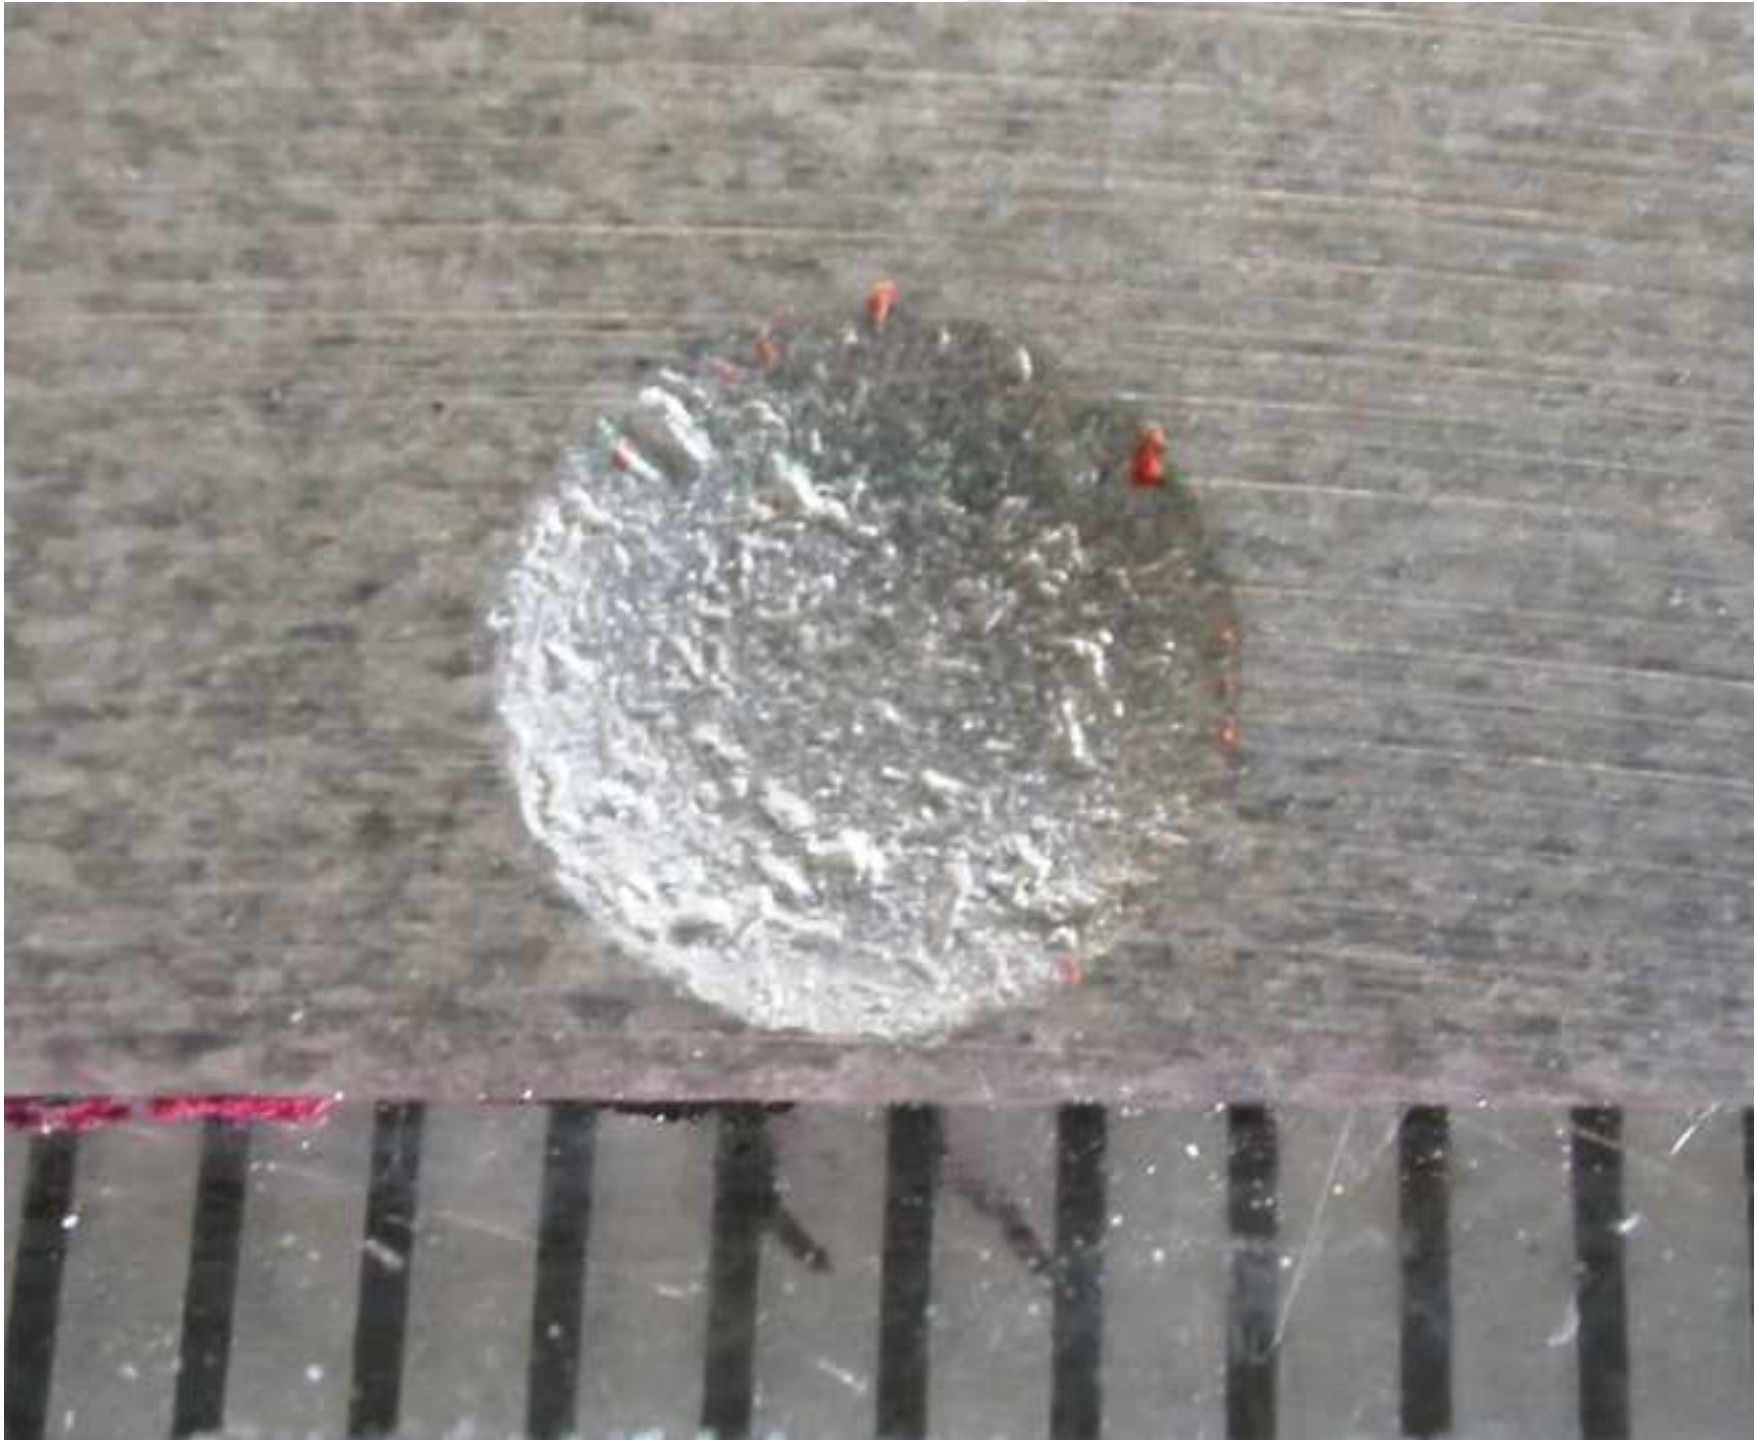
- Figure 7 Indentation produced on substrate after impact at 50 J
- Figure 8 Phased array C scan image of delamination damage produced after 30 J impact on to the aluminium substrate.

The impact produced an approximately circular indentation on the substrate outer surface (see Fig. 7). On the GLARE side of the sample the external surface developed a local bulge opposite the impact site; it was roughly elliptical shape with the long axis oriented along the glass reinforcement direction. The dent and bulge areas were measured using an optical microscope. Table 3 shows the optically detectable damage areas produced on the substrate and on the GLARE sides of the sample. Surface damage on both sides increases with increasing impact energy. For the greatest impact energies, the bulge area produced on the GLARE side is approximately 5 times greater than the dent area on the substrate. C-scan measurements revealed that the damaged areas in GLARE had a roughly elliptical shape as shown in Fig. 8. Figure 9 shows a plot of the impact damage area as measured using ultrasound and shows that the damage area increases with increasing impact energy, reaching 800 mm² after 50 J impact. This is almost a factor of 10 times greater than the damage area visually detectable listed in Table 3.

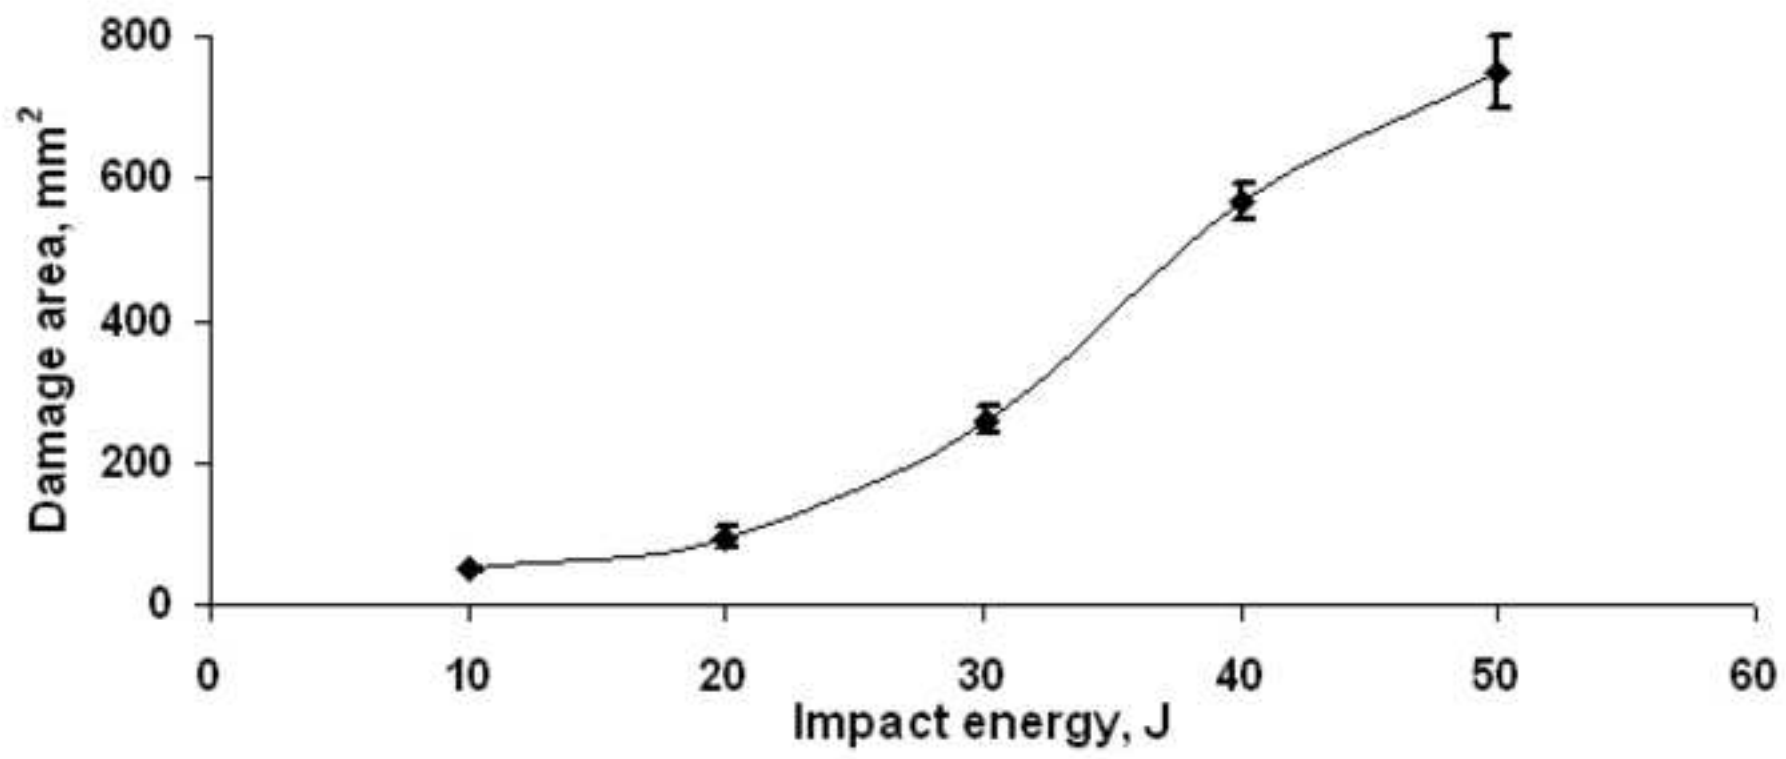
figure 9

- Figure 9 Damage area in GLARE layer Vs substrate impact energy. the error bars refer to the calculated standard deviation from the 4 samples tested at each energy level

It is important to note that C-scanning studies (Fig. 9) show that damage was formed even after 10 J and 20 J impacts and that the internal damage extended further than the size of the visible dent (Table 3). Similar behaviour was observed by Wu in testing GLARE 5-2/1 and GLARE 4-3/2 laminates when directly impacted in the range 7–40 J [31] and after chemically removing the outer aluminium layers. In this research,
