Towards an Integrated Approach to Recording Military Aircraft Crash Sites

Peter Masters, Cranfield Forensic Institute, Cranfield University, Defence Academy of the UK, Shrivenham, Swindon, Wiltshire SN6 8LA p.masters@cranfield.ac.uk

Abstract

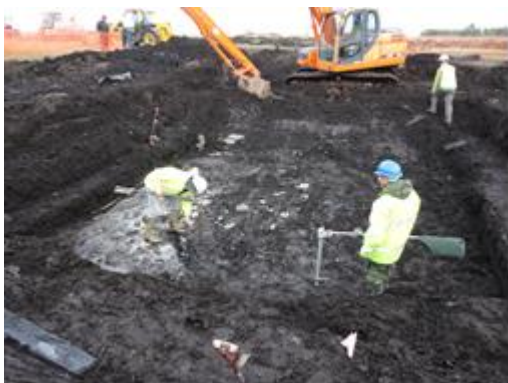
Fig.1 – Foerster Ferex magnetometers in use on the Great Fen Spitfire October 2015

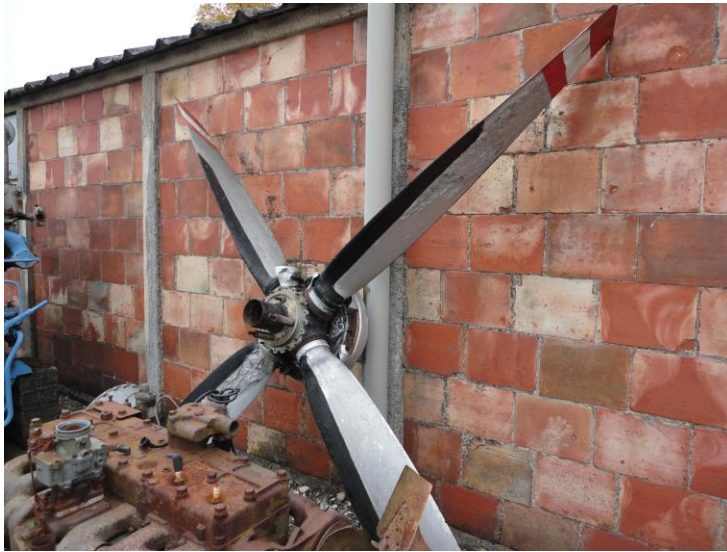
Figure 2 – Eden Camp – propeller in background.

long term. Many lie outside in the elements up against buildings that are used for other purposes to exhibit information about aircraft and airfields from the Second World War (Figure 2).

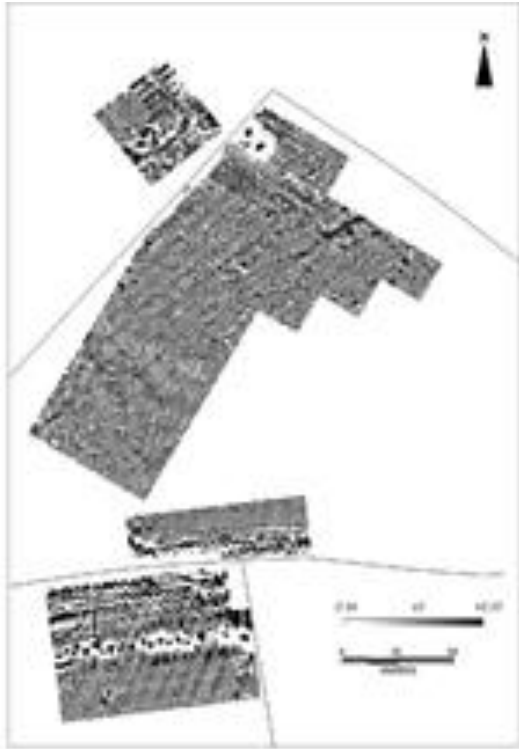
Figure 6 – Magnetometer survey results of the Liberator, Lynham, Wiltshire

Magnetometry has played an important role in the mapping of crash sites especially the impact zone to date. The magnetic signatures recorded have shown differences in whether the aircraft has nose-dived such as the Upavon Spitfire or any other crash site. In comparison, aircraft that belly flopped into the ground have shown a completely different signature and a good example of this is the Liberator at Lyneham (Figure 6).

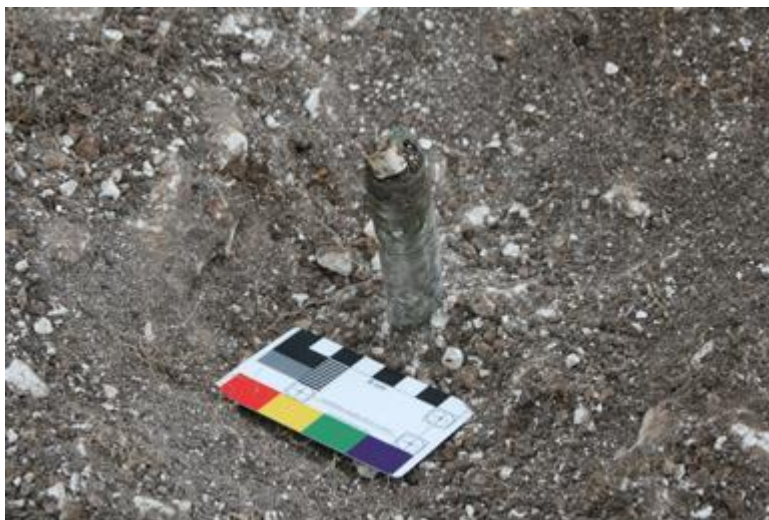
Figure 9 – Upavon spitfire Pito tube vertically stuck in the chalk.

Excavation of the impact crater confirmed the geophysical survey results and it was possible to from the detailed recording of the site to determine the type of crash. The P9503 when shot down went into a vertical dive and crashed into the chalk. The pitot tube (measuring air speed; Figure 11) was found vertically stuck into chalk supporting the crash theory.

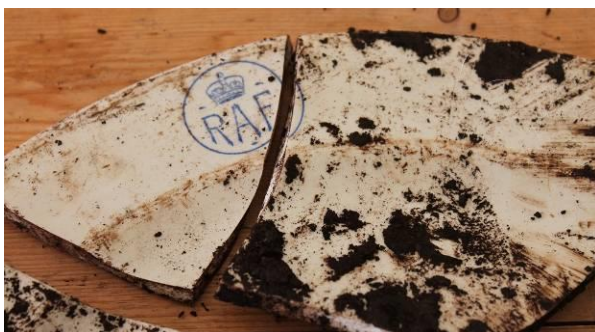
Figure 10 – RAF Mess plate, Holme Fen Spitfire

In October 2015, OAE undertook the excavation and recovery of the remains of the Spitfire Mk1a X4593 ‘Kerala’ (Haskins, A;Fairbairn, J;Brown 2016). During a routine training flight, the X4593 crashed into Holme fen on 22nd November 1940 and the Pilot Officer Harold E Penketh was killed. Following the crash, a recovery team was deployed to excavate down to the crashed aircraft according to the MoD records. During the excavation in October 2015, evidence was found of this subsequent excavation and recovery of P/O Penketh along with an RAF mess plate (Figure 12) left by the recovery team as a marker.
