Experimental observations of an 8 m/s drop test of a metallic helicopter underfloor structure onto a hard surface: part 1

K Hughes*, R Vignjevic, and J Campbell

Crashworthiness, Impacts and Structural Mechanics Group, School of Engineering, Cranfield University, Bedfordshire, UK

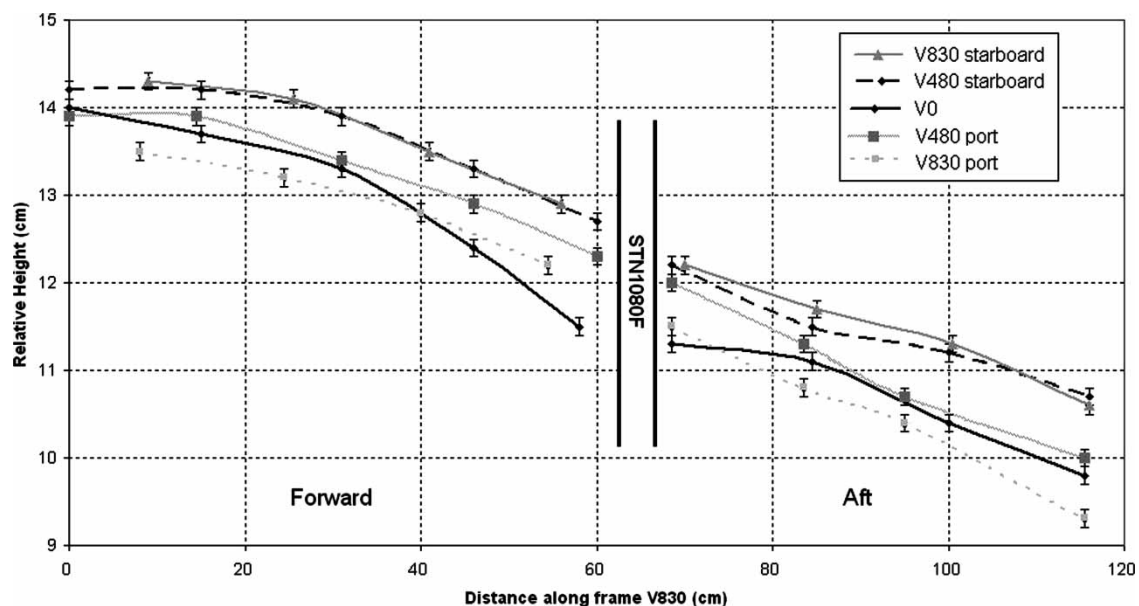
A comparison between the compacted heights for all three-frame configurations can be found in Fig. 12, which clearly demonstrates an increase in deformation towards the aft part of the subfloor, which is a direct consequence of the separation of STN1710F.

Fig. 12 Variation in height of the upper seat track assembly along V0, V480, and V830, as a function of the distance along the frame towards STN1710F

in failure mode and the resulting separation significantly affects the balance of the loading either side of STN1080F in Fig. 12, where the relative difference in height between the forward and aft most points of the rails varies between 2 and 4 cm.

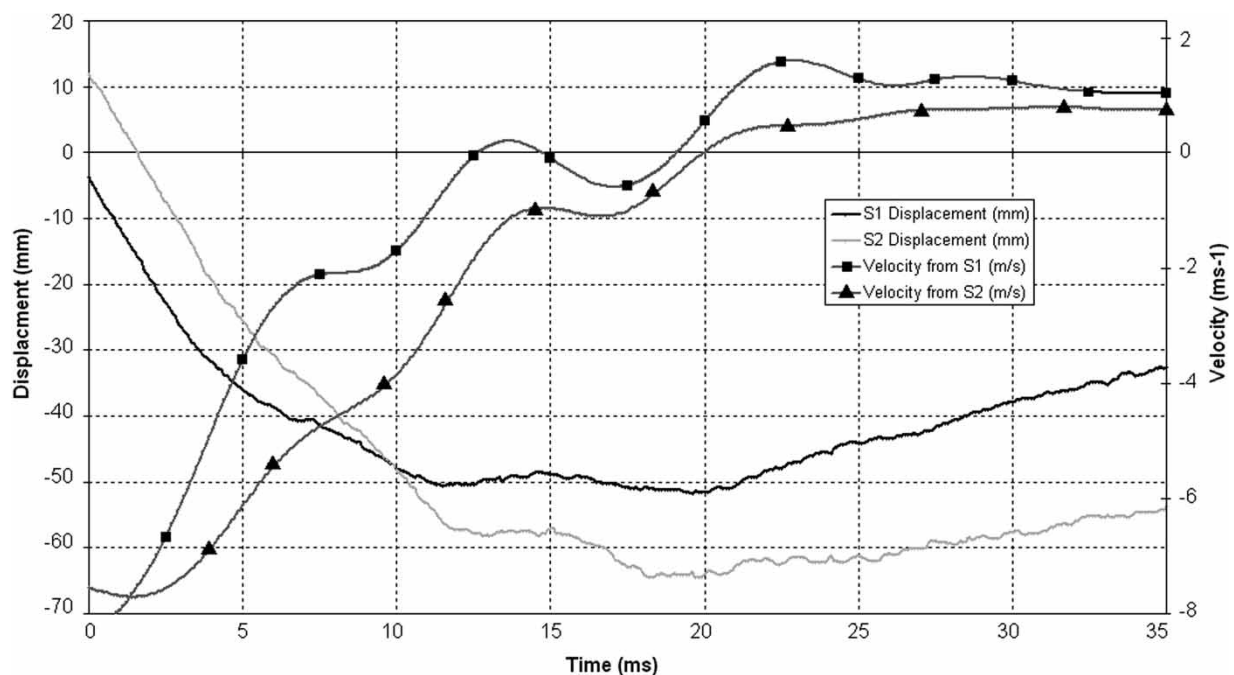
Shear failure of the rivets attaching STN1710F to the aft part of the component floor was attributed to a change in load path caused by a rotation of the steel loading plate around the central connecting I-beams of the guided trolley assembly. The cause of this rotation was due to an unexpected flexibility of the joints connecting the four transverse I-beams in Fig. 3 and the central guided I-beam. It was assumed that these connections would be rigid, which was not the case upon post-processing the results. This rotation was unexpected, as the test rig was designed to constrain movement in the vertical direction only. This rotation was detected through laser-displacement sensors tracking the motion of the steel plate in Fig. 16, together with the asymmetry of the damage observed. The velocity time histories were obtained from the displacement results and can also be found in Fig. 16. Despite the differences recorded by the two lasers, the results provide well-defined markers for when the floor is brought to rest, as the rebound occurs between 12.5 and 20 ms, which corroborates what is observed by the high-speed cameras.

Fig. 16 Comparison between the displacement-time histories obtained from laser displacement sensors S1 and S2, and the corresponding velocity-time curves obtained from these results

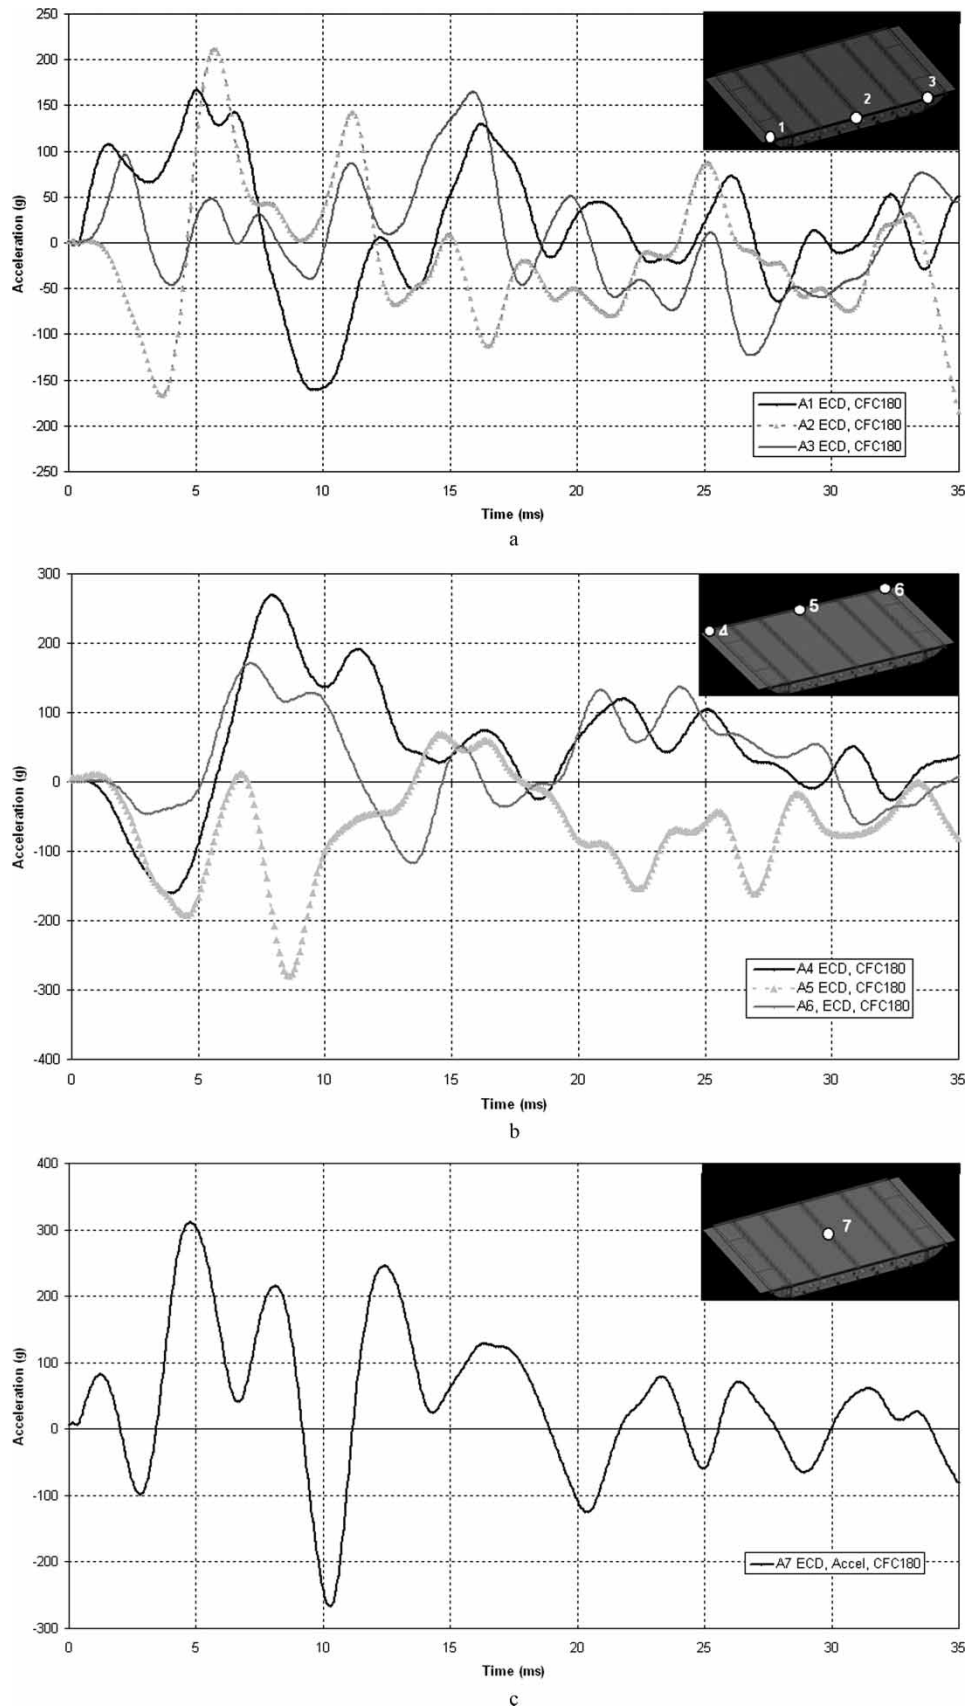
Fig. 19 Experimental acceleration-time histories for A1 through A7

STN450F, V0, and STN1710F. During setup however, the accelerometers were directly attached to the top surface of the steel plate, presumably out of ease from an experimental point of view. The time histories in Fig. 19 shows that there appears to be no consistency between traces, as the signals are extremely noisy, even when low frequency CFC60 filters are applied.

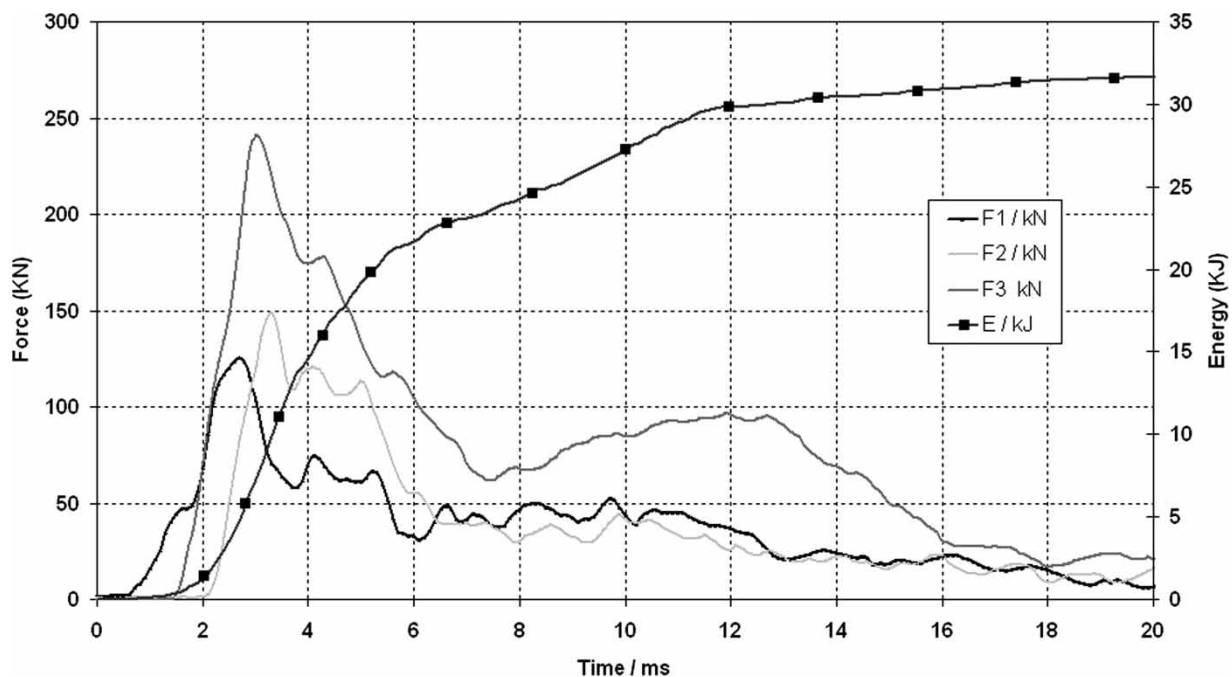
Fig. 20 Comparison between the force-time histories obtained for the three dynamic force sensors F1, F2, and F3. Also plotted is the global energy absorbed by the structure, which was obtained from the force and displacements measurements recorded during the drop test

The magnitudes for the peak force for F1 and F2 are similar, ranging from 120 to 150 kN, whereas the peak force recorded for plate F3 is much larger at 240 kN.

Combining the data from the laser displacement sensors and extrapolating the force results to obtain the global force–time history, the total energy absorbed by the floor can be estimated. With a combined floor and ballast mass of 1005 kg and an impact velocity of 8 m/s, the initial kinetic energy to be absorbed equates to 32 kJ. The energy–time history is plotted in Fig. 20, which shows that all the impact energy has been absorbed through structural deformation.

From the force–time histories and the frame failure mechanisms observed, it is clear that improvements could be made by providing a more progressive collapse front through considering different frame construction, triggers, and material type, as opposed to the single dominant hinge line currently observed. The bulk of the energy absorbed is within the first 12 ms as shown in Fig. 20, after which, there is little further increase due to a reduction in the load-carrying ability offered by the structure once failure occurs. This modification would result in a higher collapse load in the region of deep collapse and increase in the energy absorbed plastically by the structure.
