Investigating accidents involving aircraft manufactured from polymer  
composite materials

School of Engineering

PhD

Supervisors: Prof. Graham Braithwaite & Dr. Matthew Greaves  
March 2013

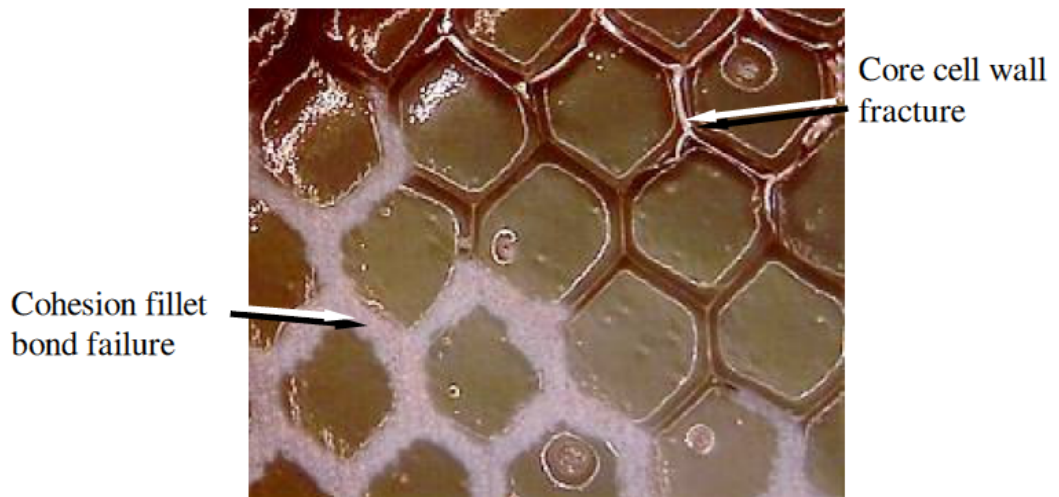
It is suggested by Davis & Bond (2007) that when encountering cohesion failures in sandwich panels, the most likely cause will be internal pressure within the core due to heating cycles, especially when moisture is contained within the core. They go further to suggest that impact damage is likely only to cause cohesion failure of the adhesive if the impact energy is high enough to cause visible evidence of an impact occurring. This however will involve visible crushing of the core and fracture of the fillet bonds. Fatigue, they suggest, is not likely to occur as the adhesive shear strength of the adhesive is substantially higher than the shear strength of core.

**Figure 5-33 - Flatwise tension failure of a sandwich panel. Internal pressure developed during a repair heating cycle causes cohesion failure of the fillet bonds and core cell wall fracture. (Davis & Bond, 1999)**

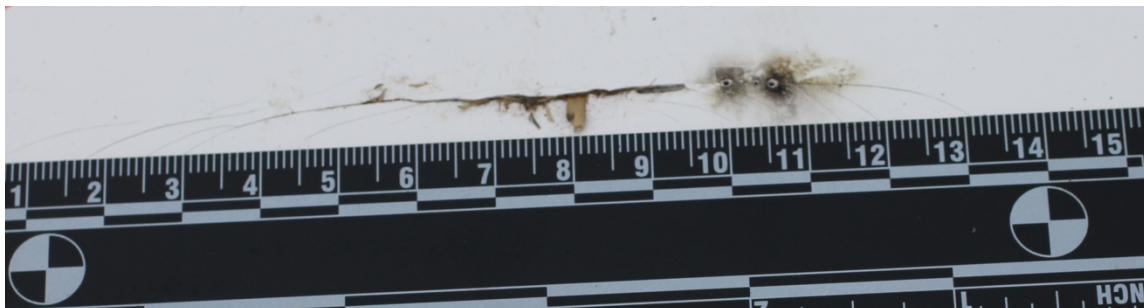
The third group consisted of visible damage that was likely to have been associated with the accident. The most significant damage was localised span-

wise cracking of the skin along the spar foot, and points of visible arcing. Both of these damage mechanisms contained visible sooting deposits and were further assessed using NDE.

**Figure 6-4 – Span-wise crack showing evidence of arcing damage (Source: Author)**

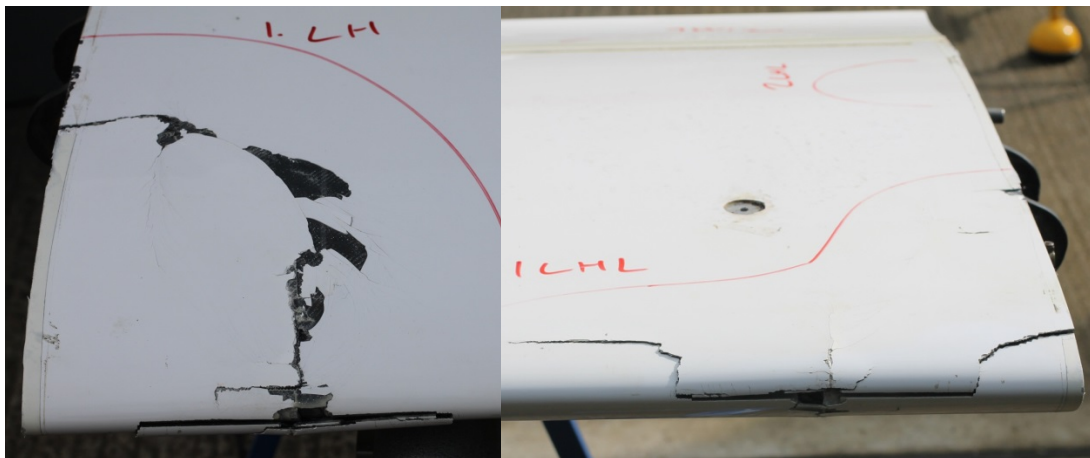
The final category involved sections of the wing which were deemed as unacceptable for use in the testing. This included an area on the leading edge of the right and the root of the outer wing section. This area had suffered significant damage consistent with crushing damage of the leading edge root section following forward momentum movement of the outer wing section, pivoting about the main spar.

**Figure 6-5 – Leading edge damage of the right and the root of the outer wing section. Left picture = Upper surface, right picture = lower surface (Source: Author)**

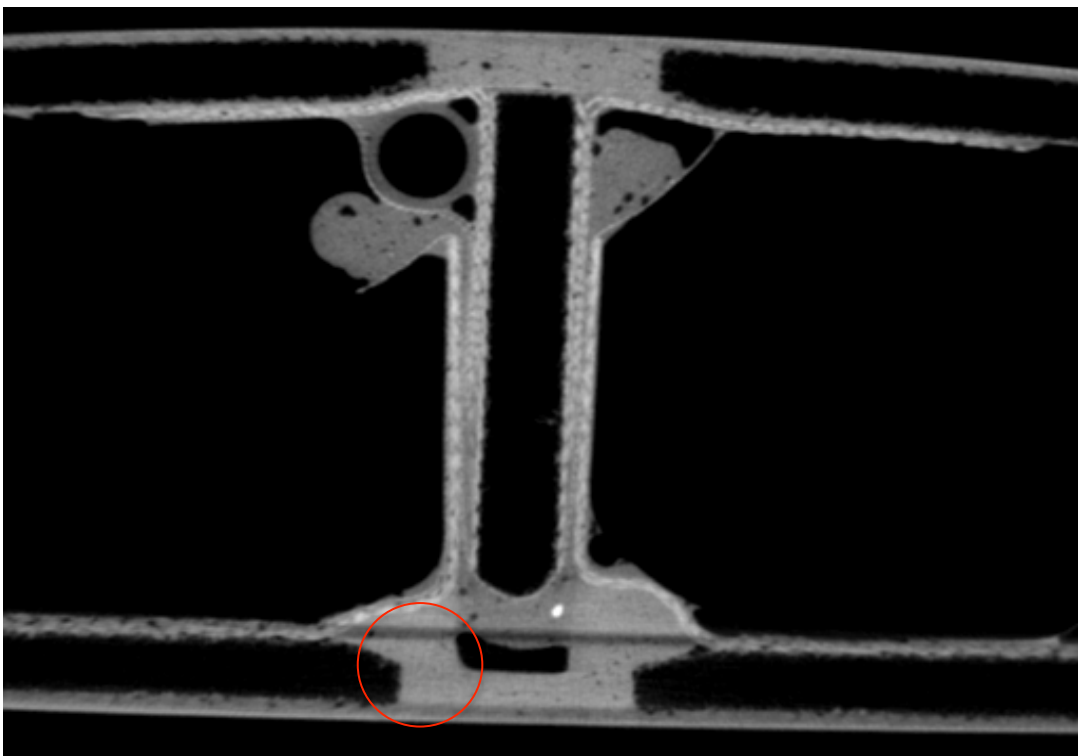
There were however indications of a non-symmetric placement of the lower spar cap between the left and right wing sections, which can be identified by comparing figures 6-11 & 6-12. This was confirmed by examining the visible spar in the cut sections and was present primarily in the outer sections of the left wing, with the specimens near the root having a lesser degree of non-symmetry. It was felt that the anomaly would not present an issue for conducting the fracturing programme. Moreover, the anomaly may be of value during the visual and macroscopic examination where the fractured surface will be examined to confirm if the non-symmetrical placement can be identified.

Figure 6-12 – CT slice through right hand wing tip section, lower spar cap highlighted for comparison to figure 6-11 (Source: Author)

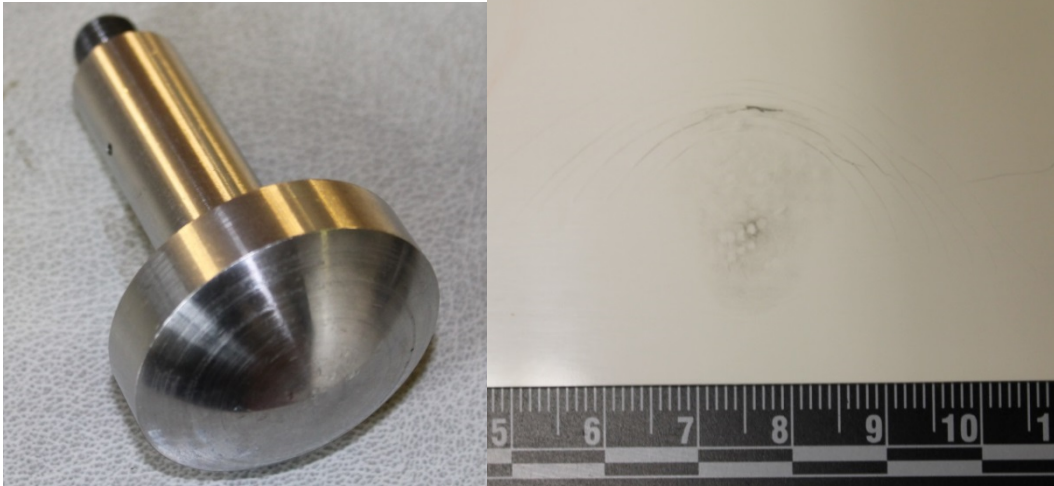
A Rosand Type 5 Falling Weight Impact (FWI) tower was used to create the impact damage to the specimens. The right hand centre root wing section received a 75J impact using an 87mm diameter hemispherical impactor (Figure 6-13). The impact location was central to the upper spar cap. The left hand centre root wing section received a 75J impact to the upper spar cap using a 20mm diameter hemispherical impactor (Figure 6-14). Additionally, the spar foot adjacent to the initial impact received a subsequent impact of 50J using an 87mm hemispherical impactor (figure 6-13 & 6-14).

**Figure 6-13 – 87mm hemispherical impactor with corresponding specimen impact damage (Source: Author)**

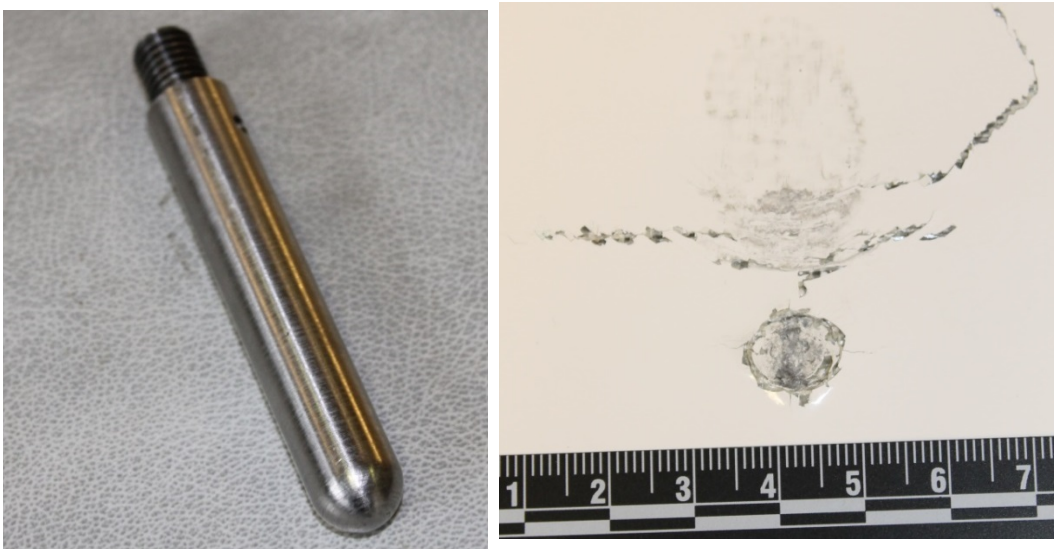
**Figure 6-14 – 20mm hemispherical impactor with corresponding specimen impact damage (lower impact point) (Source: Author)**

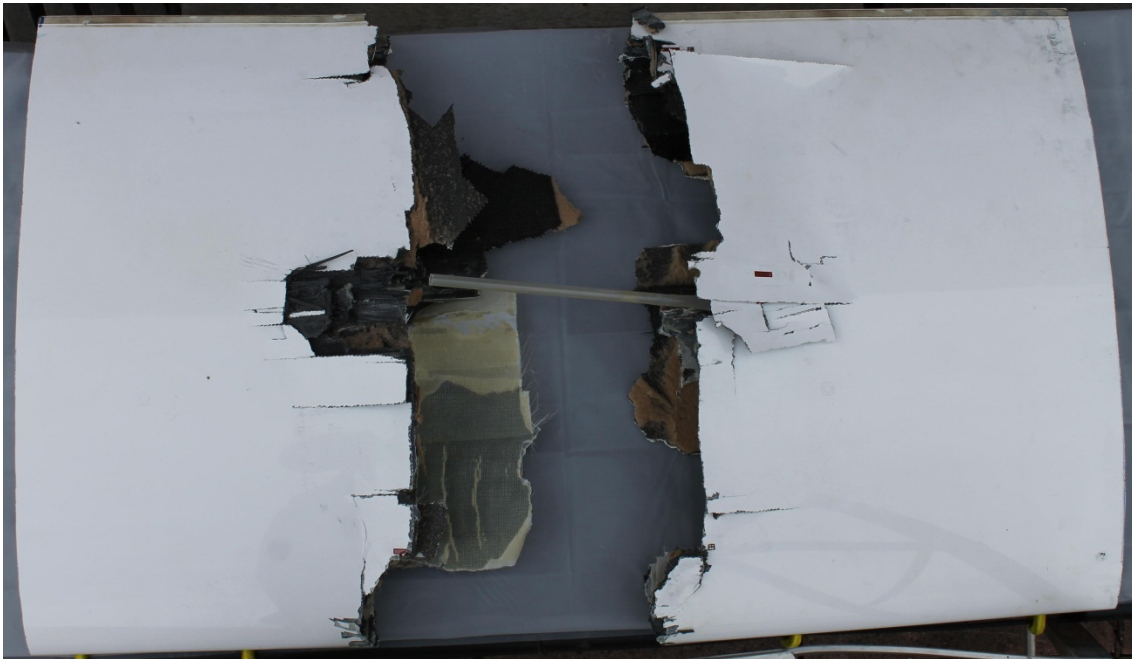
The broken specimen of the left wing section is shown in figure 6-18 (upper surface) and figure 6-19 (lower surface). The fracture is dominated by a chord-

wise translaminar fracture with the presence of span-wise secondary damage. The fractured sections remained relatively intact with materials separated from the main fracture being limited to sections of the upper spar cap, the shear web and adhesive. The upper surface consists of a translaminar chord-wise fracture which is influenced by the impact location and the aileron fittings. The lower translaminar fracture is chord-wise with the exception the regions between trailing edge spar, spar cap and leading edge, where the fracture deflects to a span-wise direction. The leading edge suffered from a span-wise fracture. The right wing section failed in a similar manner albeit the deflection on the upper surface is not present and the span-wise deflection on the lower surface is more pronounced.

**Figure 6-18 - Upper surface view of the left hand wing section (Source: Author)**

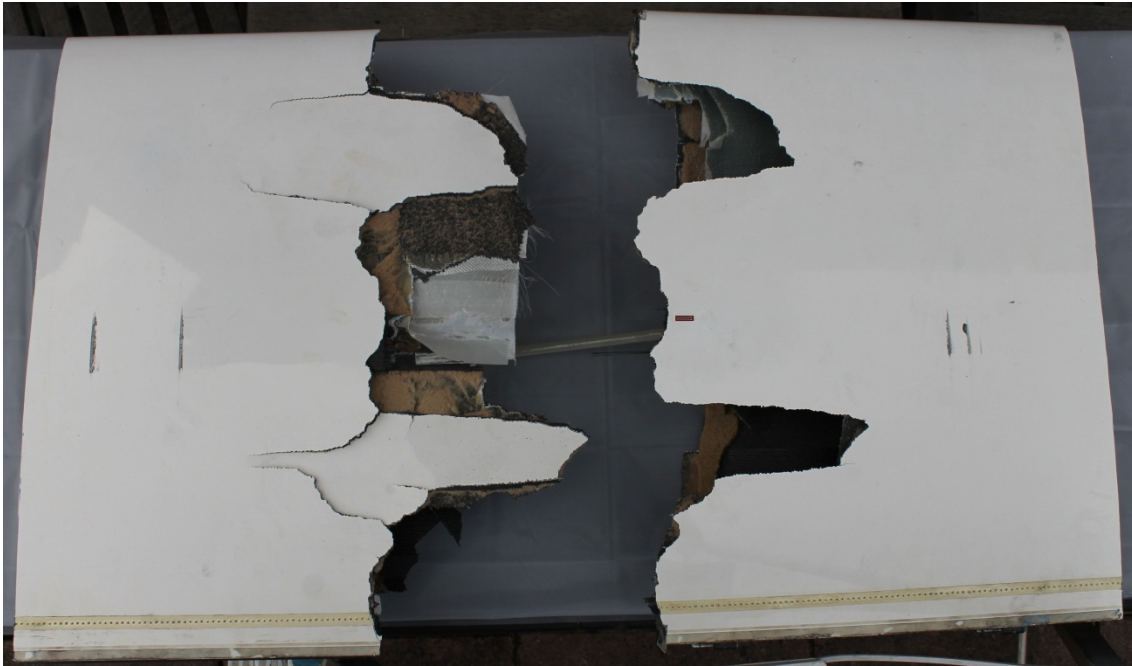
**Figure 6-19 - Lower surface view of the left hand wing section (Source: Author)**

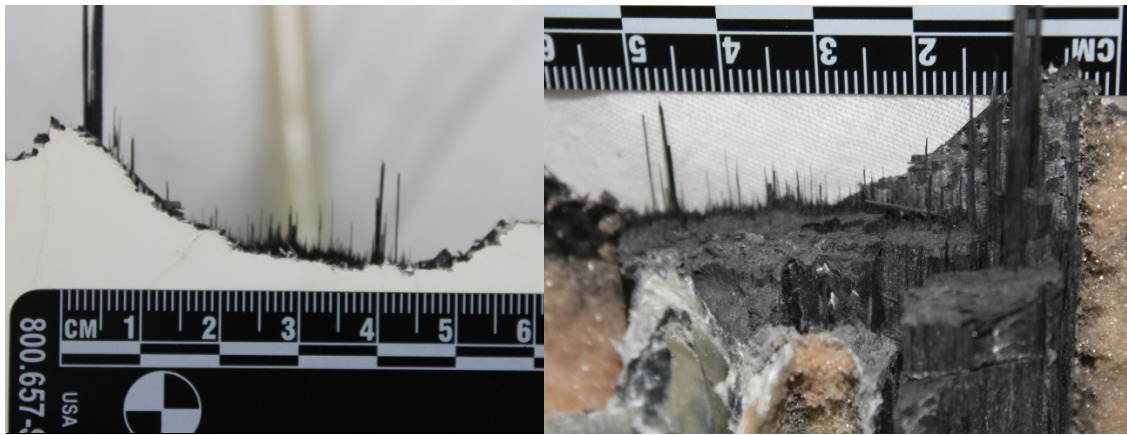
Figure 6-20 illustrates the lower spar cap from the left wing section. There are two distinct regions within the spar cap with the region closest to the lower skin showing a bright, fibrous fracture surface. The fracture surface is relatively flat with visible indications of fibre brooming across the width. The neutral axis is clearly visible and distinctly parallel to the lower spar surface.

The visual features on the lower spar cap are indicative of a tensile failure. The degree of fibre brooming between the two specimens is similar suggesting that neither fracture was significantly degraded compared to the other. The volume of fibre brooming varied across the fracture surface with the trailing edge side of the left wing lower spar cap and the leading edge side of the right wing lower spar cap have significantly shorter fibres protruding. The degree of protruding fibres increases across the surface until the opposite side of the spar cap is reached which has a considerably greater degree of protruding fibre length and

longitudinal splitting. This may be indicative of the direction of crack propagation across the fracture surface, although this cannot be confirmed.

**Figure 6-20 – Lower spar cap from the left wing showing characteristics of flexural failure. Note the tensile fracture surface (Source: Author)**

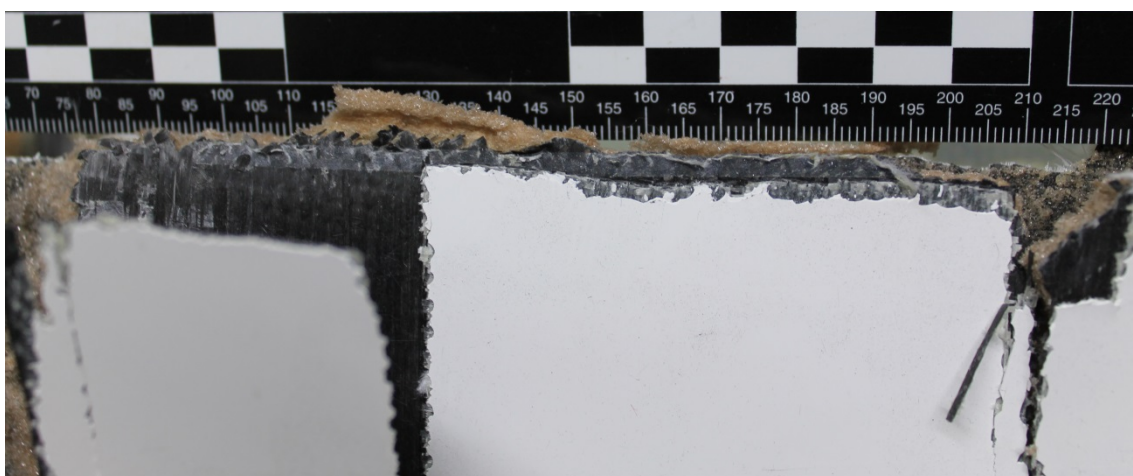
The upper aerofoil section fractured and separated chord-wise extending the whole width of the wing section, extending through the impact site and into the upper spar cap. The fracture was predominantly perpendicular to the span of the wing section. In the left wing specimen the leading and trailing edge sections where the fracture was displaced towards the root. The deflection of the fracture at these locations was approximately 50mm in the span direction and for the trailing edge deflection occurred as though deflecting around the structural reinforcement of the aileron hinge attachment. The surfaces were flat with limited evidence of protruding fibres. Of the fibres which were protruding, most were predominantly deformed out of their original plane.

**Figure 6-27 - Upper sandwich structure fracture surface from the upper wing surface (Source: Author)**

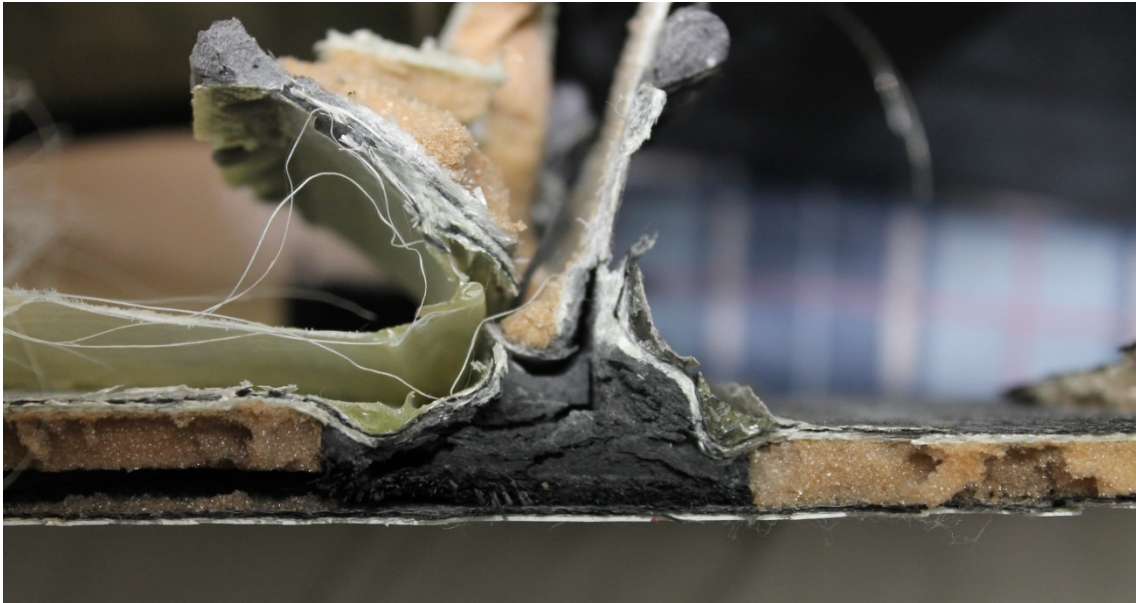
During the 3D CT examination of the specimen, the lower spar cap of the left wing was identified as having a non-symmetric placement. This was confirmed by examining the cut section of the spar cap. Upon examination of the lower spar it was apparent that although the spar had failed catastrophically, the non-symmetric placement could still be identified (Figure 6-32)

**Figure 6-32 – Left hand wing lower spar cap (Source: Author)**

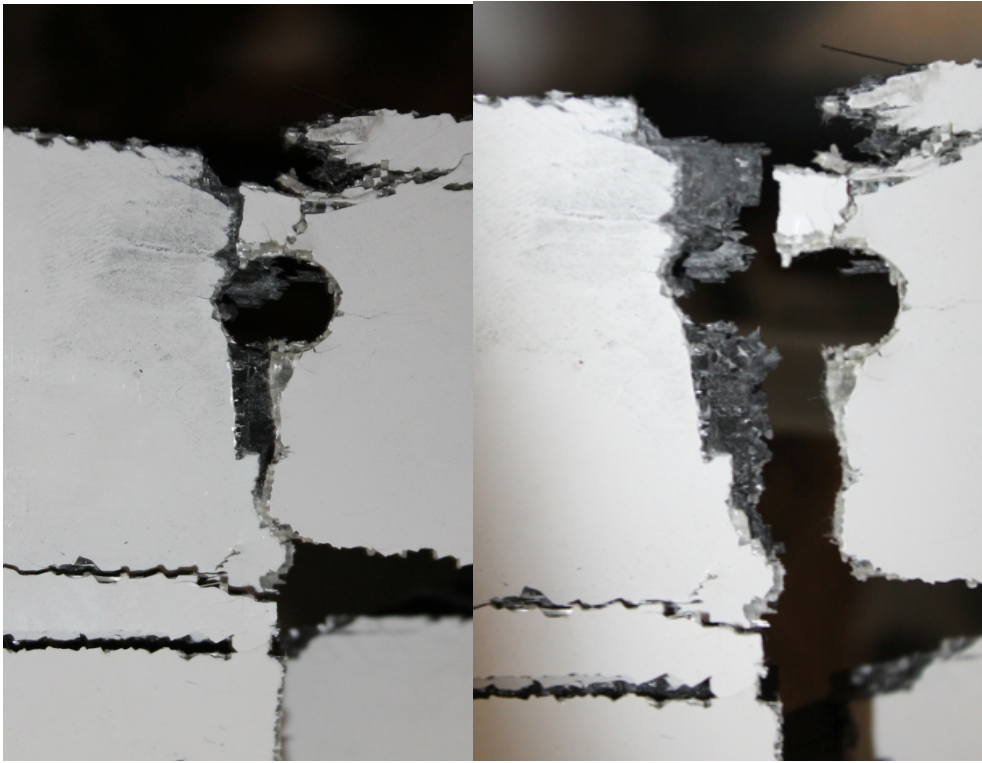
Figure 6-34 illustrates the post fracture impact region from the semi-penetrating impact occurring on the right wing. The translaminar fracture intercepting the impact location is the primary chord-wise fracture. The chord-wise fracture was the point of primary translaminar separation within the specimen and thus the impact site was separated between the specimen root section and specimen tip section. The left image illustrates the separated pieces placed in close proximity with the leftmost piece being from the tip section and the rightmost piece being

from the root. The right image illustrates the two pieces placed together, although separated slightly in the through thickness direction.

**Figure 6-34 – Left wing upper laminate from the impact location (Source: Author)**

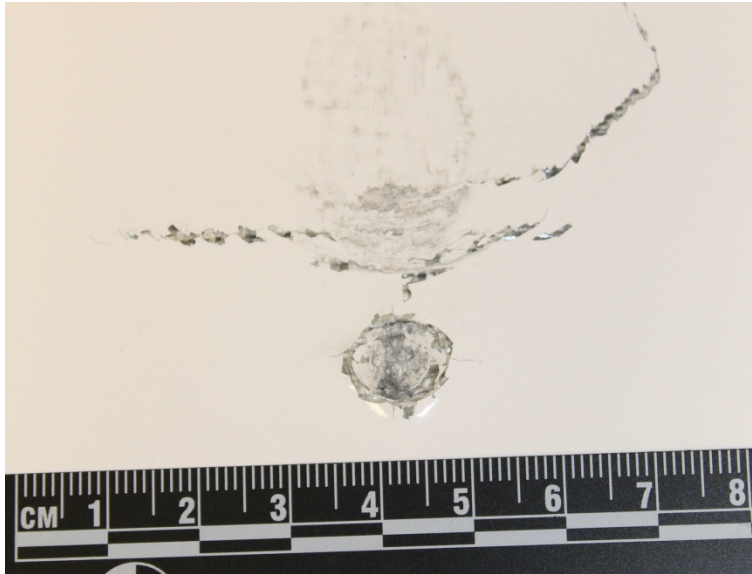
When comparing the pre-fracture and post-fracture conditions, it is noticeable that the post-fracture state has remained relatively well preserved compared to the pre-fractured characteristics (figure 6-35).

**Figure 6-35 – Left wing upper surface impact location (Source: Author)**

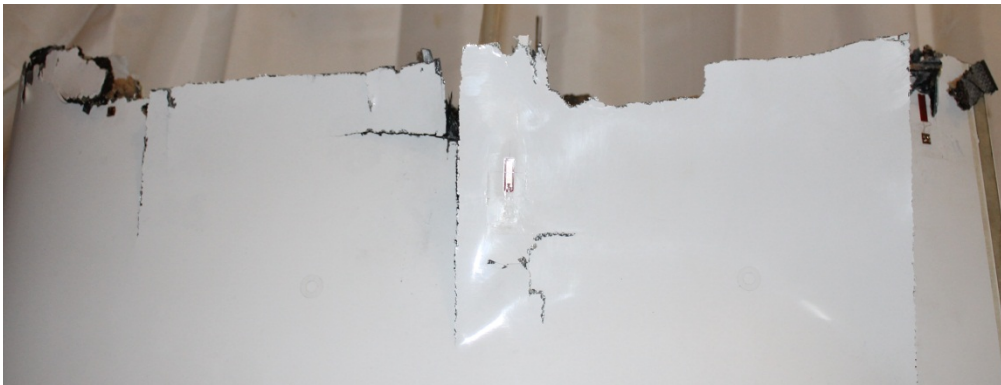
The impact location is relatively easily distinguishable compared to the chord-wise translaminar fracture. Figure 6-36 illustrates the location of impact on the tip section of the specimen. This illustrates the visible semi-circular pattern of the impact location against a relatively straight chord-wise fracture.

**Figure 6-36 – Left wing upper surface. The impact location can be identified as a semi-circular cut-out in the top centre of the image (Source: Author)**

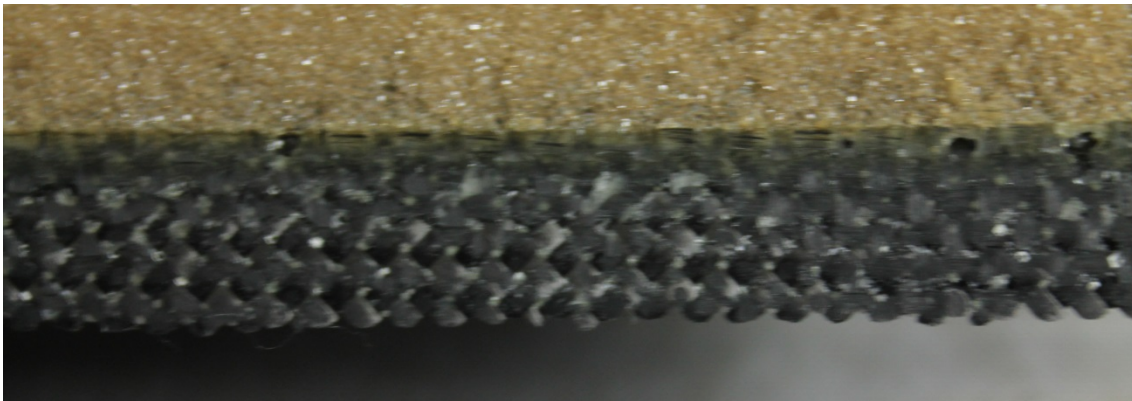
Internal fracture of the sandwich areas occurred predominantly through core failure. The trailing edge from the right hand root section exhibited adherend and a mixed cohesive / adhesive failure. There was no gross evidence within the structure associated with the smooth glossy features associated with inadequate bonding.

**Figure 6-39 – Bonding failure of the trailing edge (Source: Author)**

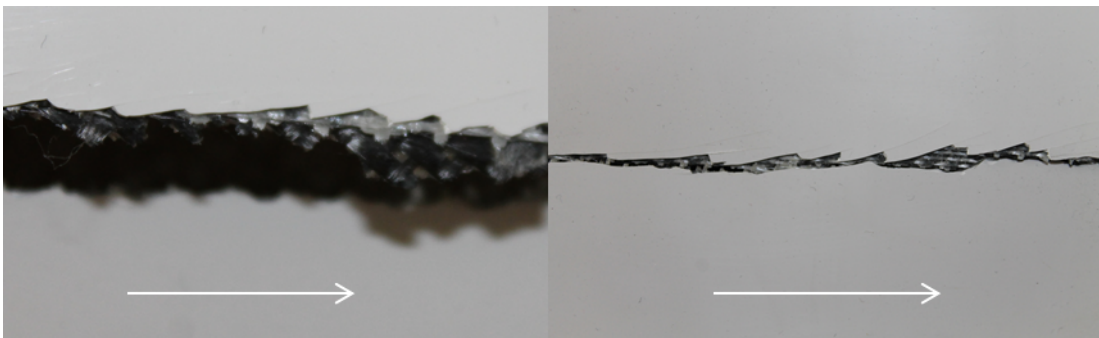
There was evidence of serrations created due to the fracturing of the gel coat. The serrations were predominantly evident on the span-wise fractures of the upper surface, with the configuration of the serrations suggesting fracture moving outwards from the primary chord-wise fracture to the root and tip sections. The serrations were indistinct along the entire fracture and thus it was necessary to consider the majority as representing the probable propagation direction. It should be noted however that the features were not supported with an academic foundation and thus were unable to suggest a failure mode or crack propagation direction with any degree of certainty.

**Figure 6-41 – Evidence of serrations on the upper gel coat (Source: Author)**

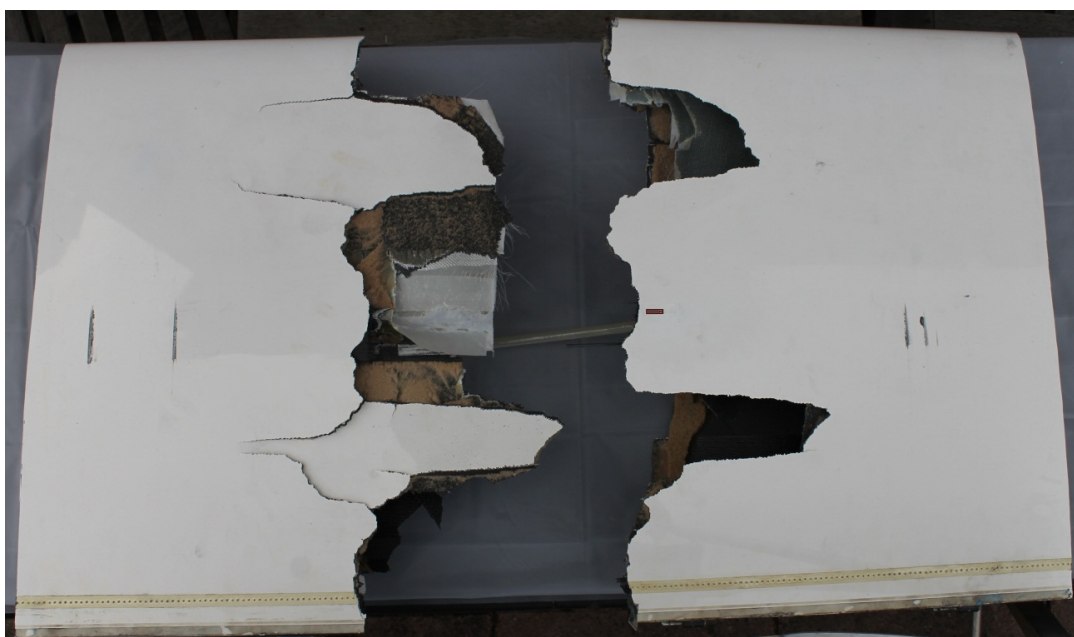
The lower aerofoil section fractured and separated chord-wise extending the whole width of the wing section. The leading edge, trailing edge and lower spar cap areas had similarly failed perpendicular to the span. The sections in-between, which represent unreinforced sandwich skin areas, have suffered fractures extending span-wise releasing a 'U shaped tab' of material. The width and depth of the trailing edge tab are approximately 60mm and 200mm respectively and the width and depth of the leading edge tab are approximately 90mm and 150mm respectively. Within the span length sides of these tabs, the composite has failed at an angle with the inner face of the composite representing the widest part of the angle.

**Figure 6-43 – Lower surface of the left wing (Source: Author)**

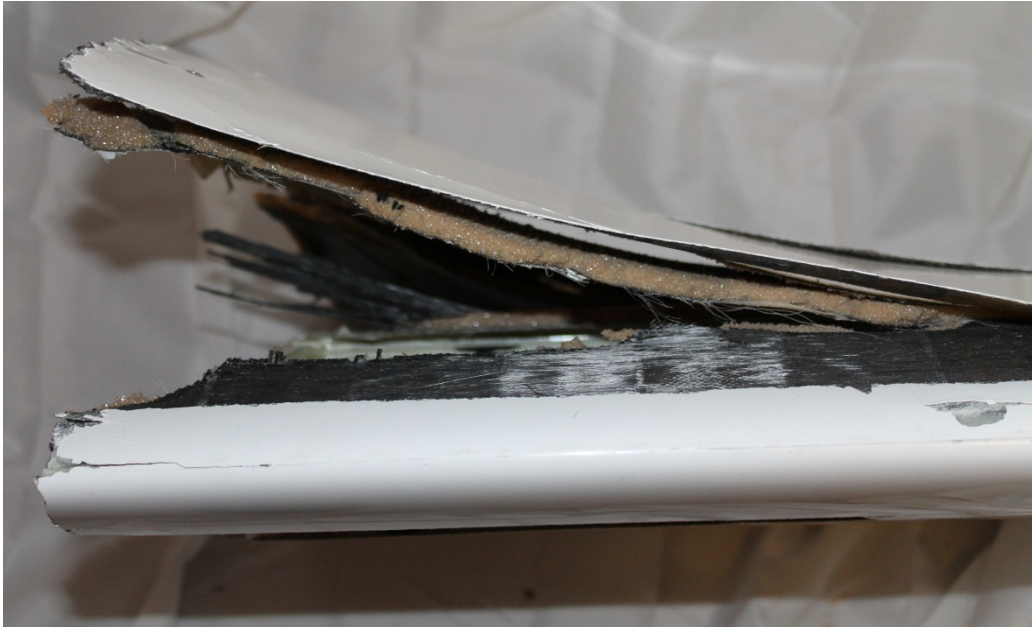
The multi-directional upper skin laminate underwent significant permanent deformation in places without significant visible translaminar cracking occurring in the deformed regions. Subsequent to lightly pressing the surfaces the deformed sections returned to their deformed shape. The deformation was present on the upper surfaces of all specimens. However it was more prominent

on the specimens which had 'tab' sections of the wing skin removed. Therefore the deformation suggests that the upper wing skins had undergone a bending motion in the positive flap-wise orientation in respect to the wing layout.

**Figure 6-44 – Leading edge of the right wing specimen (Source: Author)**
