CoA Memo M and P No. 17

THE COLLEGE OF AERONAUTICS

Test Report No. PLB0/7

Evaluation of PERPRO tools grade RD 92 machining EN 9

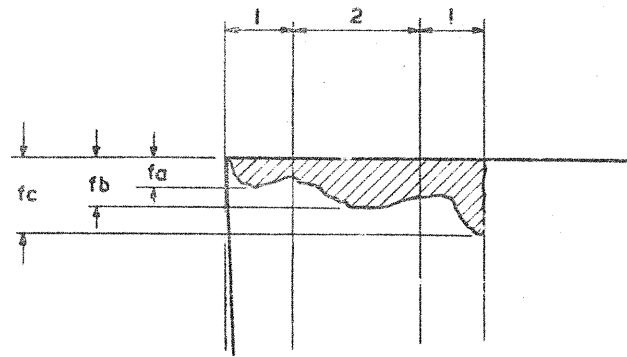
FIG. 1

The flankwear was measured as shown in figure 1 and the maximum deformation occurring along the cutting edge was also measured; the results are given in Tables 1 - 4.

FLANKWEAR MEASUREMENT

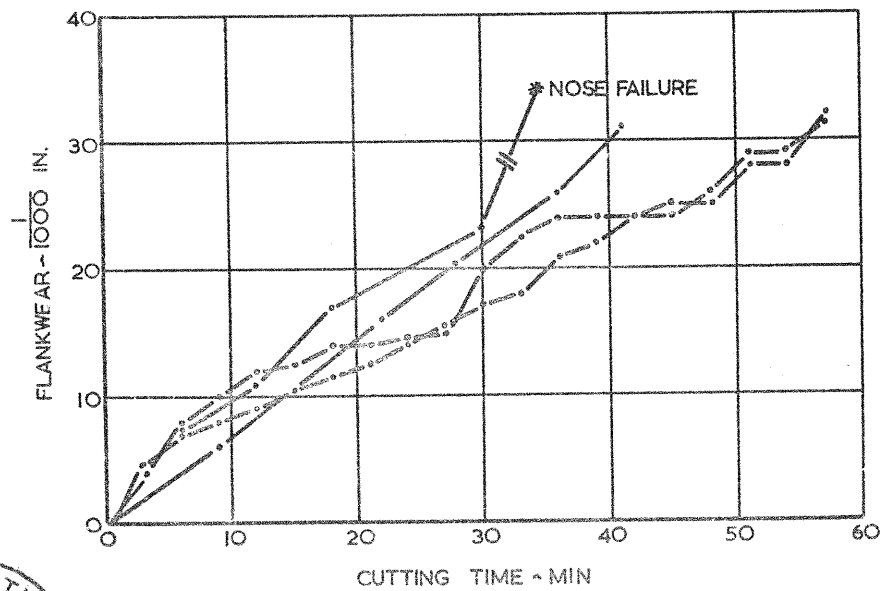
FIG. 2

Figure 2 illustrates the growth of the flankwear of the four tips which were tested. Two tips, NT154 and NT155, gave a tool life of 56 min. which is similar to the life of Sanvik SLP under the same conditions (see report No. PLB0/5). With these tips a smear of material appeared below the band of wear (see Figure 4B) and throughout the test the wear at the depth of cut was about twice as great as the wear near the nose. The other two tips gave a shorter tool life - NT156 gave 41 min. and NT153 failed at the nose after 30 min. testing. Less smear occurred with NT153 and NT156 and the wear at the nose, up to failure, was of the same order as the wear at the depth of cut.
