# Experimental observations of an 8 m/s drop test of a metallic helicopter underfloor structure onto water: part 2

**Abstract:** This is the second part of a two-part paper that describes the experimental observations for two similar sections of floor that were dropped onto both hard and water surfaces at 8 m/s, as part of one experimental campaign. The current paper provides an assessment of a simple box-beam under floor structure typically found in metallic helicopters and provides an overview of the failure modes and the collapse mechanism observed when dropped onto water at 8 m/s, as well as providing quantitative data for the skin deflections observed.

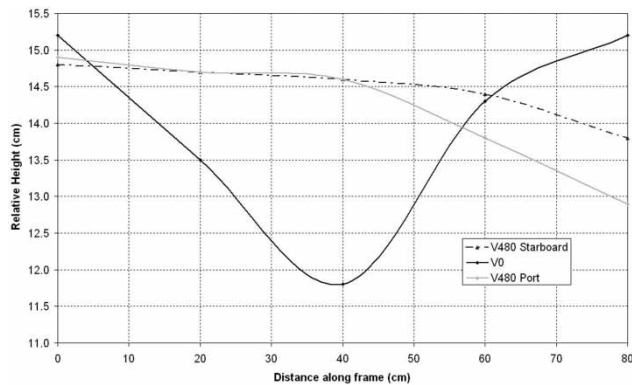
To conclude, due to the high strength nature of the construction and the inability to transfer the membrane loads generated in the skin, the forces generated are insufficient to initiate collapse in the longitudinal frames. This lack of deformation means that their contribution to energy absorption will be small, as demonstrated by the comparison presented in Fig. 12 for the relative heights at different points along these frames. This infers that the failure strength of the structure is a critical parameter for a water impact and indicates that the current construction exhibits too high a failure strength, due to the inefficient use of structural collapse as an energy absorbing mechanism.

**Fig. 12** Graph of compacted heights for the longitudinal frames which shows that the lack of collapse demonstrates that the membrane loads generated are insufficient to trigger collapse

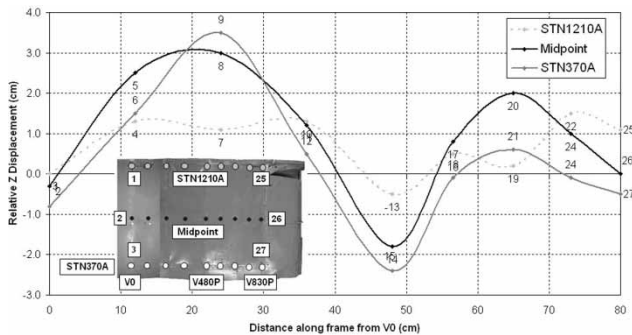
**Fig. 15** Comparisons between the relative skin deflections near STN1210A, located between V0 and V830P. All measurements taken relative to aft of V0

small and is typically of the order of 1.5 cm. The skin deflections along the midspan and STN370A are comparable, which peaks at the midpoints in-between the longitudinal frames V0 and V480P. The deflections are of the order of 3 cm and correspond to the failure of the single skinned STN370A at this location, due to the interpenetration of the central z-stringer shown in Fig. 7.

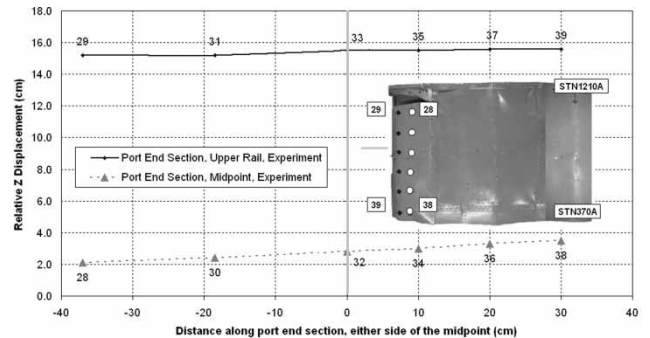
Table 4 provides a comparison between the relative displacements for the skin at various port side locations for the curved end section, using the same reference point at the intersection of V0 and STN1210A. Due to the limited relative deformation presented in Fig. 16, the results demonstrate how the shape can cause the redirection of the water surface, which can be beneficial in minimizing the loading at these locations.

**Fig. 16** Comparisons between relative skin deflections along lower and upper part of port curved end section. All measurements taken relative to the intersection of V0 and STN1210A

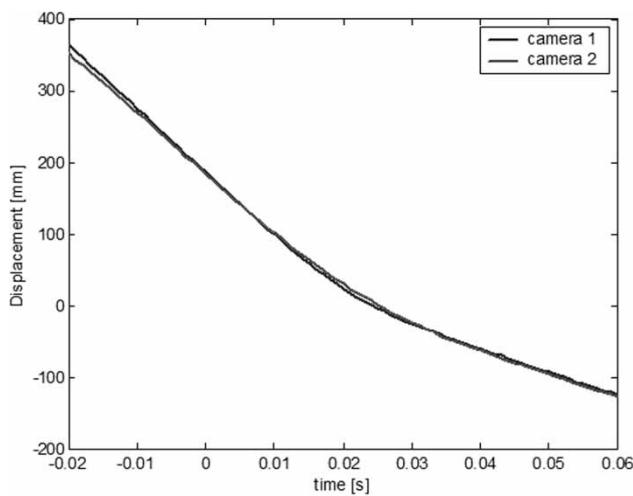
In order to provide an estimation for the whole body deceleration experienced by the guided trolley assembly, the displacement measurements shown in Fig. 17, were obtained from the two high-speed cameras located 20 and 5 m away from the drop tower, respectively. The images were calibrated against a fixed

**Fig. 17** The vertical displacement of the guided trolley assembly determined from the high-speed camera images

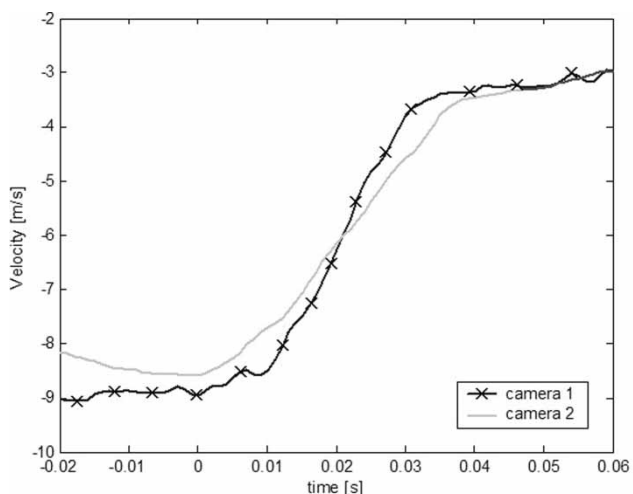
**Fig. 18** The velocity time history of the trolley assembly was obtained by differentiating the displacement data obtained from the high-speed cameras

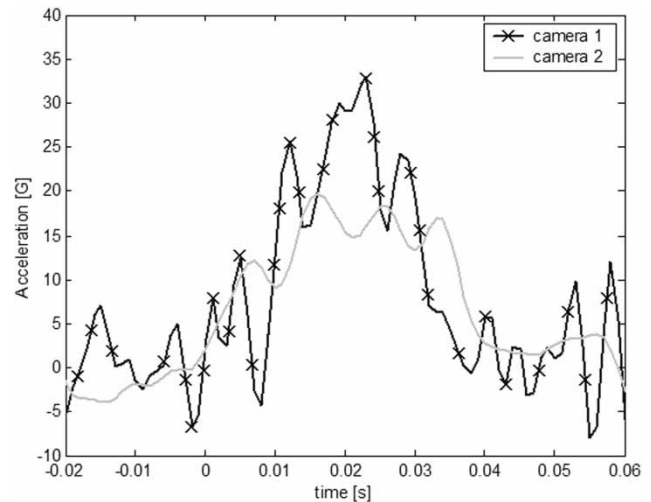
After the drop test had been performed, it was found that the accelerations exceeded the range of the data acquisition system, as this was set to be sensitive to a maximum of 50 g. Therefore, no accurate data exists regarding the acceleration pulse shape, duration, or magnitude along any of the seat rails.

**Fig. 19** The whole body deceleration of the trolley assembly was obtained by differentiating the velocities obtained from the high-speed camera displacement data

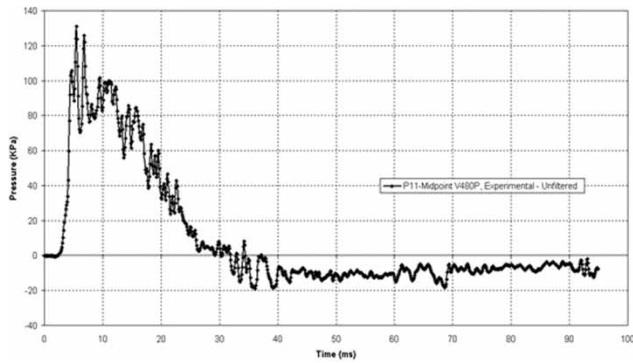
For example, Fig. 20 shows the results obtained for a pressure transducer located under the midpoint of V480P. As can be seen, the pressure rises to approximately 120 kPa, before going negative after 30 ms. The negative region is not an indication of cavitation, as it is an artificial effect caused by the inertial properties of the transducer. The oscillation of the sensor provokes this false reading, which can result in misinterpretation if the analyst is not aware of this effect. Removing this noise is difficult to achieve in practice and raises questions as to the validity of the results in this region.

**Fig. 20** Experimental pressure time history for P11 situated underneath the midpoint of V480P

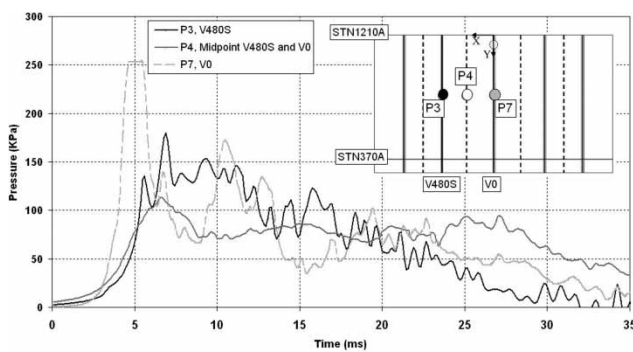
**Fig. 21** Experimental pressure time histories for three different strength locations of the floor, namely V480S, V0 and the midpoint

The results presented in Fig. 21 provide a comparison between the pressure results obtained along the midpoint of V480P and V0, which represents 'hard' locations where little frame deformation occurs, together with the flexible skin section located in between these two frames where significant inward deflections occur and is termed a 'soft' location. The pressures recorded underneath the frames of P3 and P7, results in high pressures of approximately 179 and 253 kPa, respectively. The hard results are higher than those at the soft location, as a peak pressure of only 113 kPa is recorded. This is expected and can be explained by the differences in stiffness between the two locations, as the more deformable locations are better able to counteract the sudden increase in pressure due to yielding, resulting in the lower pressures being recorded.
