## Analysis of the Effect of Impact Damage on the Repairability of Composite Panels

### Abstract.

The present paper aims to provide further understanding of the behaviour of Carbon Fibre Reinforced Plastic (CFRP) composite panels under high velocity impact and develop design guideline for repair of damaged composite panels in order to increase the aircraft survivability. This work consists of two parts: part one is a combination of experimental investigation and numerical simulation to evaluate the impact of a woven CFRP laminate which were subjected to selected impact velocities (100m/s – 500m/s) in order to evaluate the induced impact damage in two different thicknesses of CFRP composite panels (4.125mm and 2.625mm). In part two a finite element model is developed to design a guideline for repairing of a composite panel. In order to achieve this an optimised repair models with variable parameters such as number of steps and length of steps in the stepped lap joints are investigated. The penetration process and also change of kinetic energy absorption characteristics have been used to validate the finite element results. Finite element results were in close agreement with experi

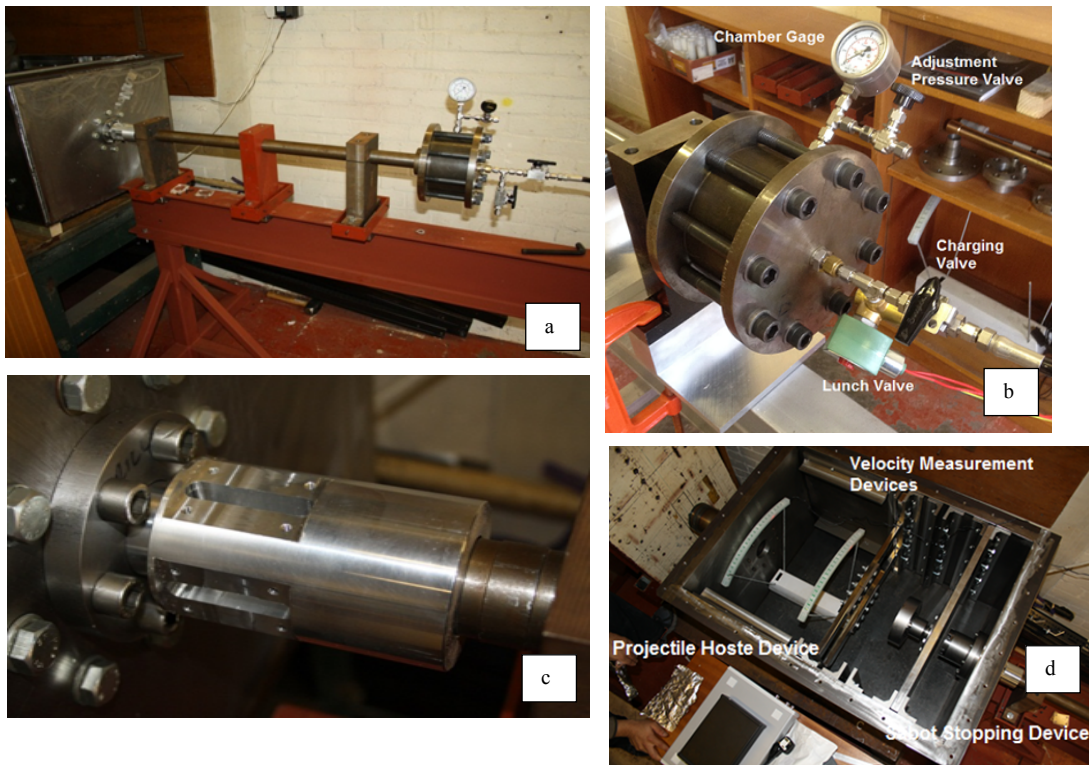
Fig. 1. a) gas gun test rig, b) gauge and valves in gun system, c) gas release device and d) impact chamber box.

The high velocity impact test rig was used to test composite panels subjected to various ranges of impact velocities. The modular design gives the gas gun the advantage of allowing easy repair, replacement, trouble-shooting or change of components without affecting other parts of the product. The gas gun test rig was designed employing a process of problem definition, team assembly, concept development, final concept review, prototype development and testing. The gas gun test rig, shown in Figure 1, utilises a variety of systems, including the gas system, support system and the velocity measurement system. This gas gun was single-stage, consisting of a pressure chamber and a nitrogen gas was used to launch it. The projectile velocity was measured using foil-screens and a digital oscilloscope was used to record the times of foil-screens perforation.

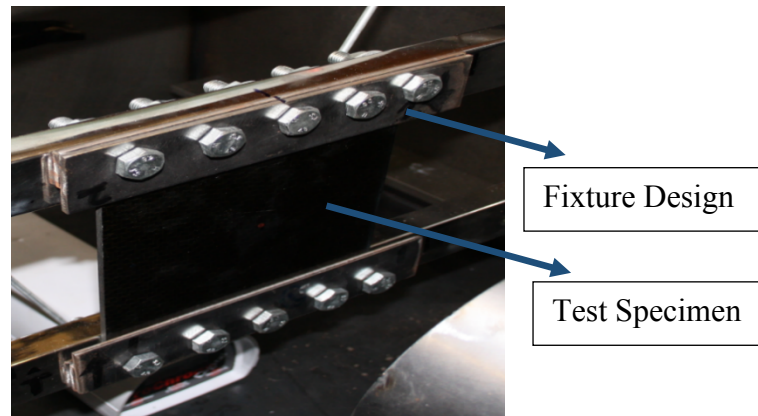
Fig. 2. Boundary conditions of the support frame.

These panels were comprised of 7 and 11 layers, using the following stacking sequence: [(0/90)/(±45)/(0/90)/(±45)/(0/90)/(±45)/(0/90)/(±45)/(0/90)/(±45)/(0/90)] and [(±45)/(0/90)/(0/90)/(±45)/(0/90)/(0/90)/(±45)] and also 16 layers (Hazell, et. al., 2008) respectively. Dimension of specimens was 150×150mm<sup>2</sup> with 4.125mm and 2.625mm in thickness, respectively. All composite specimens were secured into the support frame by clamping the top and bottom edges and leaving the side edges free (Figure 2).

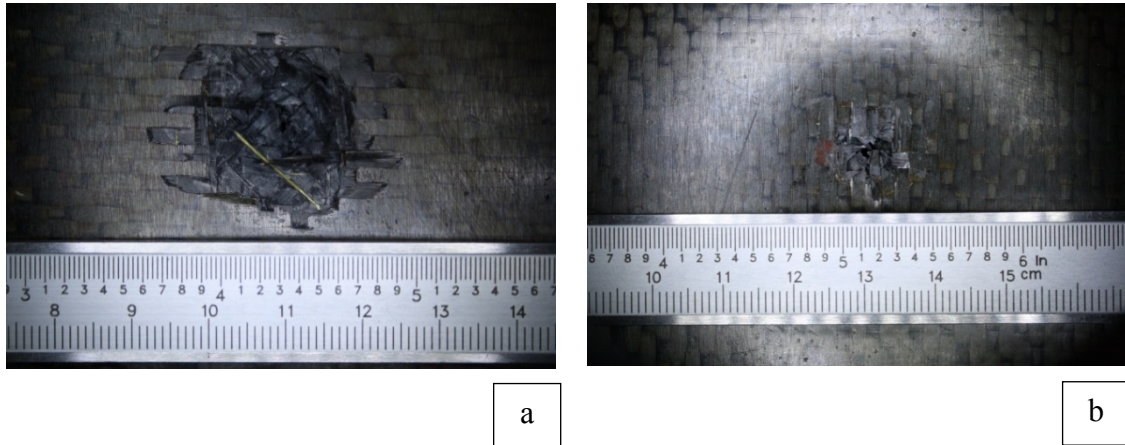
Fig. 3. Impact failure of 11 layered CFRP woven composite panel impacted at 141 J (200 m/s): (a) rear surface and (b) front surface.

Figures 3(a) and 3(b) show the failure behaviour of the 11 layered CFRP composite panel subjected to impact energy of 141 J (200 m/s) by the steel sphere projectile. Figure 3(a) shows a damaged area with a diameter of about 24mm on the rear surface of the panel. Figure 3(b) shows the front surface of the damaged panel, where the diameter of the damaged area is estimated about 15 mm. These Figures clearly show that the damaged area changed significantly with the projectile velocity through the composite panel, with the damaged area on the front being smaller than the damaged area at the rear surface (Hazell, et. al., 2008), where a petalling or plug formation was apparent.

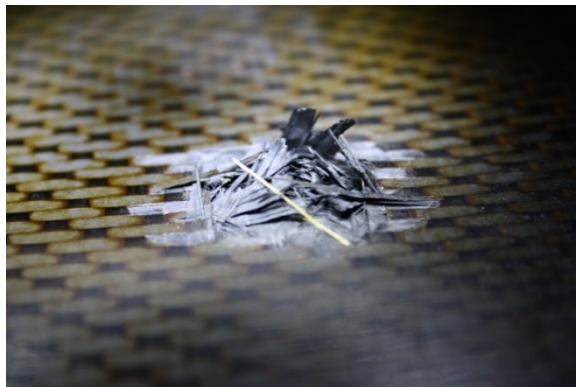
Fig. 4. Petalling formation failure of 11 layered CFRP woven composite panel impacted at 141 J (200 m/s).

When the projectile velocity was less than 200 m/s, the failure (penetration) mechanism exhibited petalling (Figure 4), and when the velocity exceeded 200 m/s, the failure mechanism appeared as a plug formation.

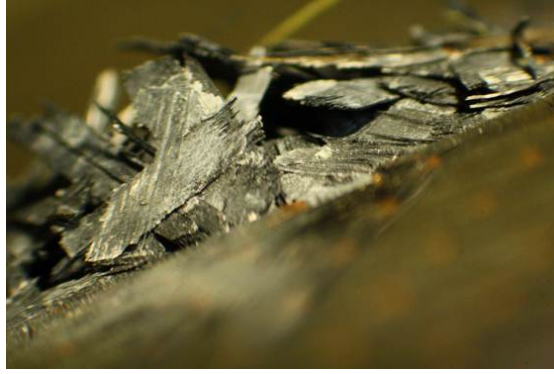
Fig. 5. Micrograph of impact failure of 7 layered CFRP woven compost panel impacted at 141 J (200 m/s).

Fig. 5 presents a micrograph of the impact failure of the 7 layered CFRP woven composite panel impacted at 141 J (200 m/s). This image shows the plies relaxing and closing up after impact by a steel sphere projectile. The tensile and compressive failure in petalling formation can be clearly observed.

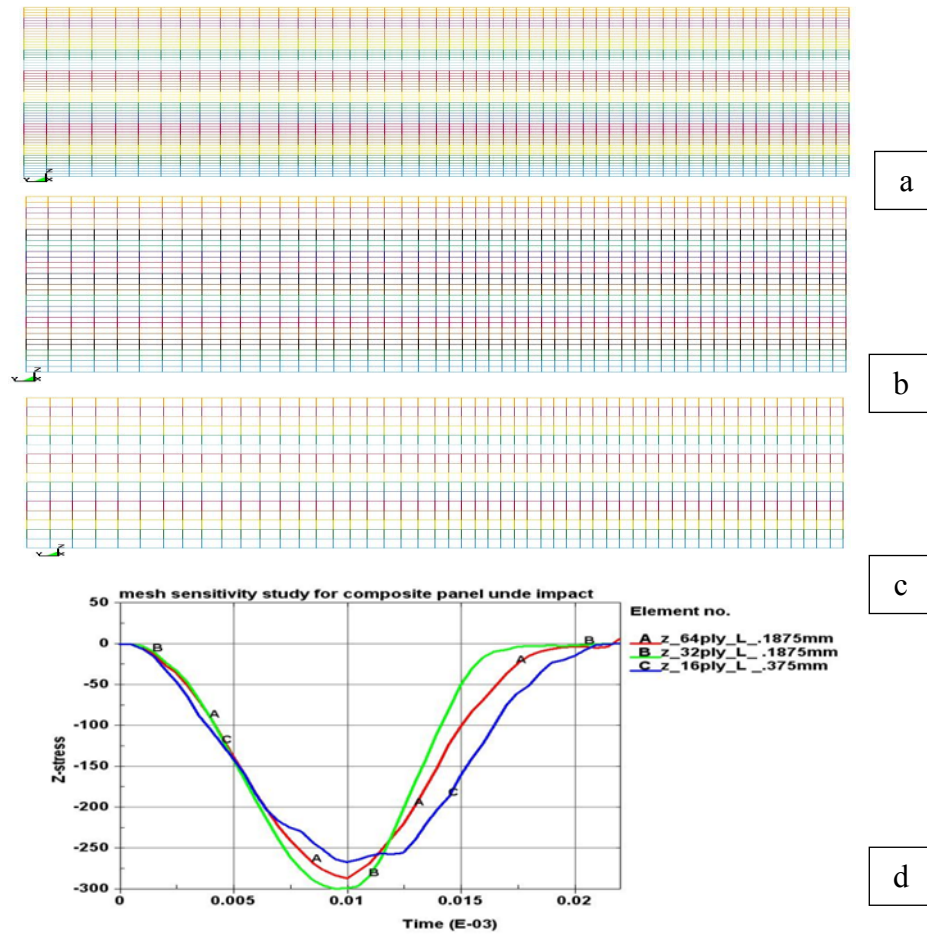
Fig. 6. Stress (MPa) vs time (sec) curves of the composite panels for different mesh size. a) no. of element = 445572, b) no. of element = 222786, c) no. of element = 111393 and d) mesh sensitivity analysis.

The 4.124-mm thick CFRP panel was made from 11 plies and the 2.625 mm thick CFRP panel was made from 7 plies, each side with a length of 100 mm. The CFRP panel was meshed with 111393 elements and 121380 nodes (see Figure 6), whereby one solid element was used to represent the thickness of each individual ply. The steel sphere projectile was meshed with 1023 elements and 1240 nodes and assigned an initial velocity. The solid elements (8 node hexahedron element) used a single integration point (ELFORM = 1) due to its computational efficiency over fully integrated elements. In addition, symmetry planes were defined to reduce computational time. Since it is a localised impact, the mesh of the plate under the projectile was much finer than other parts of the plane. Simply supported boundary conditions were

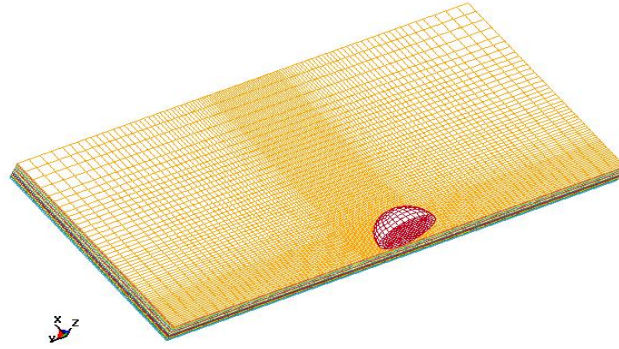
Fig. 7. Finite element model of plate and striker.

Simulations were performed for composite panels subjected to high velocity impact by spherical projectiles Figure 7. The range of projectile velocity is between 180-400 ms<sup>-1</sup>. When the projectile penetrates the panel, significant damage occurs, including delamination, compression through thickness failure, out-of-plane shear failure and in-plane tensile failure of the fibres located at the rear surface, where high tensile stresses develop. The results of this simulation show the capability of the methodology to capture the material failure mechanisms during penetration.

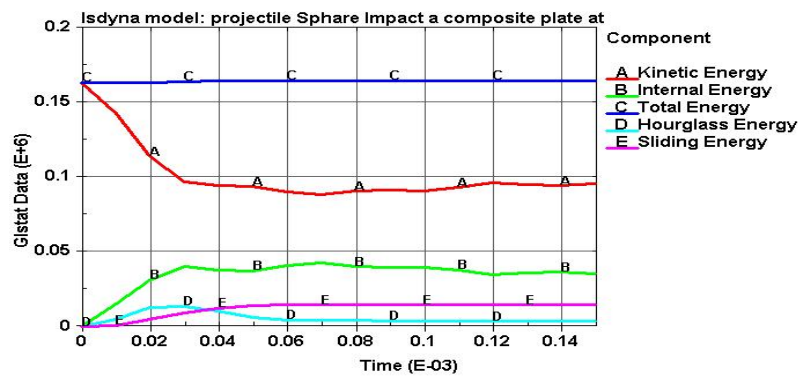
Fig. 8. Simulation results showing the global energy (J) versus time(s) for the 16 layer laminates.

The kinetic energy of the projectile is transferred to the target. Therefore, the kinetic energy of projectile will be reduced and the internal energy of the system will be increased as shown in Figure 8. Damage growth can be attributed to the combination of fibre failure modes. For example, the fibre crush provides high resistance to penetration which has been shown in Figure 8 as decrease of kinetic energy from 0 to 0.03. Figure 9 shows the comparison between experimental and simulation results for penetration processes in a specimen with initial velocity  $354\text{e}+3 \text{ mm/s}$ . Once the projectile impacts the target the fracture initiates immediately in the composite panel. These fractures occur within  $2\mu\text{s}$  and the projectile reaches the end of the target at  $30\mu\text{s}$ . The plug was formed and pushed in front of the projectile at  $60\mu\text{s}$  and the specimen completes the penetration at  $70\mu\text{s}$ .

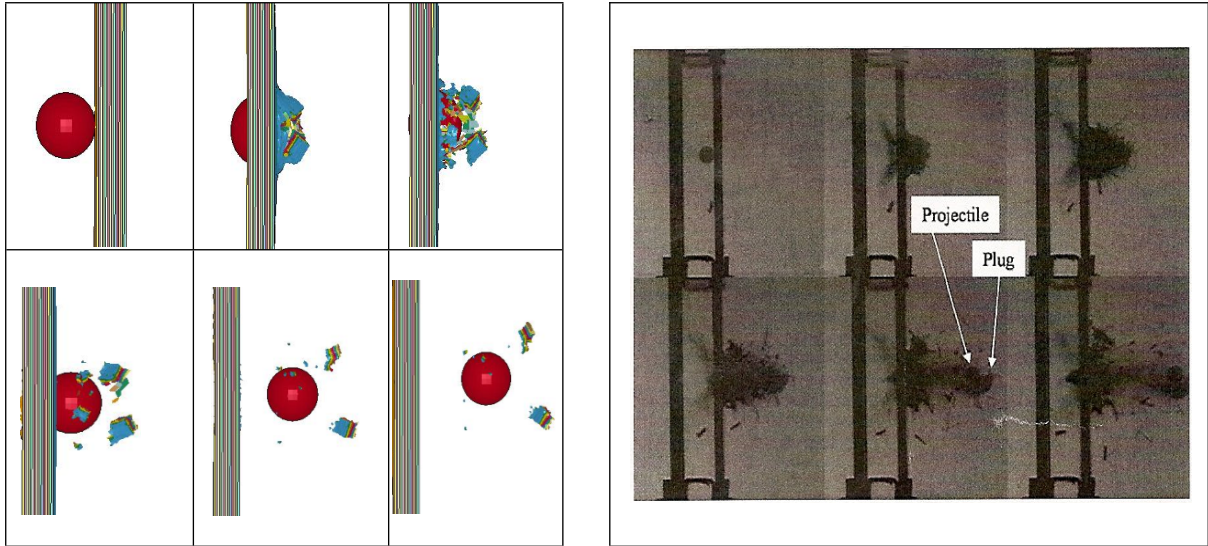
Fig. 9. Penetrations of CFRP laminate panel (a) simulation (b) experiment [42].

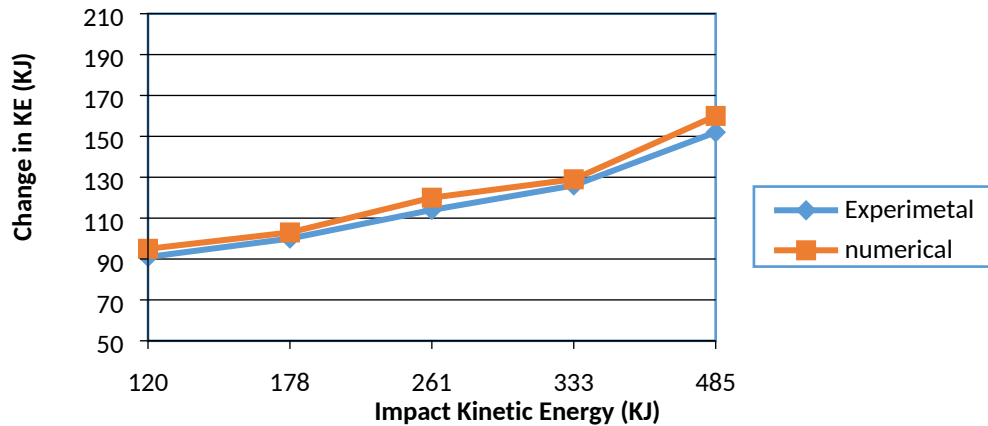
Fig. 10. The change in kinetic energy of the projectile against the initial impact energy between 120 kJ ( $v = 183\text{m/s}$ ) to 485 kJ ( $v = 368\text{m/s}$ ).

Figure 10 shows the variation of the change in kinetic energy versus the initial impact kinetic energy. This figure also compares the experimental and the simulation results for the change in kinetic energy. It can be seen that the results significantly matched in all simulated cases and the absorbed energy was adequately captured. The residual kinetic energy is 5.0 % larger than experimental data. This slight difference in the residual kinetic energy of the projectile can be attributed to neglect of the frictional energy of eroding elements surrounding the projectile during penetration, and/or the mesh size may not be refined enough for the penetration.

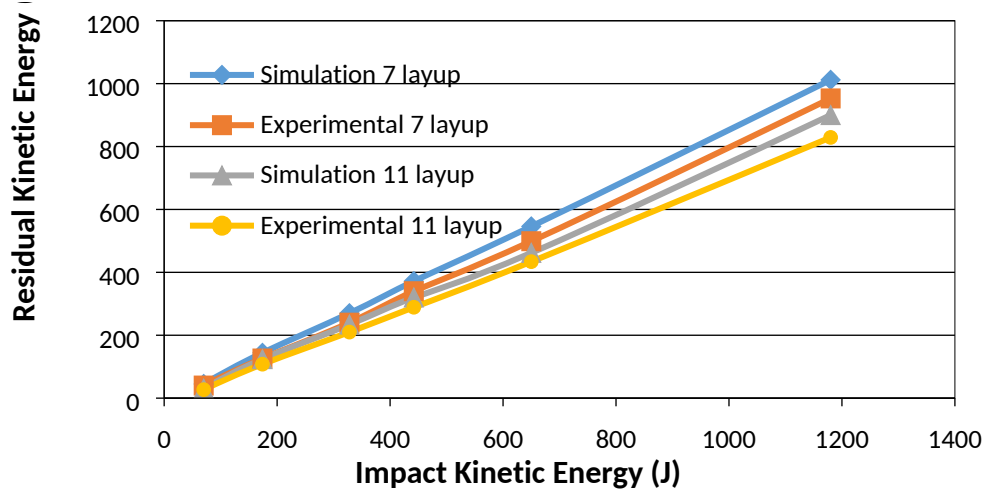
Fig. 12. The residual kinetic energy of the projectile against the initial impact kinetic energy for two different thickness composite panels: 2.625mm (7 layers) and 4.125 mm (11 layers).

This comparison shows the residual kinetic energy for the 7 layered CFRP composite panel is higher than other panel (11 layers), which is in line with the expectations. The difference indicates that the 11 layered CFRP composite panel provided better penetration resistance than the thinner with 7 layered panel. This behaviour of CFRP composite panels under high velocity impact shows the effect of the thickness of panels on residual kinetic energy. The residual kinetic energy of a projectile increases with increasing initial impact energy, which means the kinetic energy is absorbed by an increase in composite panel layers.

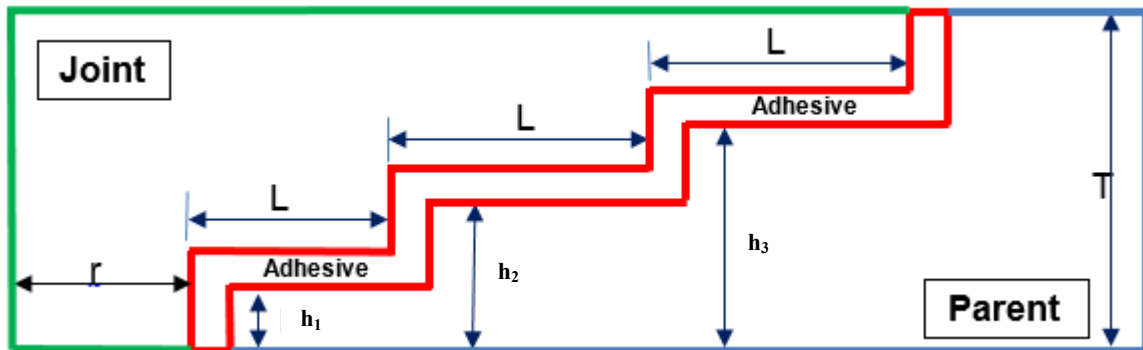
Fig. 14. Height and length of each step ( $n=3$ ). Total repaired composite panel thickness = 4.125mm, length (Tall) = 150 mm and adhesive thickness ( $D$ ) = 0.375mm.  $h_1=1.125$  mm,  $h_2=2.25$  mm and  $h_3=3.375$  mm.

The modelling of the geometry of repaired CFRP composite panel was carried out via the TRUGRID program. The geometry includes three steps as outer repaired area (parent part); hole area (joint part); and stepped area including the parent, joint, and adhesive parts. The number of steps ( $n$ ) can be defined as the number of horizontal length of steps ( $L$ ) and radius ( $r$ ) which are defined in Figure 14.

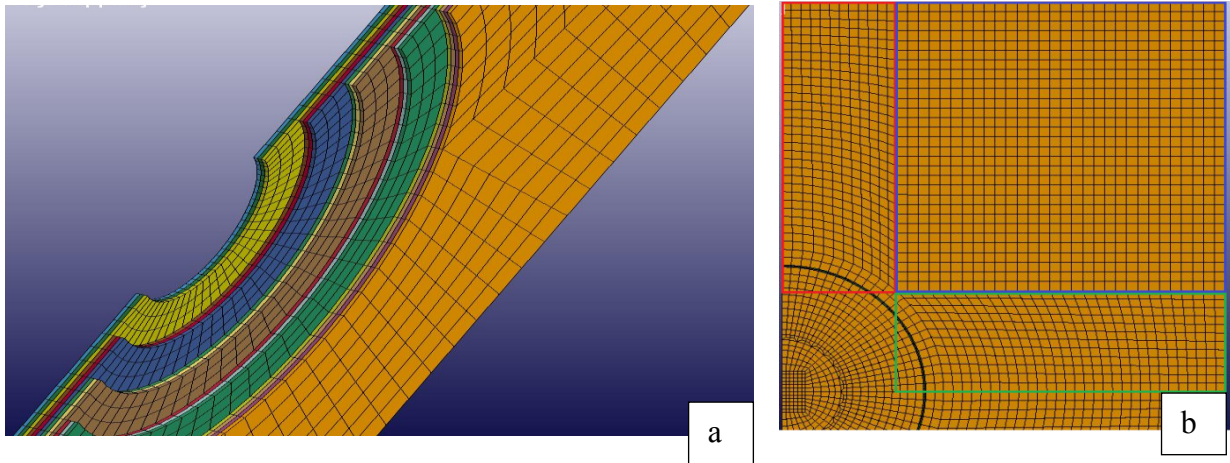
Fig. 15. Complete FE model for the parent part a) side view & b) top view.

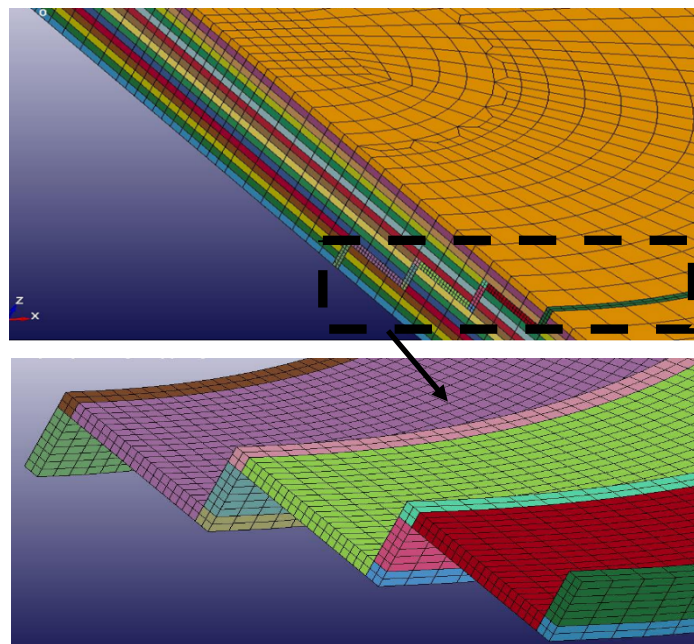
Fig. 16. Step area including joint area, adhesive area and parent area.

The step area was modelled using the sphere projection method and the transition block boundary interface technique (reduction element number), which reduced the number of elements to minimise the time cost. Figure 16 shows the quarter step area, including joint area, adhesive area and parent area, which is presented via the transition technique.

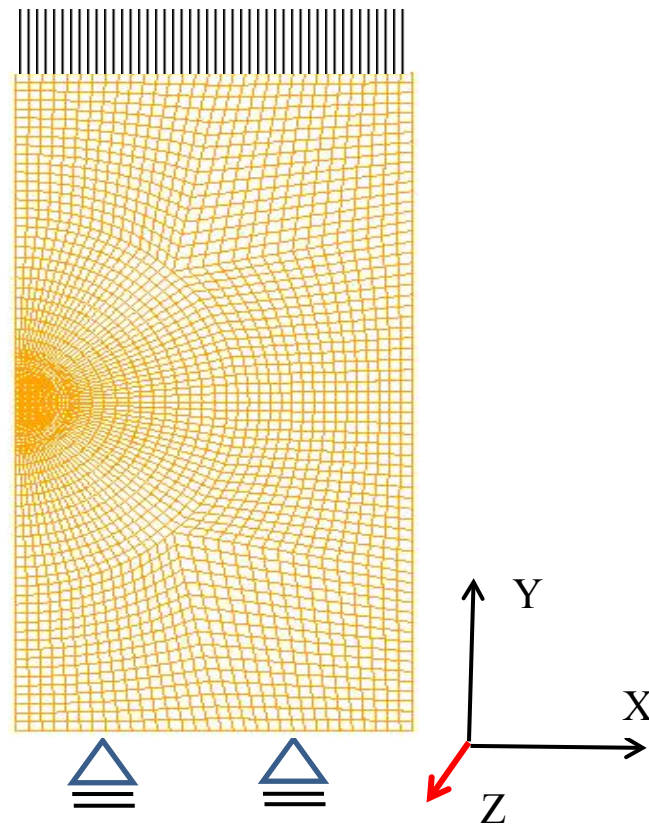
Fig. 17. Boundary conditions of the repaired CFRP composite panel.

Due to the symmetry assumption the panel was modelled as half specimen. The boundary condition of the model was clamped at one end and the load was applied to another end as shown in Figure 17.

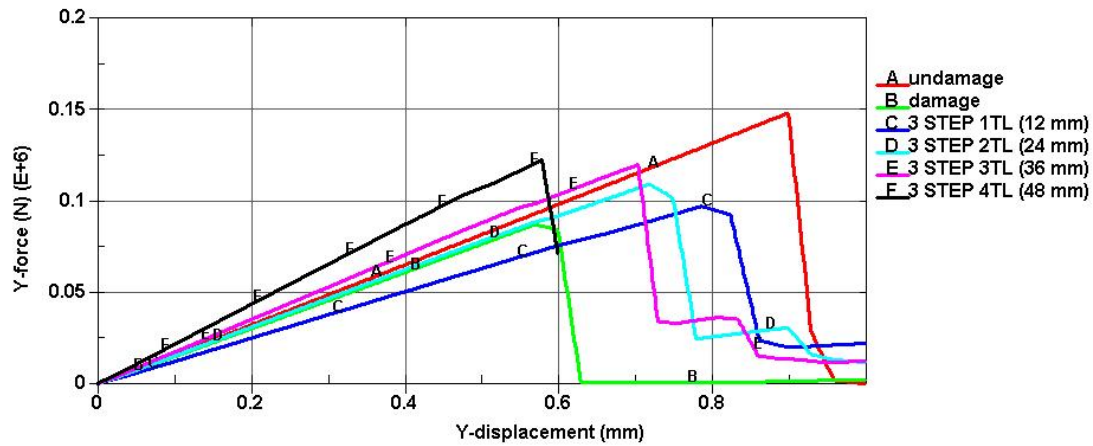
Fig. 18. Failure load versus displacement for various stepped lap joint.

Figure 18 shows the failure load of stepped joints (three steps) for various overlap lengths (TL). The failure loads increase when total overlap length increases from 12 mm to 48 mm as shown in Figure 18. The undamaged panel failed at an average of 450 (MPa) and damaged panel failed at a significantly smaller compression load compared to the panel, with an average reduction in peak load of 52%.

As seen in Figure 18 the stepped lap joint with the three different overlap lengths configuration was able to restore the compression failure load of the damaged panel to 82% of that for the undamaged panel. The compression failure load increases by 14% when the overlap length increases from 12 mm to 36 mm. However, further increases overlap length to 48 mm had no significant effect. Therefore it has been defined the optimal overlap length (36 mm) in the three stepped lap joint level. A typical compressive strength versus displacement is shown in Figure 19. It is apparent that the compressive strength of damage panel is much less than undamaged panel by 55 %. The compressive strength for repaired panel increase by 11 % when the overlap length increase from 12 mm to 24 mm. Then the compressive strength significantly decreased by 17% when the overlap length increases to 36 mm and 48 mm. The compressive strength of the repaired panel decreased slightly as a result of local buckling.

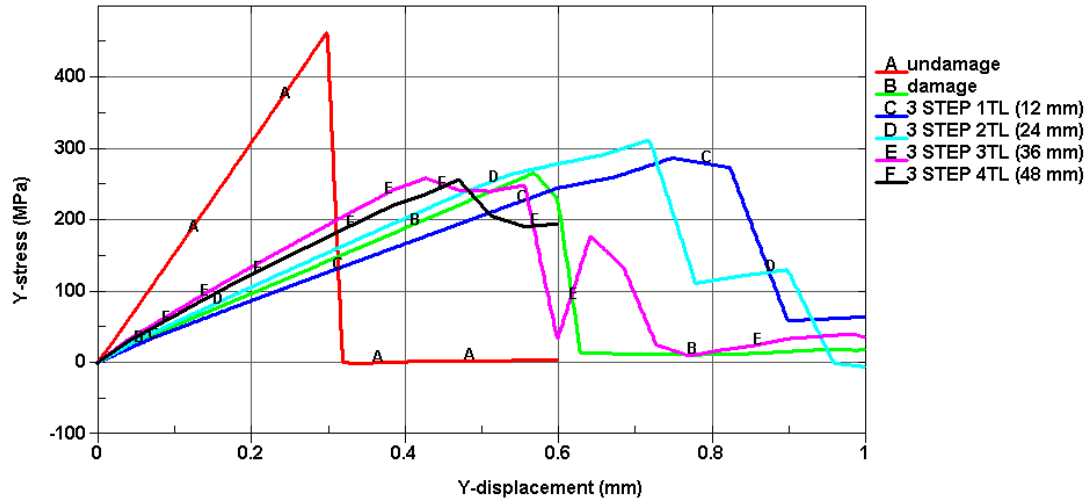
Fig. 19. Compressive strength versus displacement for stepped lap joint with different overlap length.

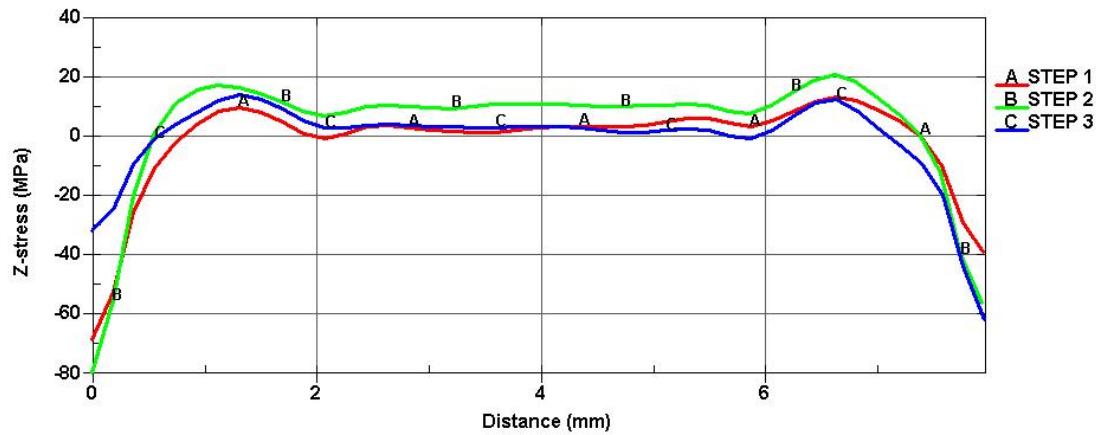
Fig. 20. Stress along the path line of mid-surface of the stepped lap joint.

Figure 20 shows the stress (z-direction) along the path line of mid-surface of various stepped lap joint. The peak stress at the end step explains why failure always initiates at the end step of the bonded region.

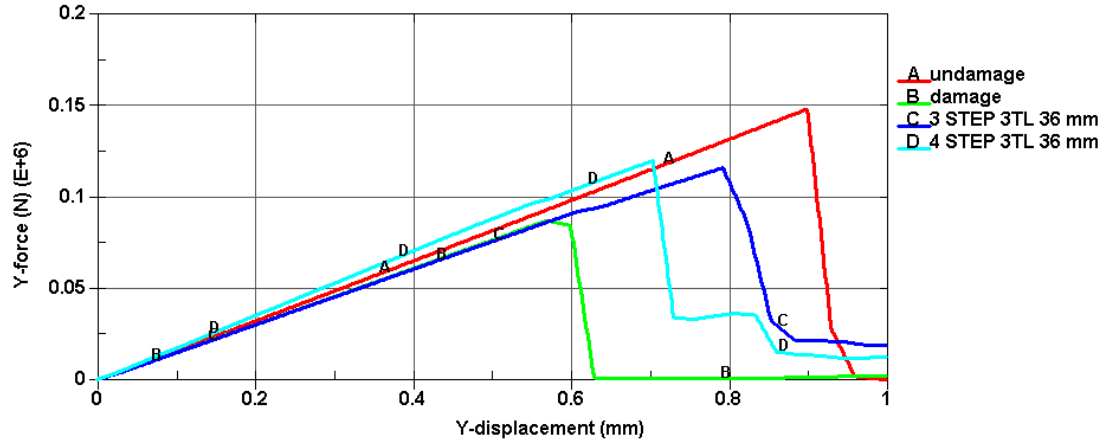
Fig. 21. Stress along the path line of mid-surface of the stepped lap joint.

Two main factors which have been studied in a repaired geometry were number of steps and overlap length. Figure 21 shows the overall stress level which increases with the increase of overlap length.

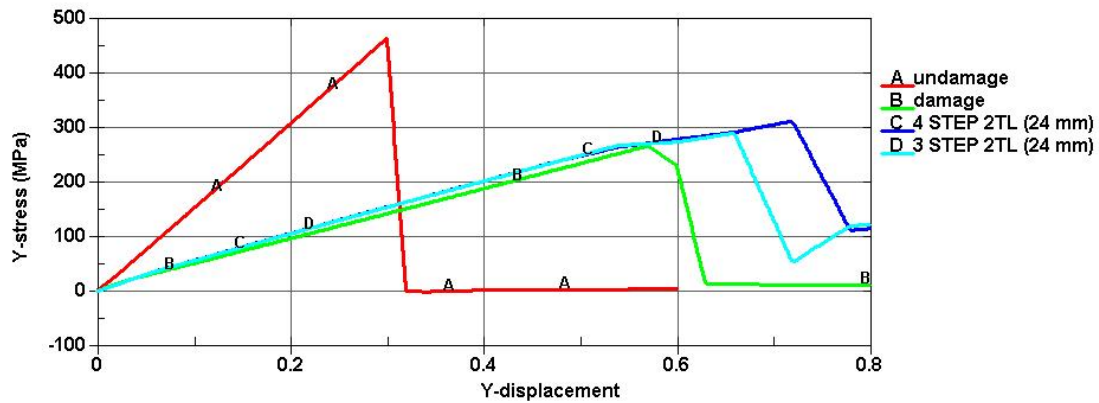
Fig. 22. Comparison between undamaged and damaged model with different steps.

Considering the results presented in Figure 22 in terms of repaired methods (number of step), for most of the joint geometries, the maximum joint failure load are found in the stepped lap joints with three steps by 82% from undamaged panel. When the number steps is three steps the failure load increased by 12.5 % from fourth step. The compressive strength for two different repair design methods (number of steps) are 280, and 310 (MPa). Typical load–displacement curves of stepped lap joints (four steps) under compression with different overlap length are shown in Figure 23.
