Recent experiences of helicopter main rotor blade damage

Abstract

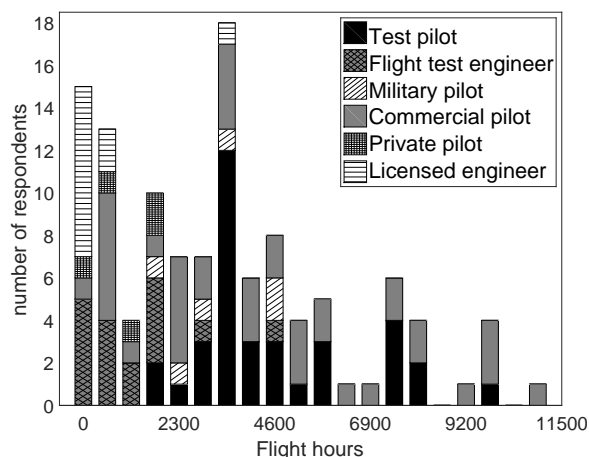
Fig. 1 Respondents flying experience.

In total 115 participants worldwide consisting of test pilots (30 %), flight test engineers (14 %), military pilots (5 %), commercial pilots (36 %), private pilots (4 %) and licensed engineers (11 %) answered the survey. Figure 1 show the distribution of the participants and their respective experience in terms of flight hours. Each target group provides valuable input based on their extensive flying experience, different operational tasks, maintenance expertise, and their ability to evaluate the helicopter’s performance and behaviour in a practical way. The participants cover a large variety of helicopters, ranging from a maximum take off weight (MTOW) of 600 kg up to 18,000 kg. Some of these pilots have flown over 100 different types of helicopters.

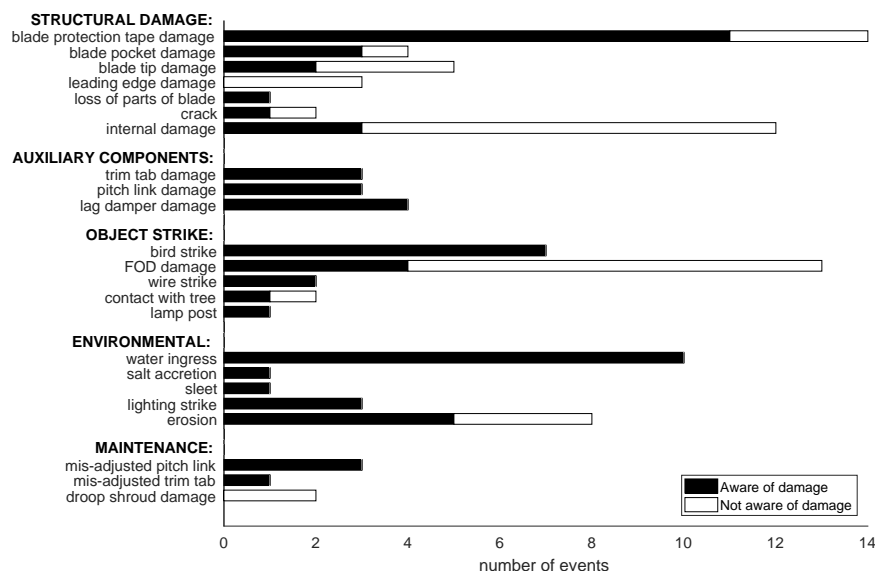
Fig. 2 Awareness of damage during flight for all occurrences.

Before questioning the participants on experienced rotor blade damage scenarios, they were asked to state whether they have ever flown a helicopter with a damaged rotor blade and whether they were aware of the damage in flight. Out of all respondents, 65 % had flown a helicopter with a damaged blade. In total 105 damage situations were reported and these were classified into five categories: structural damage (39 %), auxiliary components (10 %), object strike (24 %), environment (22 %), and maintenance/ground handling (6 %). A detailed breakdown of these damage types is presented in Fig. 2. It should be noted that not all damage events were noticed by the pilot or crew. Altogether 33 % of the participants were not aware of the damage during flight. This feedback confirms that minor defects do not change the blade rotational frequencies significantly due to the high centrifugal loading [10] and hence, is not noticeable by the pilot or crew. Interestingly all leading edge damage or droop shroud damage went unnoticed in flight. It can be seen that the most common damage events (14 out of 105) are caused by debonding or complete loss of the blade protection tape. FOD was reported 13 times, internal damage 12 times and water ingress 10 times, followed by bird strikes and erosion which both occurred 7 times. The survey results showed that 9 out of the 12 reported internal damage occurred on composite rotor blades and in only one case the

pilot was aware of damage. It is interesting to note that external causes are considerably greater than those due to cracks and internal damage, which account for only 13 % of all listed damage events.

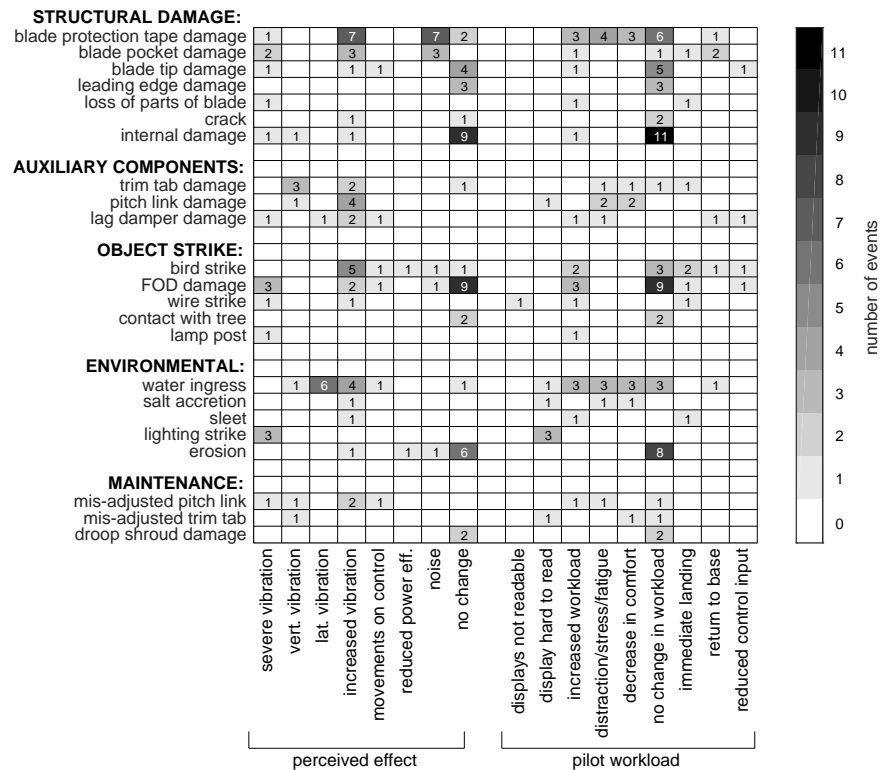
Fig. 3 Damage linked to perceived effects and pilot workload.

The results of the survey have been arranged into different groups relating to pilot perception and workload (Fig. 3). It can be seen that most of the damage is immediately felt by the pilot either through increased vibration or noise. The relationship of how damage affects pilot workload highlights that most internal damage and all erosion type damage resulted in no additional workload even though vibration was evident.
