Strain and damage monitoring in CFRP fuselage panels using fiber Bragg grating sensors. Part I: Design, manufacturing and impact testing

This is the first paper of a two-paper series describing design, implementation and validation of a strain and damage monitoring system for CFRP fuselage stiffened panels based on fiber optic Bragg grating sensors. The monitoring system was developed and tested on the basis of three load-scenarios: compression to failure of the undamaged panel, compression to failure of the impacted panel and compression to failure of the impacted and fatigued panel. This paper focuses on the design of the fuselage panel, the design of the monitoring system, the embedment of fiber sensors in the panel during manufacturing and the impact testing. The network of the sensors was designed based on a numerical buckling analysis from which the strain field of the panel was computed as a function of the applied compressive load. Embedment of fiber sensors in the panel was done so as to minimize risk of fiber breaking during manufacturing and impact testing and to effectively capture strains that are representative of damage developed in the panel due to compressive load

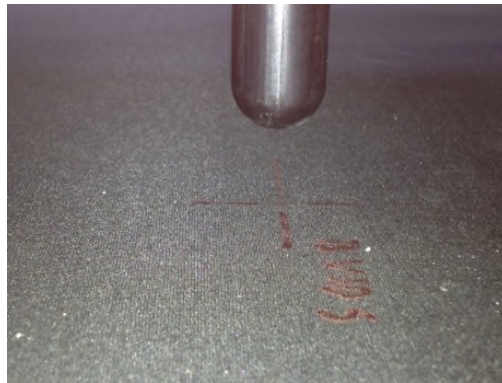
Fig.15

- Fig.15: Photo of the impactor above BVID5 location.
- Fig.16: Photo of the panel supported by the metallic device just before subjected to impact testing.

Impact damage was created in panel_2 and panel_3 using an INSTRON Dynatup 9250 HV drop tower. Several experiments were conducted to create BVID and VID sites at the specified locations indicated in Fig.6 using a semi-circular impactor with a diameter of 16 mm (Fig.15). During testing force and energy versus time and deflection were recorded. A full lateral support at the large sides of the panels was applied during impact. To apply these boundary conditions, the special metallic device shown in Fig.16 was built.
