The response of aluminium/GLARE hybrid materials to impact and to in-plane fatigue

Keywords: Bonded hybrids; Damage tolerance; Fatigue crack growth; Fibre Metal Laminates; Impact

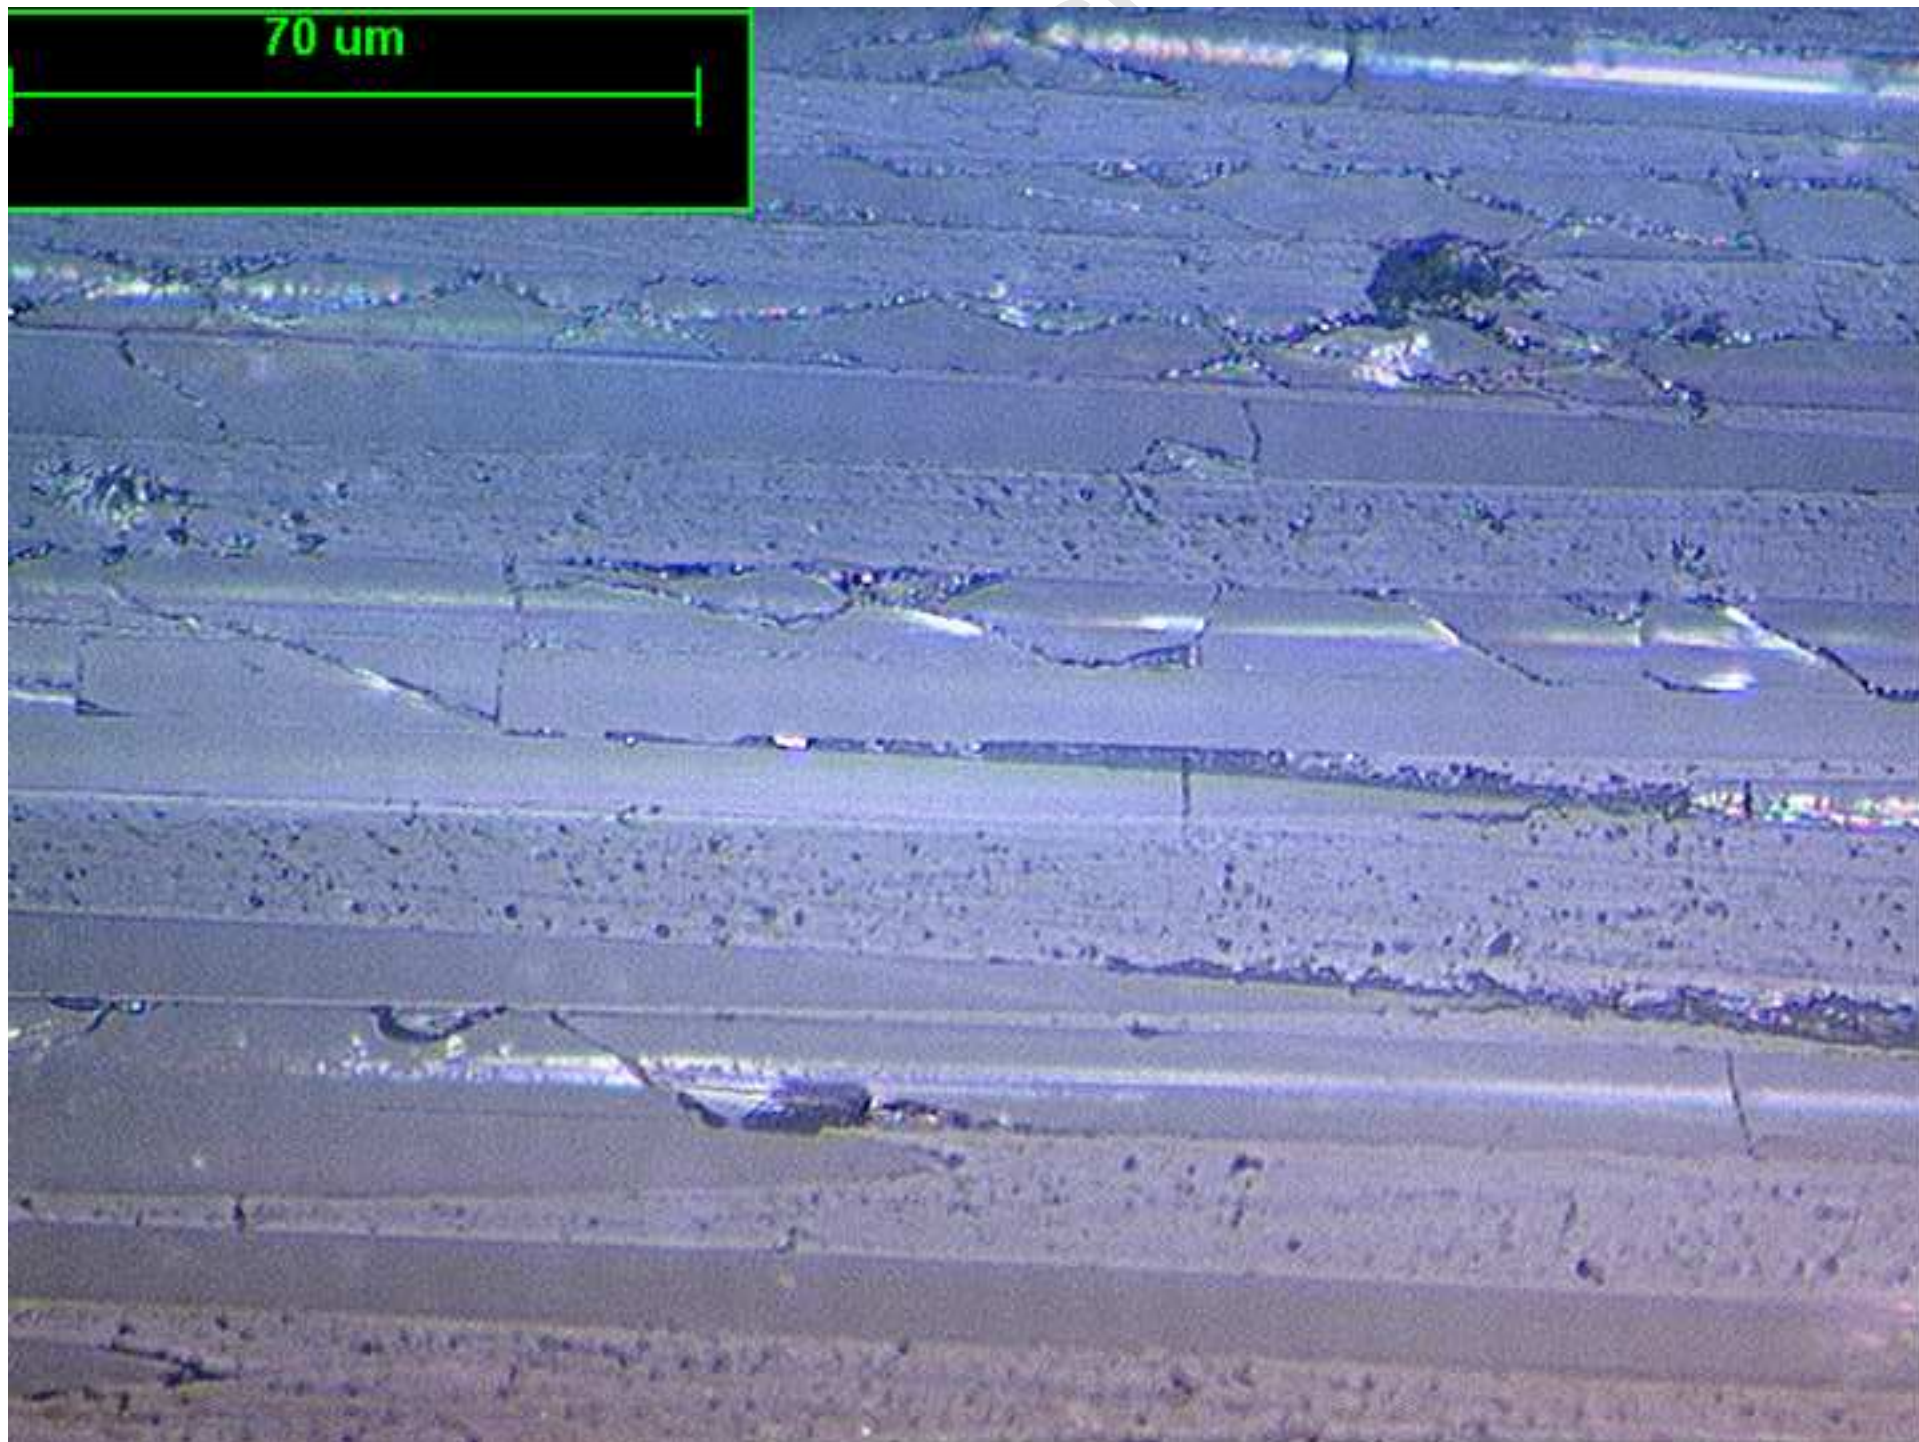
Figure 13 Changes in fatigue crack growth rate in substrate caused by the retardation action of the strap. Fatigue crack growth rates in 7085 without a bonded strap are also shown for comparison.
